Tote, Inc.’s Response to the National Cargo Bureau, Inc.’s “Report on Review of Cargo Securing Manual and Cargo Stowage and Securing” dated August 4, 2016

On August 9, 2016, the National Transportation Safety Board (“NTSB”) posted on Accellion a report produced by the National Cargo Bureau, Inc. (“NCB”), dated August 4, 2016, and entitled “Report on Review of Cargo Securing Manual and Cargo Stowage and Securing” (“NCB Report”).

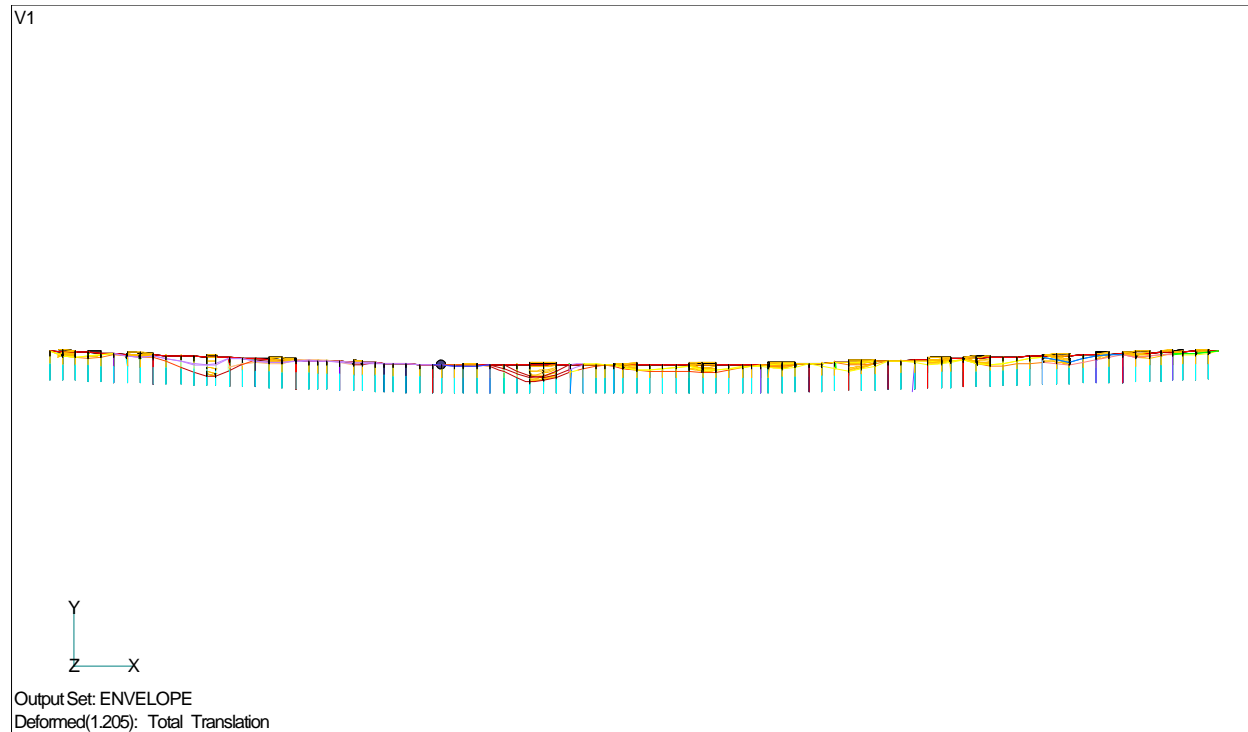
Figure 5 – Deflected model

At these locations the container supports are located between pillars, both at centerline and at the side girders, therefore allowing larger deflections than in most places where there are pillars either at or very

close to the container supports. These areas also correspond to areas in need of reinforcement as is explained later.

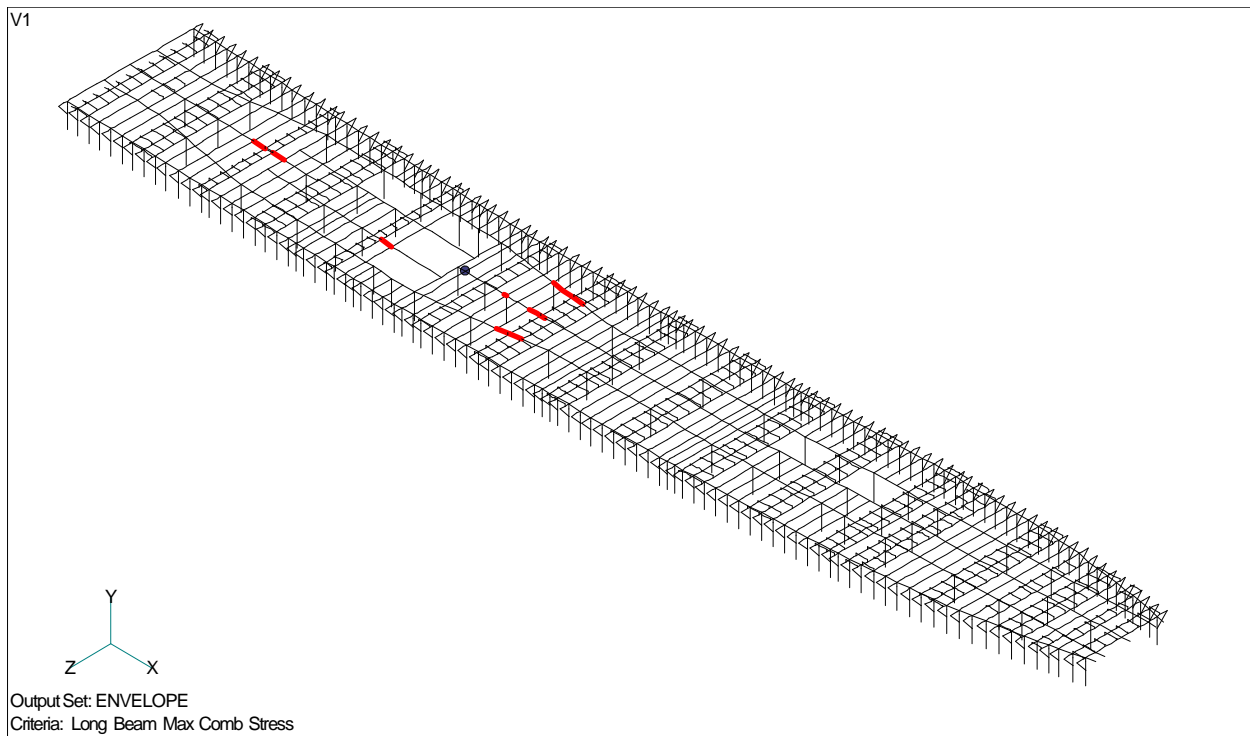
Figure 6 - Failed Longitudinal Members

Table 1 - Failed longitudinal and transverse members

Ref #	Frame Location	Scantling	Top FEM Stress	Bottom FEM Stress	Allowable Stress	% overstressed at top	% overstressed at bottom	Axial Stress	Allowable	% overstressed
13	34 CL	12x79#	18.70	18.06	20.16	-7.26%	-66.56%	17.19	13.03	31.94%
16	82 CL	14x84#	17.99	15.62	20.16	-10.78%	-71.07%	14.14	13.04	8.41%
18	138 S	12x85# with doubler	23.37	13.85	20.16	15.93%	-31.28%	5.55	14.24	-60.99%
22	215 P	14x127#	21.99	14.62	20.16	9.10%	-27.49%	10.79	13.92	-22.47%
23	215 S	14x127#	21.96	15.62	20.16	8.90%	-22.54%	10.73	13.92	-22.91%
24	234 CL	14x95#	19.16	16.87	20.16	-4.96%	-16.33%	15.00	13.87	8.12%

Upgrades for the overstressed details are detailed in Table 3. The repairs are mostly doubler plates on the flanges of the overstressed members. The exceptions are the pillars that fail the buckling criteria, where extra flanges are fitted on the flanges of the I-beams to give the members extra support in the weak direction.

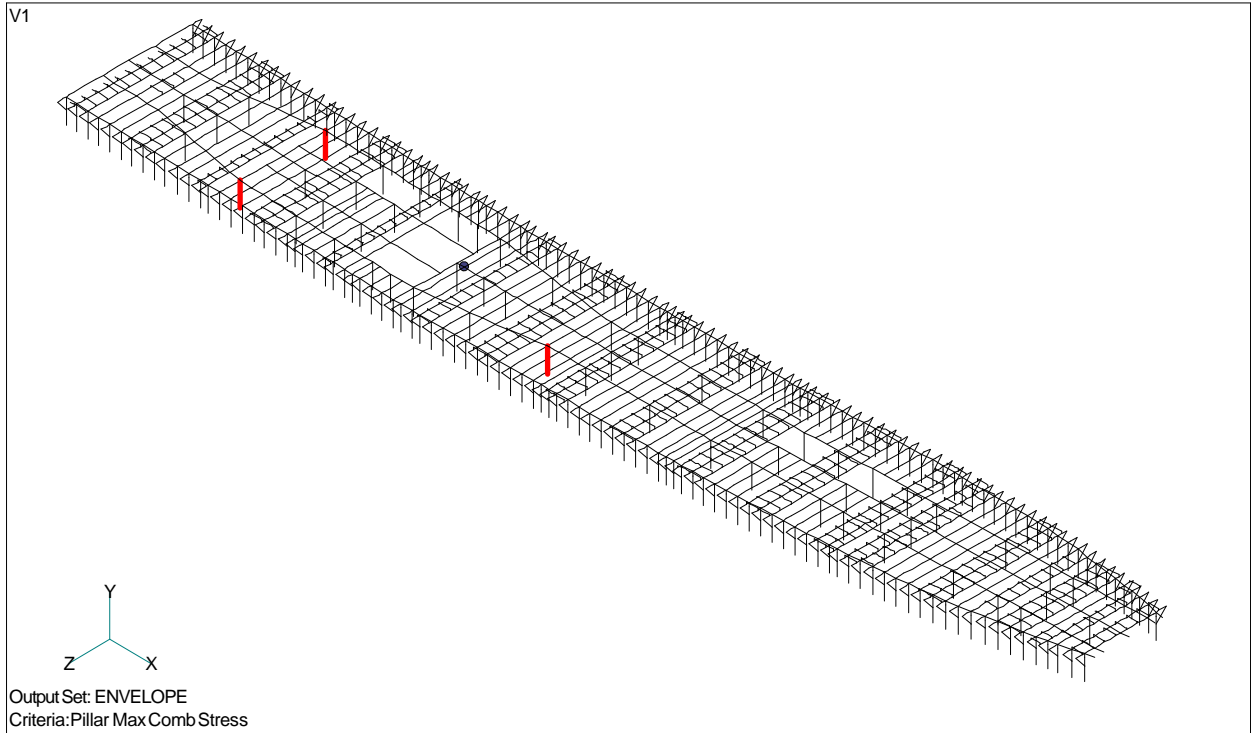
Figure 8 - Failed Pillars – combined stress evaluation criteria

Table 2 - Failed pillars

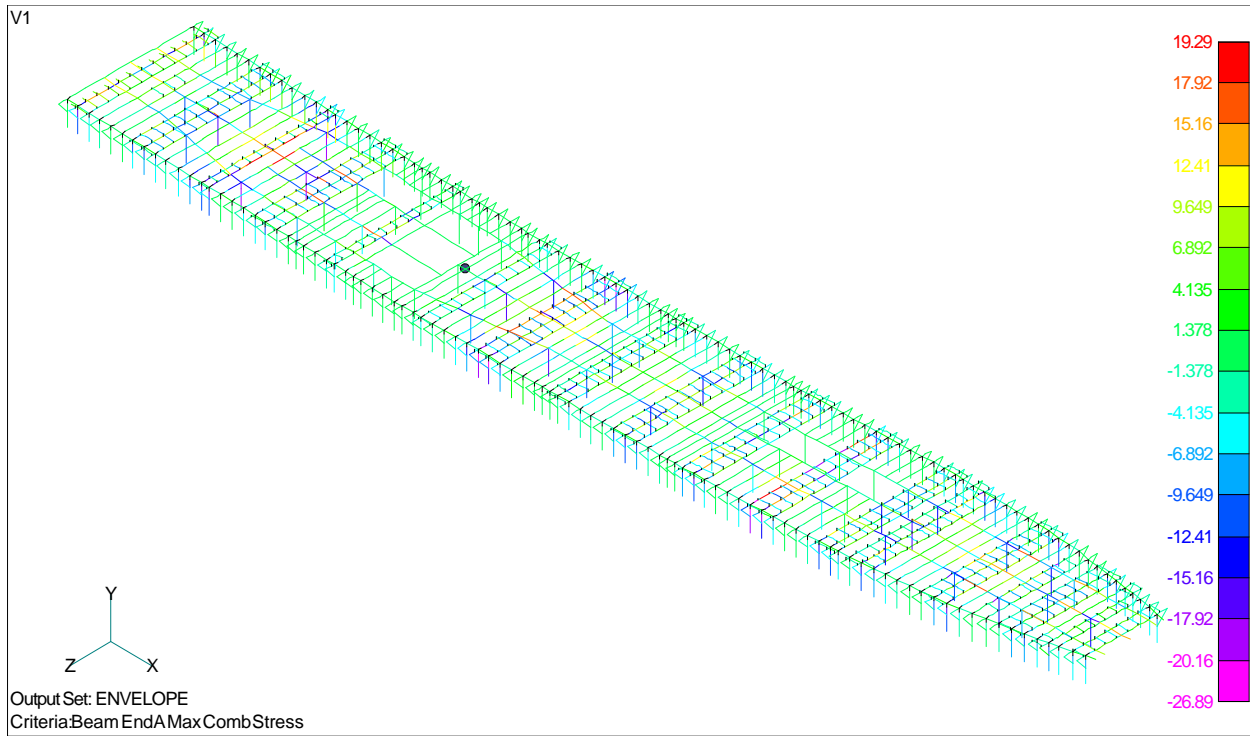
Figure 10 - Maximum combined stresses for all load cases

There are some high compressive stresses reported in the side shell elements at the location of the large deck bracket on Frames 144 and 147. These stresses occur at locations where the support from the bracket will give enough stress relief that this is not an issue.

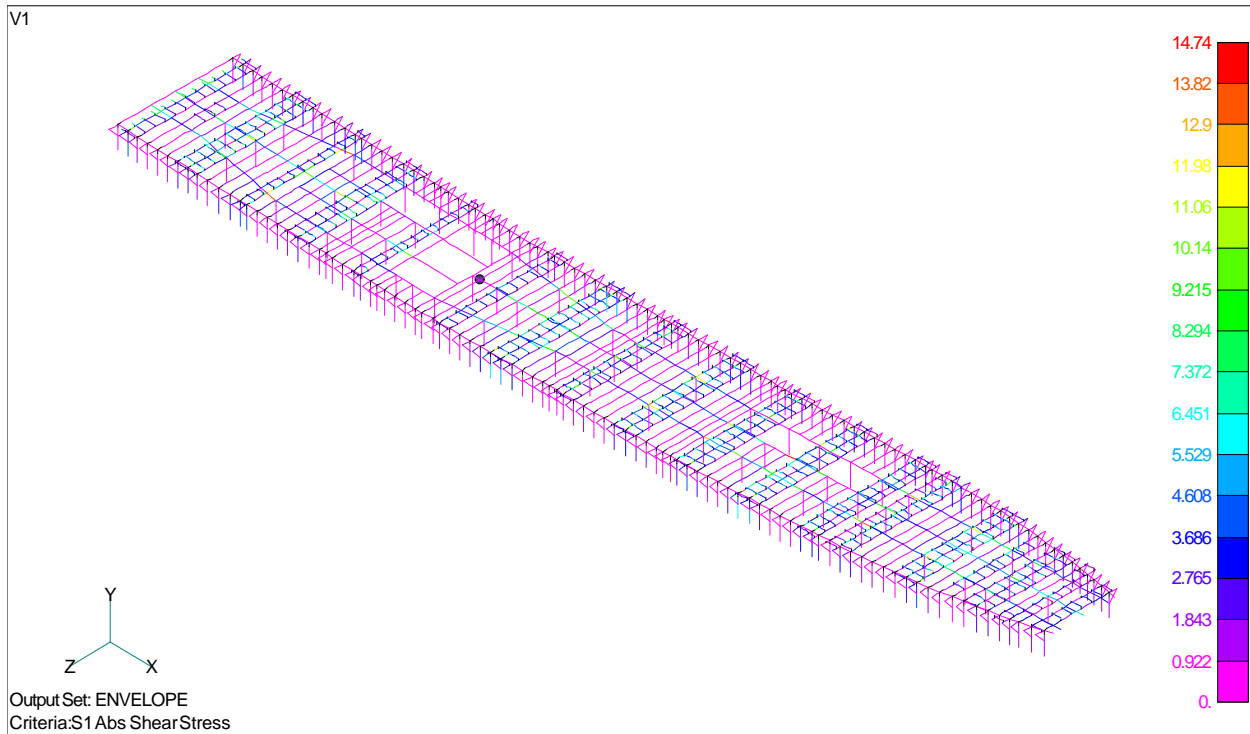
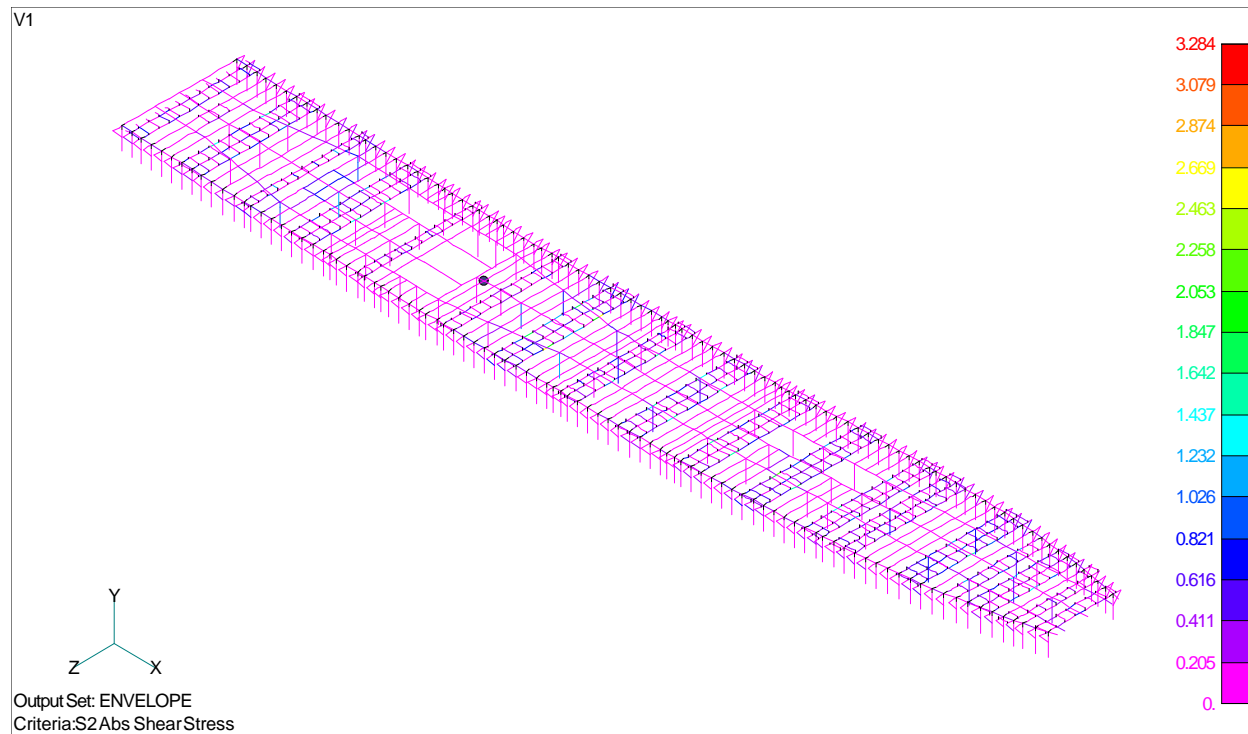
Figure 11 and Figure 12 show the maximum shear stresses from all load cases in the two primary element directions. All shear stresses are below the limit of 15 ksi.
