Tote, Inc.’s Response to the National Cargo Bureau, Inc.’s “Report on Review of Cargo Securing Manual and Cargo Stowage and Securing” dated August 4, 2016

I. OVERVIEW

On August 9, 2016, the National Transportation Safety Board (“NTSB”) posted on Accellion a report produced by the National Cargo Bureau, Inc. (“NCB”), dated August 4, 2016, and entitled “Report on Review of Cargo Securing Manual and Cargo Stowage and Securing” (“NCB Report”).

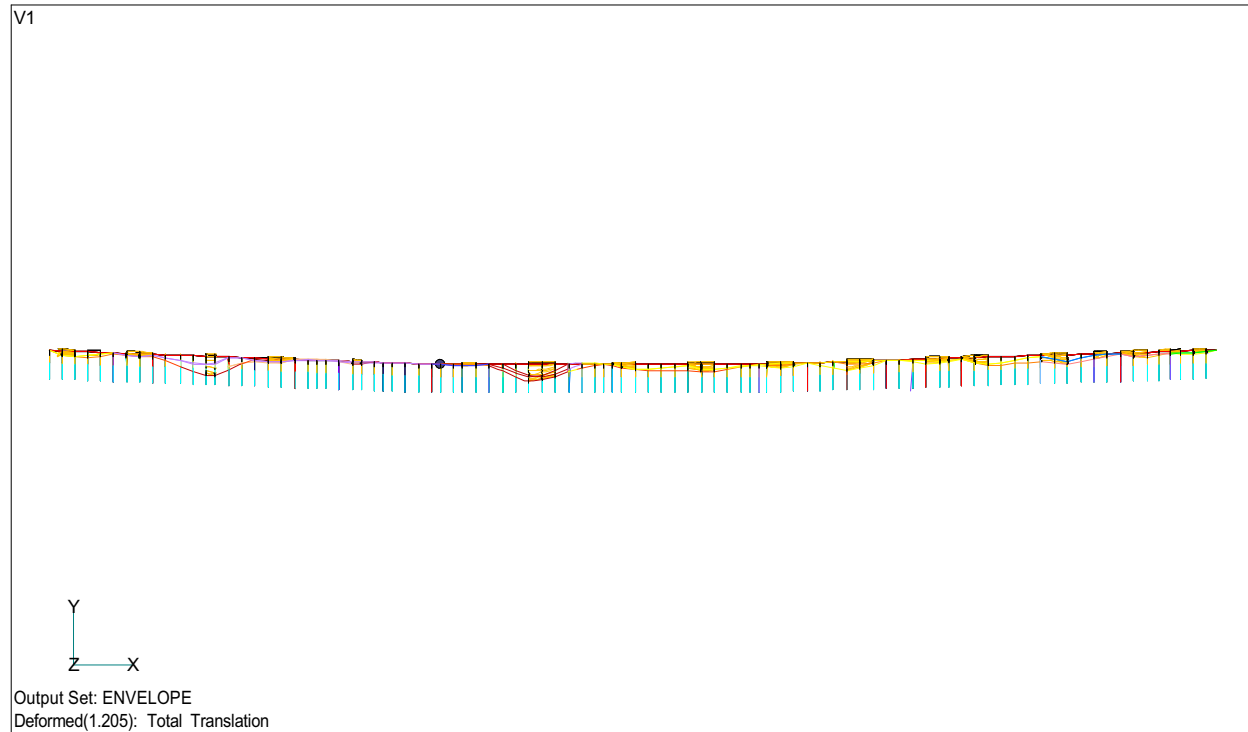
Figure 5 – Deflected model

At these locations the container supports are located between pillars, both at centerline and at the side girders, therefore allowing larger deflections than in most places where there are pillars either at or very

close to the container supports. These areas also correspond to areas in need of reinforcement as is explained later.

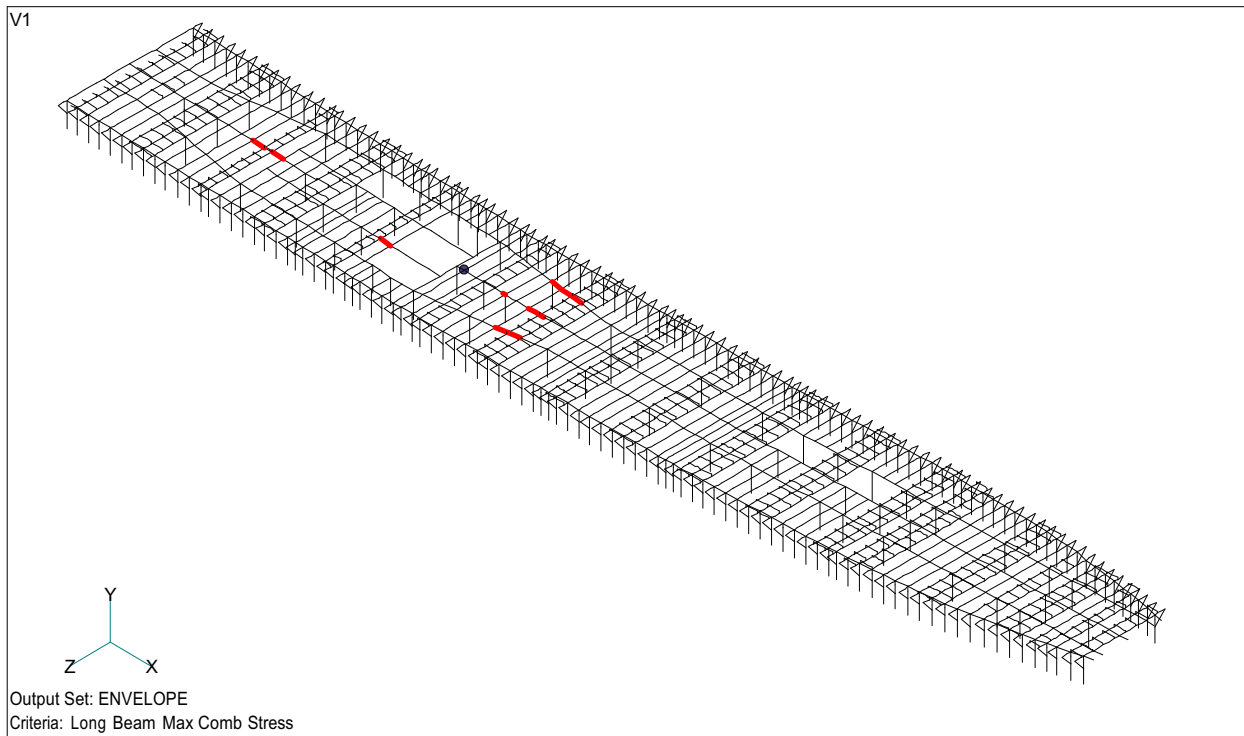
Figure 6 - Failed Longitudinal Members

Table 1 - Failed longitudinal and transverse members

Ref #	Frame Location	Scantling	Top FEM Stress	Bottom FEM Stress	Allowable Stress	% overstressed at top	% overstressed at bottom	Axial Stress	Allowable	% overstressed
13	34 CL	12x79#	18.70	18.06	20.16	-7.26%	-66.56%	17.19	13.03	31.94%
16	82 CL	14x84#	17.99	15.62	20.16	-10.78%	-71.07%	14.14	13.04	8.41%
18	138 S	12x85# with doubler	23.37	13.85	20.16	15.93%	-31.28%	5.55	14.24	-60.99%
22	215 P	14x127#	21.99	14.62	20.16	9.10%	-27.49%	10.79	13.92	-22.47%
23	215 S	14x127#	21.96	15.62	20.16	8.90%	-22.54%	10.73	13.92	-22.91%
24	234 CL	14x95#	19.16	16.87	20.16	-4.96%	-16.33%	15.00	13.87	8.12%

Upgrades for the overstressed details are detailed in Table 3. The repairs are mostly doubler plates on the flanges of the overstressed members. The exceptions are the pillars that fail the buckling criteria, where extra flanges are fitted on the flanges of the I-beams to give the members extra support in the weak direction.

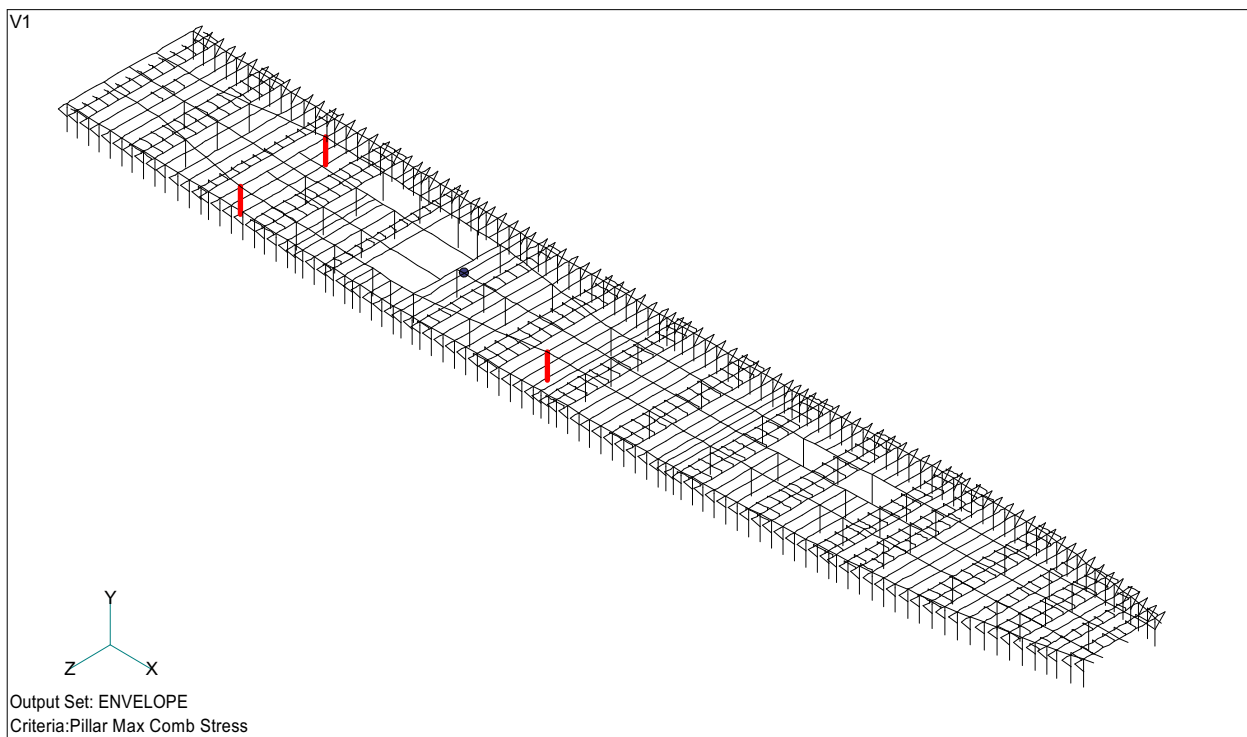
Figure 8 - Failed Pillars – combined stress evaluation criteria

Table 2 - Failed pillars

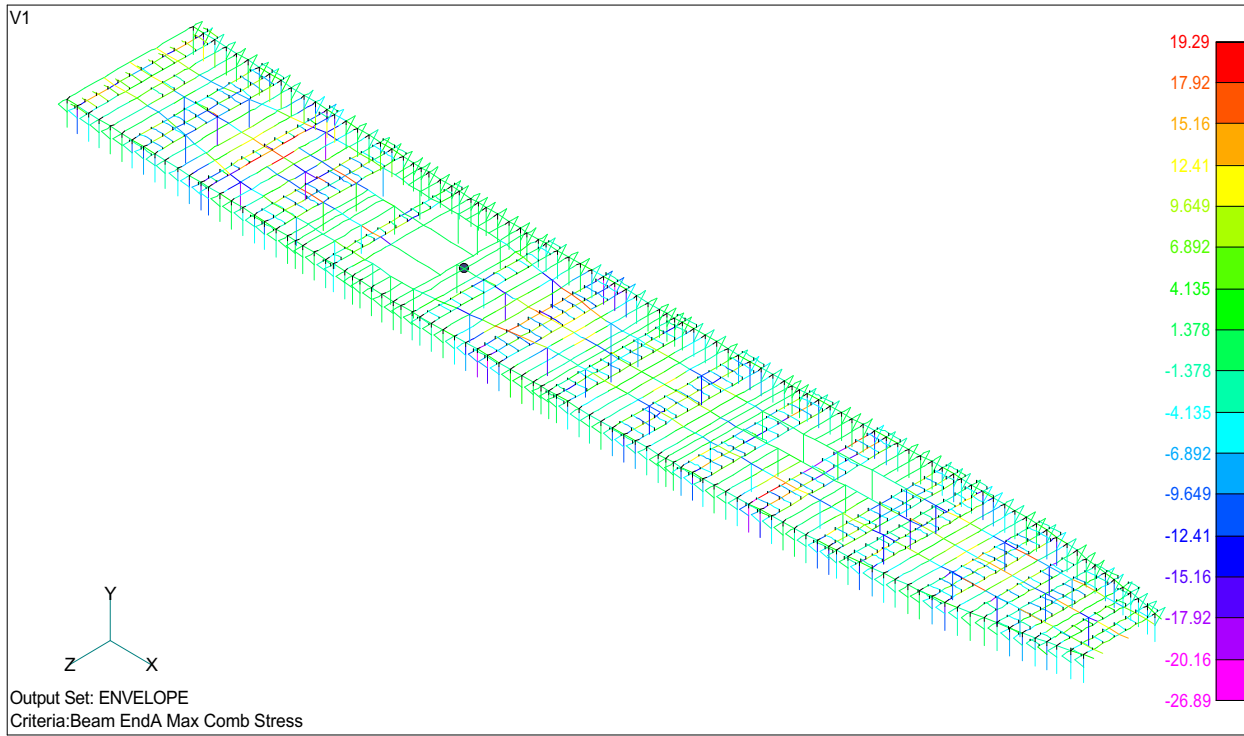
Figure 10 - Maximum combined stresses for all load cases

There are some high compressive stresses reported in the side shell elements at the location of the large deck bracket on Frames 144 and 147. These stresses occur at locations where the support from the bracket will give enough stress relief that this is not an issue.

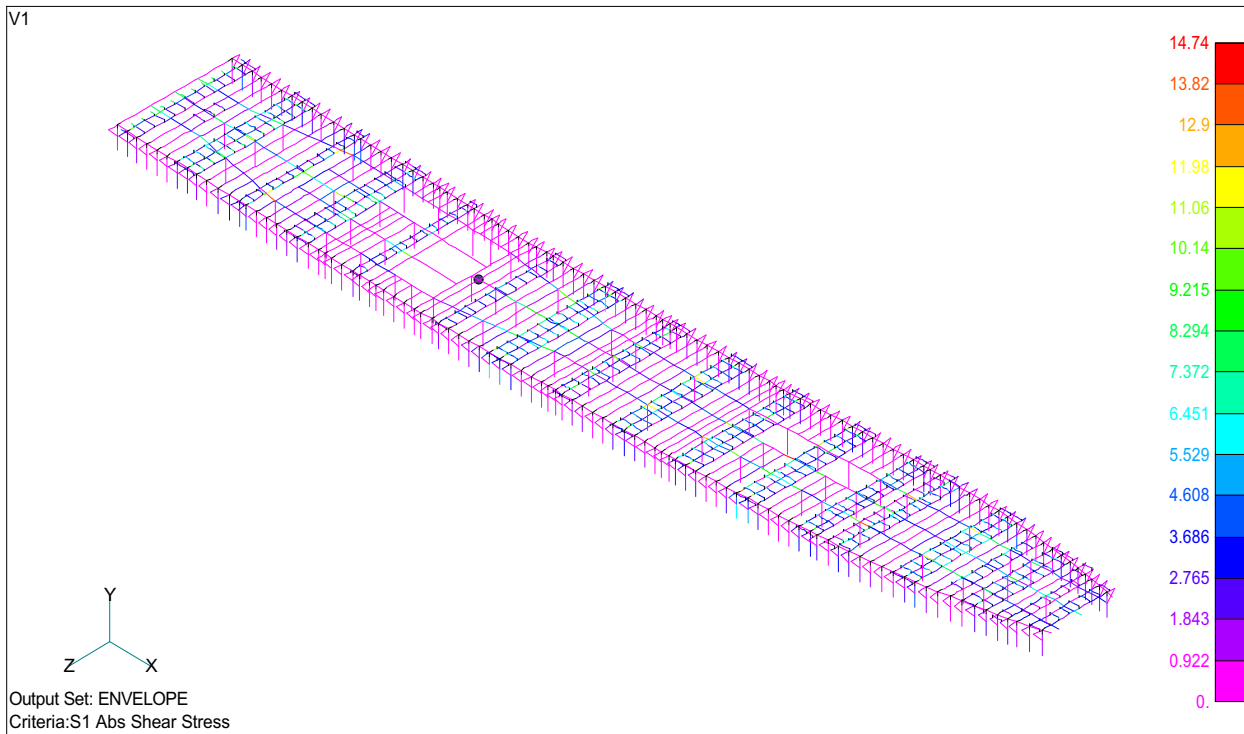
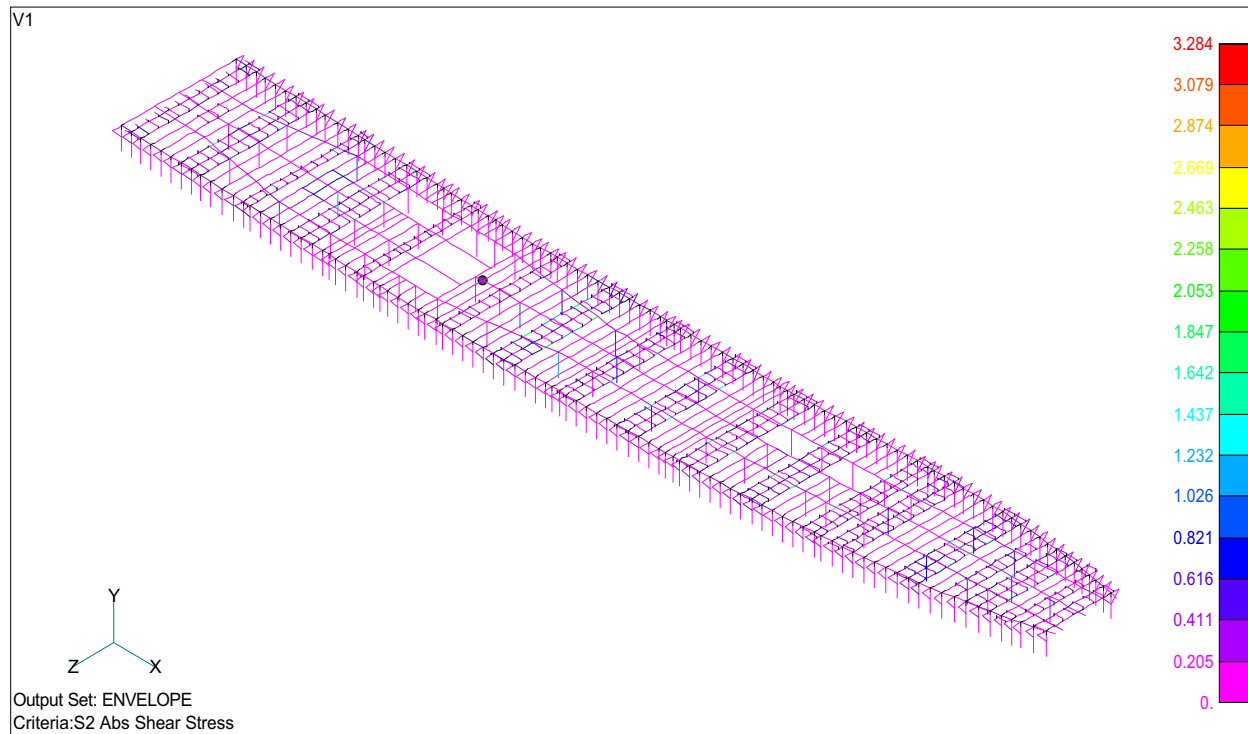
Figure 11 and Figure 12 show the maximum shear stresses from all load cases in the two primary element directions. All shear stresses are below the limit of 15 ksi.
