1 **National Transportation Safety Board**

5
6
7
8
9
10 **Group Chairman’s Factual Report**

11
12
13
14 **Operations Group**
15

16
17
18
19 *Stretch Duck 7*

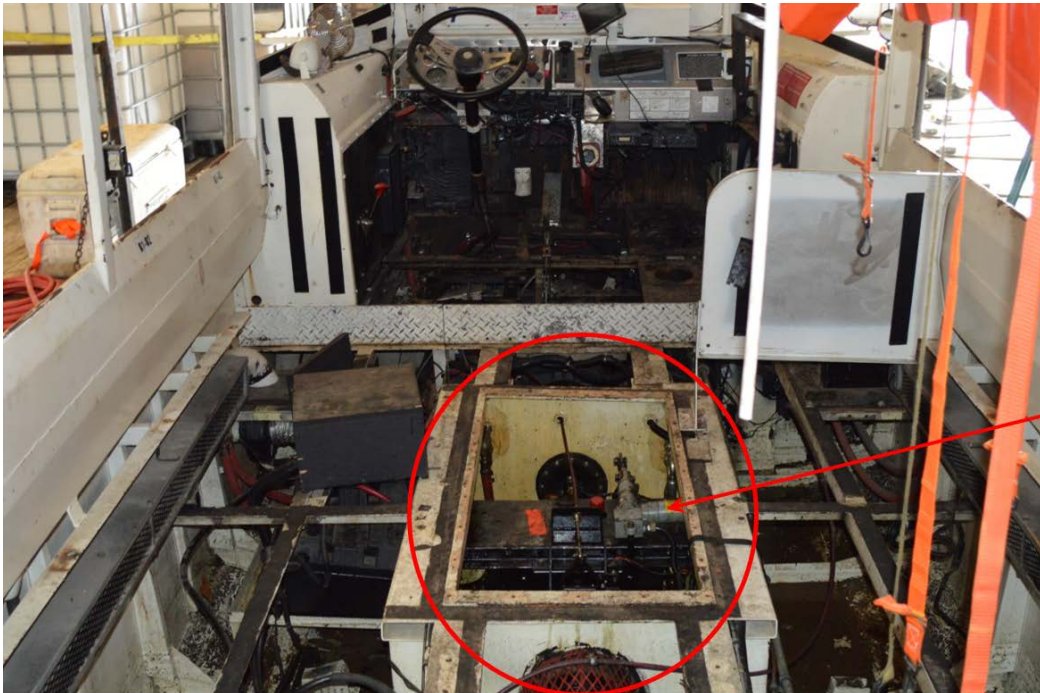
4
5 ***Stretch Duck 7's* sea chest after the vessel's salvage. The sea chest is the wintertight box on the**
6 **centerline, indicated by the red circle and arrow. (Photo by MSHP)**

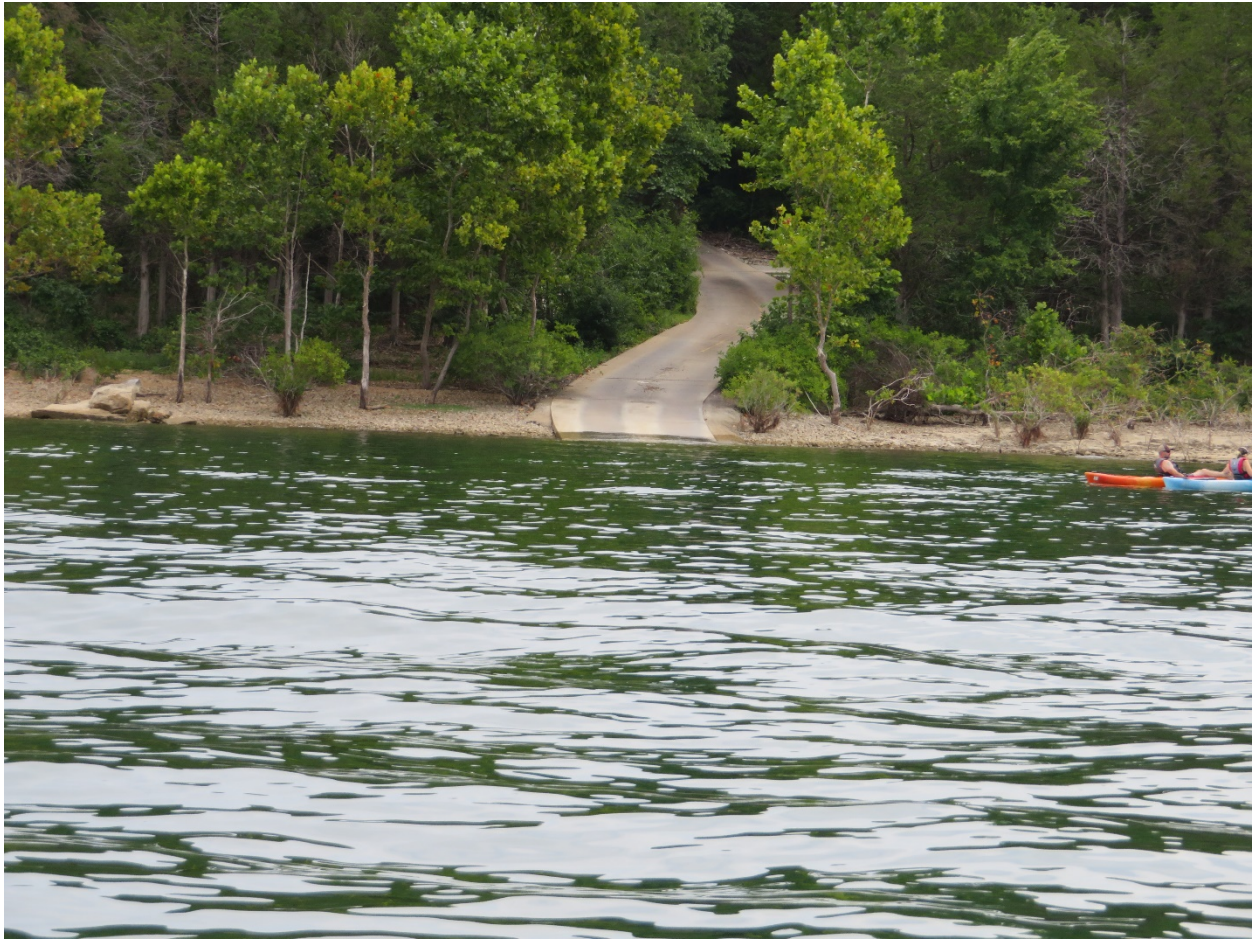
9 **Duck entrance ramp, south of *Showboat Branson Belle*. Picture taken days after the accident.**

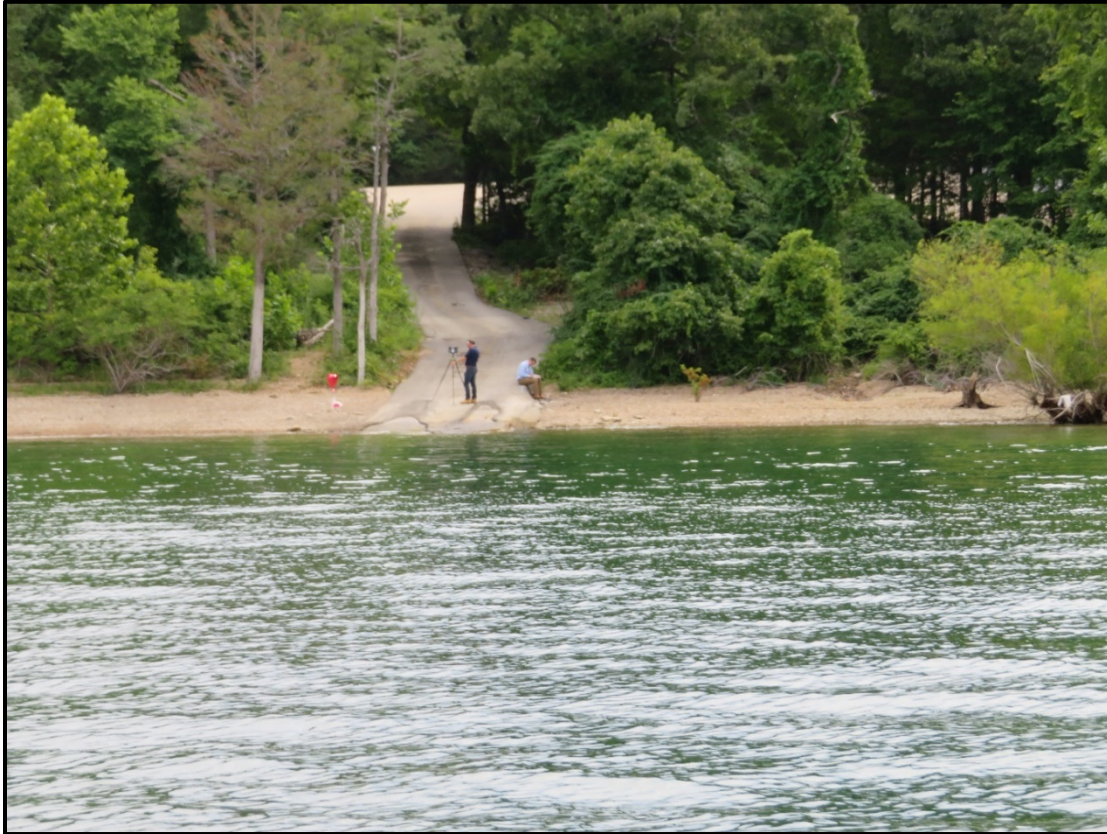
6 **The north exit ramp, seen from the vicinity of the sinking after the accident**
