Porto di visita <i>Port of survey</i>	Data della visita <i>Date of survey</i>	Pratica <i>File</i>			
		16	XL	305	01
San Juan, PR	02/09/2016

<b>Nome Nave</b> Caribbean Fantasy <i>Name of ship</i>	<b>Numero RINA</b> 76747 <i>RINA Number</i>
---	--

With reference to the previous report - VISITE 2 , issued on 24 August 2016, following continuation of the surveys carried out at the owner's request, we did attend onboard the M/V CARIBBEAN FANTASY - IMO 8814263, while she was berthed at pier 15, San Juan, PR on 01/09/2016 in order to inspect the structural damages sustained from the fire, which started in the Engine Room and spread to other compartments on 17/08/2016.

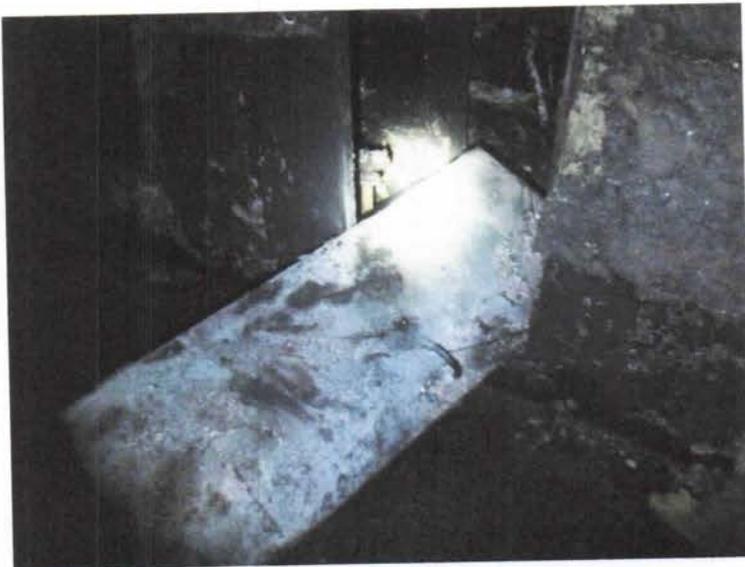
1. Cargo Deck C: No structural damages. However some fiber/plastic pipes for sewage located in overhead are melted. Cargo deck is covered with soot.
2. Cargo Deck B: Bunker Station (Port Side): Door pushed out and off the hinges.

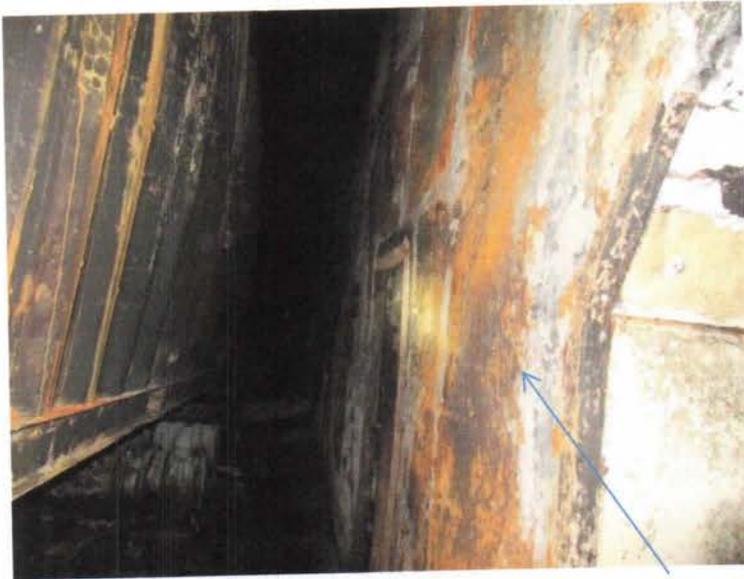
Longitudinal bulkhead

The corresponding longitudinal bulkhead of the bunker station is deformed from fr. 72-83 due to the intense heat

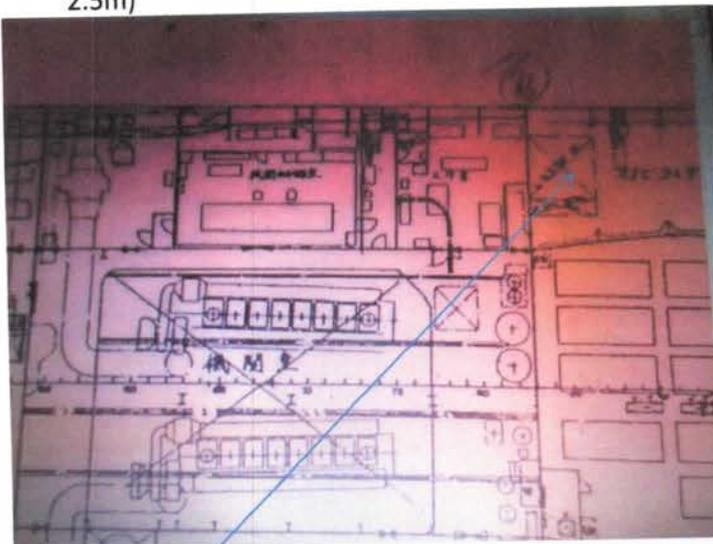
Lube oil storage tank port  
Form VISITE 2 – 02/2015

- Upper deck longitudinals located over aft portion of the port Main Engine are deformed but intact
- Transverse deck girder 6-8 (counting from aft WT Bulkhead at frame 54) are deformed but intact
- Fwd transverse WT bulkhead port side at frame 83 upper portion is deformed from the 2<sup>nd</sup>-10<sup>th</sup> deck longitudinal (counting from outboard-inboard). This is approximately 2.5m long. Maximum depth of deformation is approximately 35-40mm
- The aft bulkhead of the Port Lube oil storage tank which is integral with the WT bulkhead at fr. 83 (see below drawing) the maximum depth is about 35-40mm. Deformations are along the aft bulkhead (approximately 2.5m)

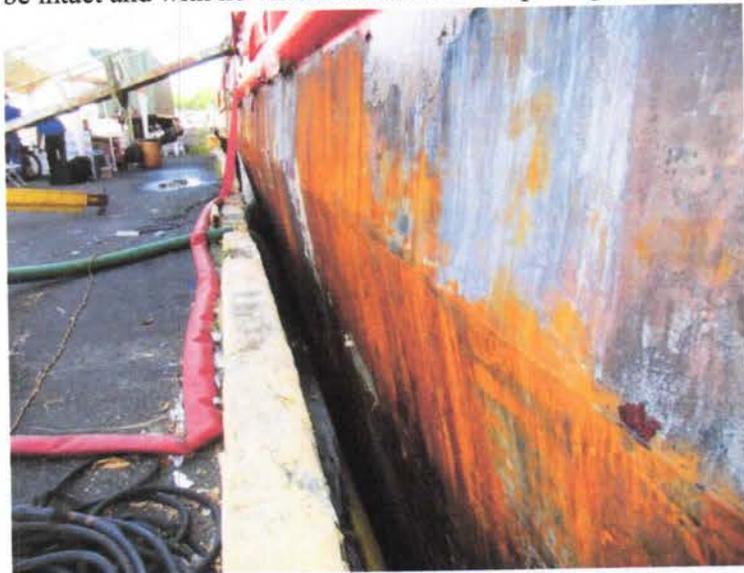
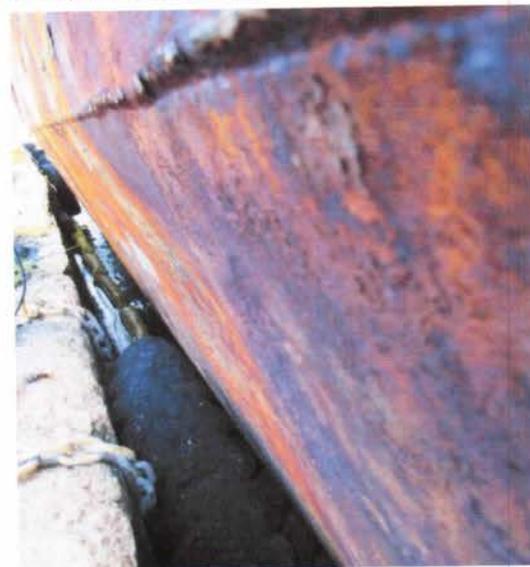
- The Side Shell plating has slight deformations/indentation between frames 68-79, and from 500mm up to 2.5m above the water-line. The deformations/indentations measure approximately 25-50mm at the deepest part. Frames appear to be intact and with no visible fractures in the plating, when inspected from outboard side.

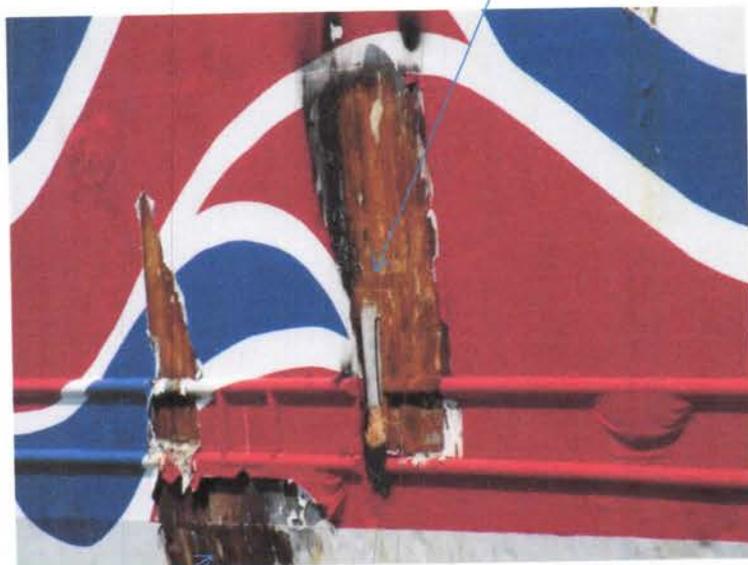
- Port side shell plating: Plating shows some deformations 25-30mm maximum, between fr. 65-69 around 500mm, above the water line. Additional Side shell plating deformations between frames 65-70 above bunker station door. Deformation in plating around 25-30mm

Deformations in the side shell (port side) plating

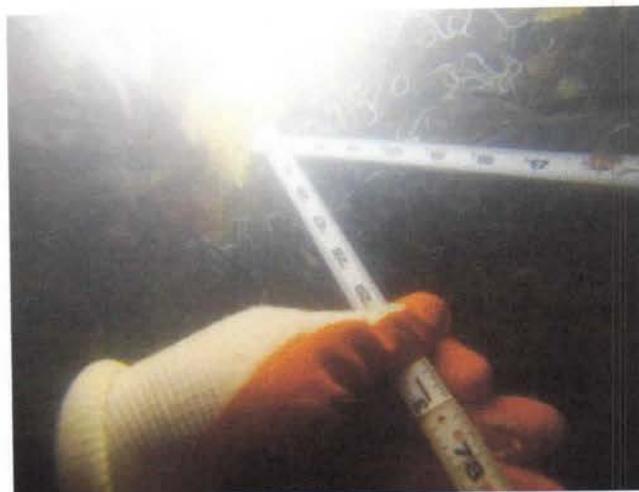
- According to the Diver's report provided (see attachment 1), the damage identified in way of frame 55 (separating oil tank), centerline a small indentation with approximate opening of 150 mm x 13 mm.
- On 06/09/2016 divers attended from Commercial Diving, Inc, San Juan and carried out another inspection. A fracture was found near a longitudinal weld seam at the Keel plate between frames 60-61, not at frame 55 as previously reported. The fracture is within the ring cofferdam that surrounds the Main Engines. The fracture measures approximately 584mm long with 25mm opening in the middle (see below).

A repair proposal submitted by Subsea Global (attached) has been reviewed and accepted. The repairs consists of the following:

Large fracture (No. 1 (as referenced by Divers))

1. Fractures were drill stopped at each point noted using a 12mm drill bit

2. Fracture was ground smooth and beveled at 45° to allow proper penetration of weld
3. Doubler/insert plate was contoured to the hull deformations to allow a tight fit in the affected areas of the shell plating.
4. The fractures that extend past the affected area forward and aft. These consist of a "y" on the forward side have been re-welded and with the drill stops re-welded.

At the conclusion of the repairs, the welds were checked with magnetic particle, with satisfactory results.

The above repairs are considered temporary for the single voyage from San Juan to a shipyard, located in Caribbean area. A relevant Conditional Safety Construction Certificate will be issued upon Flag authorization.

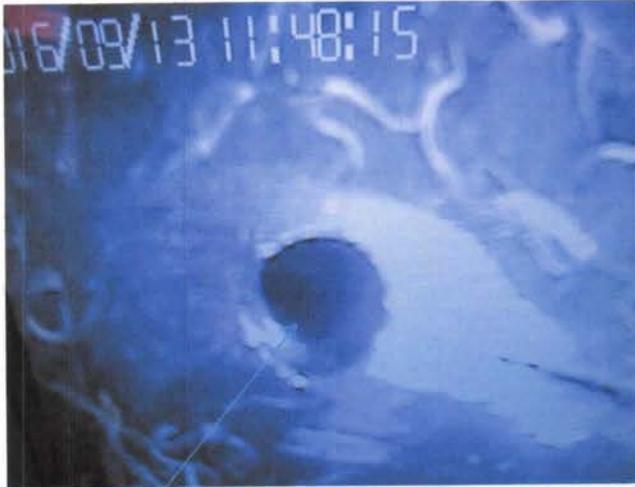
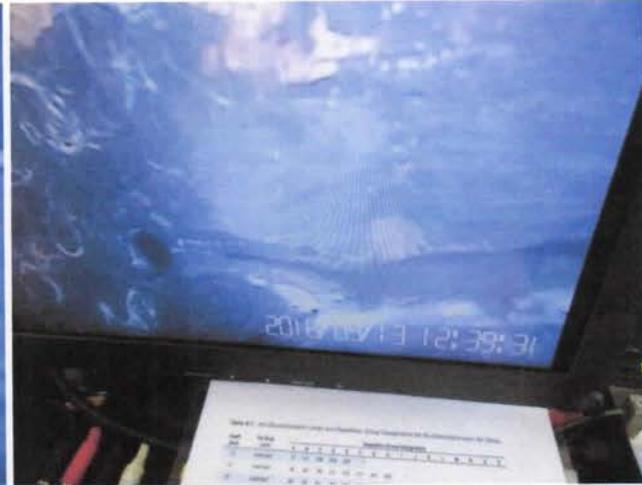
Drill stop at end of fracture
