PORT STATE CONTROL PREVENTIVE ASSESSMENT

File No. 16/XA/695/01

Ship's Name CARIBBEAN FANTASY

Date of Survey: 14/07/2016

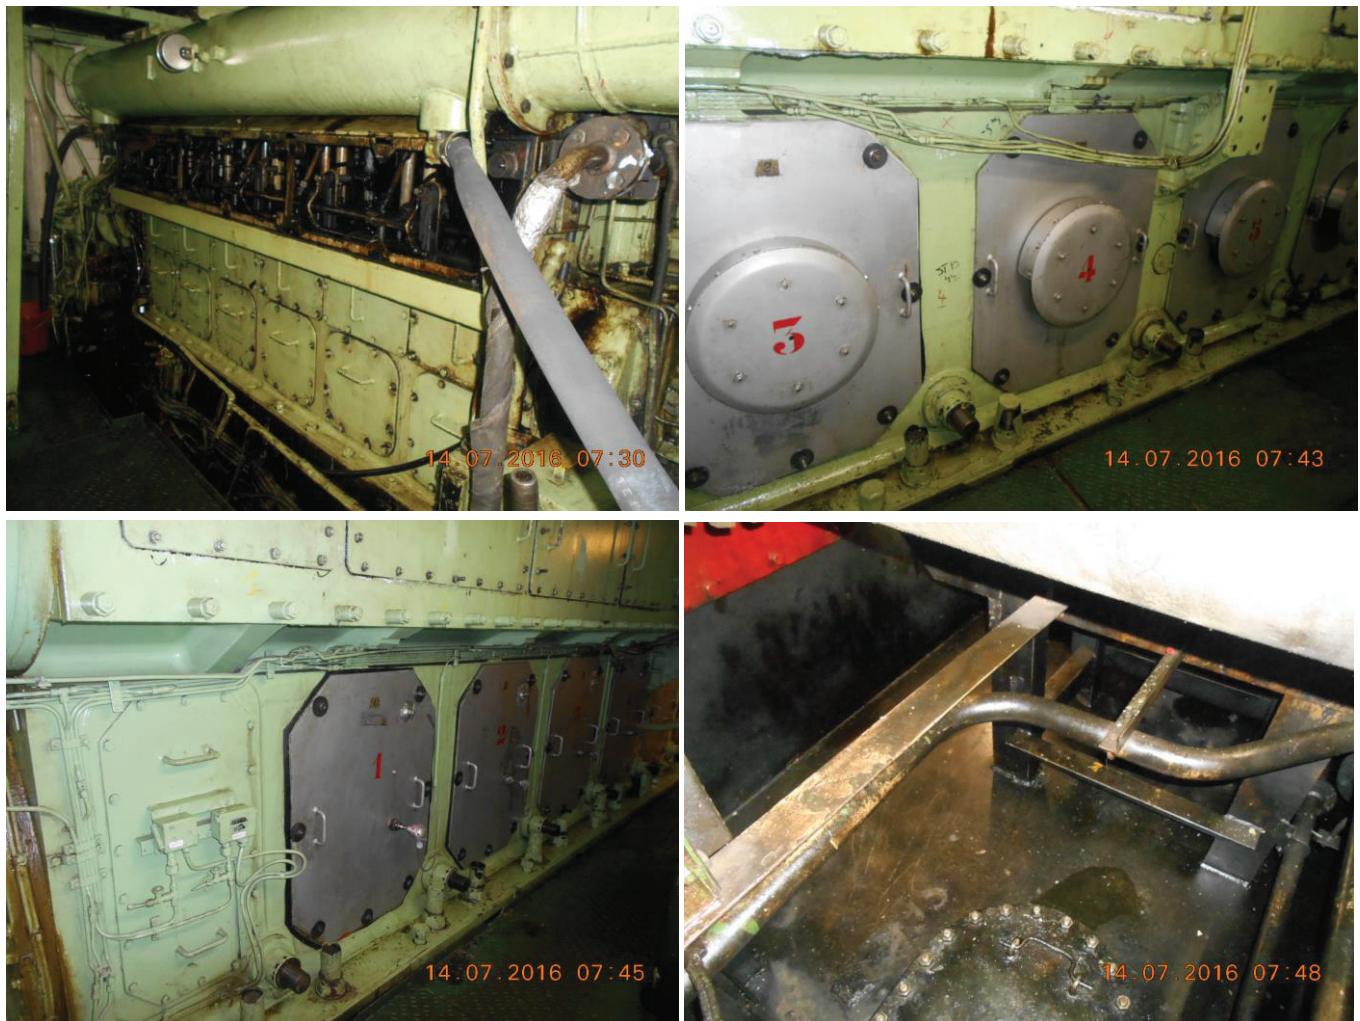
14	Outfitting and Cleanliness of engine room and steering gear room
----	--

Cleanliness of engine room has been improved during the inspection and found in satisfactory condition.
