1 **National Transportation Safety Board**

5  
6  
7  
8  
9 Group Chairman's Factual Report

10  
11  
12  
13 **Engineering/IIC Group**  
14

15  
16  
17 *Stretch Duck 7*

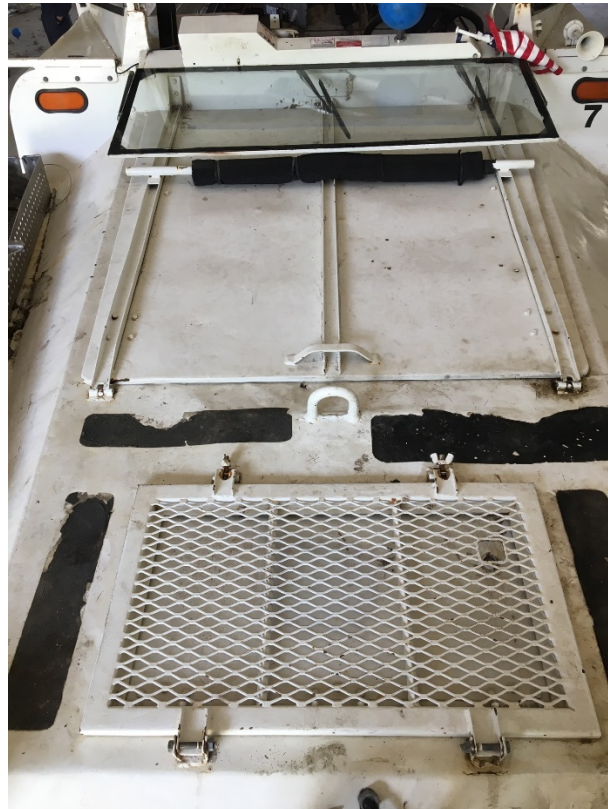
14 **Top: Engine compartment cover (hood) in closed position. Bottom: Forward ventilation**  
15 **grating of *Stretch Duck 7* with spring loaded damper in closed position.**

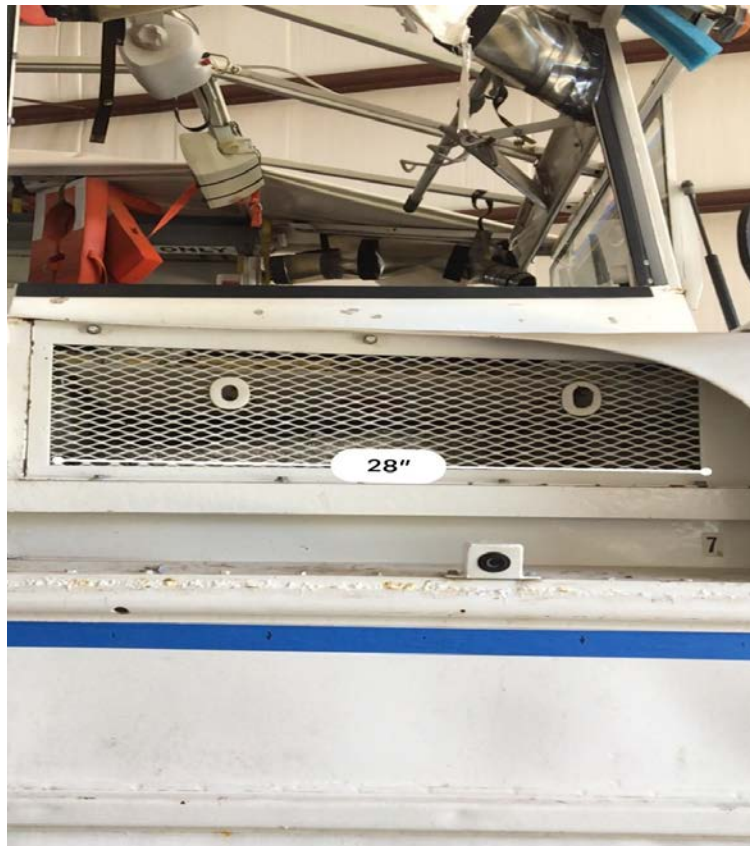
**Starboard side engine cooling air exhaust grating on *Stretch Duck 7*.**

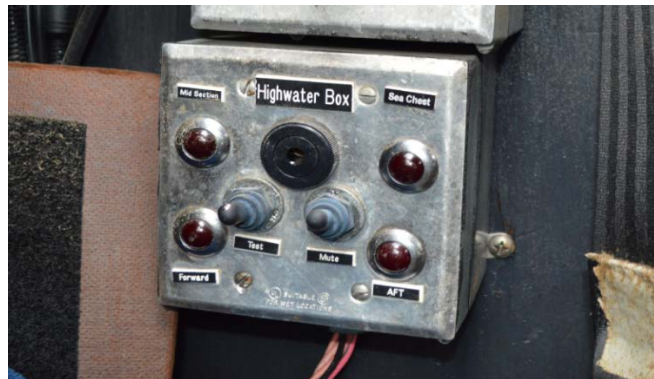
**“Highwater Box” on the starboard side of the captain’s station of the *Stretch Duck 7***

16 The external battery power was connected to the bilge alarm system. Each bilge float was  
17 tested, and successfully registered on the panel with audio and red visible alarms. The four areas  
18 were: sea chest, mid-section, forward, and aft. The only issue was that the audible alarm was unable  
19 to be silenced.
