Caribbean Fantasy - July 21th to 25th

Replacement of the port engine bearing n° 9 shells

Objet: due to the delivery time of the OEM repair size – 6 mm bearing shell, a temporary solution has been fitted to allow the departure of the vessel from Bizerte.

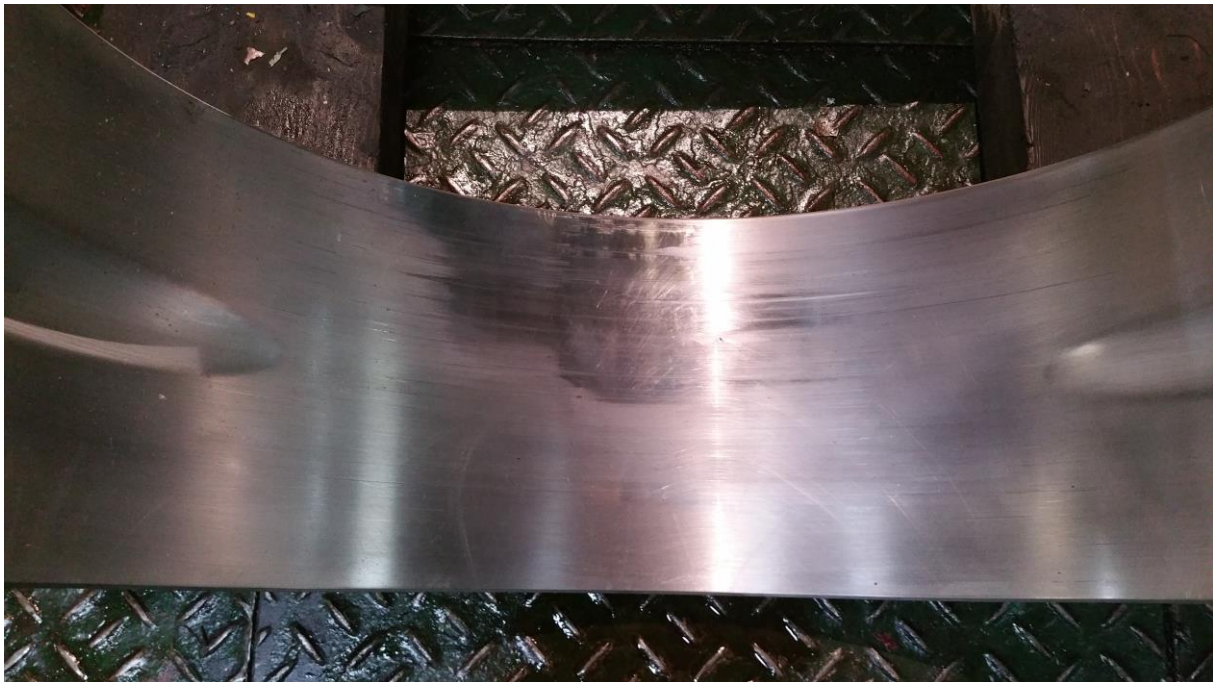
After lowering the bearing n° 9 saddle inspection of the journal and the bearing shell shows a good condition generally speaking – very few scratches on both side and no need to polish pin once again.

This confirms the efficiency of the Moatti filters sole protection of the bearing with such a polluted lubrication circuit.

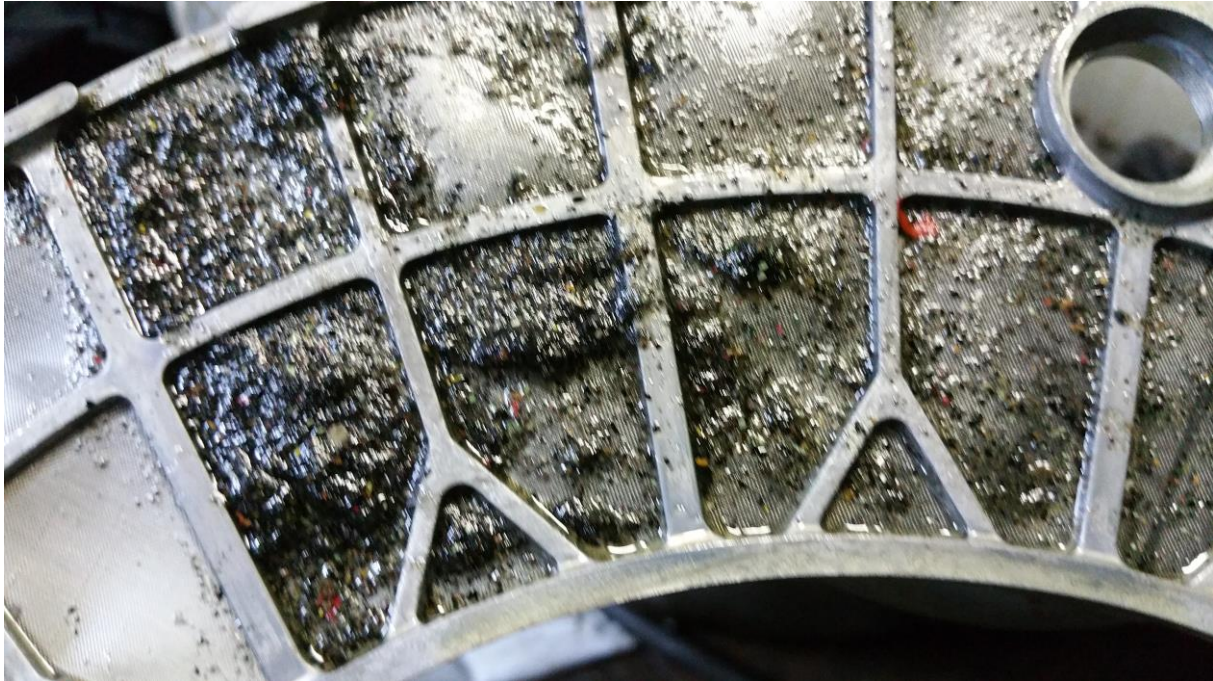
Back flow side is designed to collect the residue and it is doing a perfect job. Lot of rag residue were found- most of the residue are piece of rags however hard particle pollution is still well present

And for the time being it is not possible to see an improvement of the situation compared to the previous inspection done after flushing completion as per picture here above.

This confirms that continuous care has to be given to the filter.

- Good rotation of the hydraulic motor to be checked once per hour
- Every day drain 20 liters from the Moatti top cover drain to flush the back flow residues.
- Every 5 day – ocean crossing included – clean the back flow elements
- In case clogging indicator start turning red and even before the alarm level then stop engine immediately and clean the full flow side of the filter.
