## CARIBBEAN FANTASY

### Crankshaft investigation and adjustment program

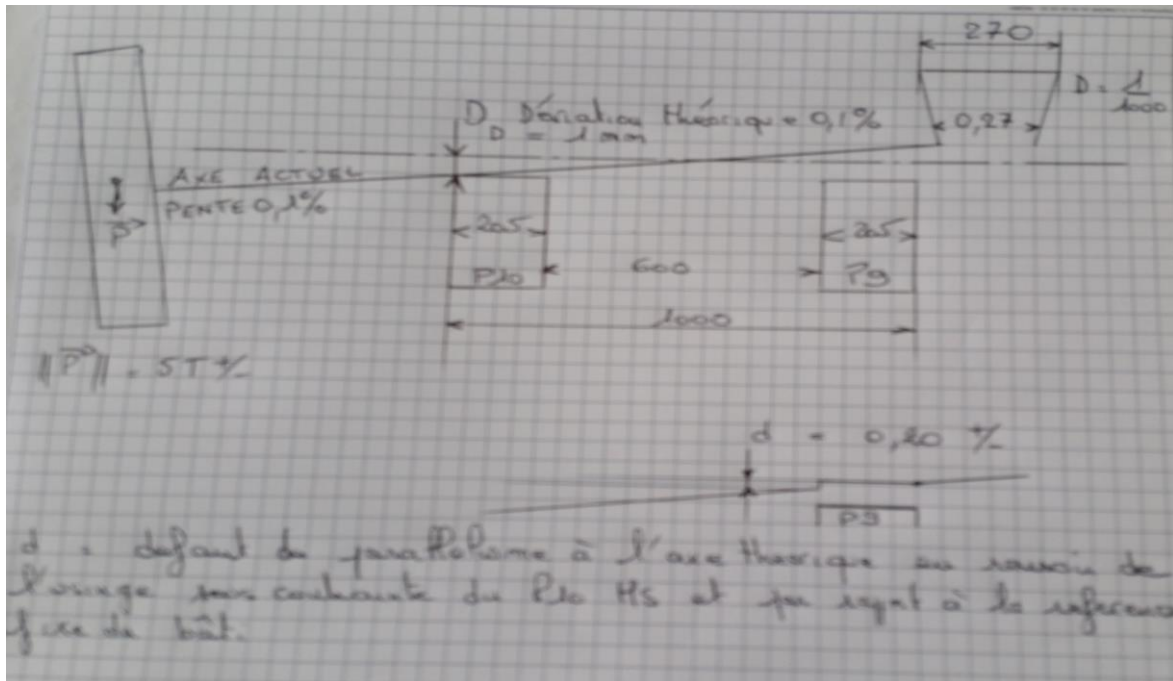
The port engine has completely lost its center axle reference at bearing n° 9 and bearing n° 10 level because:

- Bearing n° 10 geometry has been altered by the overheating resulting from the bearing failure. This situation exist at least since 2 years.
- Journal n° 9 has been machined with deflection reaching 25 / 100 mm on web n° 8 causing misalignment
- The saddle n° 9 has been machined during the same intervention in order to find a compromise between the crankshaft lift and the web deflection.

The sketch here below summarize situation during July 2014 intervention.
