1 National Transportation Safety Board

6
7
8 Group Chairman's Factual Report
9

10
11
12
13 **Engineering Group**
14

15
16 *SS El Faro*
17 DCA16MM001
18
19

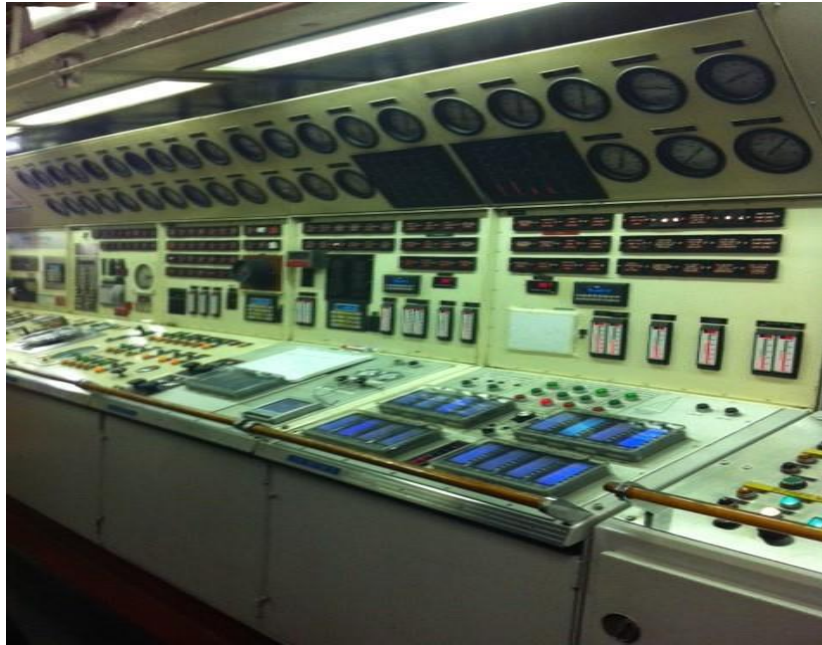
11 **Control System.** Burner management, steam pressure, and boiler water level in the boilers were
12 monitored and controlled by a system designed and installed by a company called Nortech. Off-duty
13 engineering officers told investigators that boiler automation was tested annually by the ship's crew, in
14 accordance with the periodic safety test procedure retained aboard the vessel. Investigators requested the
15 vessel-specific document from the operating company, but it could not be provided because it had been
16 kept aboard *El Faro*.

1
2 **Figure 5.** *El Faro* boiler control console (photo by Maine Maritime Academy cadet).

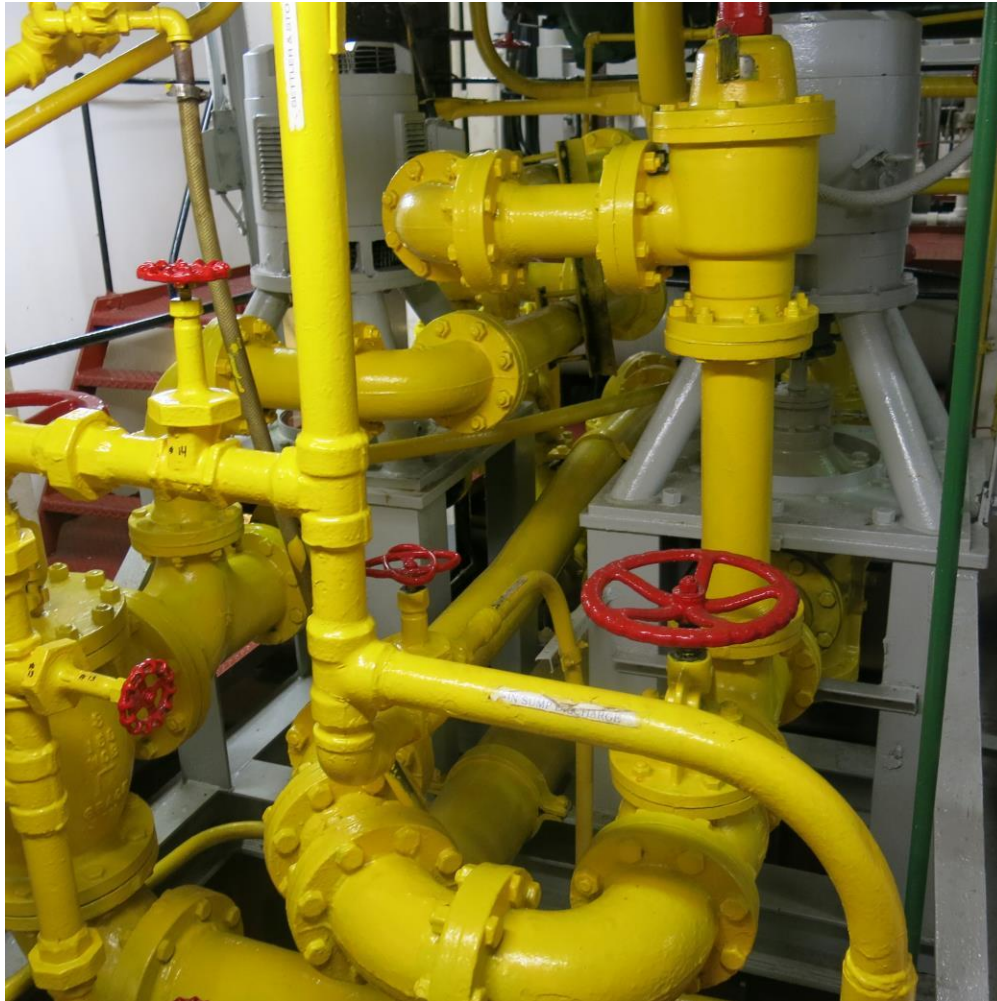
3
4 **Figure 7.** Lube oil pumps and associated piping (photo from *El Yunque*).

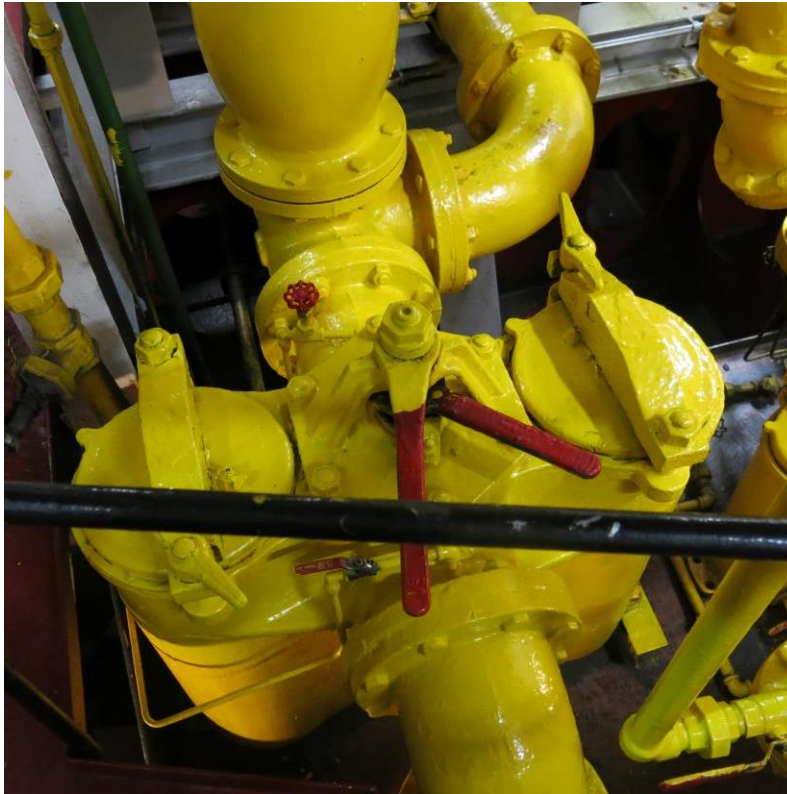
3 The lube oil service pumps took suction from the reduction gear sump through an 8-inch pipe, a
4 check valve, and a set of duplex magnetic suction strainers. According to the chief engineer’s turnover
5 notes from August 2015, both lube oil service pumps would have required maintenance during the
6 upcoming shipyard repair period. The forward pump required replacement of the mechanical seal, and the
7 after pump required the pump to be rebuilt or replaced because it was “running 3 psi lower than the forward
8 pump.” These items were identified in a worklist for the shipyard.⁶²

1
2 **Figure 9.** Lube oil service suction strainers (photo from *El Yunque*).

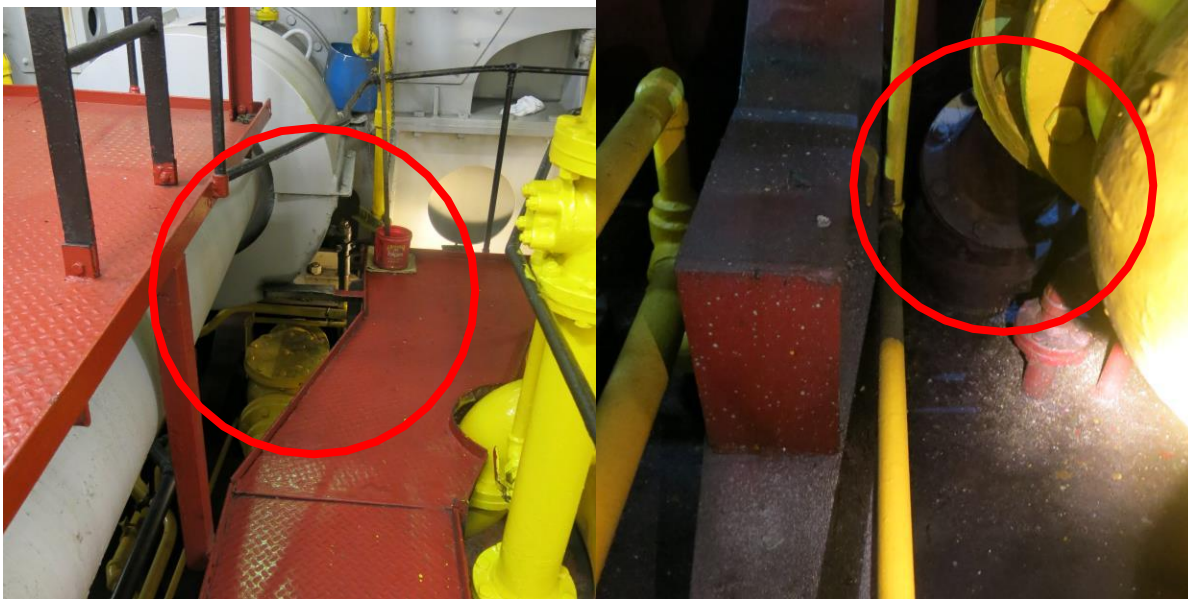
1 estimated a height of 90 inches between the bell mouth to the tanktop inside the lube oil sump. Further
2 measurements were to be made aboard *El Yunque* at the next opportunity.⁶⁴

3
4 **Figure 10.** *Left:* Lube oil check valve above sump suction below main shaft. *Right:* Lube oil suction pipe
5 at tanktop. (Photos from *El Yunque*)

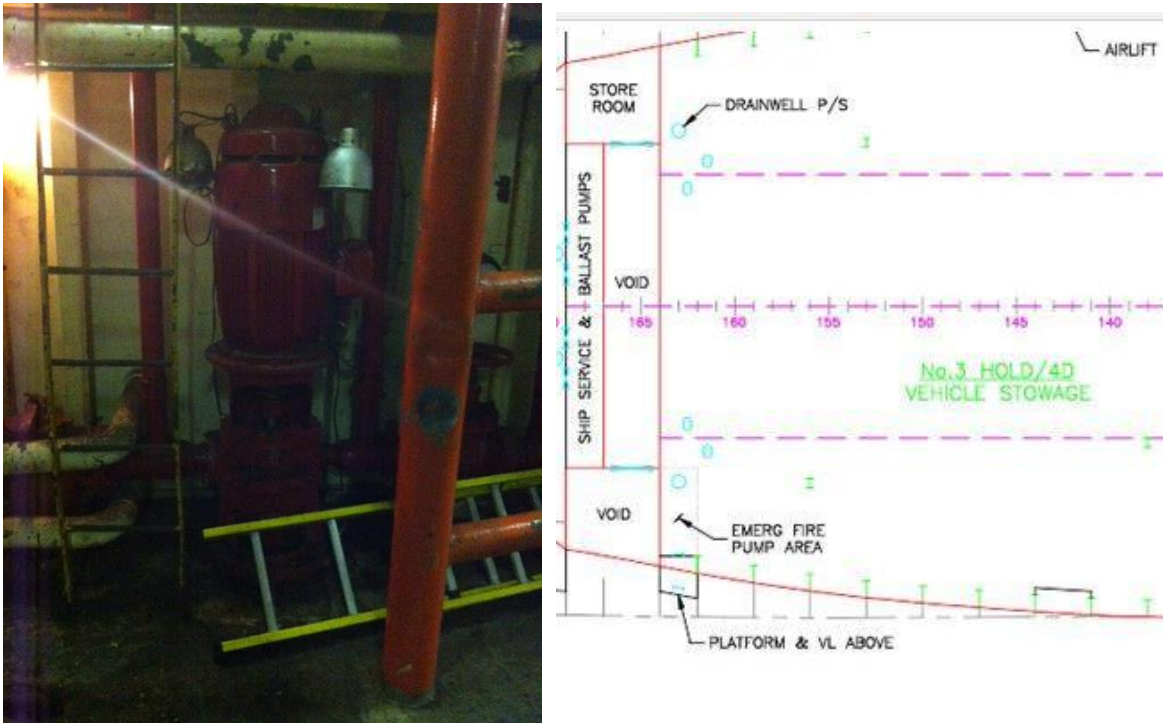
2 **Figure 16.** Left photo shows emergency fire pump in No. 3 hold (photo by Maine Maritime Academy
3 cadet). On right, diagram of emergency fire pump location in No. 3 hold, deck four (drawing by Tote).

4 While aboard *El Yunque*, investigators located the emergency fire pump in the No. 3 hold on the
5 tanktop in a similar location to that of *El Faro*'s emergency fire pump. The pump aboard *El Yunque* had
6 vertical pipes welded to the deck and framing as protection. There was no protection around the suction
7 pipe and valve.
