# National Transportation Safety Board

Group Chairman's Factual Report

Engineering Group

*Caribbean Fantasy*

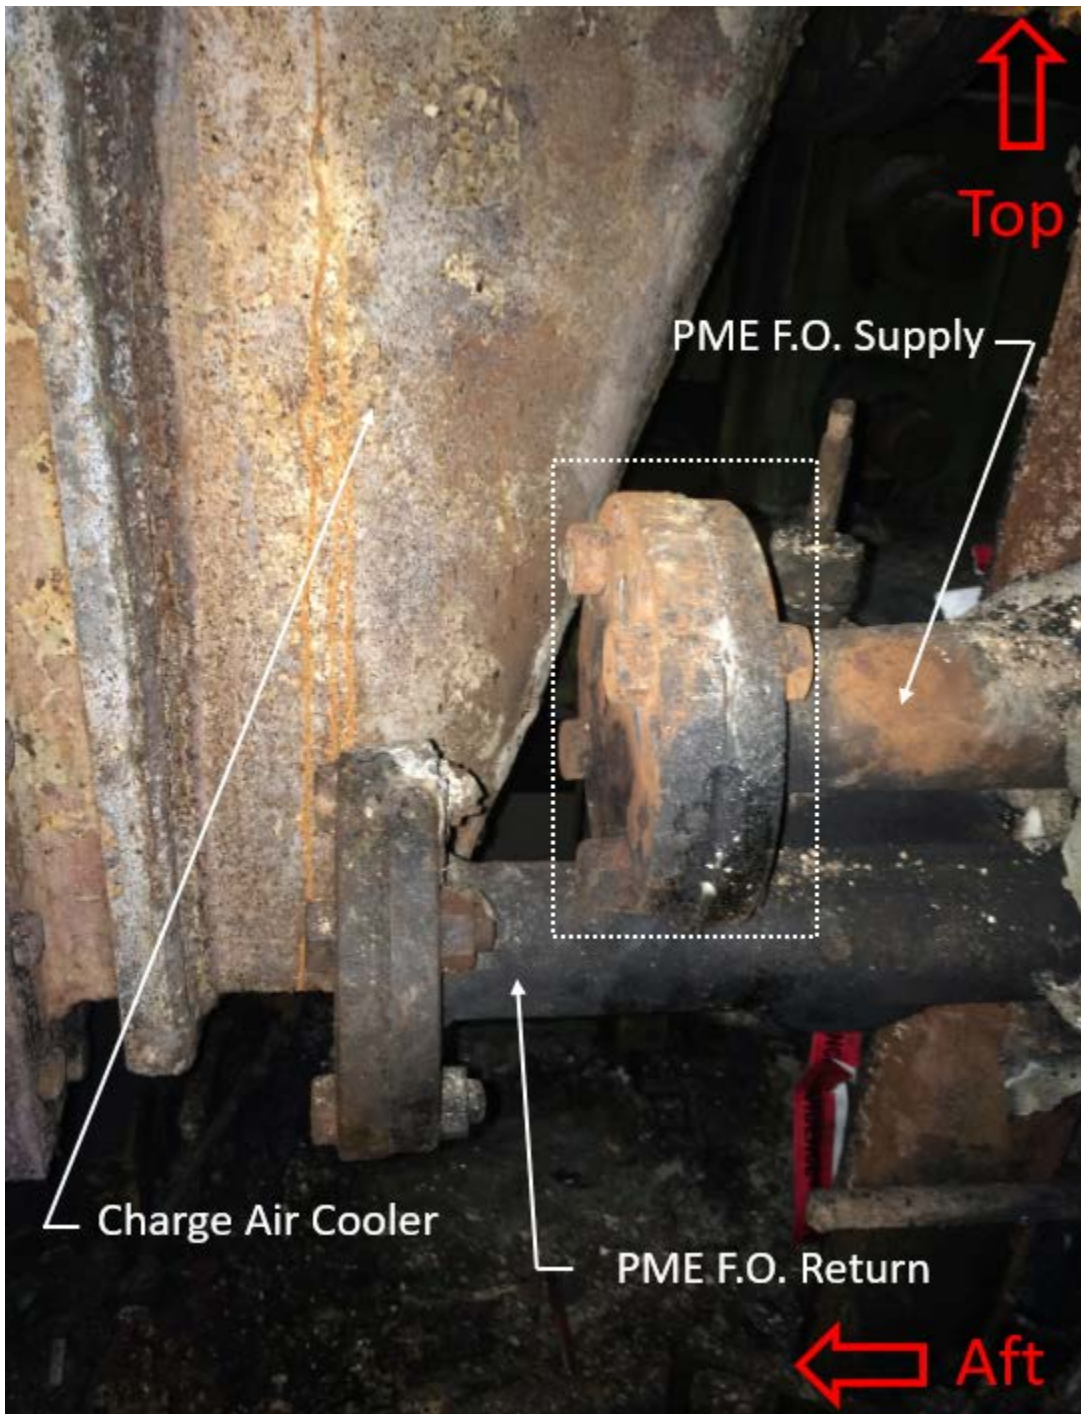
3  
4 **Figure 1. *Caribbean Fantasy's* port main engine fuel oil supply and return pipe end flanges and**  
5 **blanking plates. The white dotted box indicates the location of the fuel leak. View from the coupling**  
6 **end of the engine looking outboard to the fuel pump control linkage and charge air cooler.**

7 The chief engineer told investigators that he was about a meter away from the PME supply end  
8 flange when the fuel oil spray ignited. A large plume of fire, heat, and smoke forced the chief engineer,  
Engineering Group Factual Report Page 10 of 58

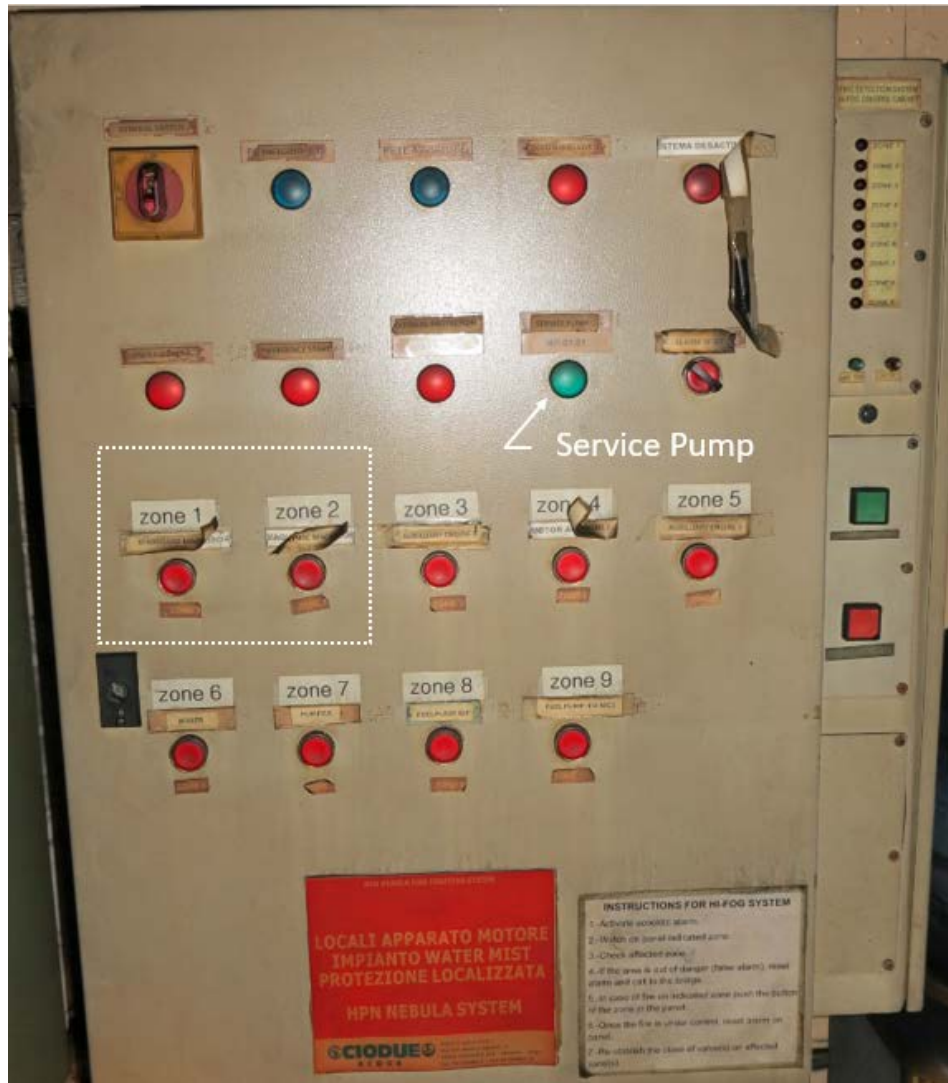
1  
 2 **Figure 4. The HPN Nebula firefighting system localized protection system panel located in the ECR.**  
 3 **White dotted box indicates the zones the chief engineer said he activated and arrow shows the green**  
 4 **indicator light for the service pump (MP.01.01)**

5           The chief engineer stated to investigators that he knew the system was on because the green  
 6 indicator light for the service pump was illuminated on the control panel in the ECR. This signified  
 7 the high-pressure pump motor controller was energized, but there was no means to verify the system  
 8 pressure or that pump was running. Further he did not state he saw any section valve light indication  
 9 on the panel. The pump was in the machinery and equipment of air condition space forward of the  
 10 main engine room on deck no. 1. There was no indicator for water mist pressure on the local control  
 11 panel located in the ECR, and the heavy black smoke inhibited the chief engineer from visually  
 12 verifying the system was operating as designed.

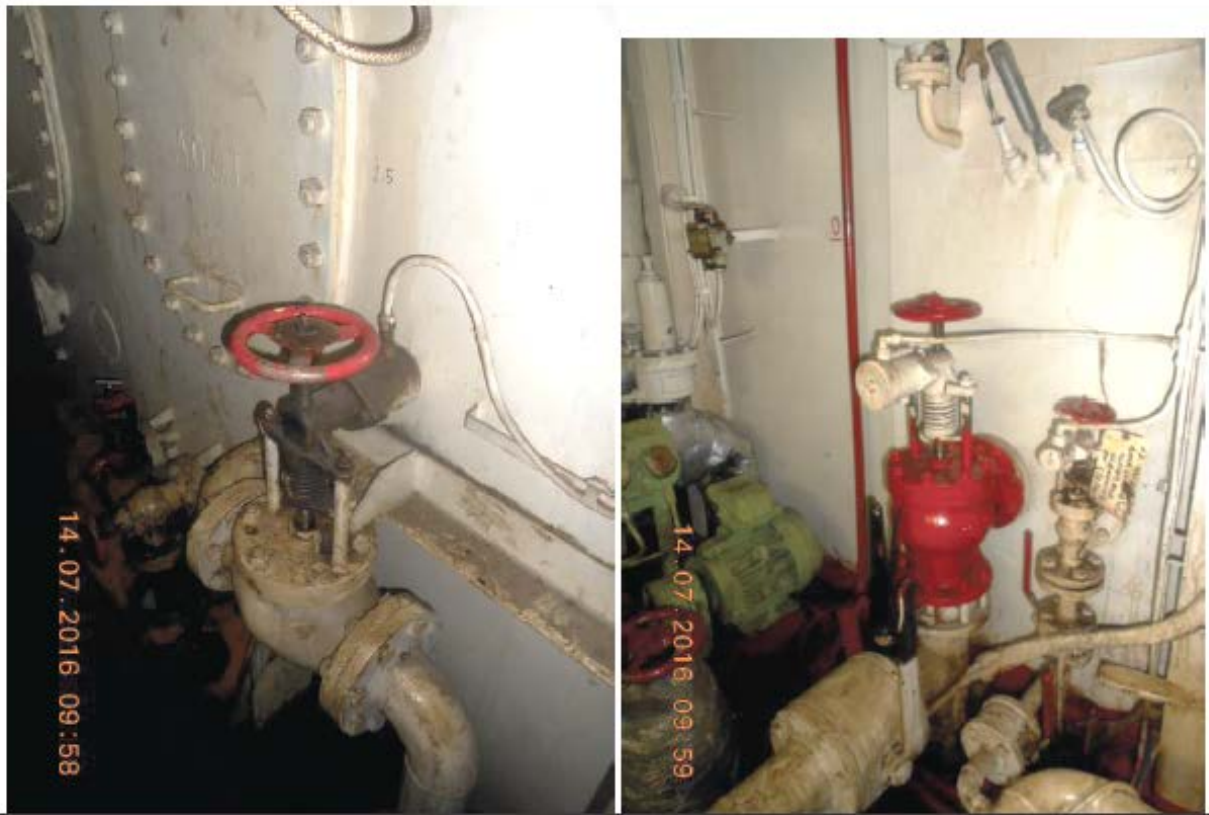
15 The two photographs in figure 5 were taken by the RINA surveyor one month prior to the  
16 accident. They were listed in section 5 of the photographs and found on page 3 of the report produced  
17 by the surveyor. The photograph on the left is the lube oil storage tank QCV. A bolt and nut have been  
18 lodged in the valve mechanism which rendered the valves unable to isolate fuel and lube oil from the  
19 main engine room during the fire, per their designed purpose. There is no description or deficiencies  
20 recorded in the narrative section for QCVs as required by the RINA report form.<sup>16</sup>

**Figure 5. RINA Port State Control Preventive Assessment photographs of QCVs.**

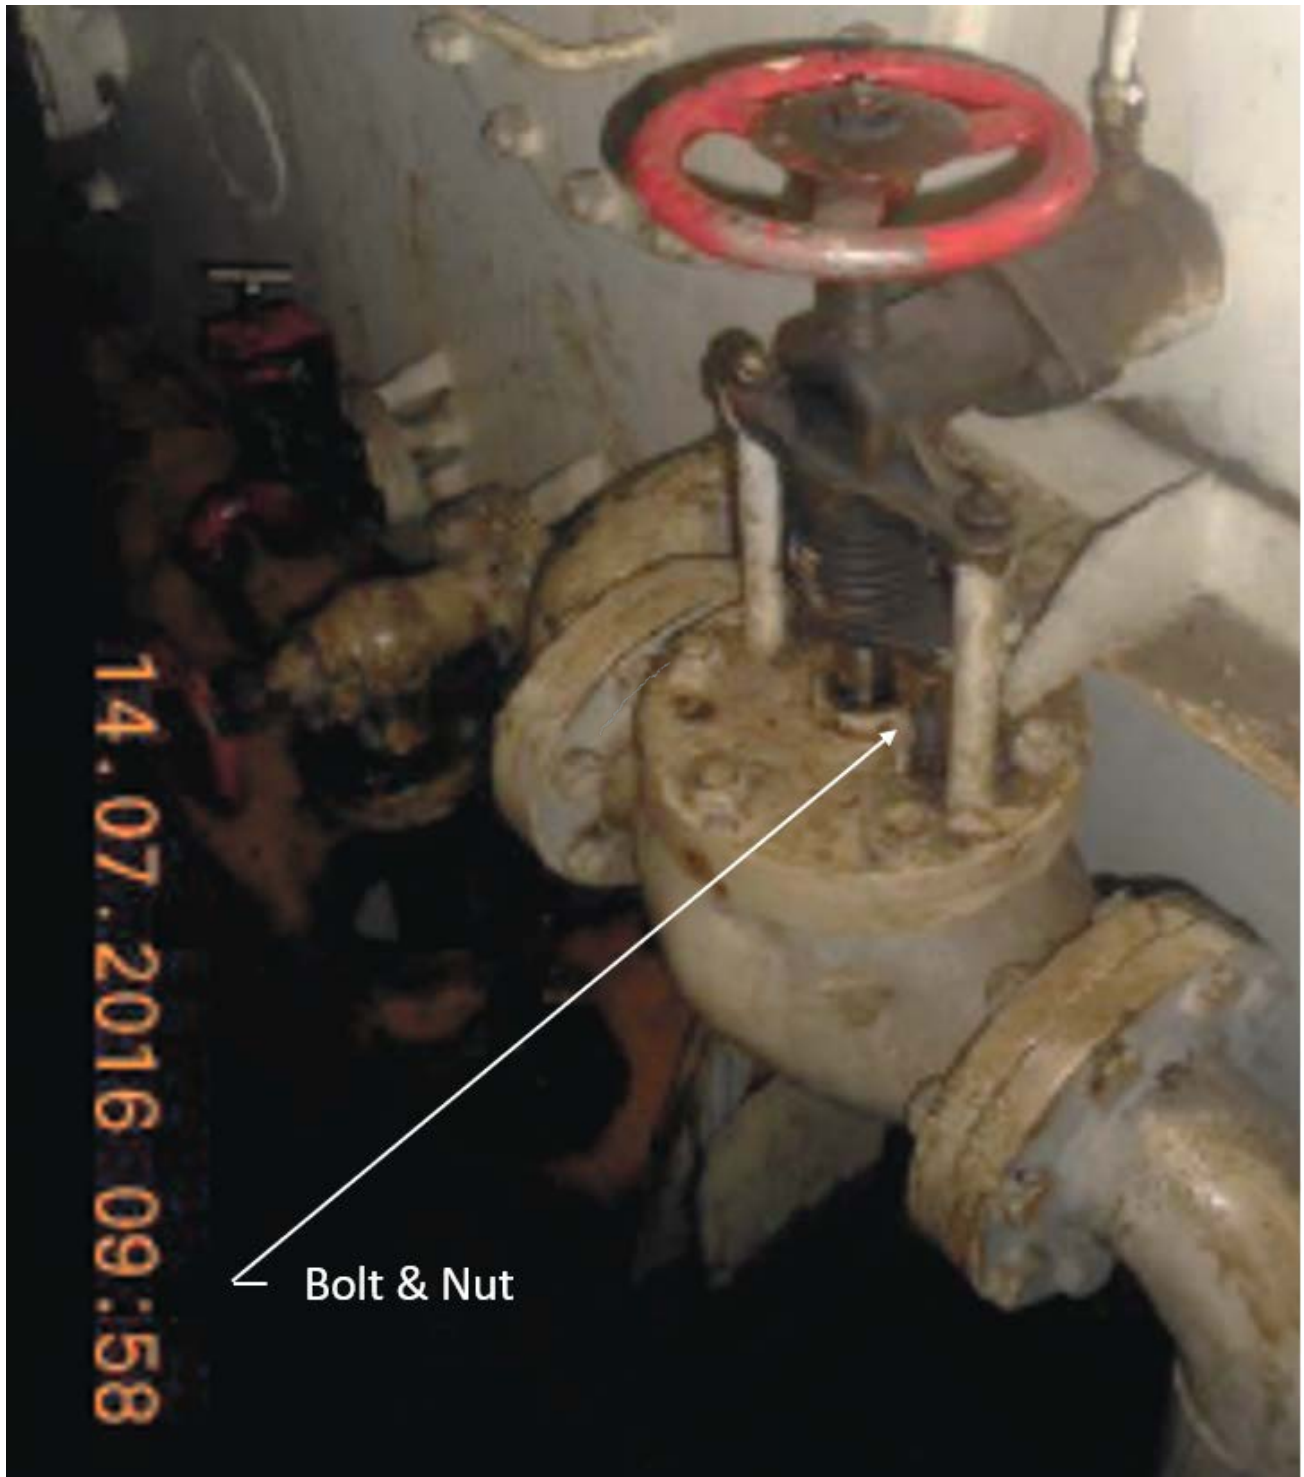
1  
2 **Figure 6. Enlarged photograph of lube oil storage tank QCV from RINA Port State Control Preventive**  
3 **Assessment.**

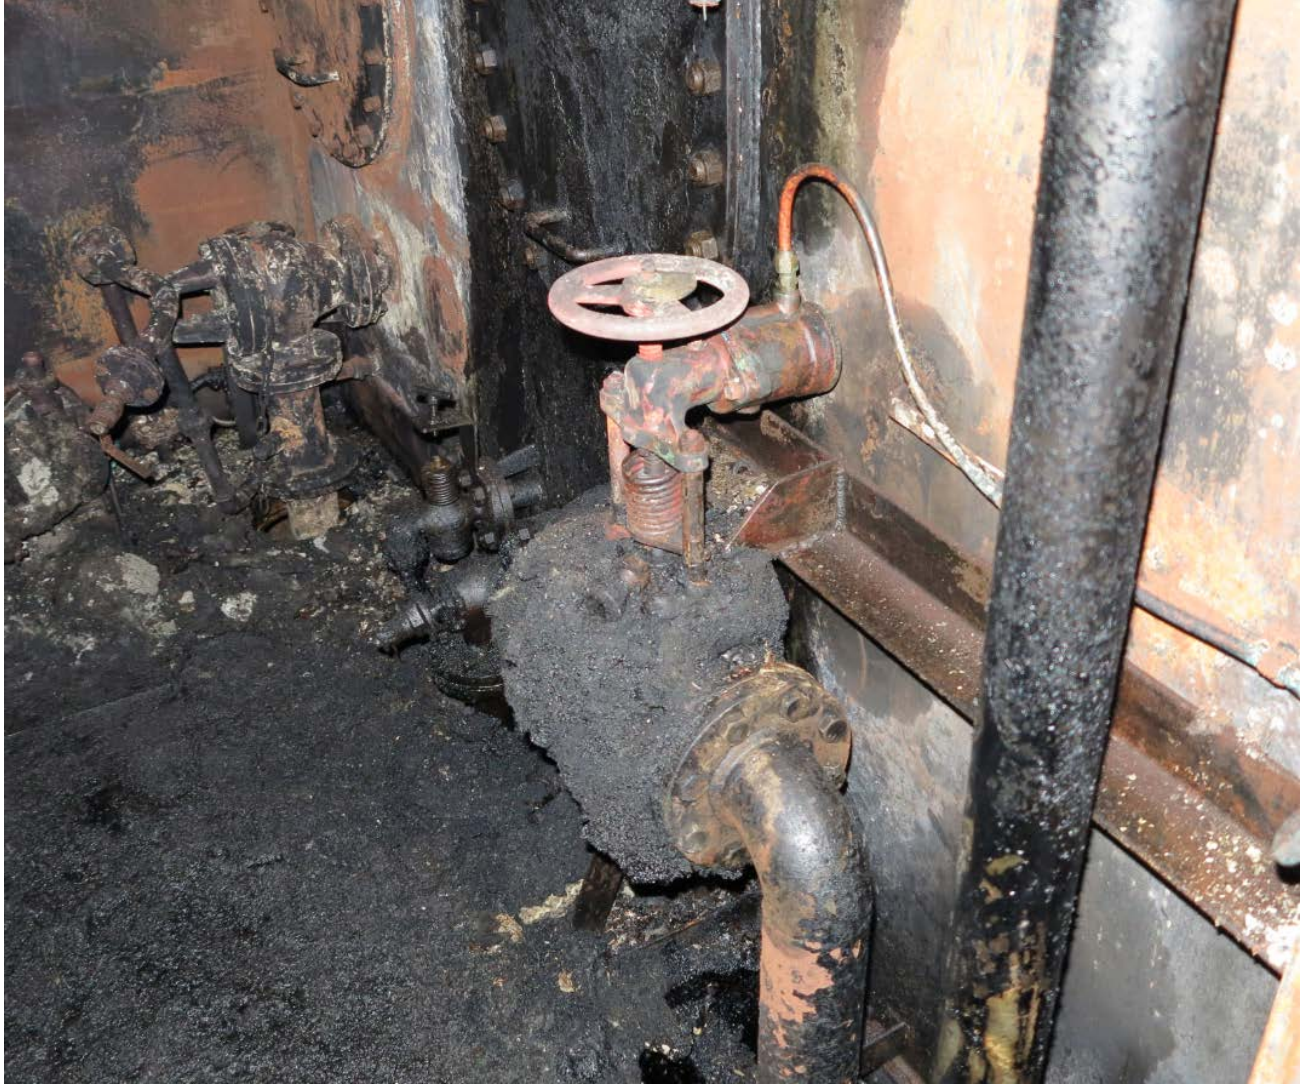
1  
2 **Figure 8. *Caribbean Fantasy's* port lube oil storage tank QCV that was intentionally blocked open. The**  
3 **bolt and nut were removed to verify the valve stem closed.**

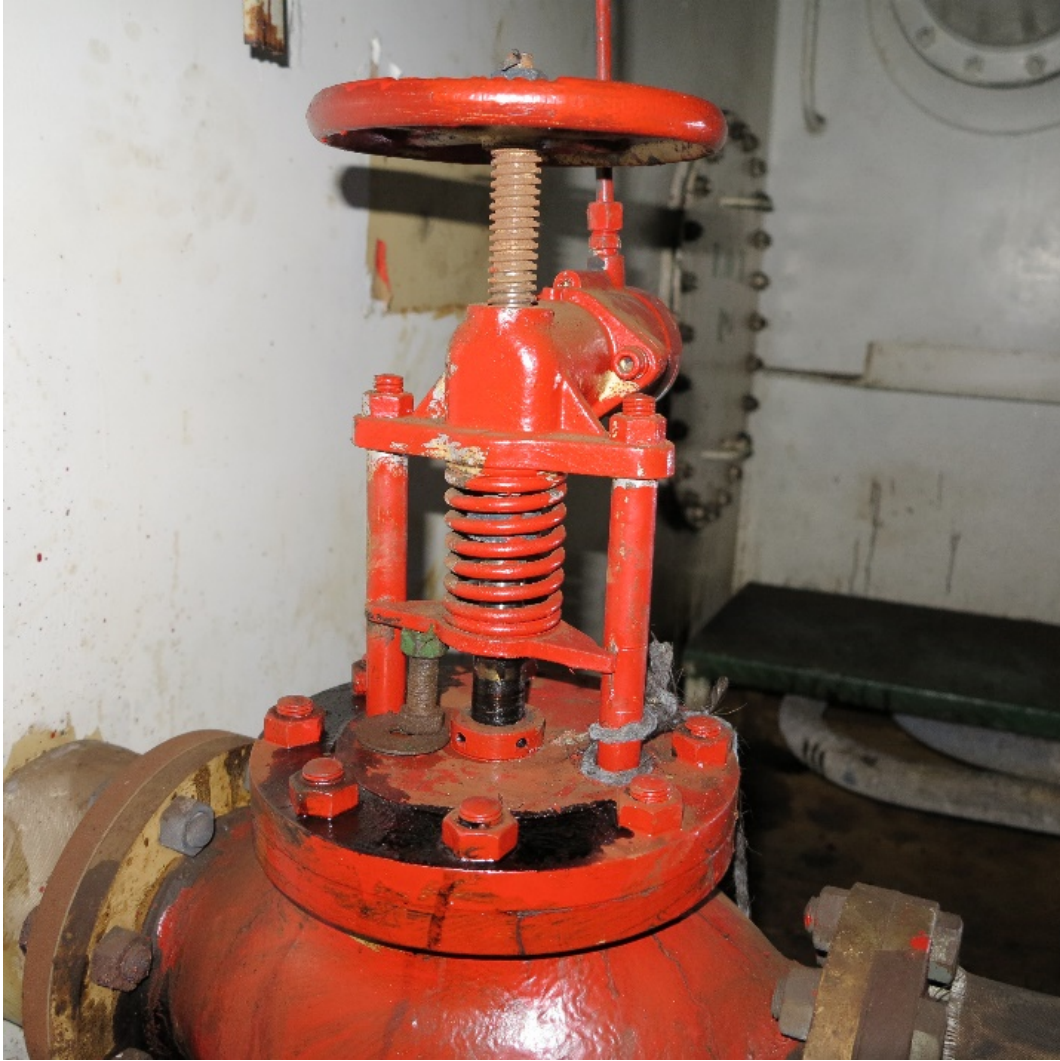
**Figure 9. *Caribbean Fantasy's* port HFO storage tank QCV that was intentionally blocked open with a bolt, nut, and washer.**

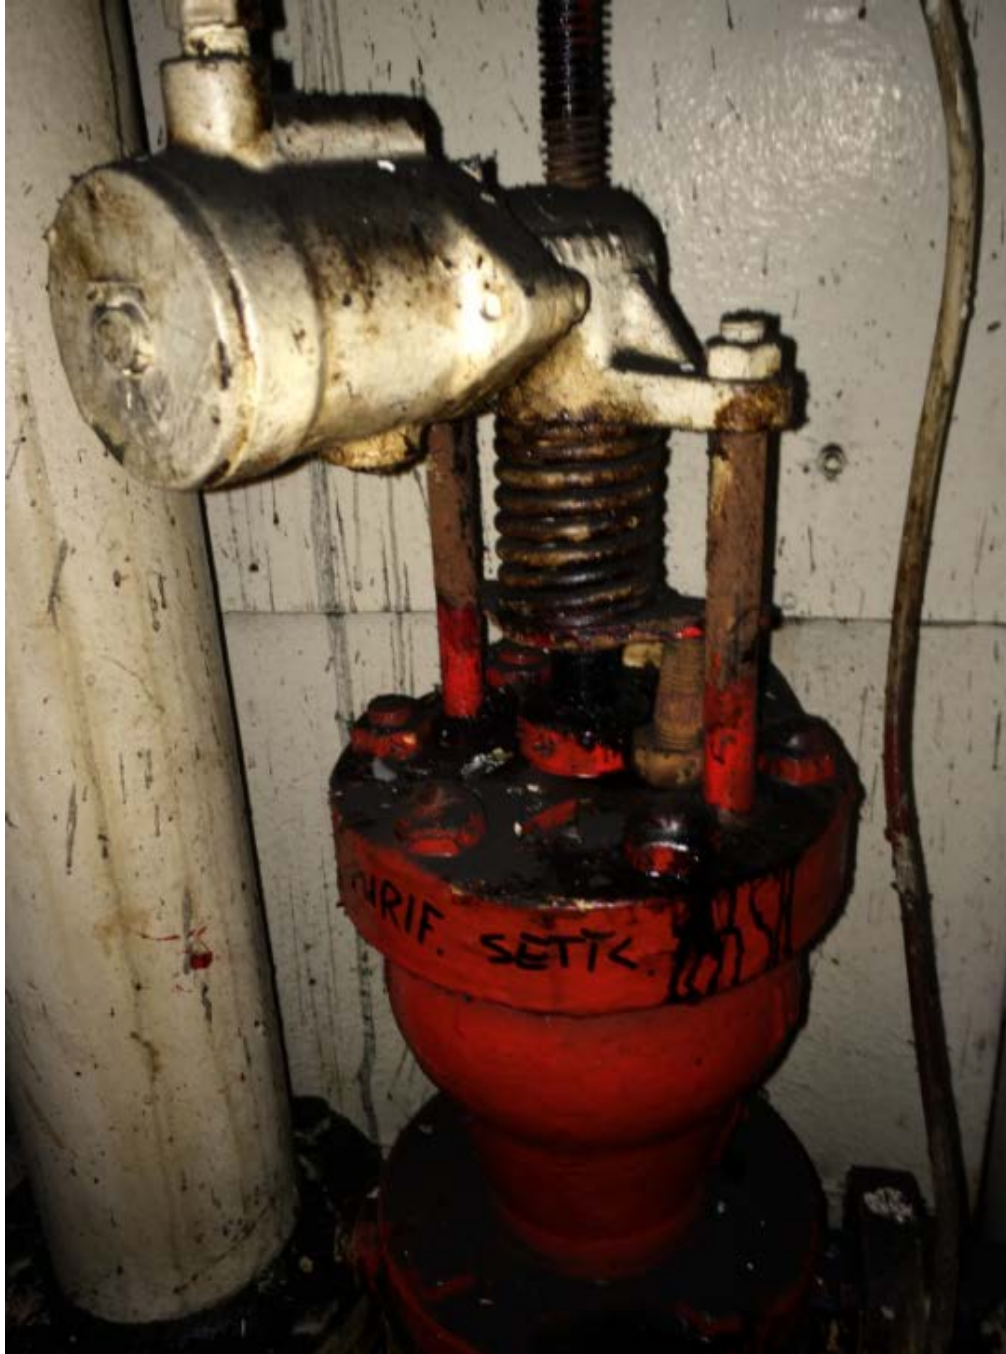
Figure 10. *Caribbean Fantasy's* HFO purifier settling tank starboard QCV that was intentionally blocked open with a bolt and nut.

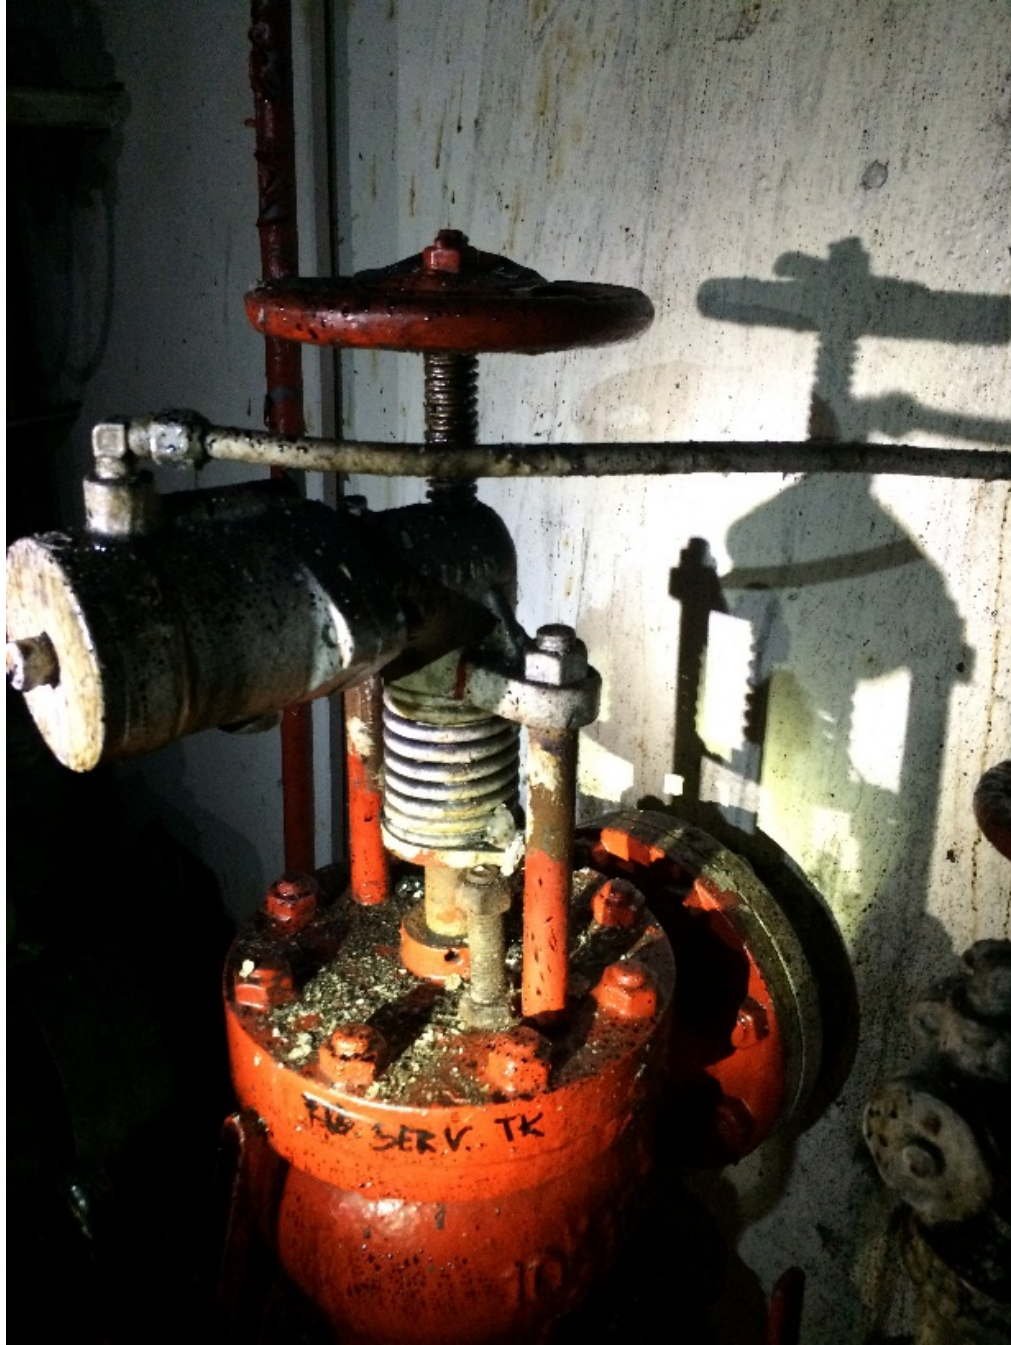
Figure 11. *Caribbean Fantasy's* port MGO service tank QCV that was intentionally blocked open with a bolt and nut.

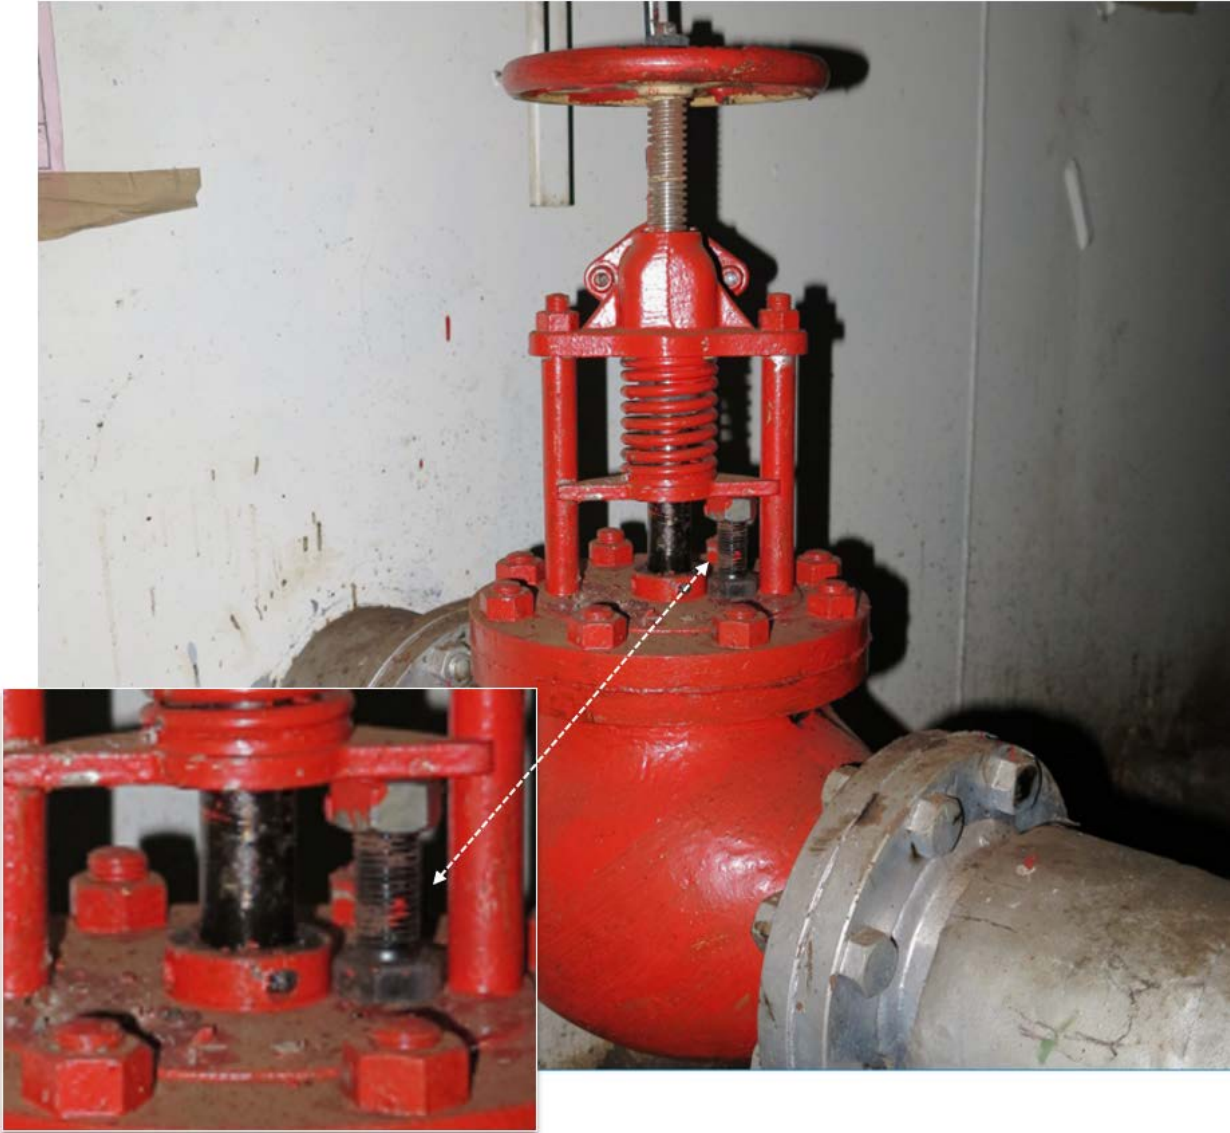
1  
2 **Figure 12. *Caribbean Fantasy's* starboard HFO storage tank QCV that was intentionally blocked open**  
3 **with a bolt and nut. Lower left image of close up view of the bolt and nut with paint and dust.**

4           Figure 12 above shows the starboard HFO storage tank QCV that was purposely blocked open  
5 with a bolt and nut to prevent the valve stem from seating when activated. The bolt is under  
6 compression in the photograph. Paint is present on the nut and bolt threads, which, along with the  
7 presence of dust, dirt, and rust, indicate the nut and bolt have been in place for an extended amount of  
8 time. The presence of soot in this area was minimal. Posted next to the valve near the manhole for the  
9 tank, were three documents. One was a gas free certificate issued on June 14, 2016, from the Tunisia  
10 Shipyard, a hot work permit issued by Grand Bahama shipyard on May 10, 2014 and a confined space  
11 permit also issued by Grand Bahama shipyard on May 10, 2014. Both had expiry dates of May 11,  
12 2014.

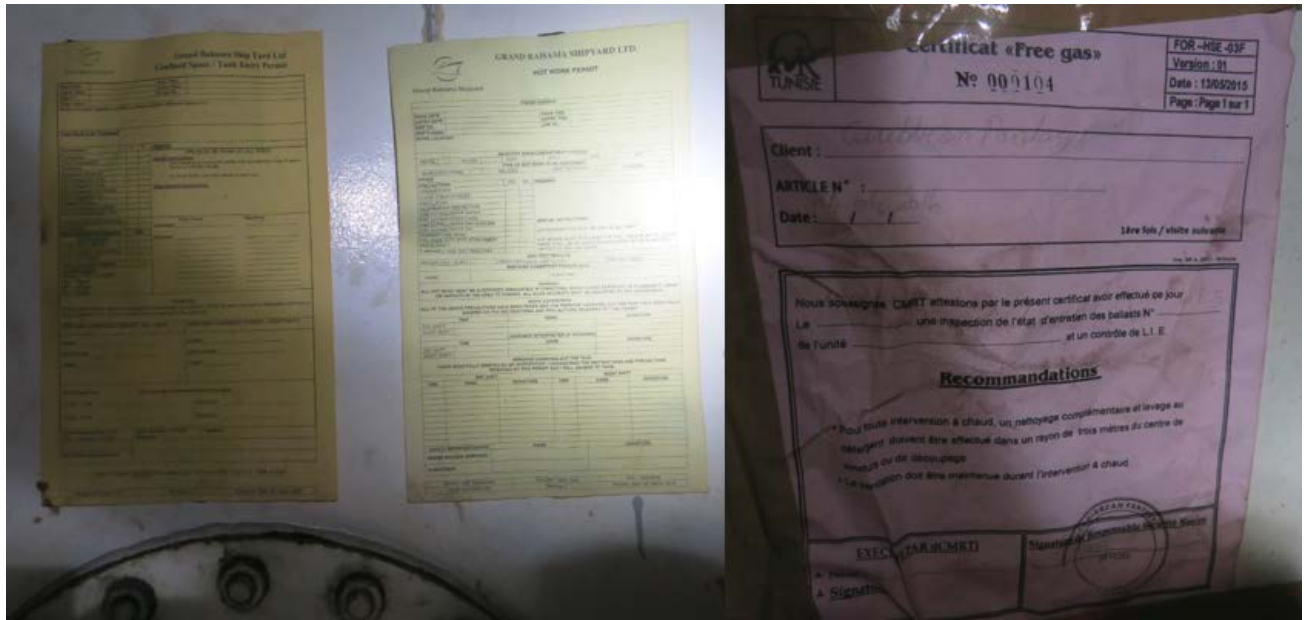
- 1
- 2 **Figure 13. Outdated hotwork, and tank entry permits found posted near manhole on the starboard side**
- 3 **HFO storage tank.**
- 4

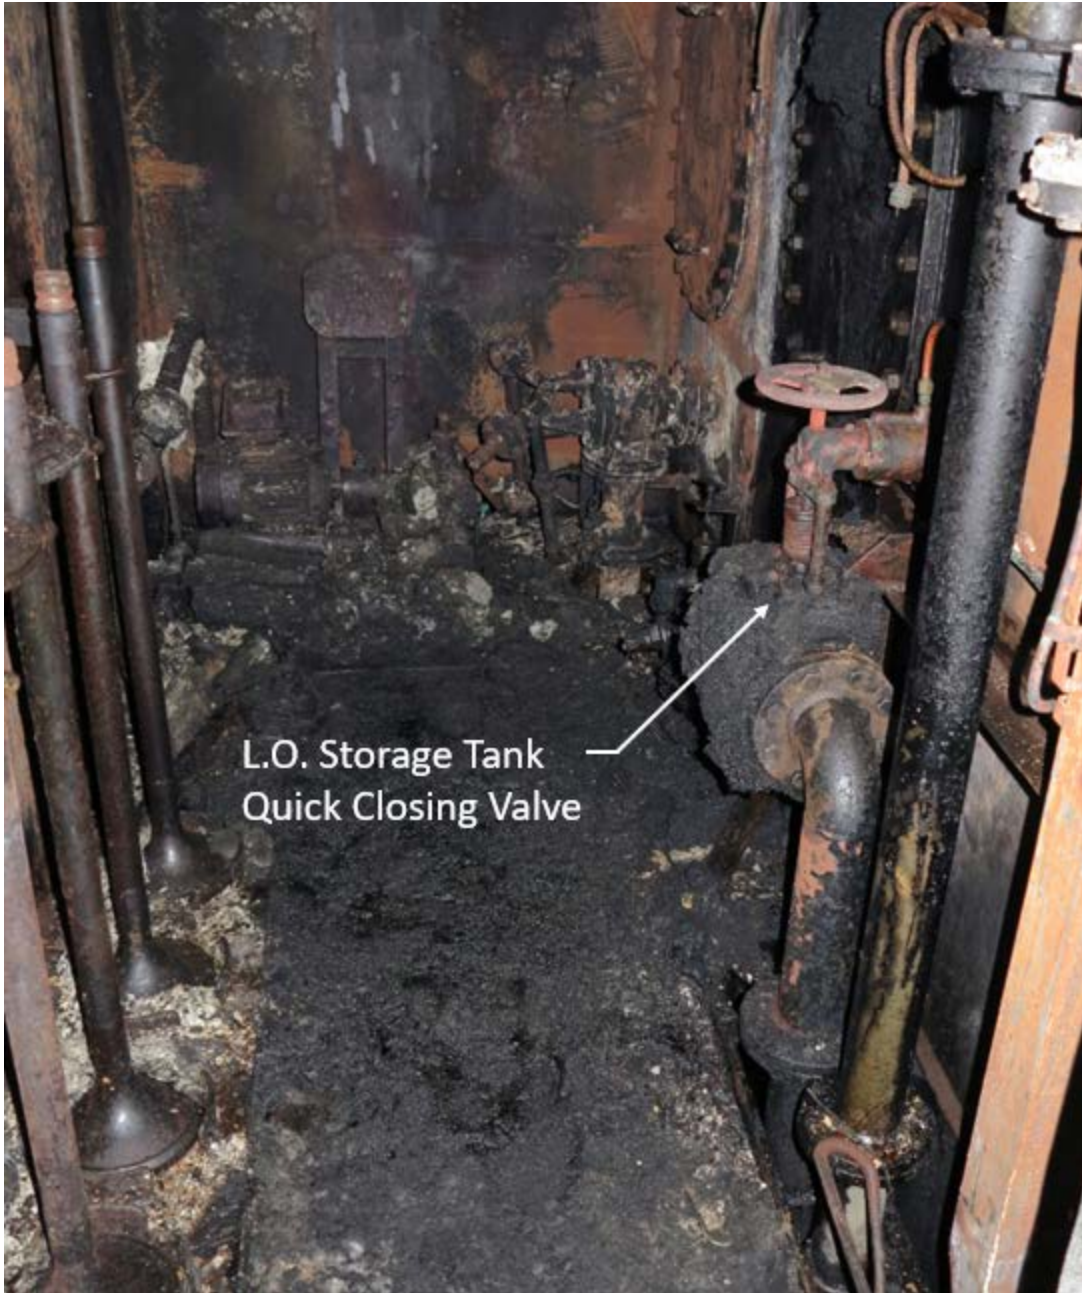
L.O. Storage Tank  
Quick Closing Valve

Figure 14. Port side view of the main engine room forward of engine workshop, deck 2, at frame 83. An inch and a half of lube oil is on the deck. The white arrow points to the lube oil storage tank QCV.

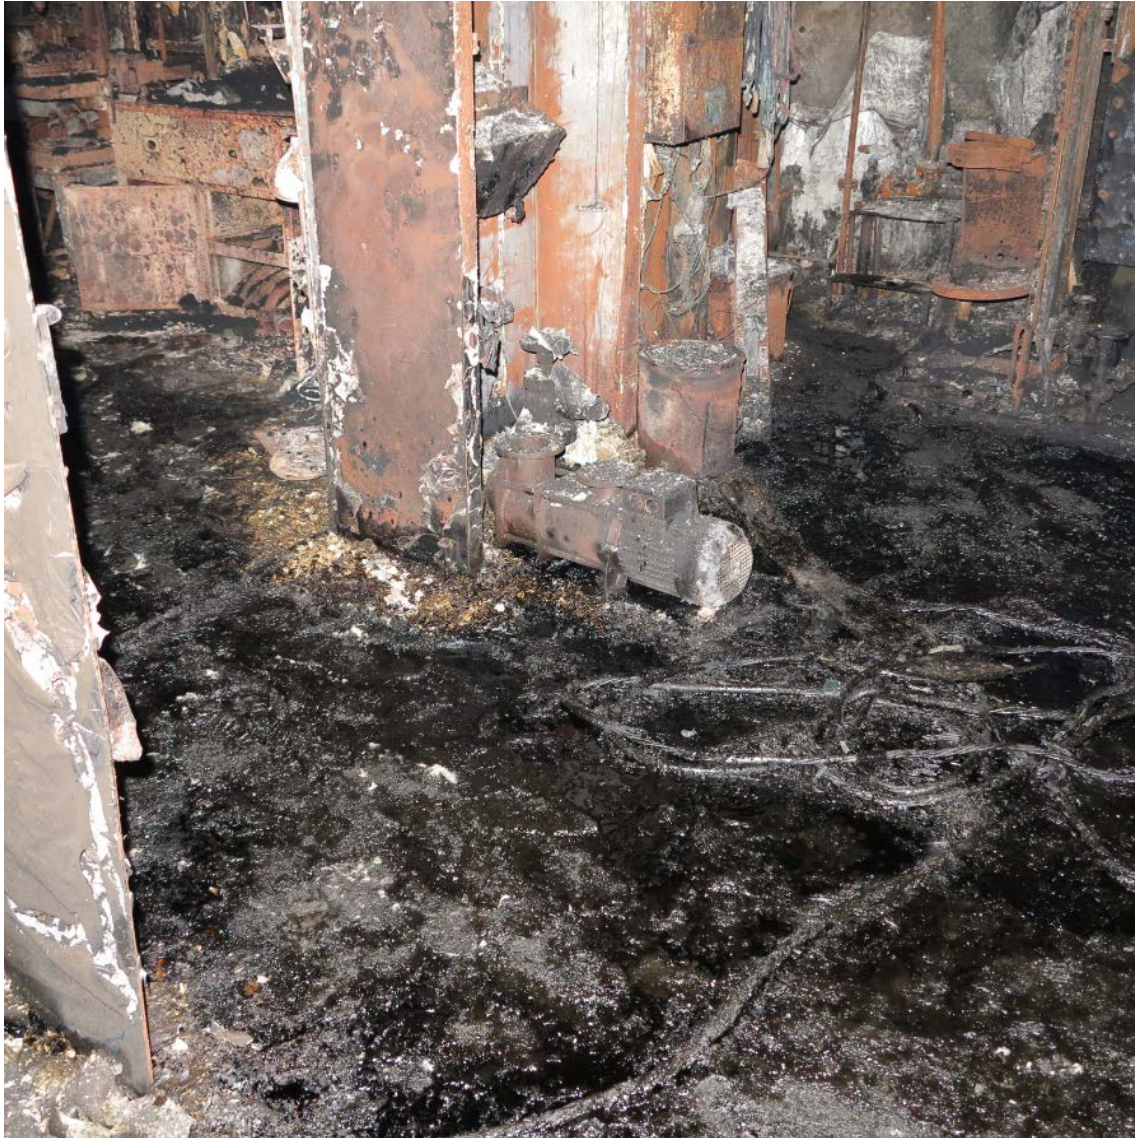
1  
2 **Figure 15. Port side view of the main engine room looking forward into the engine**  
3 **workshop, deck 2, at frame 75. An inch and a half of lube oil is on the deck.**

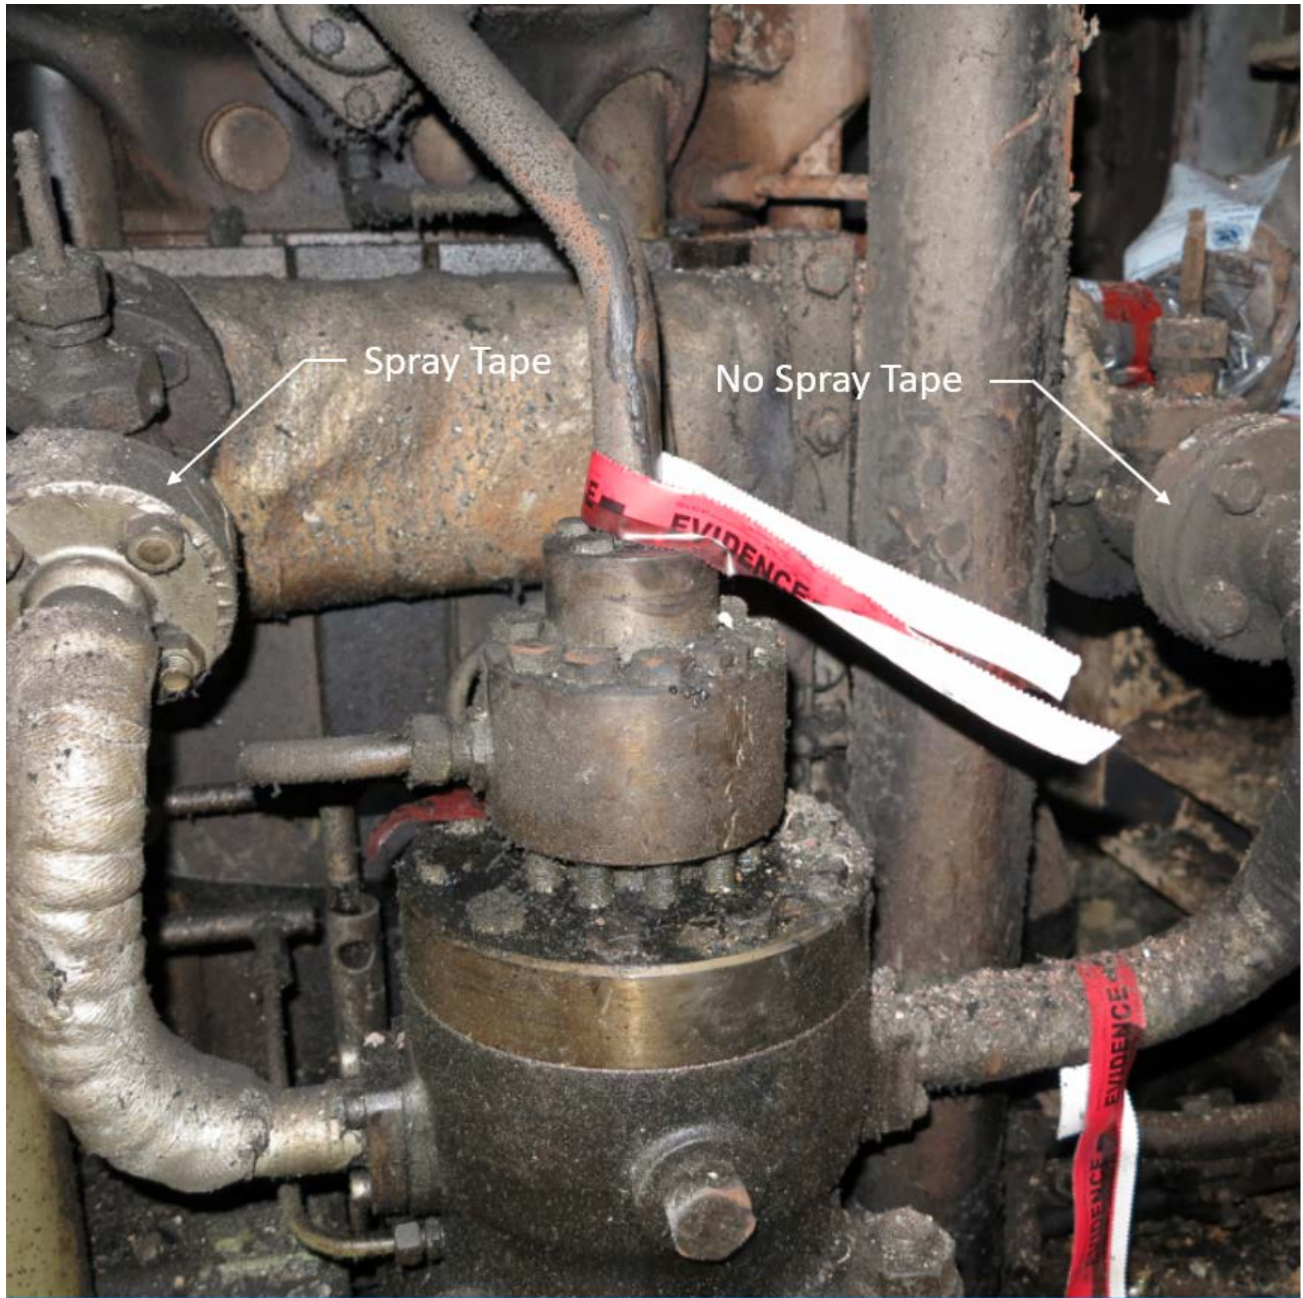
1  
2 **Figure 17. *Caribbean Fantasy* PME fuel oil supply and return line flanges on cylinder no. 8 near the drive**  
3 **(coupling) end, lower left control side where the fuel injection pumps and the camshaft are mounted**  
4 **(opposite to the exhaust manifold) after the fire. Photo illustrates the limited application of spray tape.**

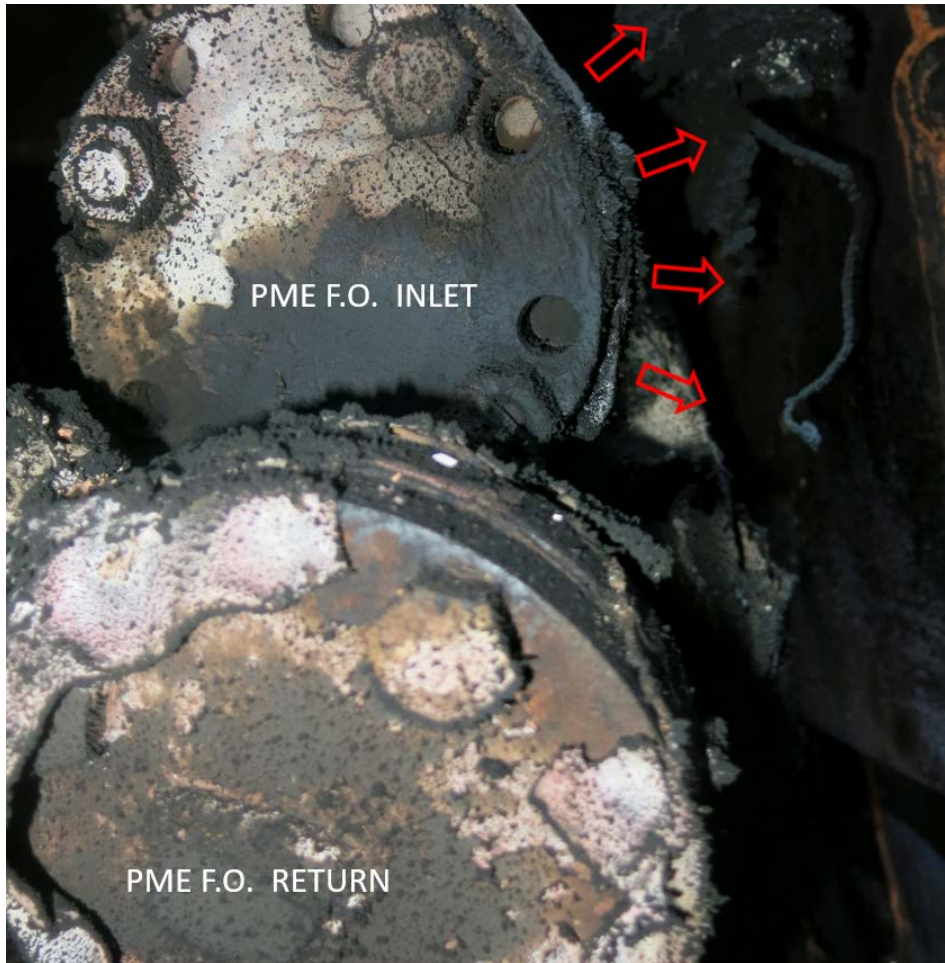
5 The photograph in figure 18 below is *Caribbean Fantasy*'s PME fuel oil supply and return line  
6 flanges with blanking plates, located near the lower left (control side) of the Mitsubishi MAN B&W  
7 engine (viewed looking forward while standing at the drive [coupling] end where the injection pumps  
8 and the camshaft are mounted, opposite to the exhaust manifold). The photo shows one layer of spray  
9 tape on the fuel oil supply line flange and blanking plate, the source of the fuel leak. Red arrows

1 depicting the direction of fuel oil spray in the direction of the exhaust manifold and turbocharger, as  
2 reported by the chief engineer during his interview with investigators.

3  
4 **Figure 18.** *Caribbean Fantasy* PME fuel oil supply and return line flanges and blanking plates near the  
5 drive (coupling) end, lower left control side where the injection pumps and the camshaft are mounted  
6 (opposite to the exhaust manifold) after the fire. Photo illustrates the degraded spray tape at the source  
7 of the fuel leak. Red arrows depict the direction of fuel oil spray. Photo was taken prior to as found on  
8 August 24, 2016 once the engine room atmosphere was cleared as safe for investigators to enter.

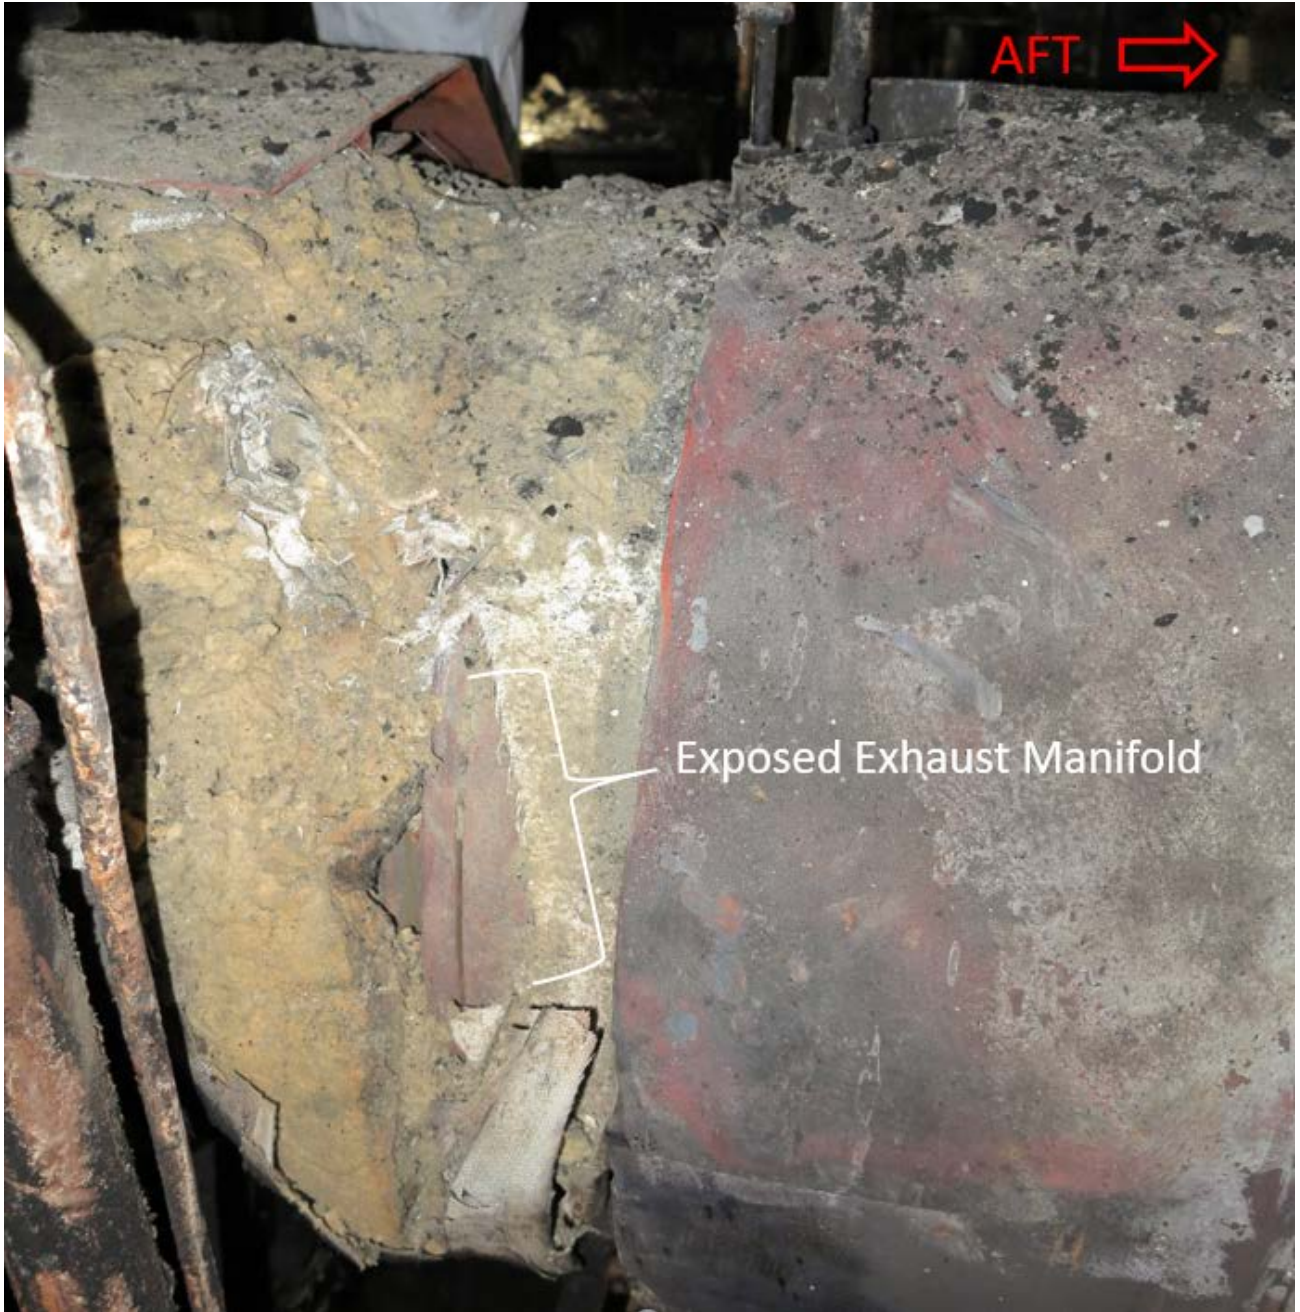
14 Investigators discovered several areas where exhaust pipe insulation was severely degraded,  
15 exposing the hot exhaust pipe manifold where the average temperature range is between 400 and  
16 450 °C (752 and 842 °F). The vessel was operating on MGO when the fire occurred and for over 7  
17 hours prior. The auto ignition temperature for MGO is 257 °C (495 °F). When MGO makes contact  
18 with a heated surface that is above 495° F, ignition can be instantaneous.

1  
2 **Figure 23. *Caribbean Fantasy's* main engine exhaust trunk with degraded insulation and exposed**  
3 **exhaust manifold pipe. Post accident photograph of the inboard inlet side of the exhaust pipe before**  
4 **the turbo taken from the PME drive (coupling) end.**
