# National Transportation Safety Board

Group Chairman's Factual Report

Engineering Group

*Caribbean Fantasy*

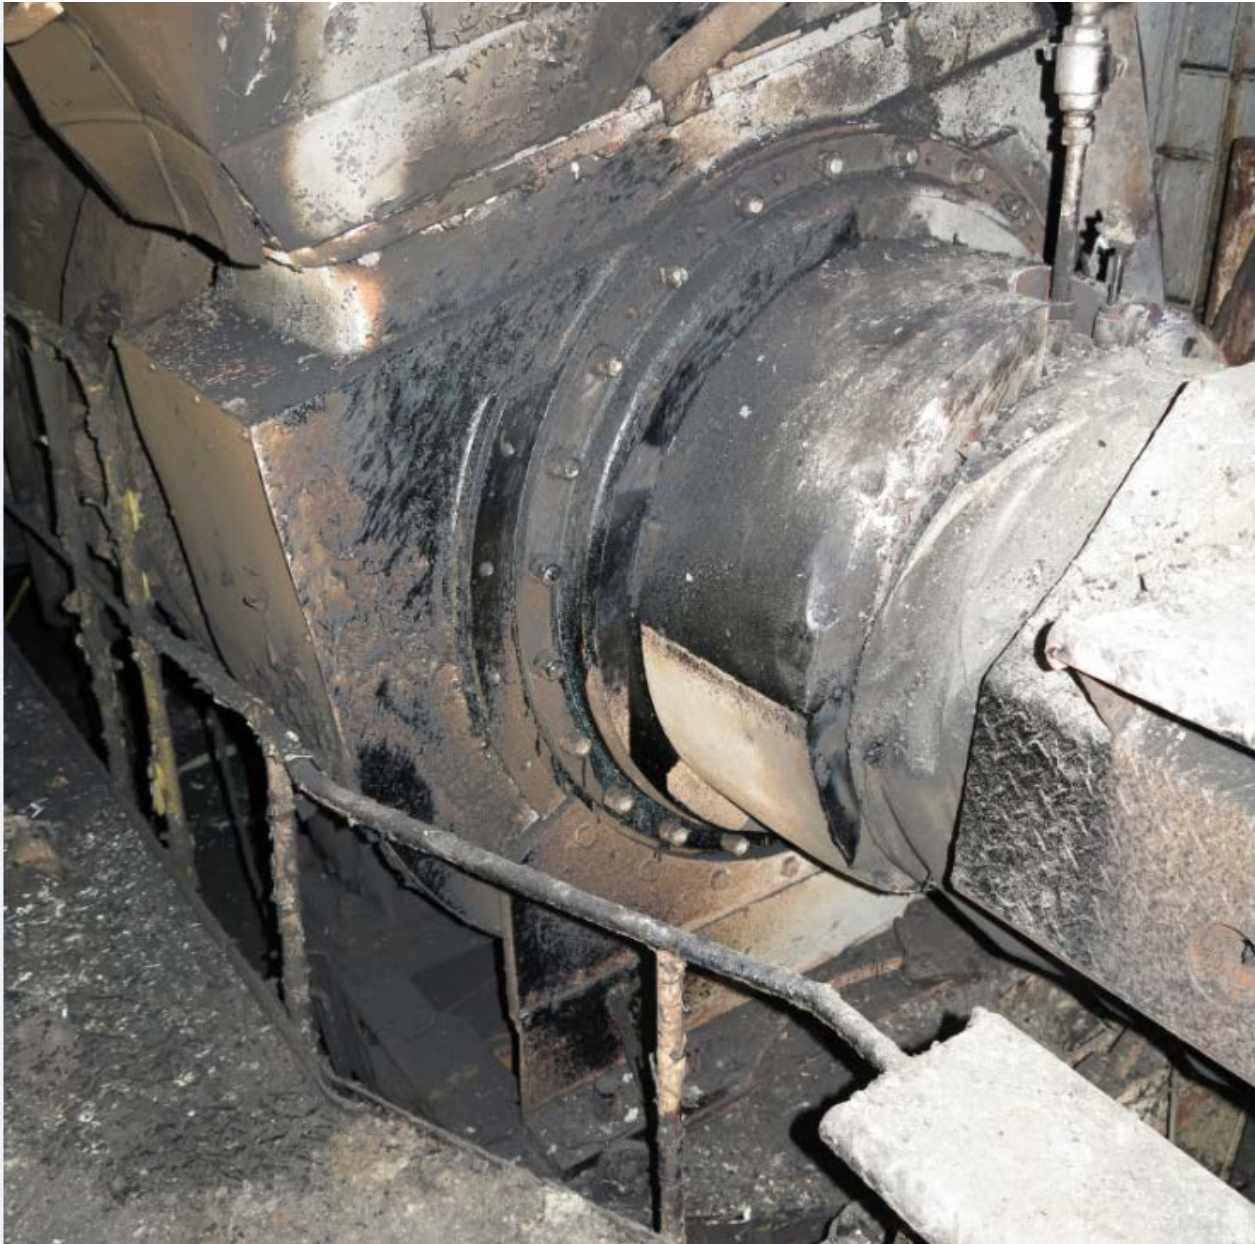
1  
2 **Figure 144. *Caribbean Fantasy's* port turbocharger casing and exhaust manifold. Dark residual oil coats**  
3 **the forward inboard side of the turbocharger casing and exhaust manifold lagging. Postaccident**  
4 **photograph taken from the inboard side of the PME.**

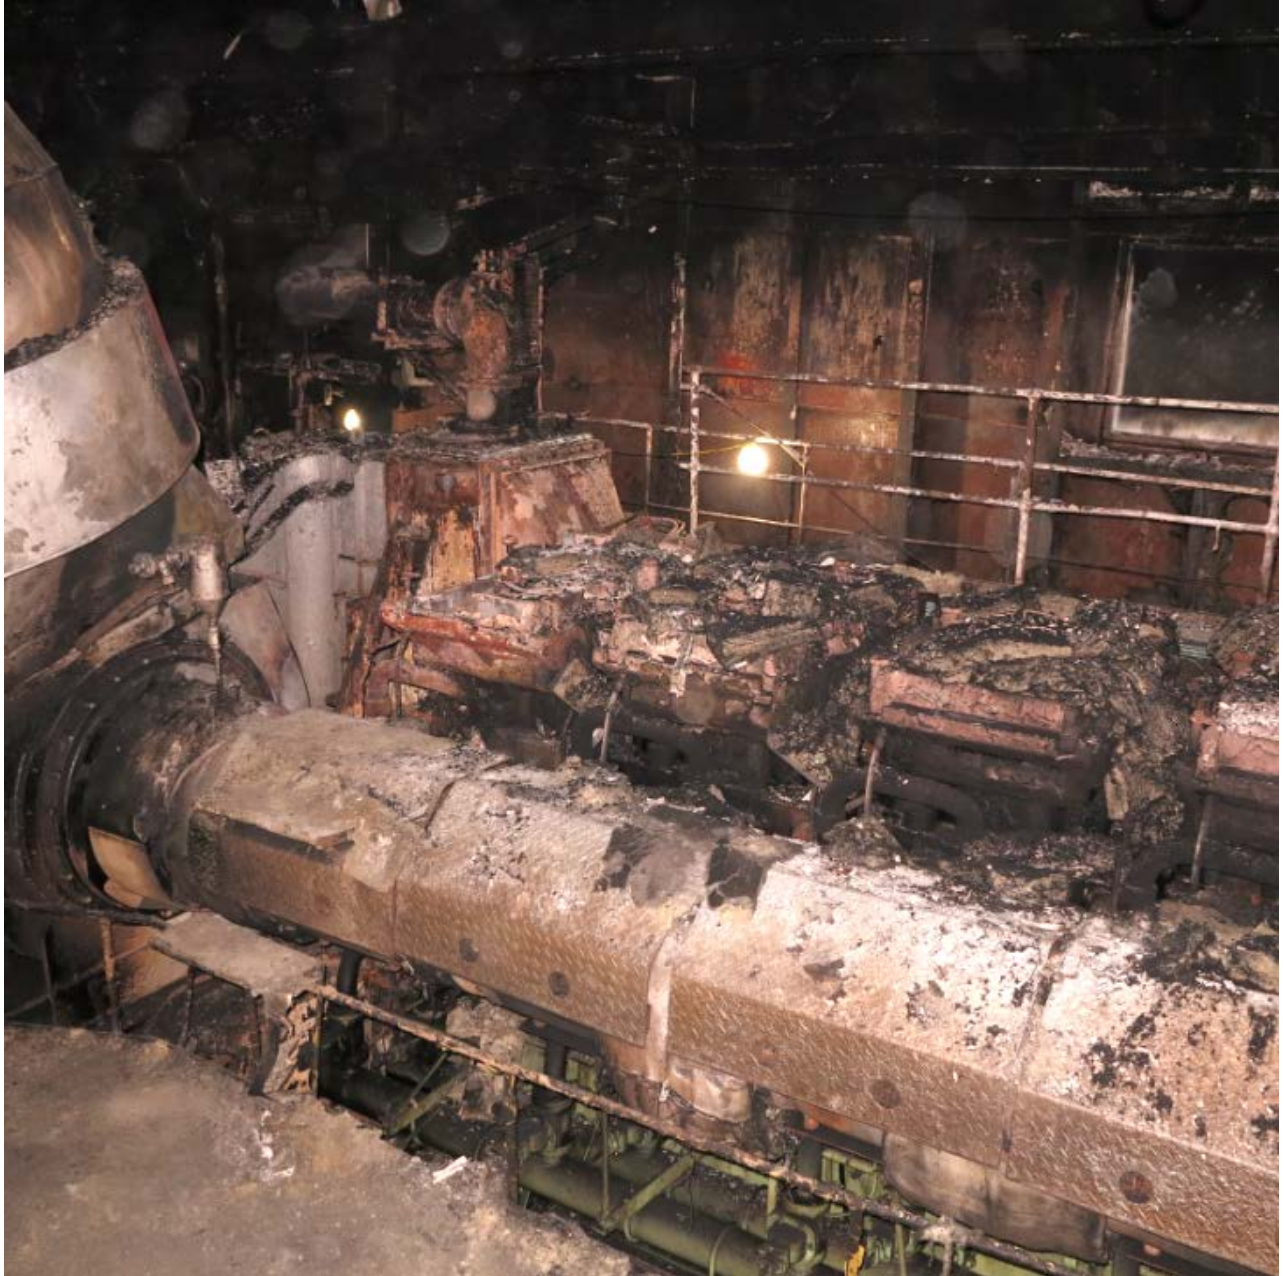
1  
2 **Figure 15. *Caribbean Fantasy*'s PME exhaust trunk manifold and turbocharger casing. Dark residual oil**  
3 **coats the forward inboard side of the turbocharger casing and exhaust manifold lagging. Post-accident**  
4 **photograph taken from the centerline of the main engine room (inboard side of the PME).**

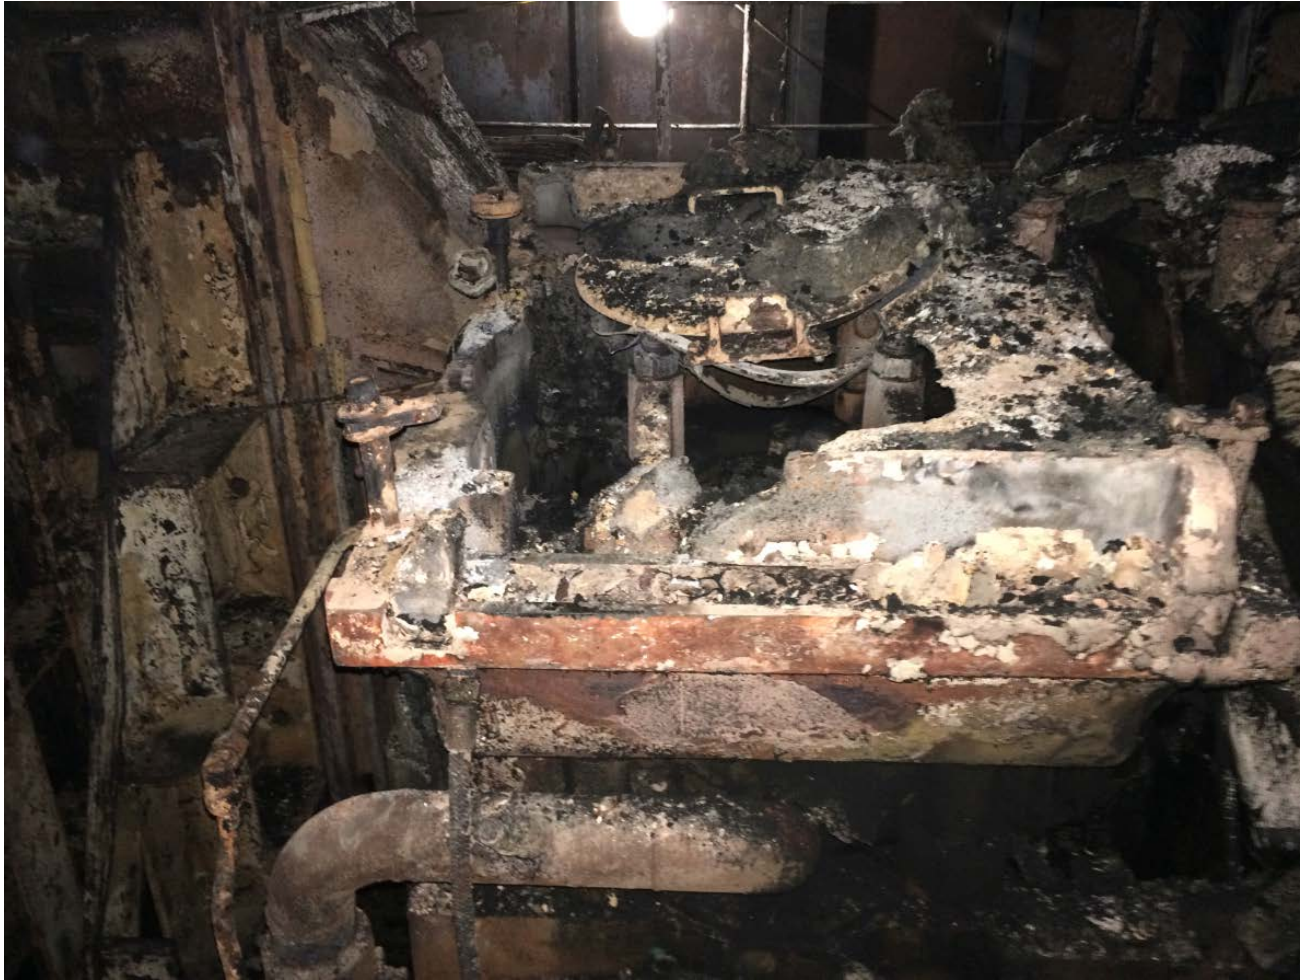
1  
2 **Figure 26. *Caribbean Fantasy's* PME cylinder no. 8. Post-accident photograph taken from the centerline**  
3 **of the main engine room (inboard, exhaust manifold side of the PME).**

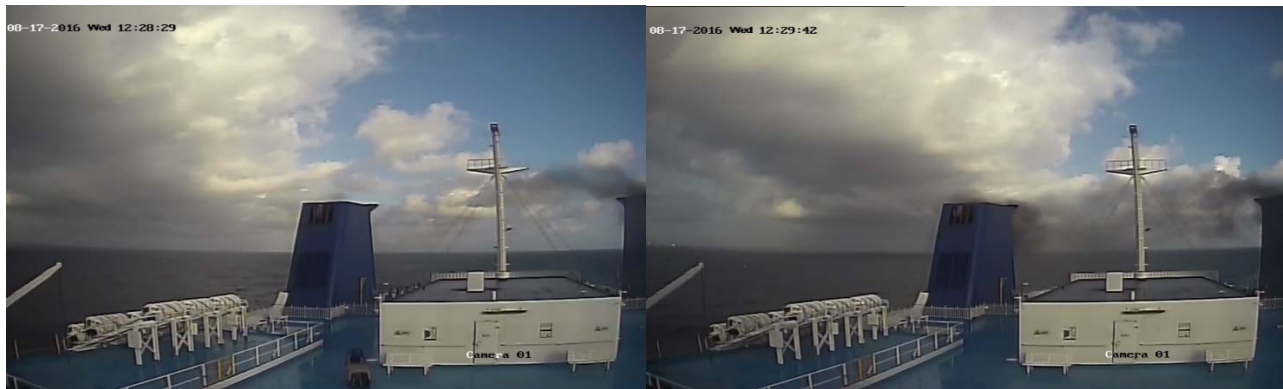
14  
15 **Figure 28. ECR CCTV view of the port and starboard stacks. The left frame shows the initial signs of**  
16 **black smoke from the port funnel at 0728 local time. Note in the foreground, a crew member is in**  
17 **process of moving one of the dogs from the kennel on this deck (deck 7) forward in preparation for**  
18 **debarcation. On the right, about one minute later, smoke can be seen emitting from starboard stack.**  
19 **The video at that point also showed the ship in a turn to port.**

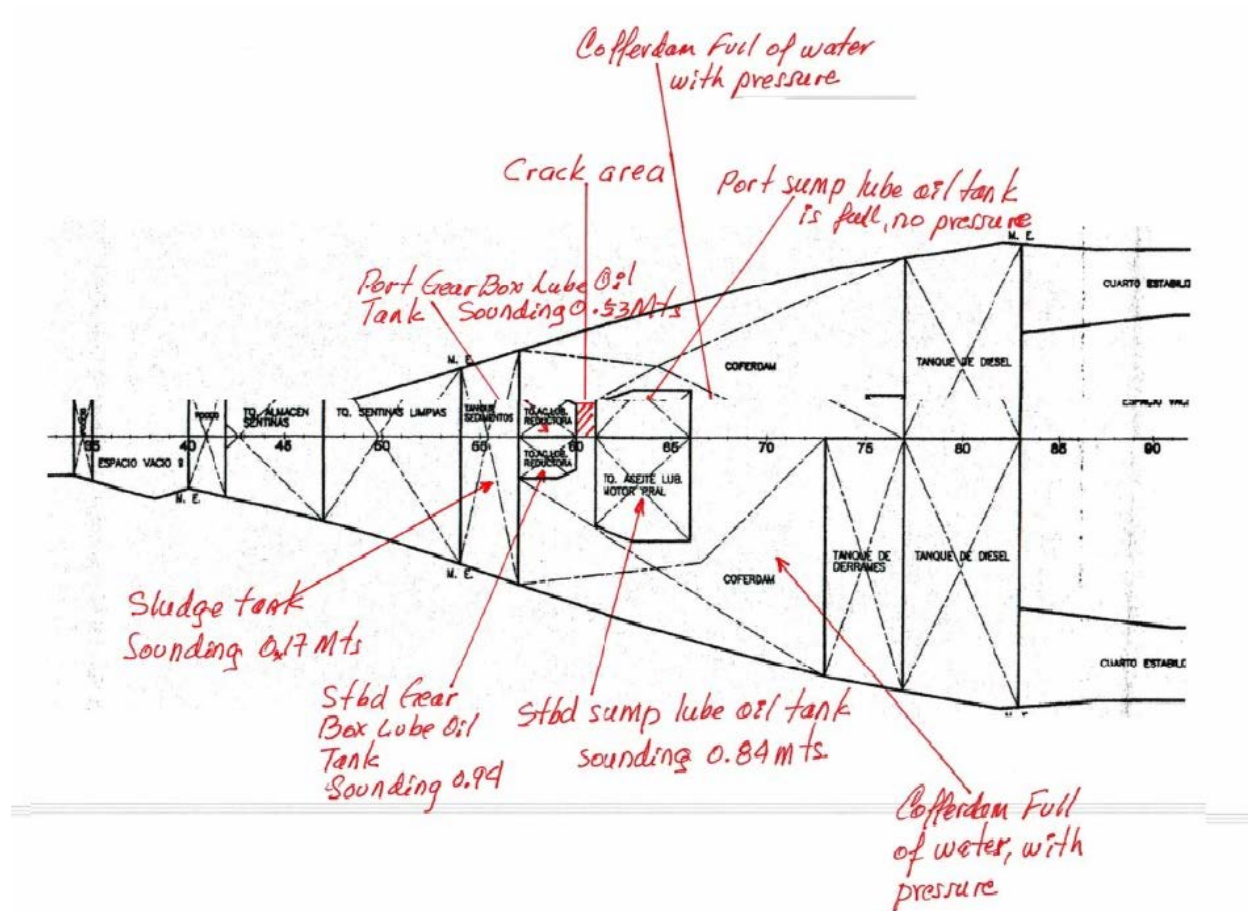
3 *Caribbean Fantasy* experienced an approx. 750 mm long and 25 mm wide fracture in  
4 the bottom plating on the starboard side cofferdam between frames FR60 and FR61.  
5 The port cofferdam between frames FR57 and FR77 and starboard cofferdam between  
6 frames FR57 and FR73 were full of sea water. All tanks in the vicinity of the fracture  
7 were sounded to verify their volume and ensure there was no pressure inside the tanks,  
8 an indication of the tank being compromised to sea water entry. The tanks included  
9 Starboard and Port Gear Box Lube Oil Tanks, Starboard and Port Sump Lube Oil  
10 Tanks, and Sludge Tank.
