1 National Transportation Safety Board

8 Group Chairman's Factual Report
9
10
11
12

13 **Engineering Group**
14
15
16
17
18

20 DCA-10-MM-017
21

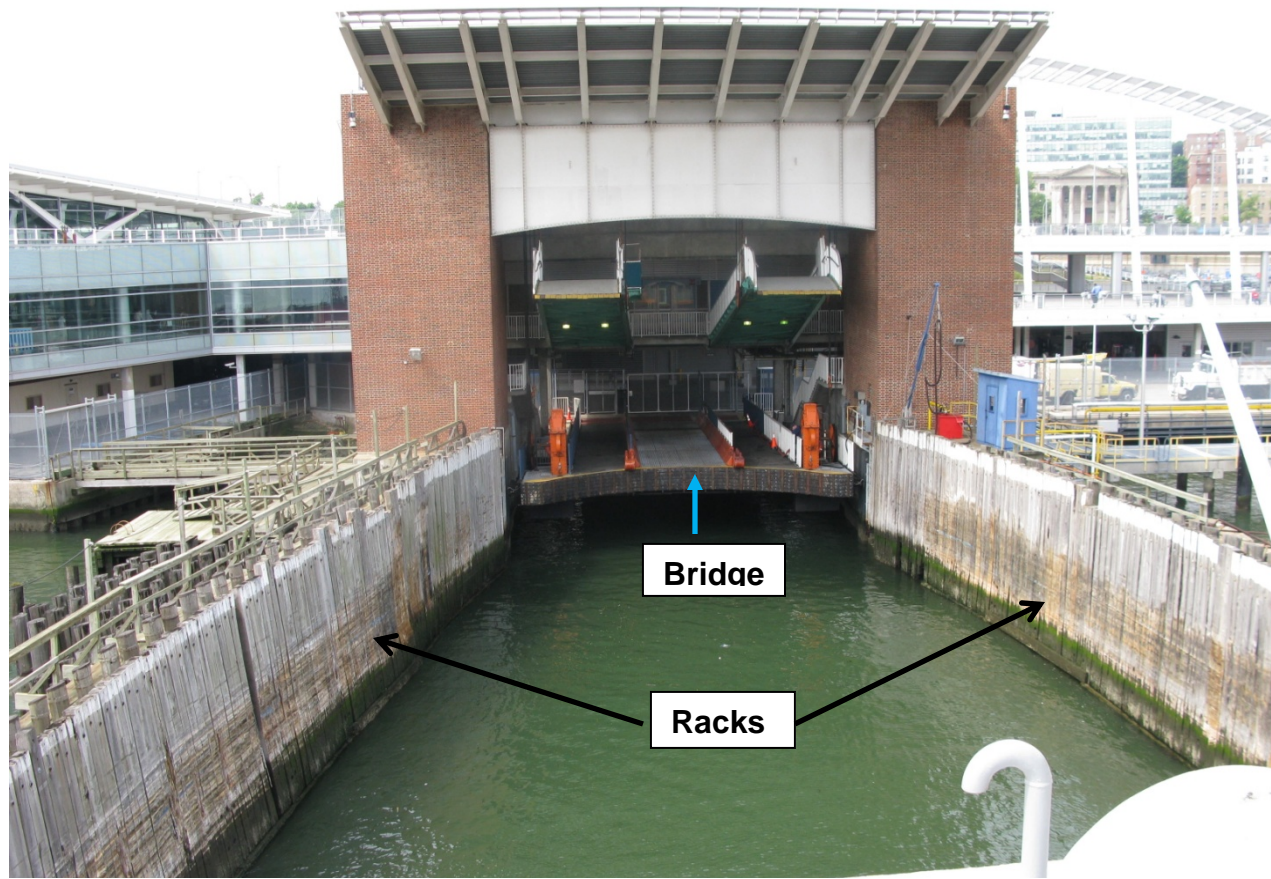
2 **Figure 1- St. George Staten Island Ferry slip**3 4.4. Events Post-Accident

5 The Staten Island Ferry Service shoreside terminal #5 slip where the allision occurred sustained
6 damage to its steel ladders and walkways. The transition bridge, which the ferry connects to upon
7 its arrival at the slip (figure 1), was pushed forward and displaced upon impact, but sustained no
8 damage. The bridge is designed to absorb impact forces and be displaced in the event of a hard
9 landing such as the allision. In the days following the accident, the bridge was rigged back into
10 place, and ladder and walkway steel damage was repaired. The cost to repair the slip was \$13,613.

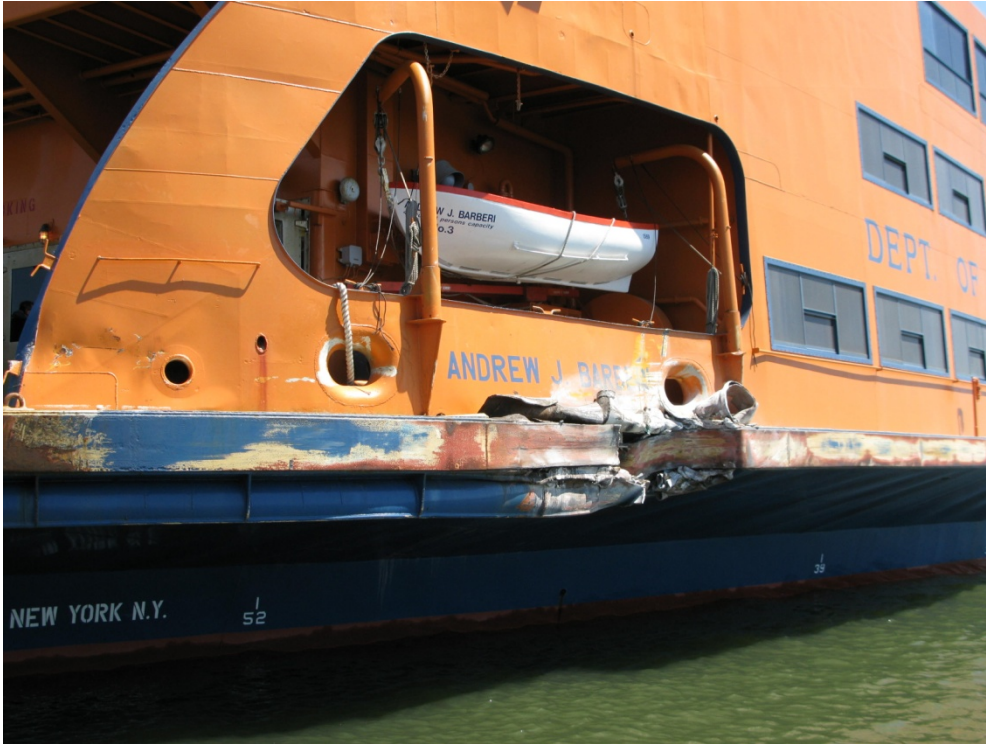
2 **Figure 6- Damage to vessel's port side**

Damage to the vessel was generally sustained symmetrically to the port and starboard sides from the point where it impacted the dock's rack pilings on both sides from frames 48 to the vessel's end. Damage to the port and starboard side, respectively, are shown in Figure 6 and 7. Damage to both the vessel's sides involved the hull being breached in that end's space containing the cycloid propulsion unit. All damage was contained to above the vessel's waterline, and in the confines of the frames of the propulsion space.

9 Damage was also identified at the bridge deck level port and starboard of the wheelhouse. This
10 damage resulted from the vessel having struck the retracted ramps that would typically be
11 lowered into position once the vessel was docked to allow passenger disembarkation. On the
12 starboard side, the manhole leading into the battery void below sustained damage. On the port
13 side of the wheelhouse over this same battery void, damage was observed to the manhole
14 cover, as well as a vent tube being broken off, and a natural exhaust trunk broken free from its
15 mount. This damage was essentially considered to be cosmetic in nature.

16 The repairs were completed, the ferry service conducted a sea trial with Coast Guard and
17 American Bureau of Shipping inspectors onboard, and the vessel returned to service on June 23,
18 2010. The cost to repair the Barberi was \$168, 625²¹, according to SIF officials.
