**3D LASER SCANNING GROUP CHAIRMAN
Factual Report**

**Train Derailment
Philadelphia, PA**

**DCA15MR010
(17 Pages)**

**NATIONAL TRANSPORTATION SAFETY BOARD
OFFICE OF RESEARCH AND ENGINEERING
WASHINGTON, D.C. 20594**

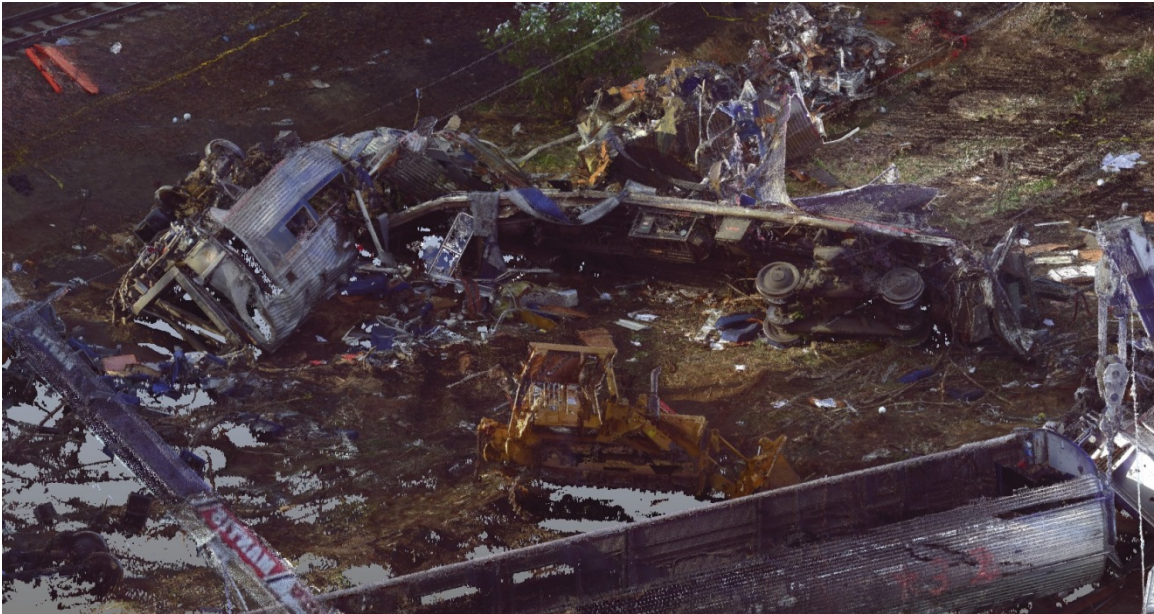
Figure 1. An image from the 3D laser scanner point cloud showing passenger Car 1 in its final rest position after vehicle extrication.

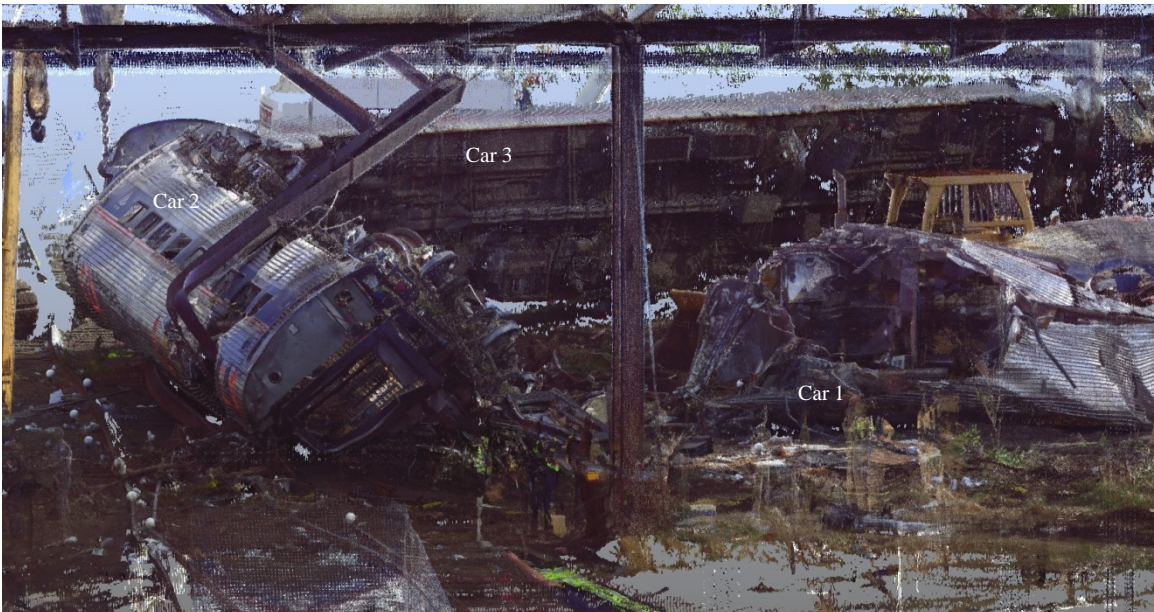
Figure 2. An image from the 3D laser scanner point cloud showing the passenger Car 2 on the left and a portion of passenger Car 1. The underside of passenger Car 3 can be seen in the background.

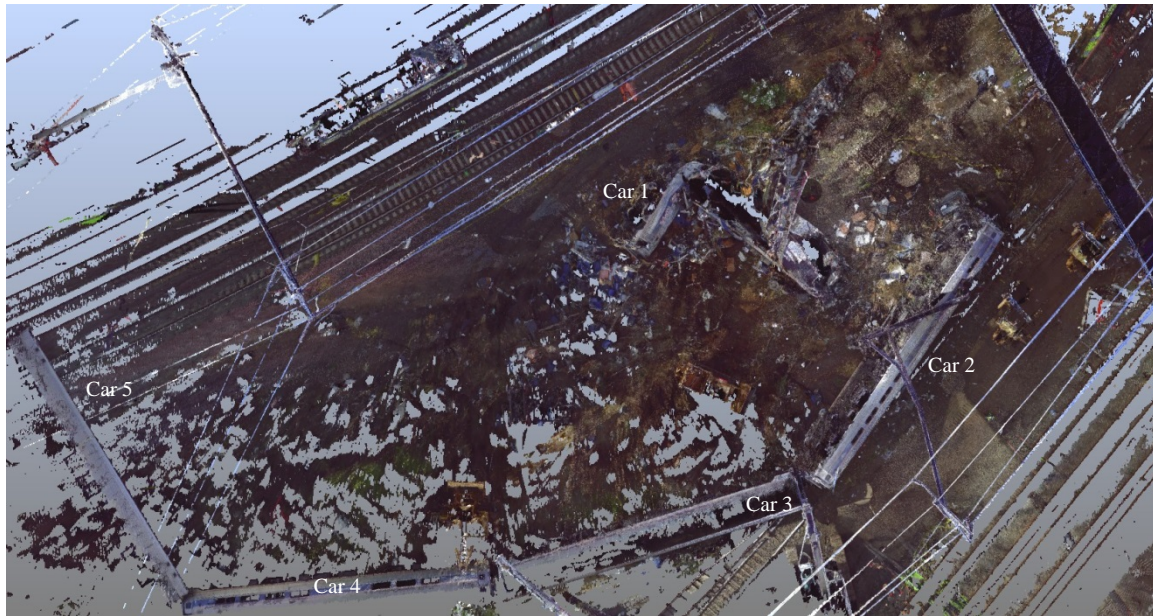
Figure 3. An overhead image from the 3D laser scanner point cloud showing passenger Cars 1, 2, 3, 4, and 5.

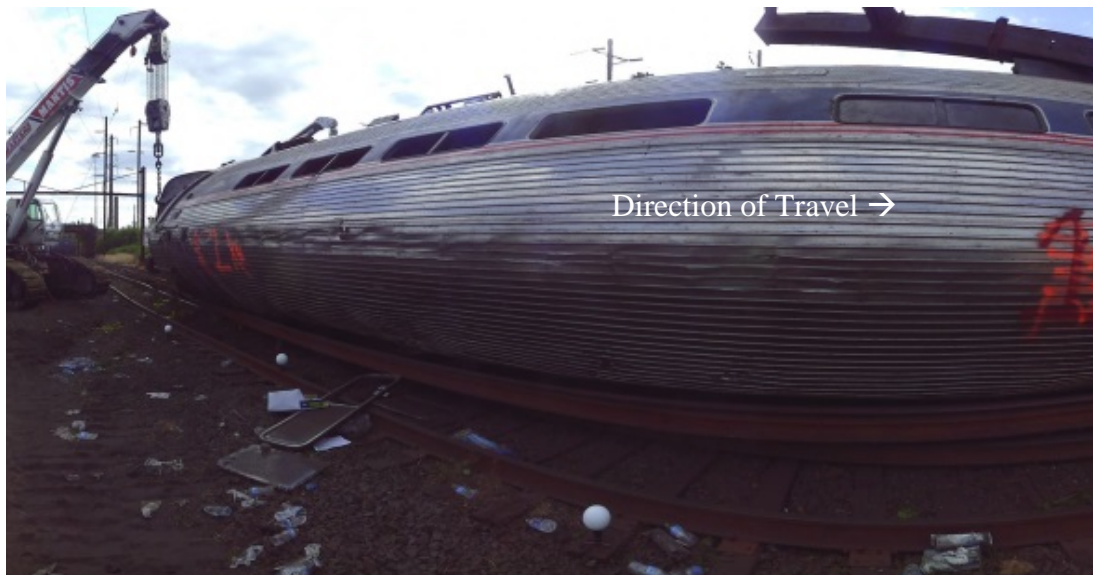
The condition of the rail car windows in Car 2 was examined from the 3D laser scan data. Images showing the condition of the windows for Car 2 are shown in Figure 4 through Figure 6.⁵

Figure 4. An image from the scanner showing the roof and left side of Car 2 in its final rest position. The direction of travel is marked on the image.

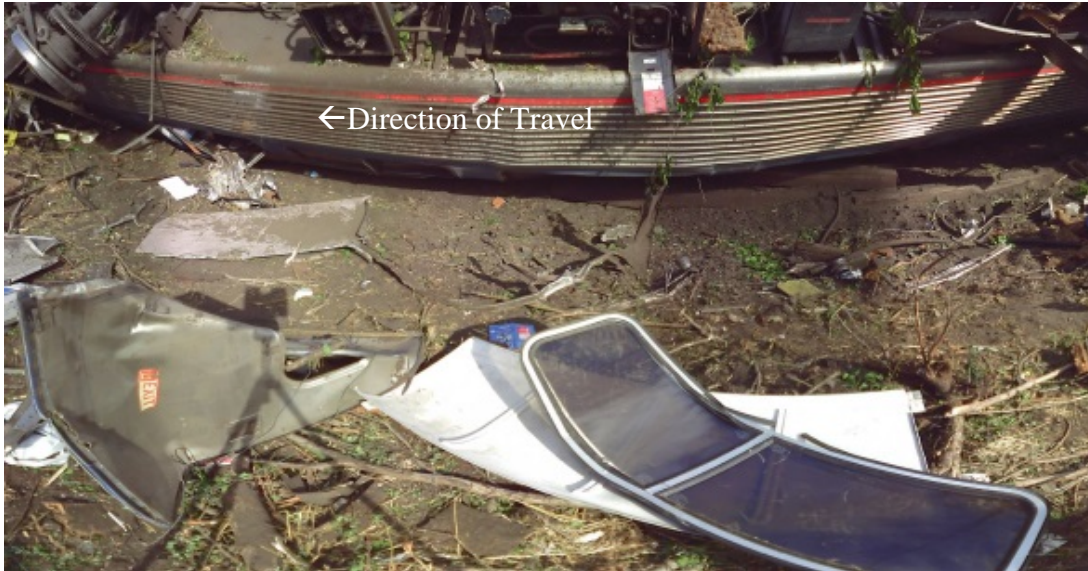
Figure 5. An image from the scanner showing the right side of Car 2, near the coupling to Car 1, in its final rest position. The direction of travel is marked on the image.

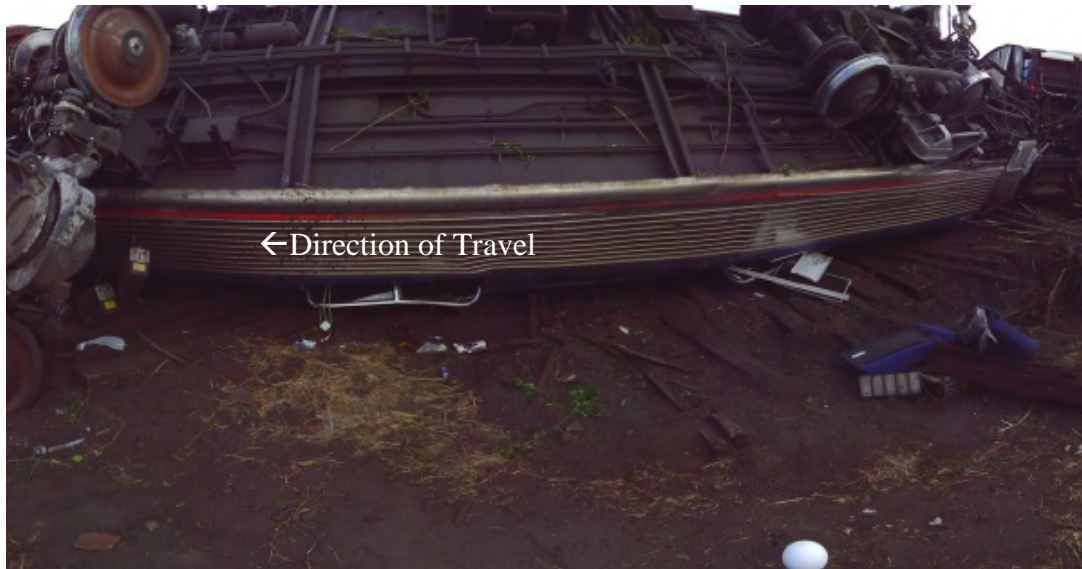
Figure 6. An image from the scanner showing the right side of Car 2, near the coupling to Car 3, in its final rest position. The direction of travel is marked on the image.

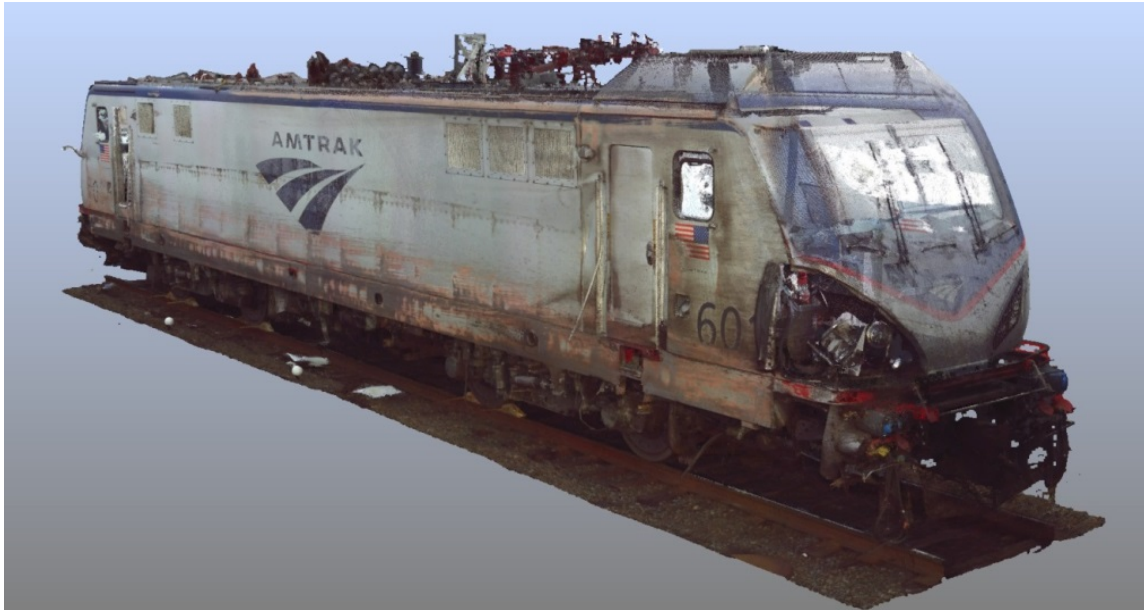
Figure 7. An image from the 3D laser scanner point cloud showing the front right of the locomotive.

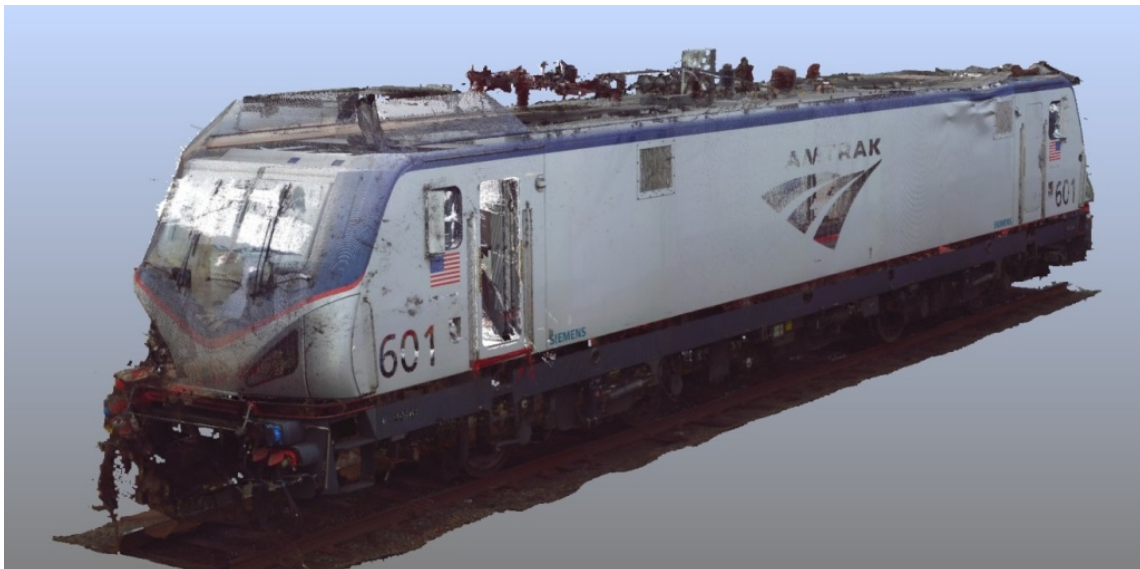
Figure 8. An image from the 3D laser scanner point cloud showing the front left of the locomotive.

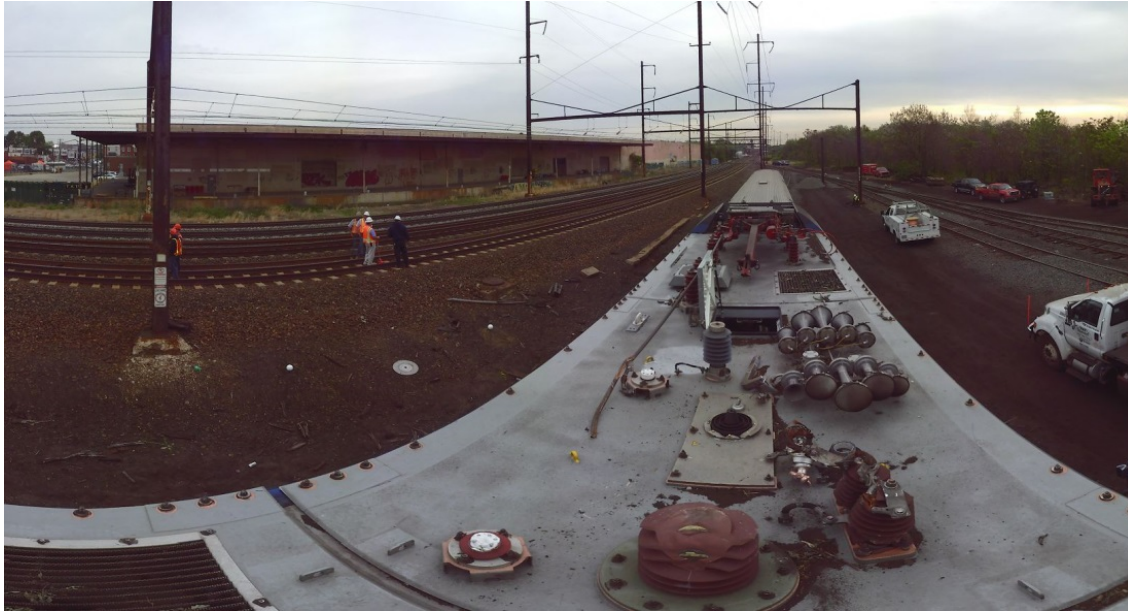
Figure 9. An image from the scanner showing the locomotive roof looking toward the engineer's cab, toward the direction of travel.

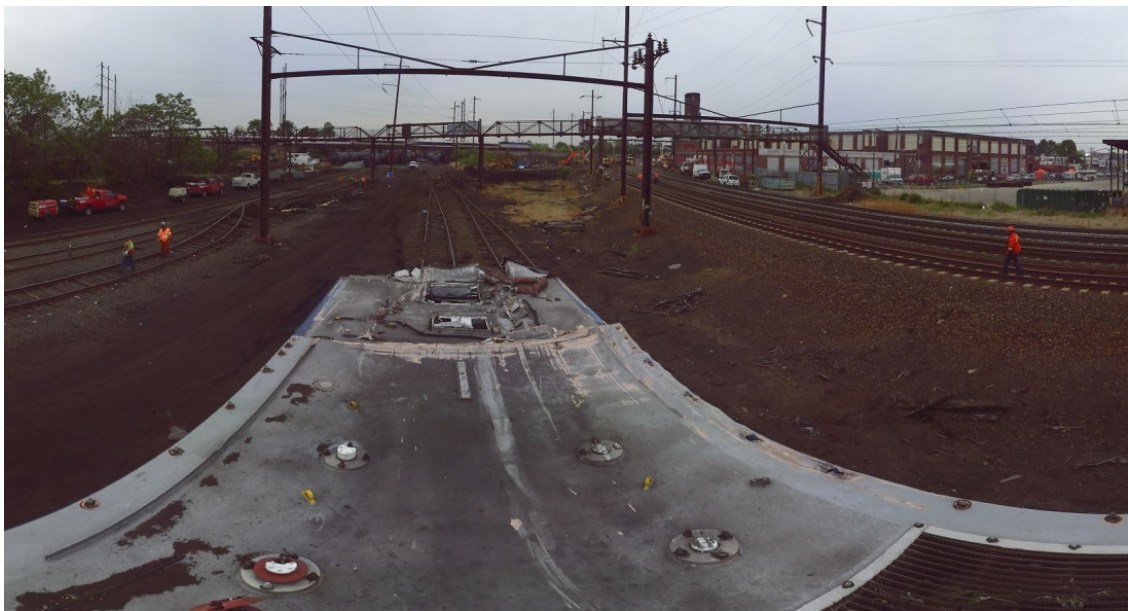
Figure 10. An image from the scanner showing the locomotive roof looking away from the direction of travel.

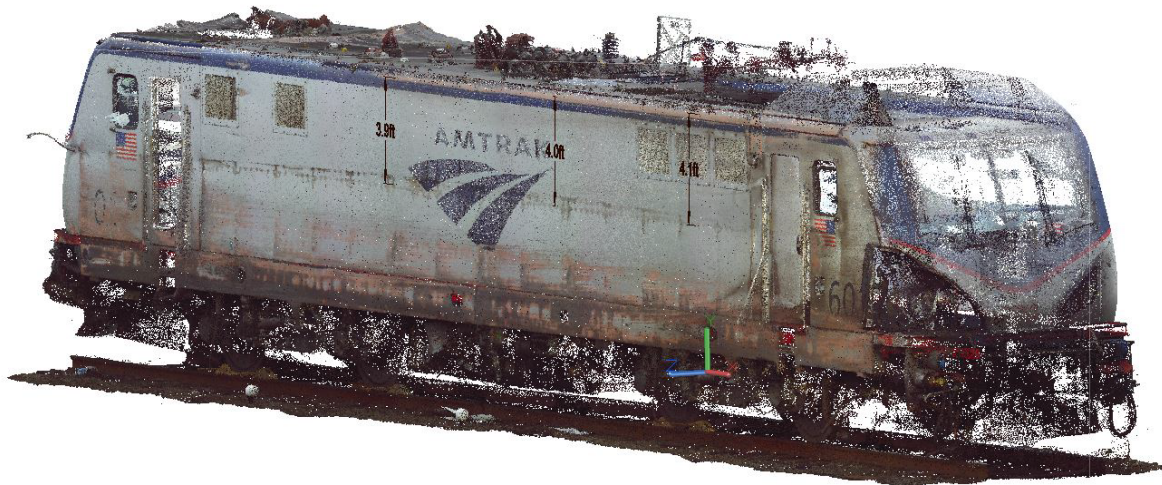
Figure 11. Measurements documenting the damage on the right side of the locomotive. The front of the locomotive is on the right side of the image. (From left to right, the dimensions are 3.9 feet, 4.0 feet, and 4.1 feet.)

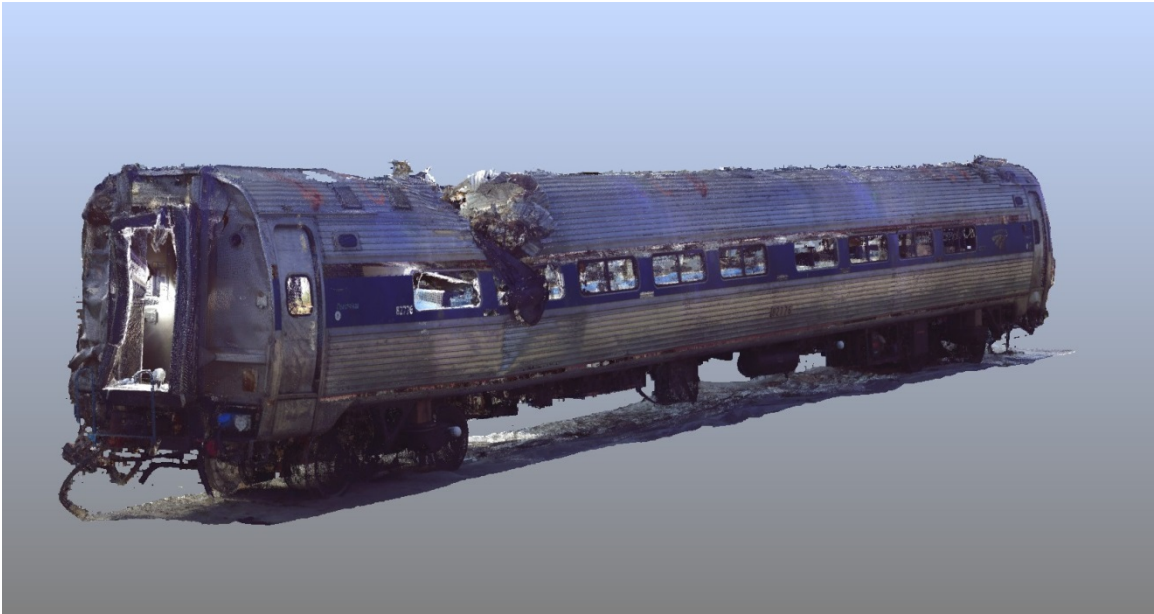
Figure 12. An image from the 3D laser scanner point cloud showing the B-end of passenger Car 2.

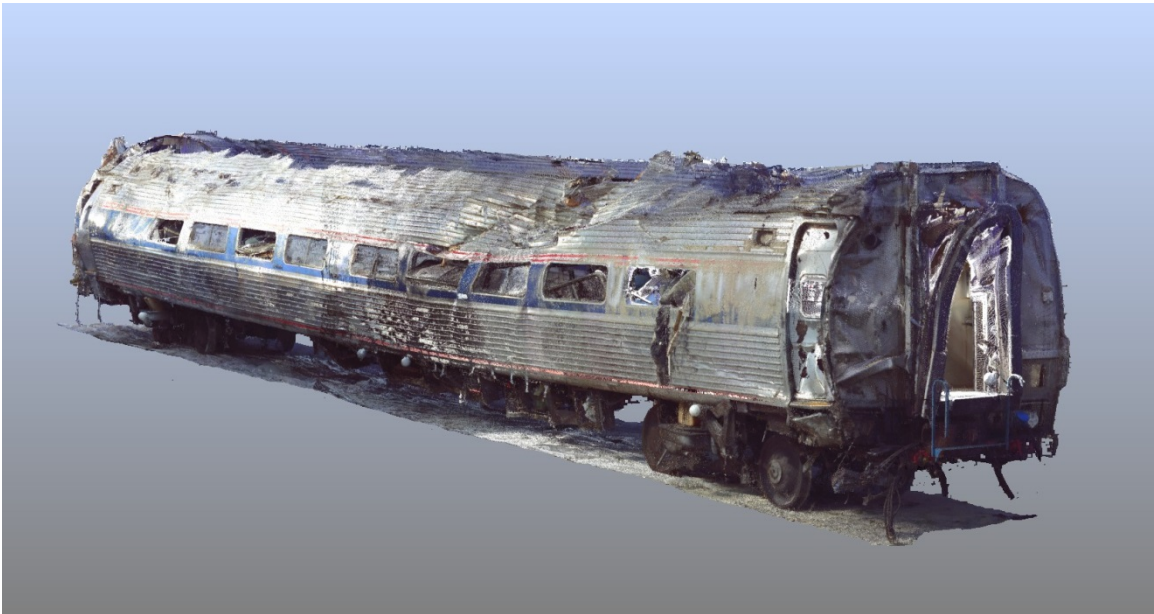
Figure 13. An image from the 3D laser scanner point cloud showing the B-end of passenger Car 2 from the other side.

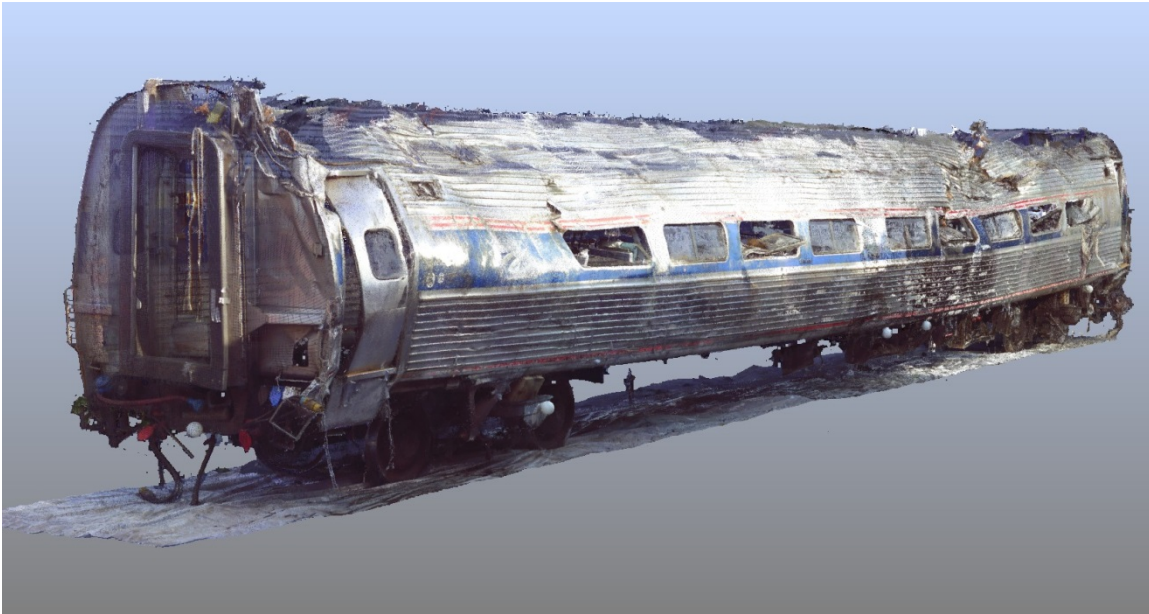
Figure 14. An image from the 3D laser scanner point cloud showing the A-end of passenger Car 2.

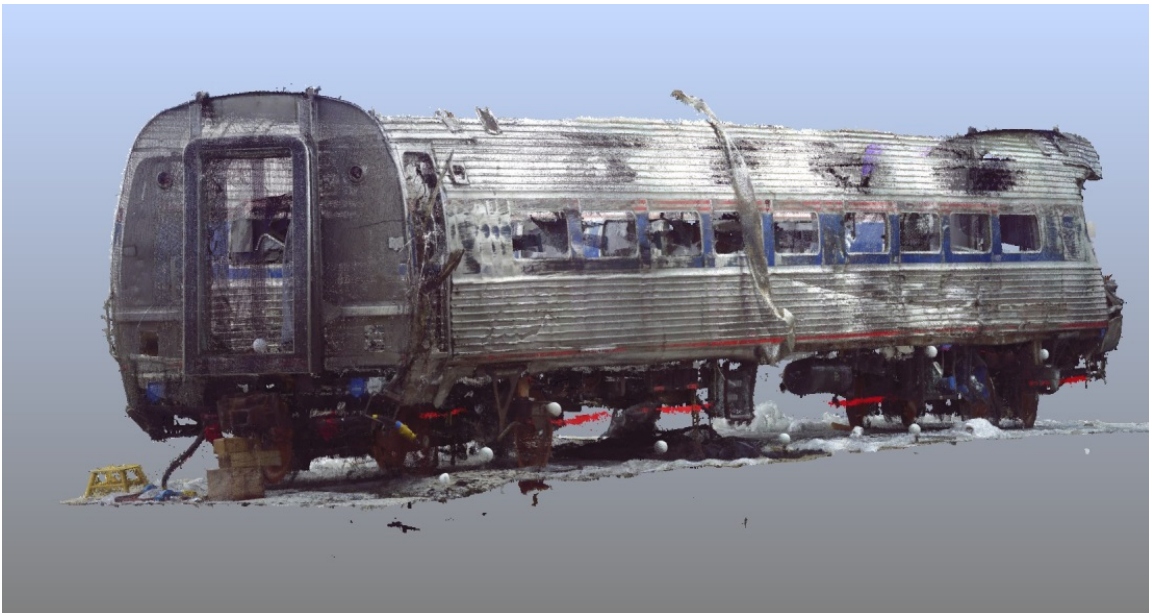
Figure 15. An image from the 3D laser scanner point cloud showing the B-end of passenger Car 3.

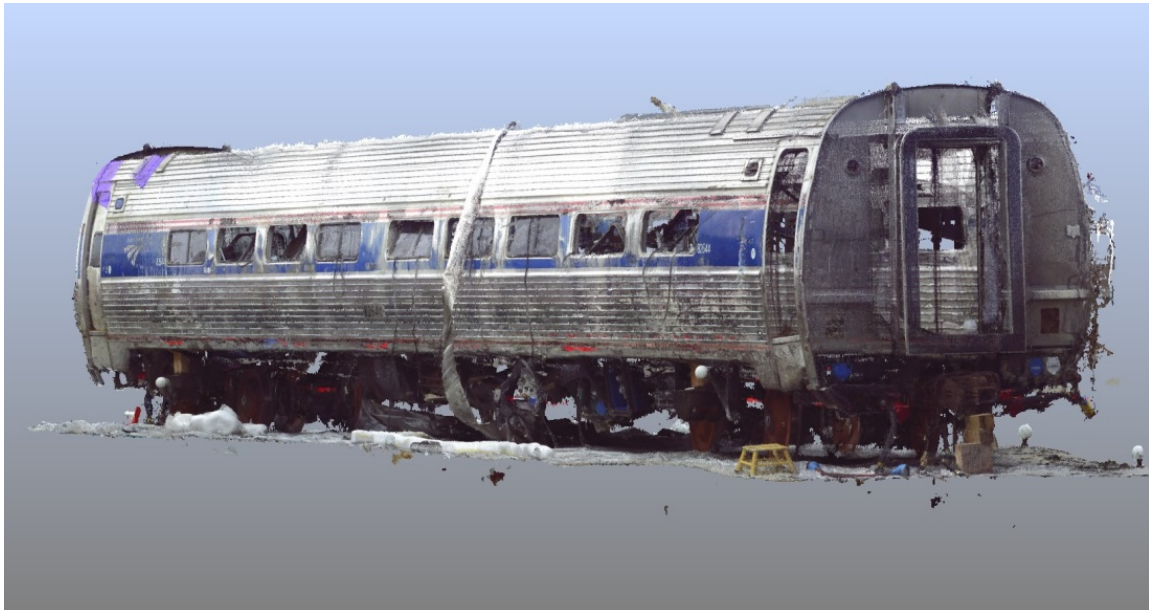
Figure 16. An image from the 3D laser scanner point cloud showing the B-end of passenger Car 3 from the other side.

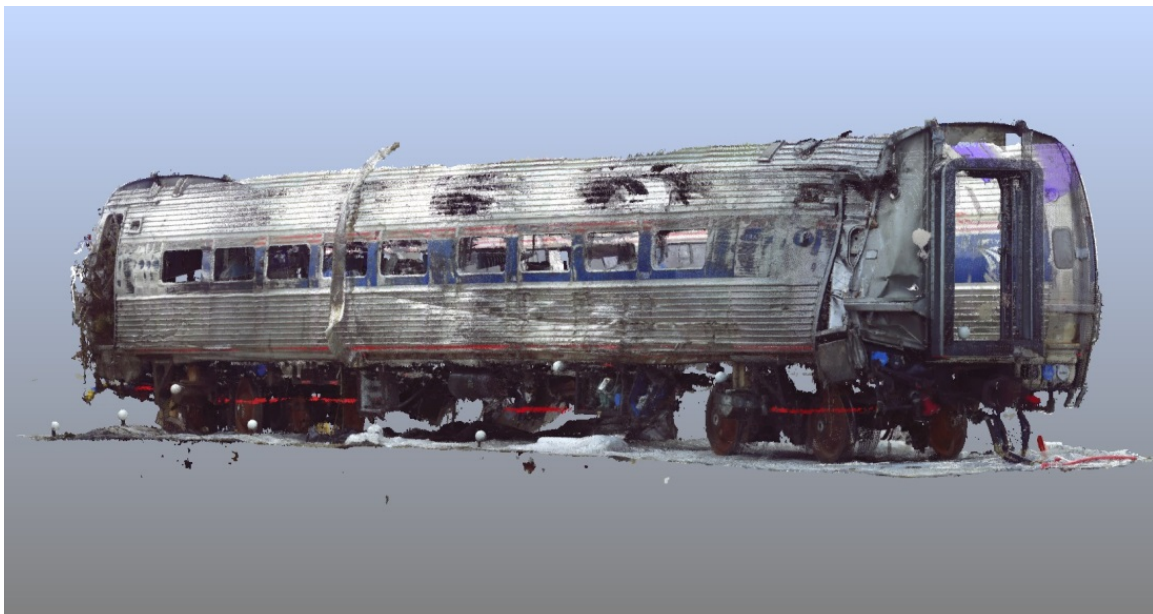
Figure 17. An image from the 3D laser scanner point cloud showing the A-end of passenger Car 3.

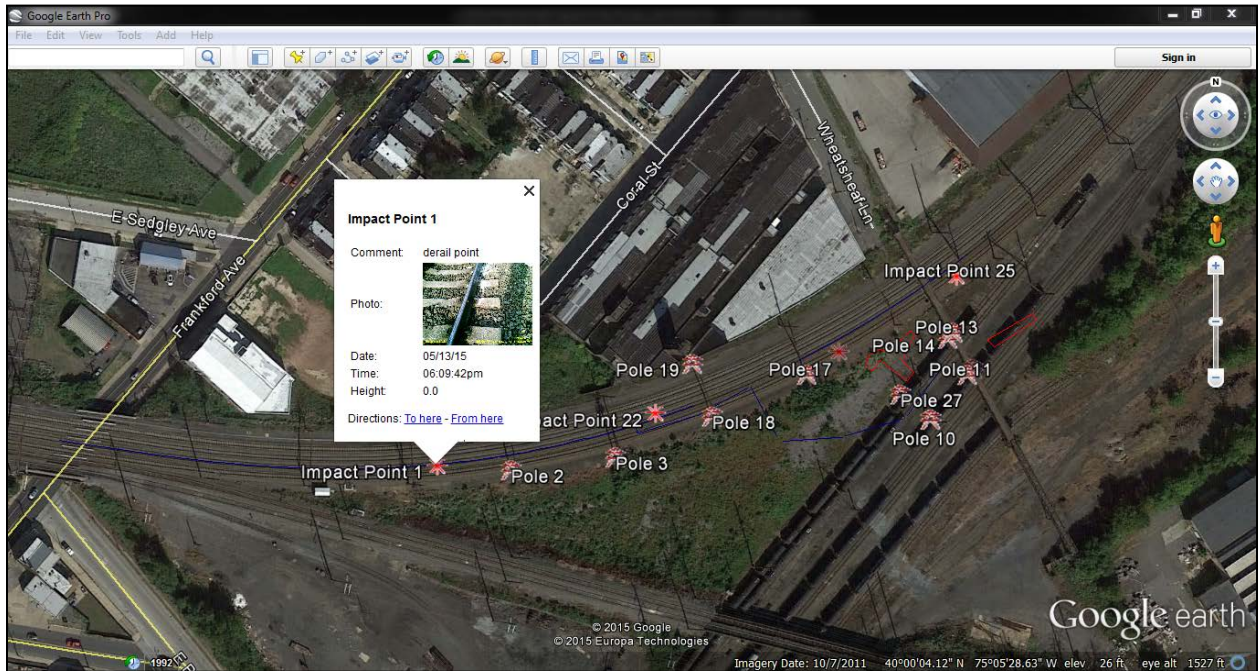
Figure 20. Screenshot of *Google Earth* with *NTSB3_AMTRAK1_1.kmz* file loaded, and survey feature #1 highlighted.
