## **3D LASER SCANNING FACTUAL REPORT**

**Train & Truck Crash  
On Railroad Right-Of-Way**

**Oxnard, California**

**HWY15MH006  
(14 Pages)**

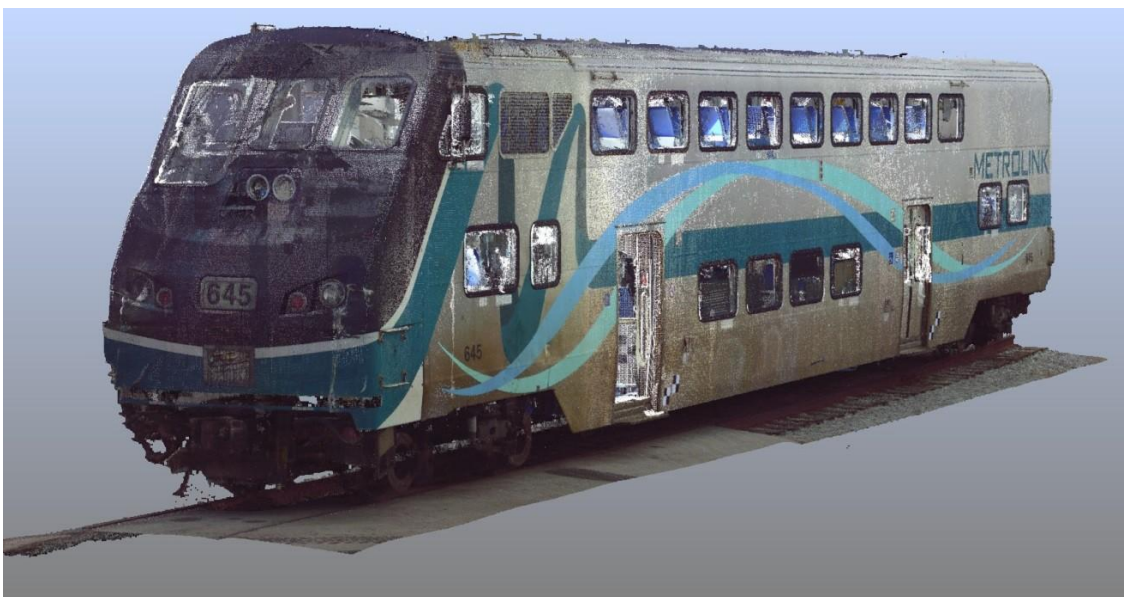
Figure 1: An image from the 3D laser scanner point cloud showing left side of the cab car - 645.

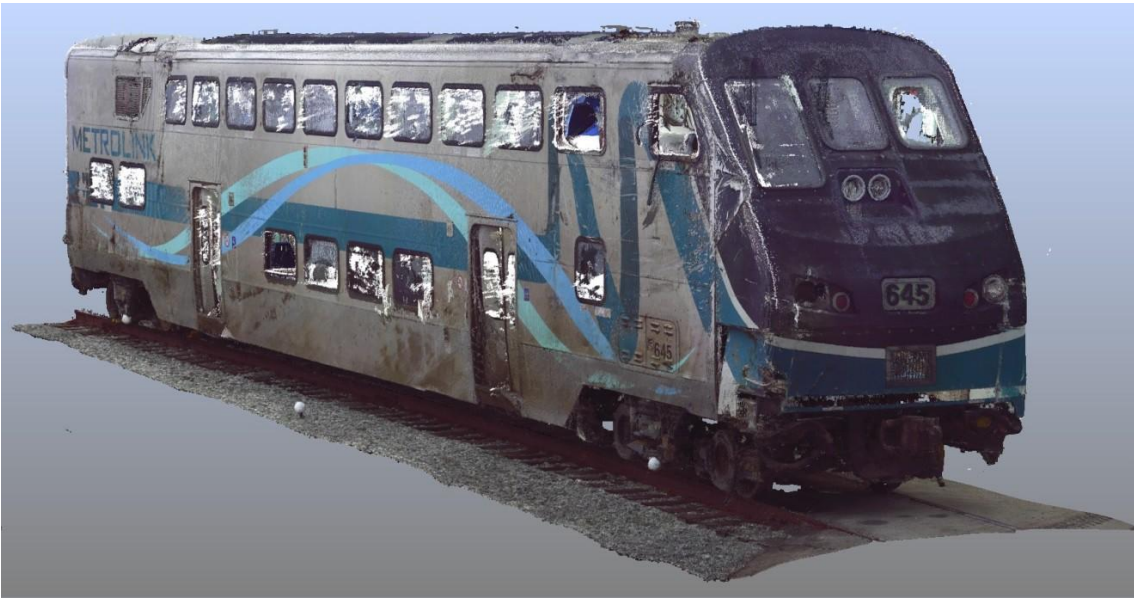
Figure 2: An image from the 3D laser scanner point cloud showing the right side of the cab car - 645.

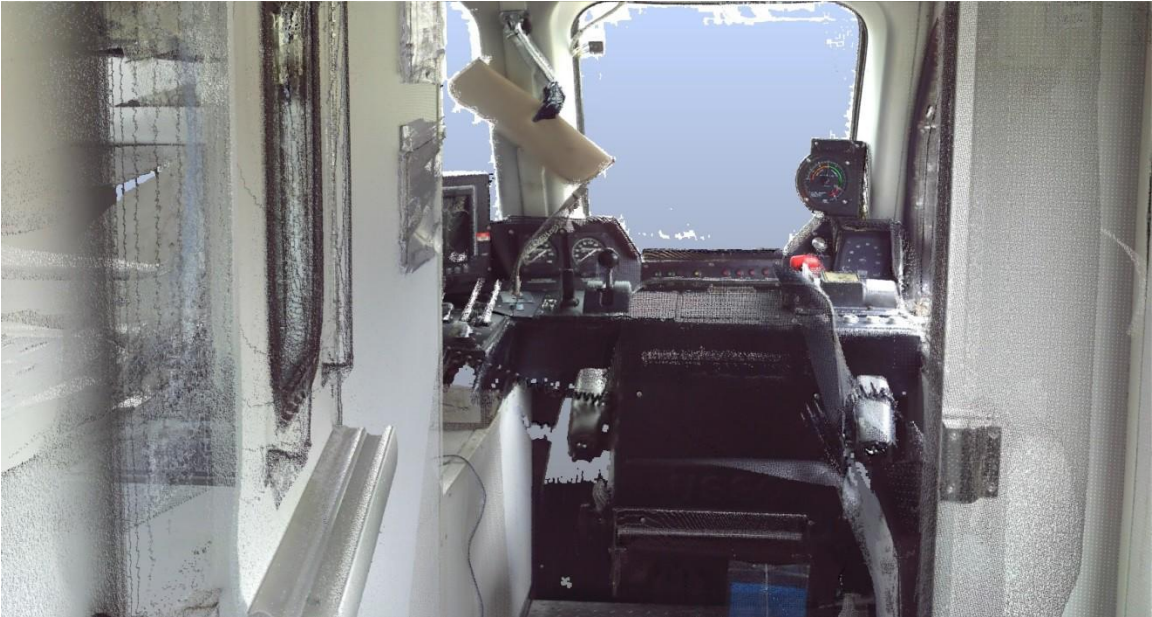
Figure 3: An image from the 3D laser scanner point cloud showing the engineer's cab in car - 645.

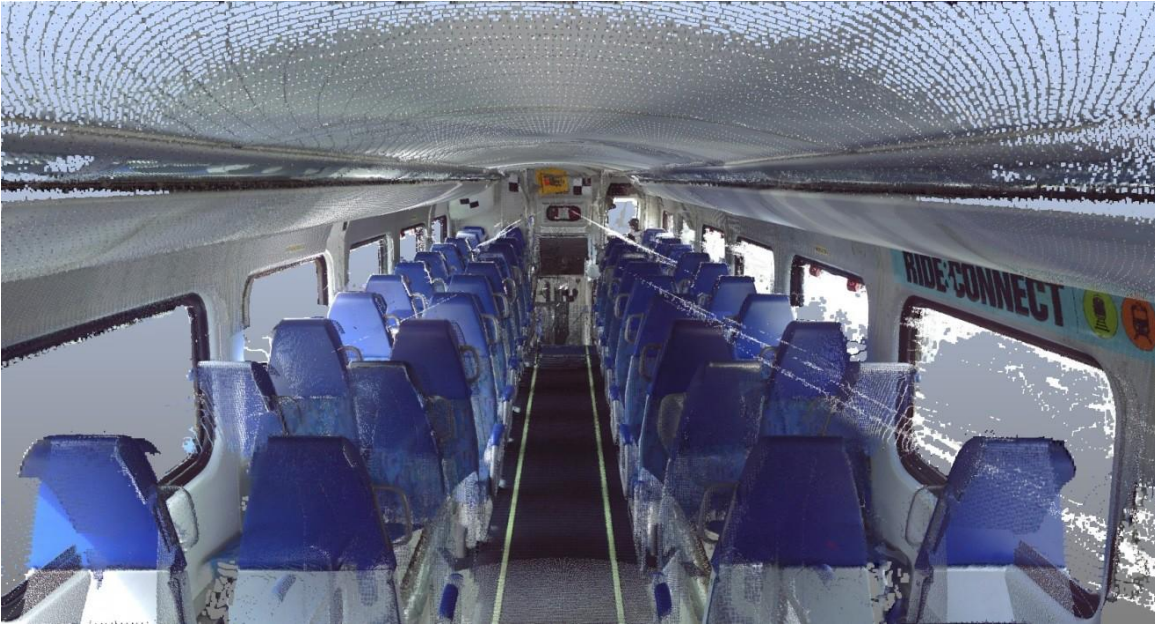
Figure 4: An image from the 3D laser scanner point cloud showing the upper level of cab car - 645.

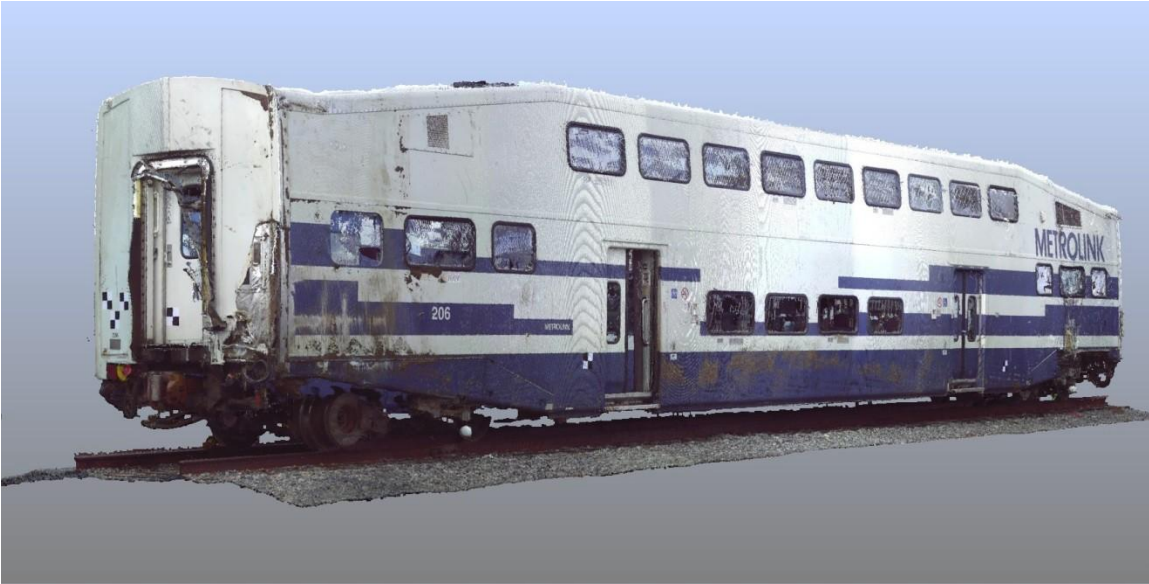
Figure 5: An image from the 3D laser scanner point cloud showing left side and the A end of the 2<sup>nd</sup> rail car - 206.

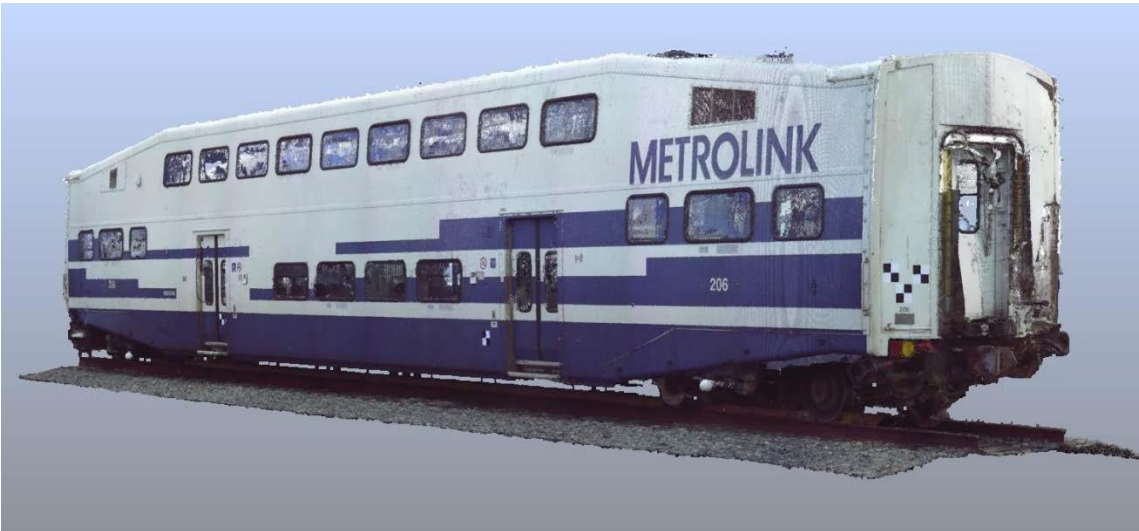
Figure 6: An image from the 3D laser scanner point cloud showing the right side and A end of the 2<sup>nd</sup> rail car - 206.

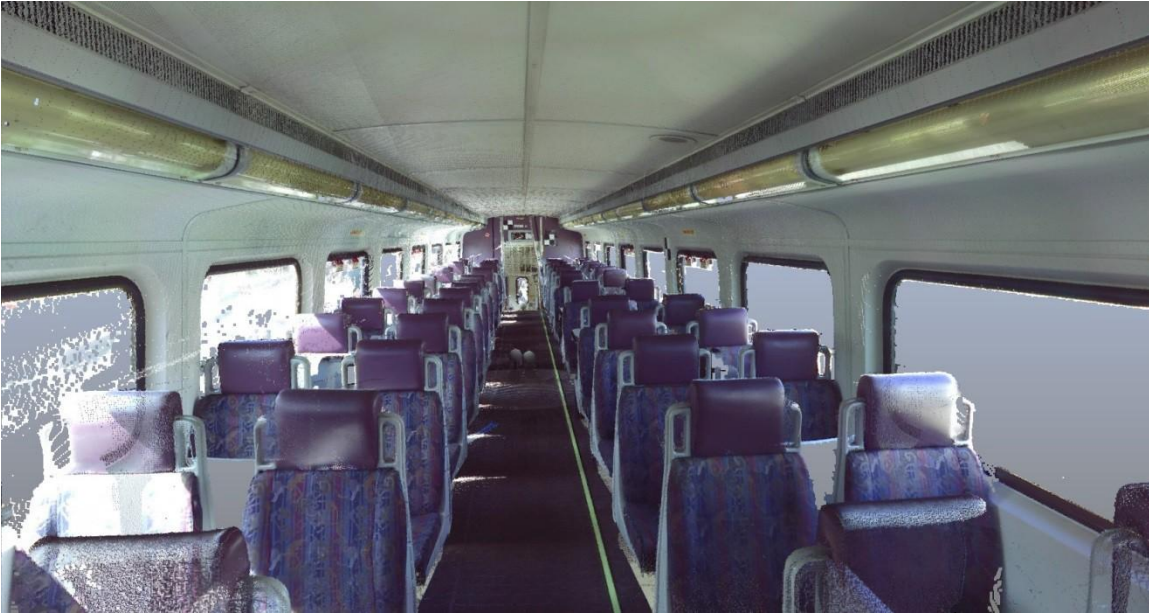
Figure 7: An image from the 3D laser scanner point cloud showing the interior of the 2<sup>nd</sup> rail car – 206 (upper level).

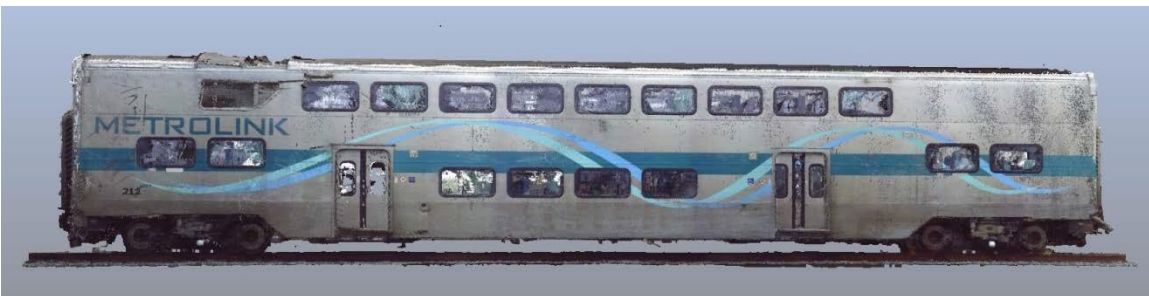
Figure 8: An image from the 3D laser scanner point cloud showing left side, with the A end on the left side of the image, of the 3<sup>rd</sup> rail car - 211.

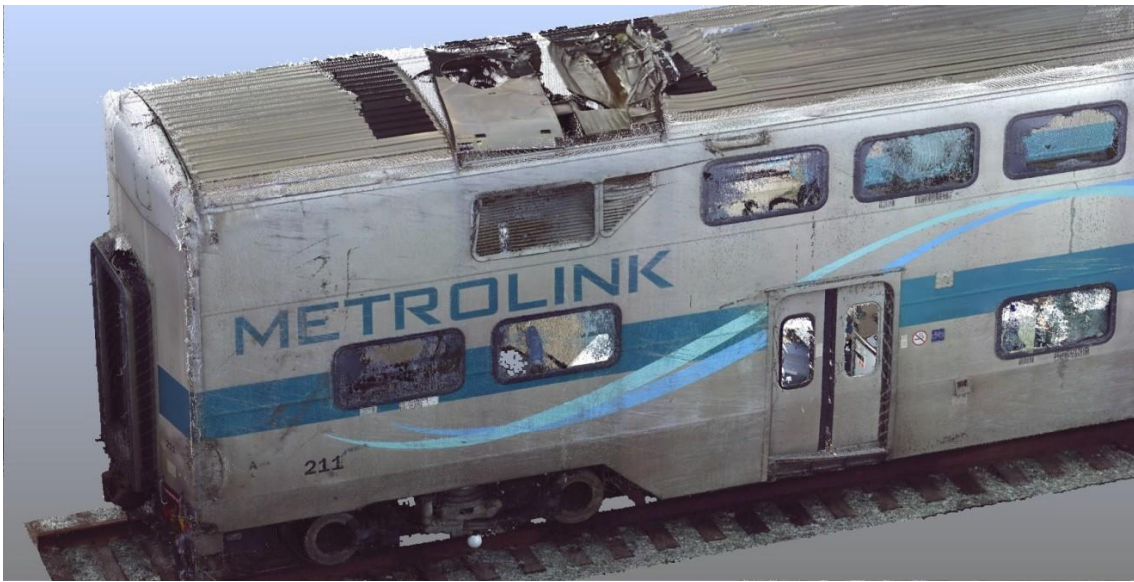
The exterior of the Rotem rail car 211, which was third in the train, was documented with a total of 16 exterior scans, including one scan from an elevated position to document roof damage and 12 interior scans. Images from the point cloud created by the scanner documenting the rail car 211 exterior are shown in Figure 8, Figure 9, and Figure 10. The interior of the car from the developed point cloud data is shown in Figure 11.

Figure 9: An image from the 3D laser scanner point cloud showing the roof damage from the left side of the 3<sup>rd</sup> rail car - 211. (The A end is on the left side of the image.)

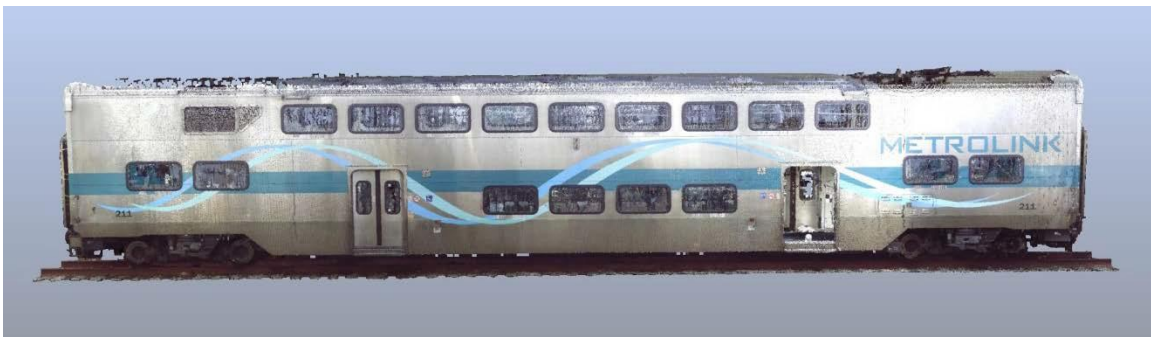
Figure 10: An image from the 3D laser scanner point cloud showing the right side, with the A end on the right side of the image, of the 3<sup>rd</sup> rail car - 211.

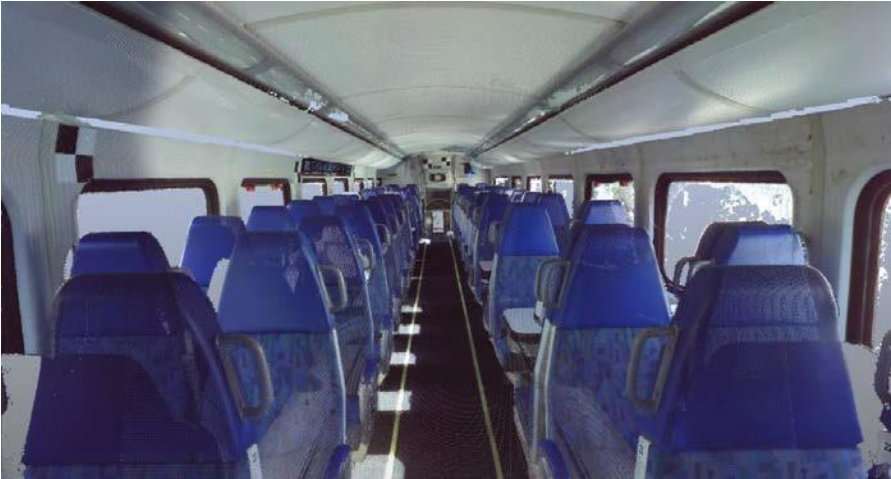
Figure 11: An image from the 3D laser scanner point cloud showing the interior of the 3<sup>rd</sup> rail car – 211 (upper level).

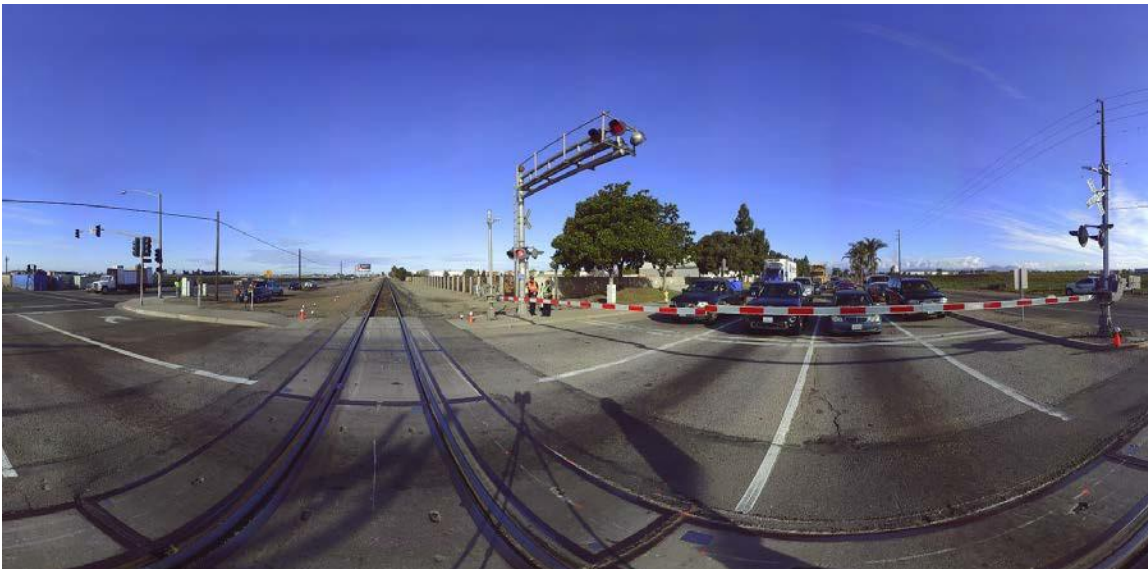
Figure 12: An image from the 3D laser scanner showing the grade crossing, looking generally to the west. To the right is the direction the truck likely came from. In the center is the track looking toward the point of impact.

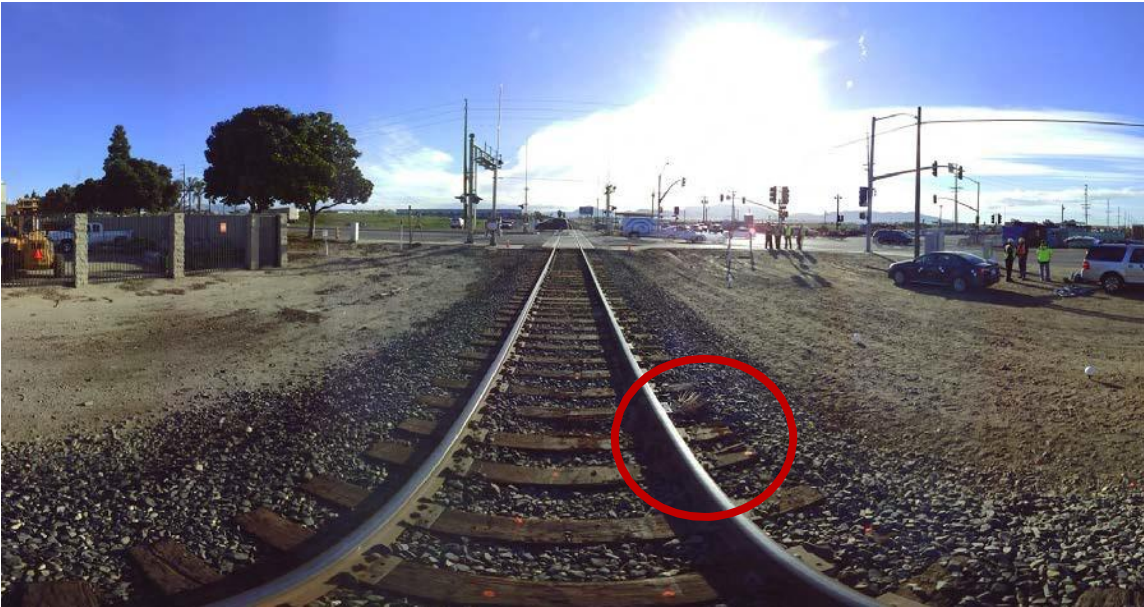
Figure 13: An image from the scanner showing the track near the point of impact. The view is looking east toward the grade crossing. The area highlighted in the red circle shows the location of the damaged railroad ties near the point of impact.

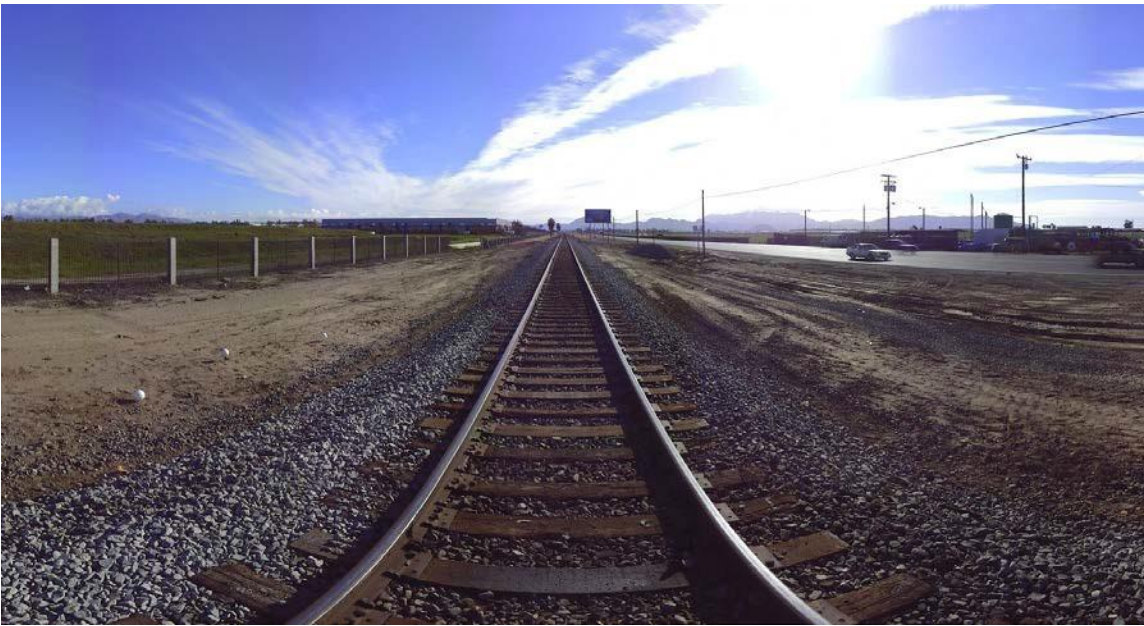
Figure 14: An image from the scanner looking to the east, showing the track in the direction of the train's final rest on the east side of the grade crossing.

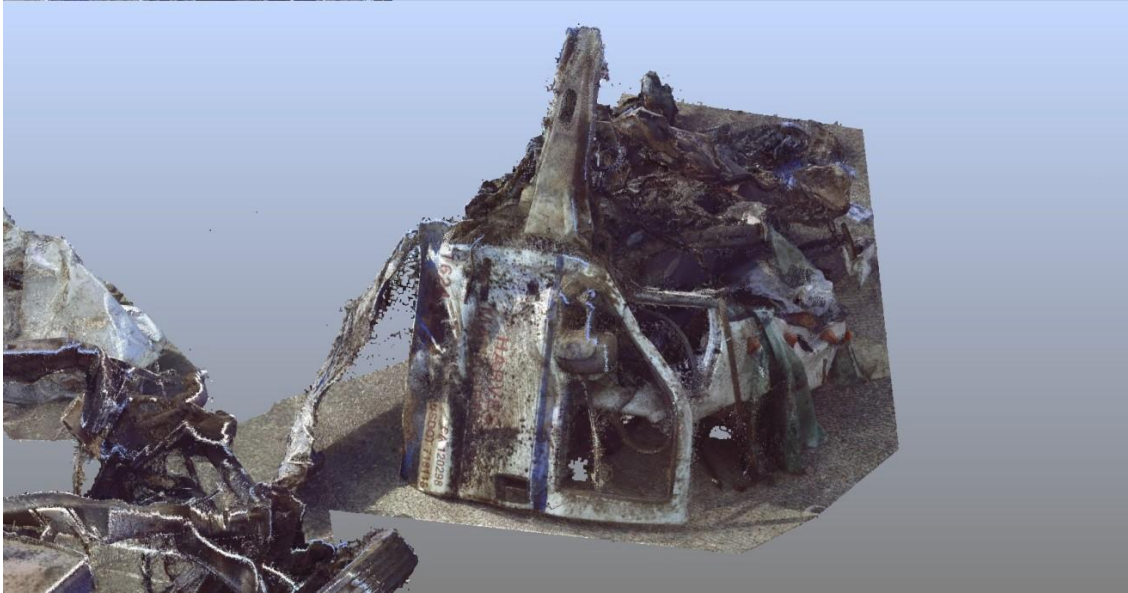
Figure 15: An image from the 3D laser scanner point cloud showing the driver side of the Ford F450. (The Ford is oriented such that the front of the truck is pointed upward in the scan.)

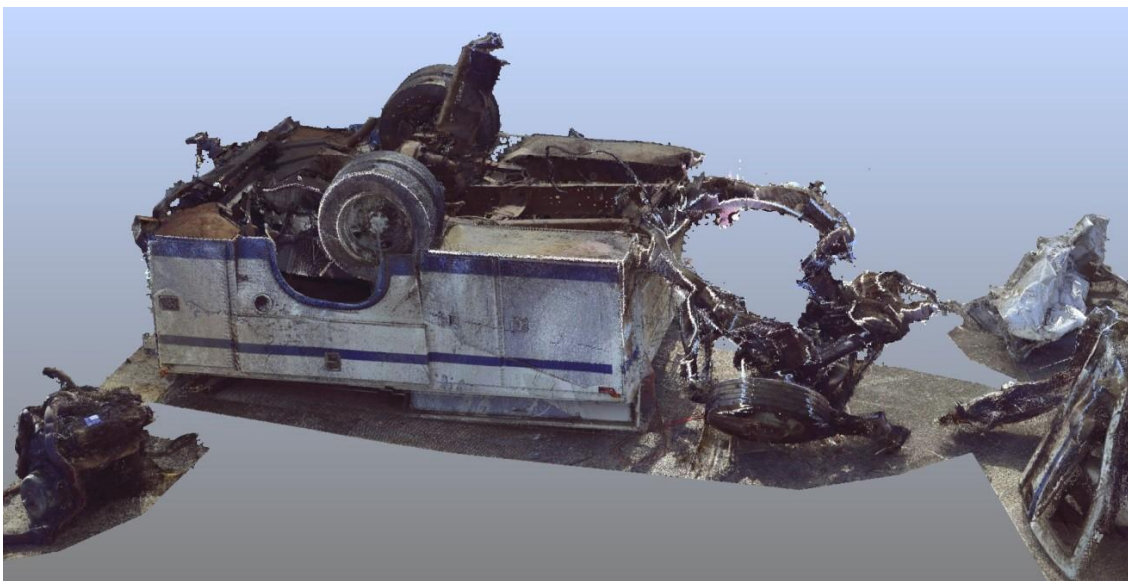
Figure 16: An image from the 3D laser scanner point cloud showing left side of the box portion of the Ford F450.

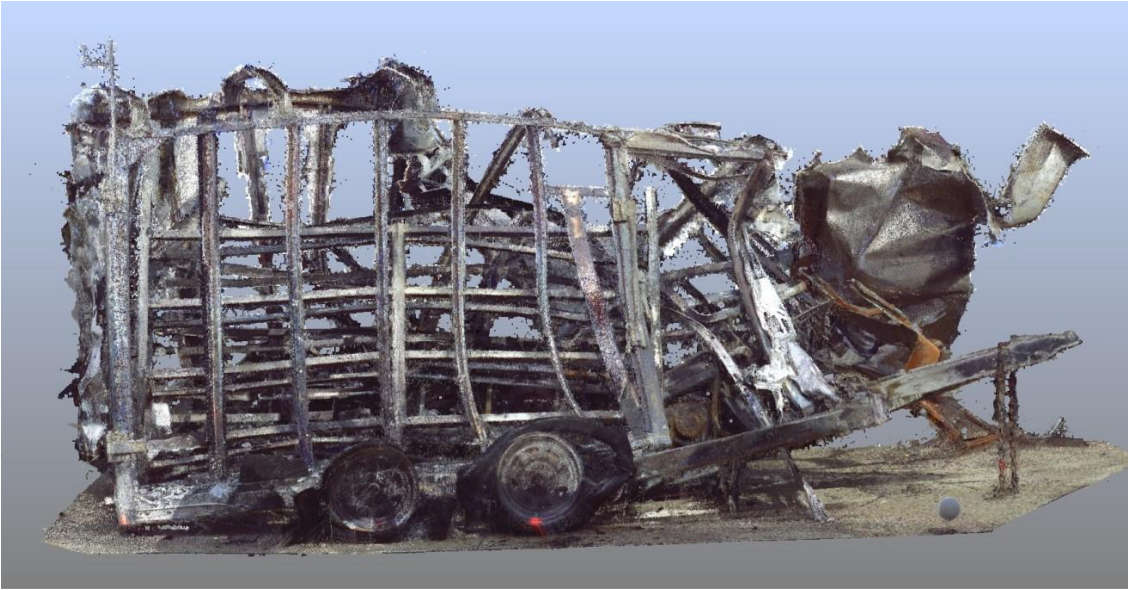
Figure 17: An image from the 3D laser scanner point cloud showing the right side of the trailer.

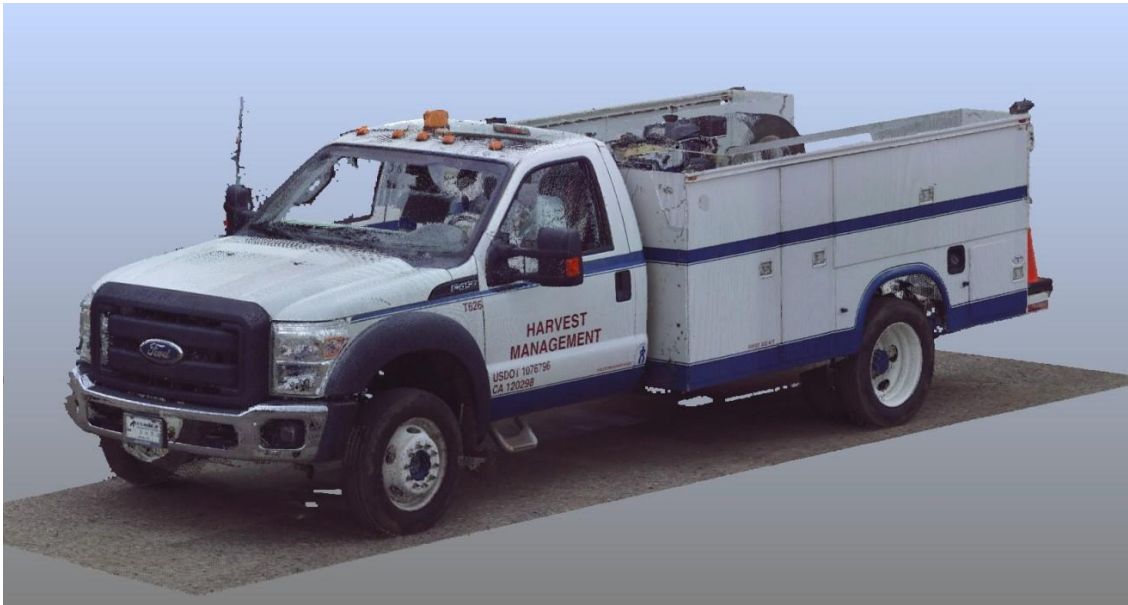
Figure 19: An image from the 3D laser scanner point cloud showing the left side of 2011 Ford F450.

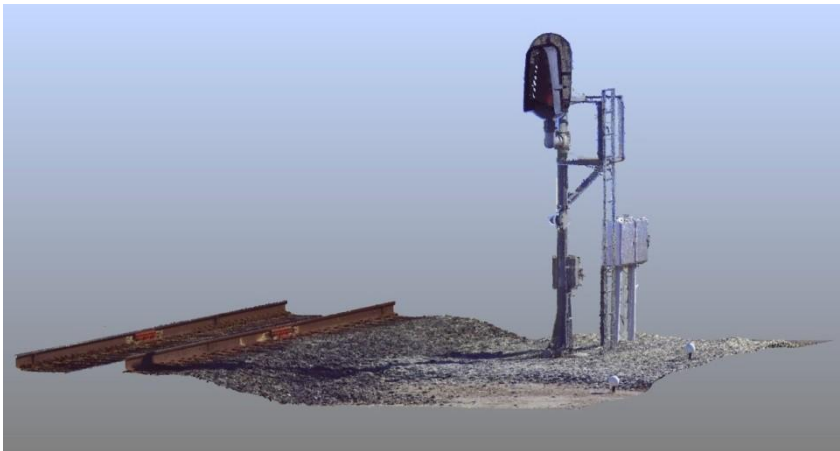
Figure 20: An image from the 3D laser scanner point cloud showing the signal facing the oncoming trains.

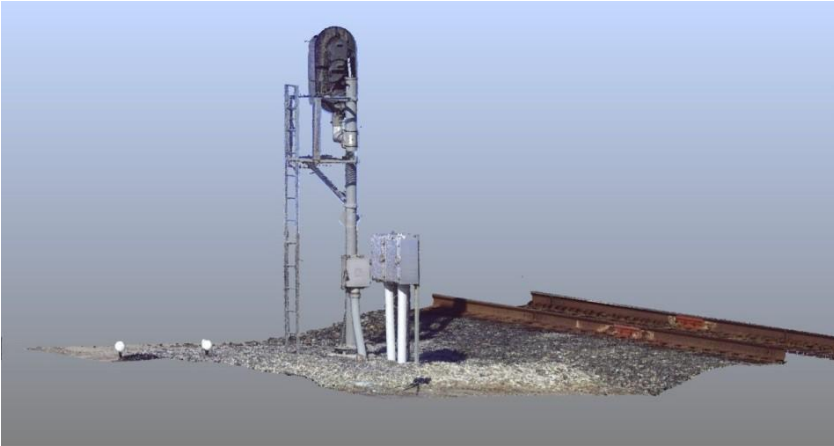
Figure 21: An image from the 3D laser scanner point cloud showing the back side of the signal.
