**3D LASER SCANNING
FACTUAL REPORT**

**Train Over-speed, Struck Passenger Waiting Area
Hoboken, NJ**

**DCA16MR011
(14 Pages)**

**NATIONAL TRANSPORTATION SAFETY BOARD
OFFICE OF RESEARCH AND ENGINEERING
WASHINGTON, D.C. 20594**

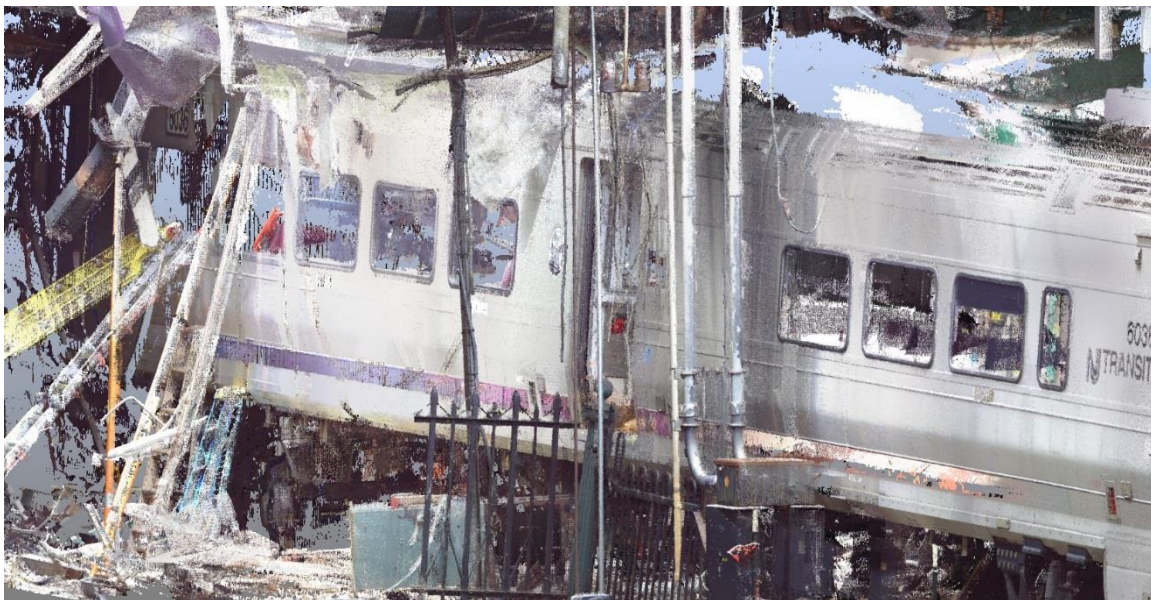
Figure 1: An image from the 3D laser scanner point cloud showing left side of the lead cab car. The direction of train travel was from the right side of the image toward the left side of the image.

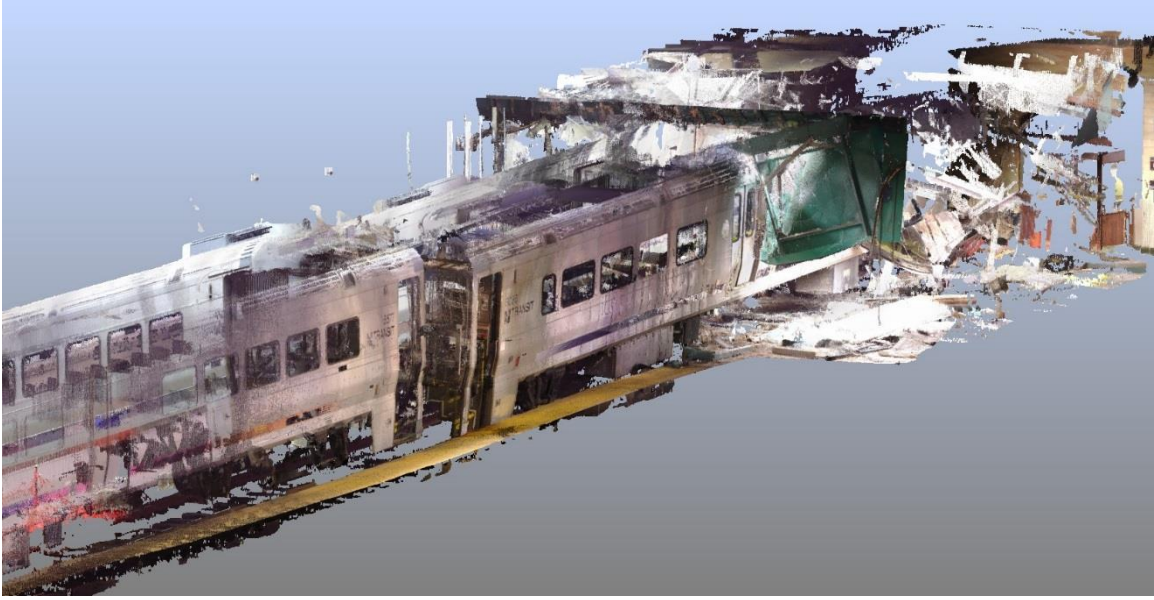
Figure 2: An image from the 3D laser scanner point cloud showing the right side of the cab car and a portion of car 2. The direction of train travel was from the left side of the image toward the right side of the image.

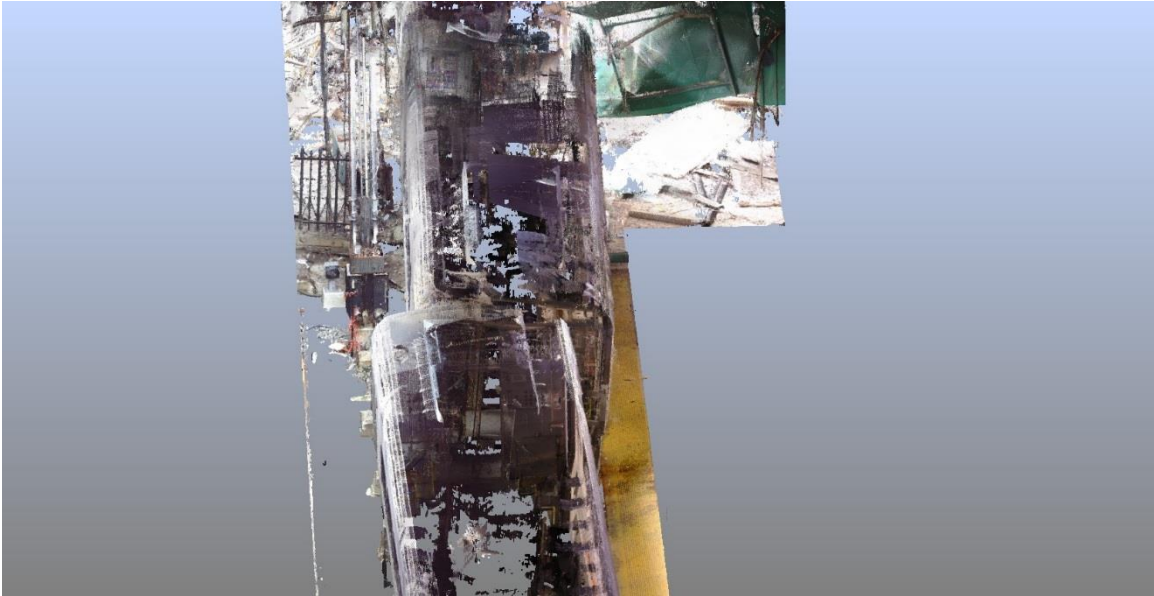
Figure 3: An image from the 3D laser scanner point cloud showing the orientation of the cab car (top of image) relative to car 2 (bottom of image).

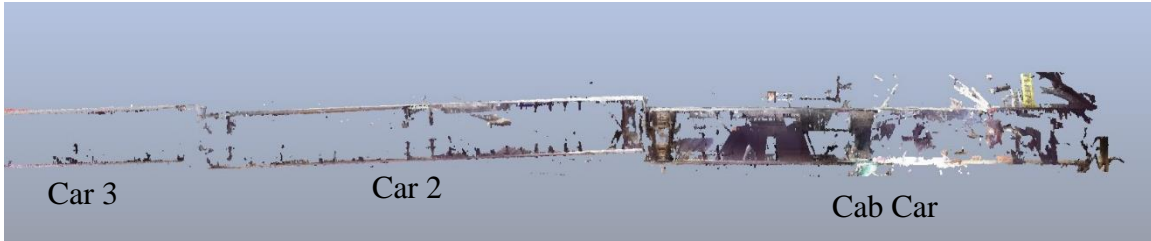
Figure 4: An image from the 3D laser scanner point cloud showing an overhead view of the orientation of the cab car relative to car 2 and car 3. The direction of train travel was from the left side of the image toward the right side of the image.

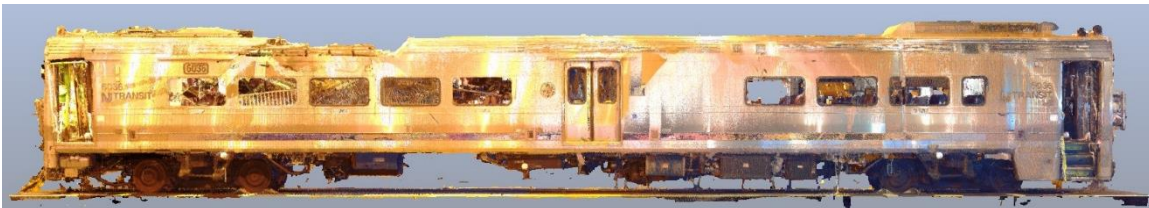
Figure 9: An image from the 3D laser scanner point cloud showing the left side of lead cab car 6036. (The F-end is on the left side of the image.)

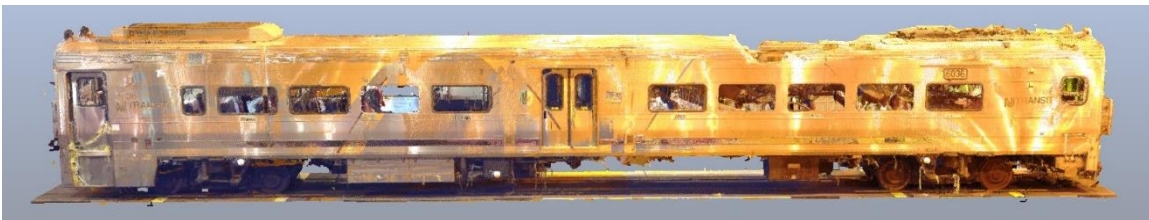
Figure 10: An image from the 3D laser scanner point cloud showing the right side of lead cab car 6036. (The F-end is on the right side of the image.)

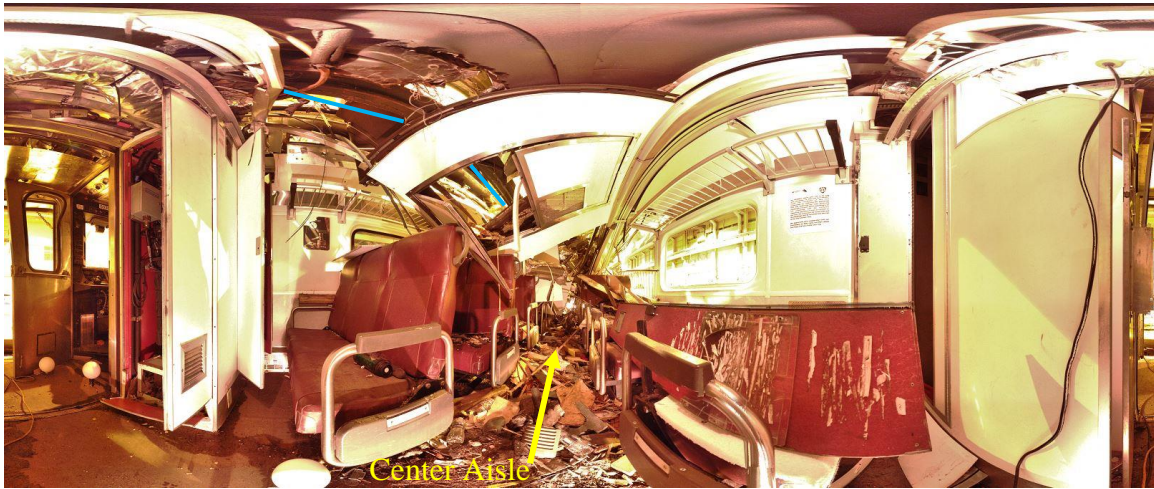
Interior scans were limited due to the amount of intrusion and debris in the forward end of the cab car and the structural instability of the I-beam in the ceiling and passenger cabin region. Planar images from the laser scanner showing the intrusion into the forward passenger compartment are shown in Figure 11 through Figure 13. (Planar views create images similar to those created with a fish-eye lens with straight lines shown as curves. The planar view allows display of a greater visual angle.)

Figure 11: A planar image from the 3D laser scanner showing the forward passenger compartment. The scanner is located near the first row of passenger seats in the center aisle and is looking rearward. The yellow arrow marks the center aisle and two blue lines denote the intruding I-beam. The train operator's cab is shown on the far left of the image.

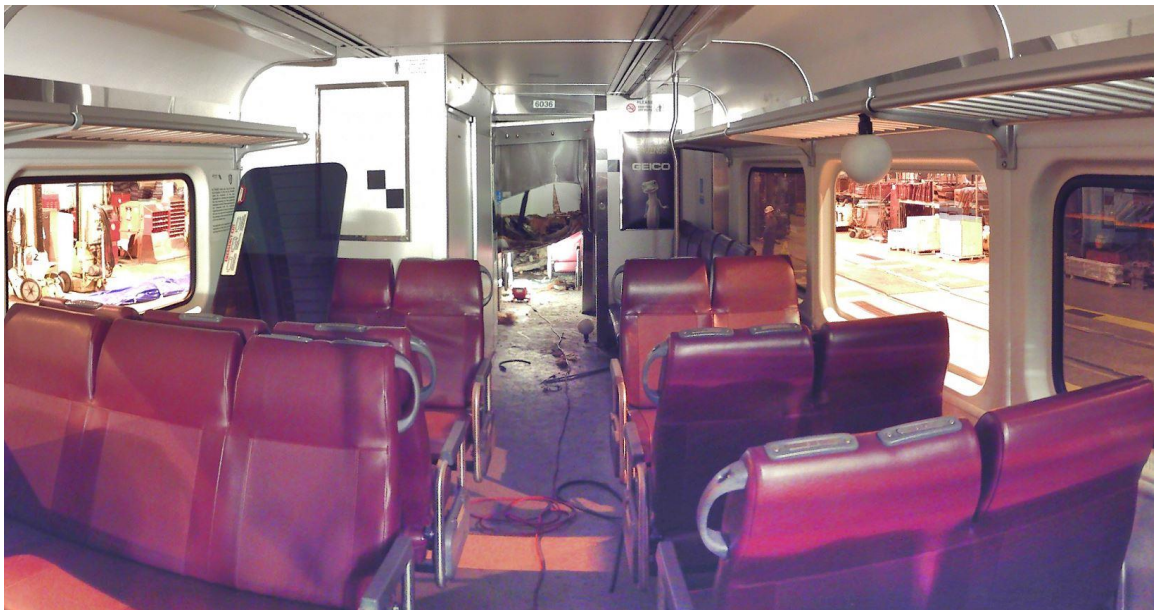
Figure 12: A planar image from the 3D laser scanner showing the rear passenger compartment and the intrusion forward of the center vestibule. The view is looking forward in the direction of train travel.

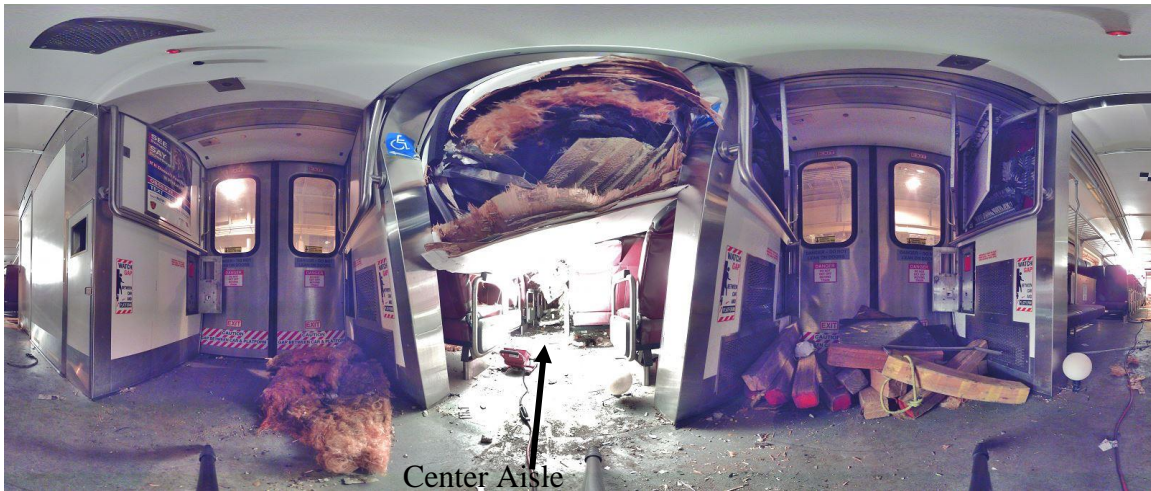
Figure 13: A planar image from the 3D laser scanner showing the center vestibule of the lead cab car and the damage from the intruding I-beam. The view is looking forward in the direction of train travel. The black arrow marks the center aisle.

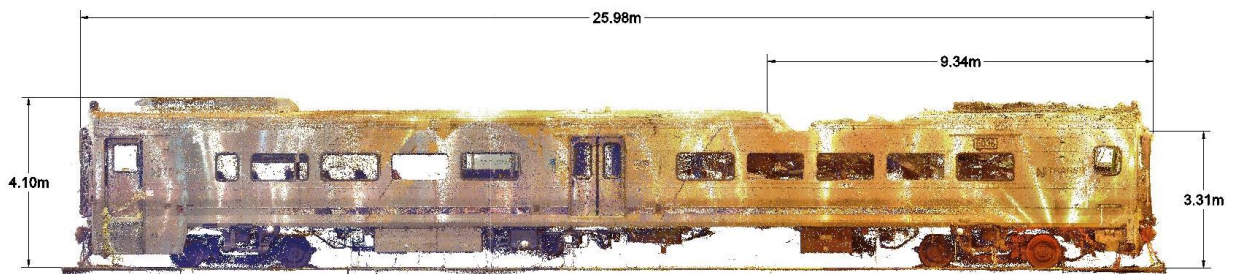
Figure 14 shows the overall dimensions of the lead cab car and the general position of the exterior damage and Figure 15 shows an overhead view of the lead cab car with the intruding I-beam highlighted. The I-beam punctured a hole in the roof to a location about 9.34 m back from the front of the car, with the punctured part of the roof being pushed down or back into the car by the end of the I-beam. The I-beam extended into the car about 13 m as measured from the front of the cab car. Slices through the point cloud highlight the intrusion into the front portion of the lead cab car. Figure 16 is an overlay of the accident lead cab car and an exemplar cab car (in pink). A yellow line highlights the top flange of the intruding I-beam and the 8° angle of the I-beam relative to the horizontal. Cross sectional slices were also taken starting at the front of the cab car and moving aft toward the center vestibule to further highlight the intrusion of the I-beam. The slices document the debris that was deposited in the lead cab car from the glass panels and concrete in the station canopy along with debris from the damaged cab car roof and ceiling. The slice locations and thickness were chosen to best visualize the point cloud cross sections. The locations of these cross sections are shown in Figure 17. Figure 18 shows an overlay of a single cross section from the accident cab car and the exemplar cab car at the same position. Further, Video 1 shows the series of these cross sections starting at the front of the lead cab car and continuing through to the center vestibule.

Figure 14: An image from the 3D laser scanner point cloud showing the overall dimensions (in meters) of lead cab car 6036 and the general region of exterior damage. (The F-end is on the right side of the image.)

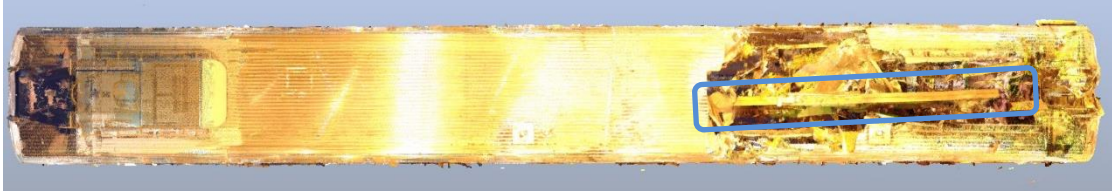
Figure 15: An image from the 3D laser scanner point cloud showing the top of lead cab car 6036. (The F-end is on the right side of the image.) The blue box highlights the intruding I-beam.

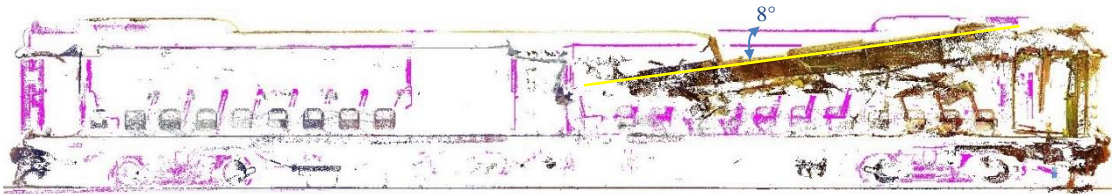
Figure 16: An overlay showing a slice through the center of the lead cab car's point cloud with an overlay of the exemplar cab car (in pink). The front of the rail car is on the right side and a yellow line highlights the I-beam that penetrated the passenger compartment. The overlay also displays the 8° angle of the I-beam with respect to the horizontal.

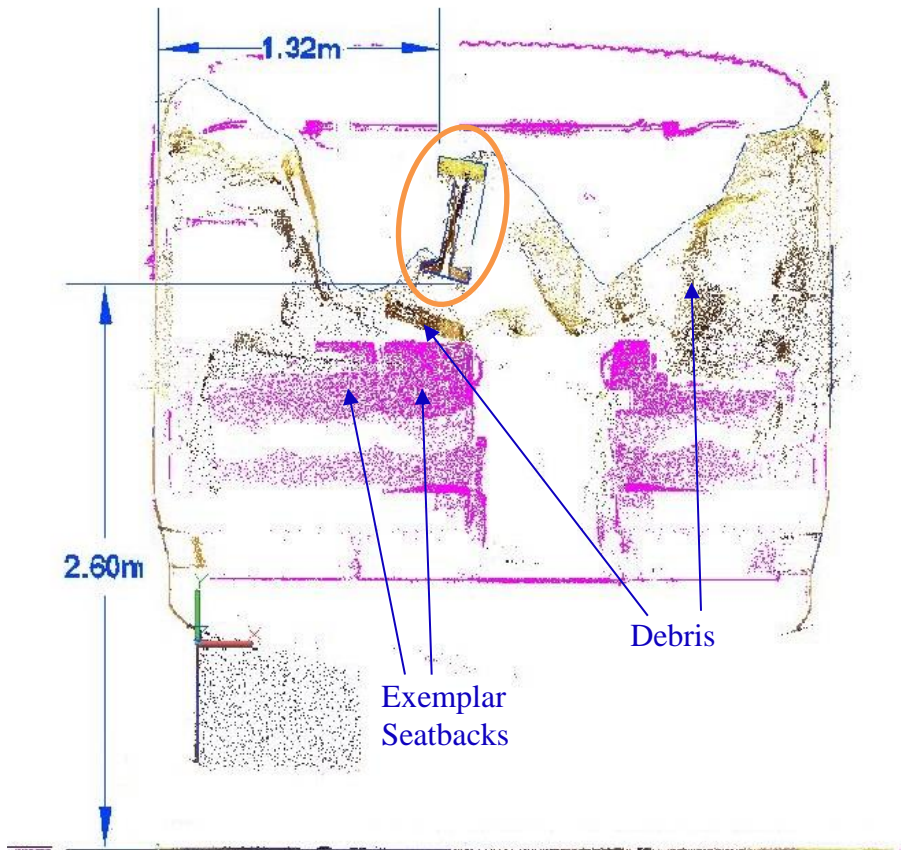
Figure 18: An overlay showing a cross section of the lead cab car’s point cloud (outlined in blue) with an overlay of the exemplar cab car (in pink). This cross section was approximately 8 meters from the front of the lead cab car. The dimensions show the location of the I-beam. An orange circle highlights the I-beam that penetrated the passenger compartment. Exemplar seatbacks and debris are also marked.

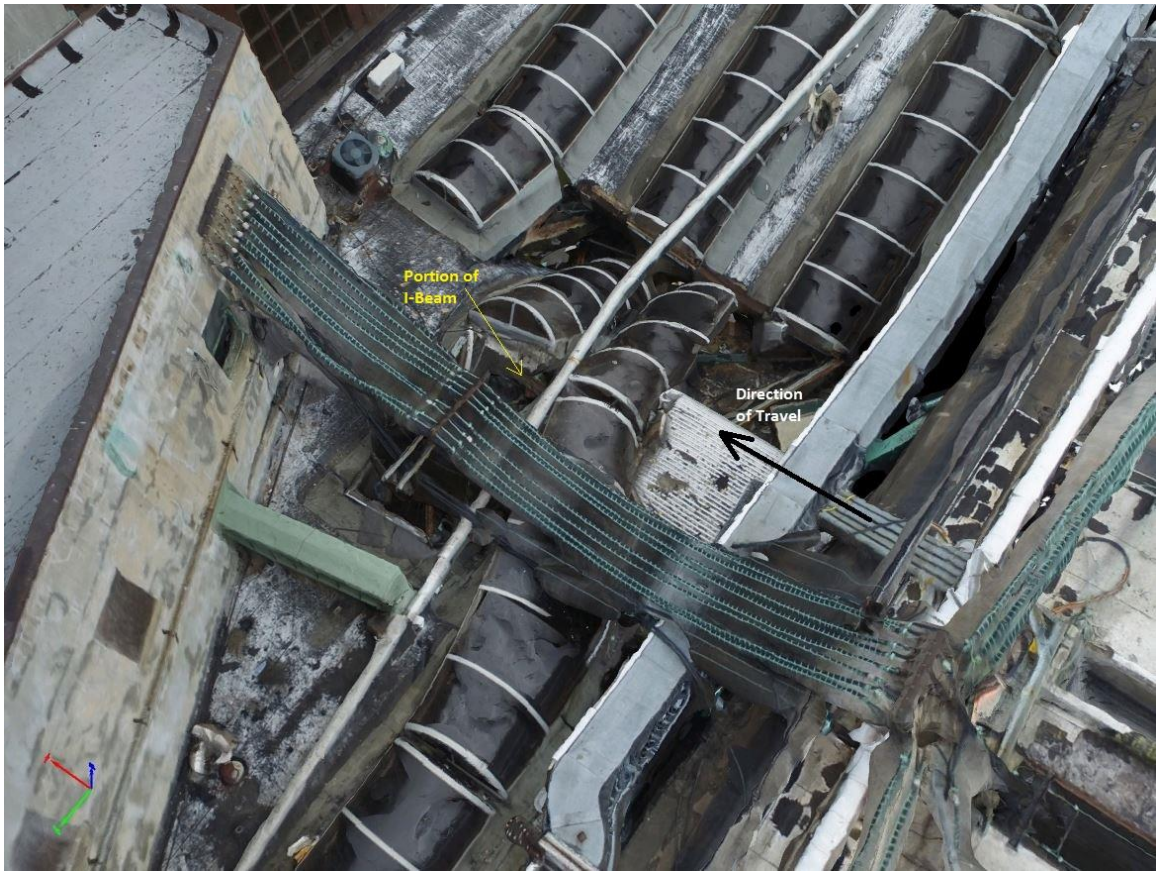
Figure 20: A photograph from the drone flyover showing the damaged canopy with glass panels and a portion of the train. The direction of train travel and a portion of the I-beam are labeled on the image.

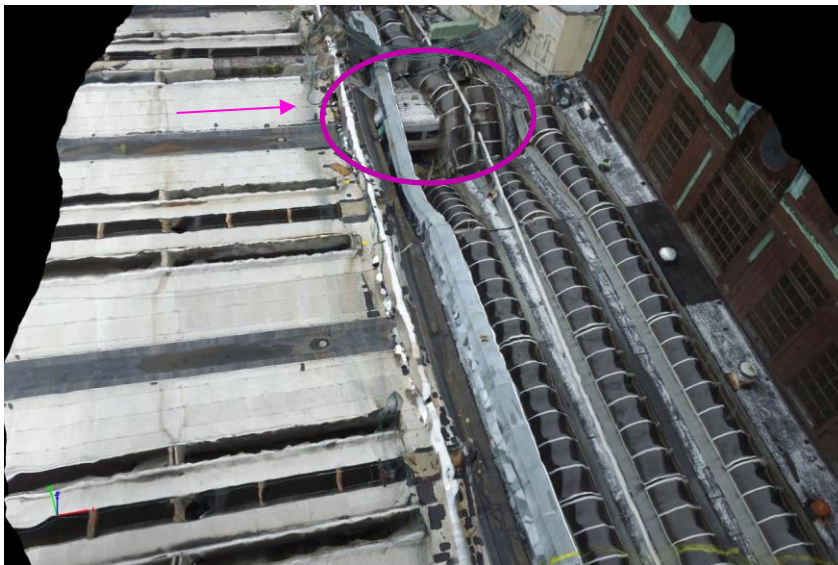
Figure 21: An image of the 3D mesh created from the drone flyover. The Hoboken terminal is on the right side of the image and the train shed is on the left side of the image. The pink circle shows the portion of the train that is visible and the pink arrow shows the direction of train travel.

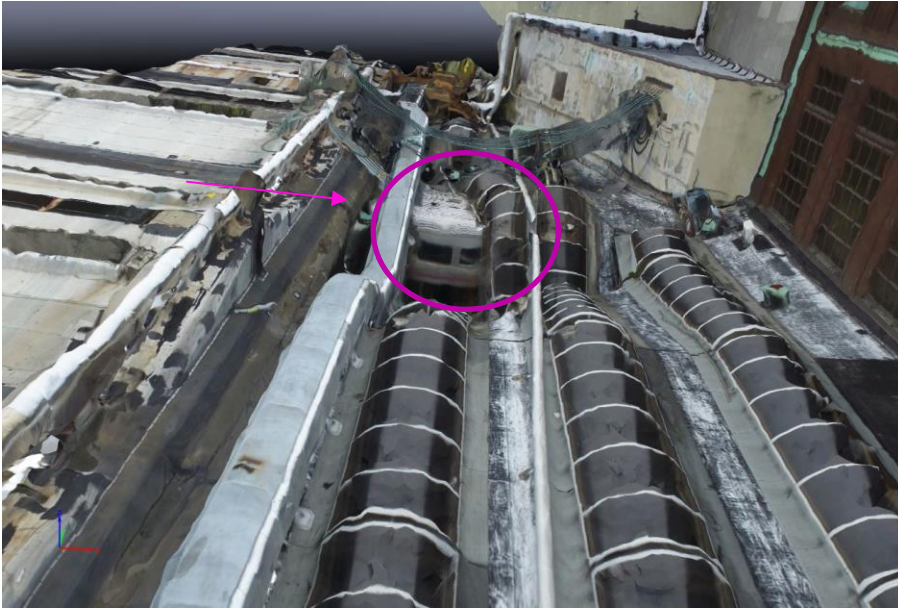
Figure 22: An image of the 3D mesh created from the drone flyover looking toward the north. The pink circle shows the portion of the train that is visible and the pink arrow shows the direction of train travel.
