**3D LASER SCANNING GROUP CHAIRMAN
FACTUAL REPORT**

Valhalla, New York

DCA15MR006
(14 Pages)

3D LASER SCANNING FACTUAL REPORT

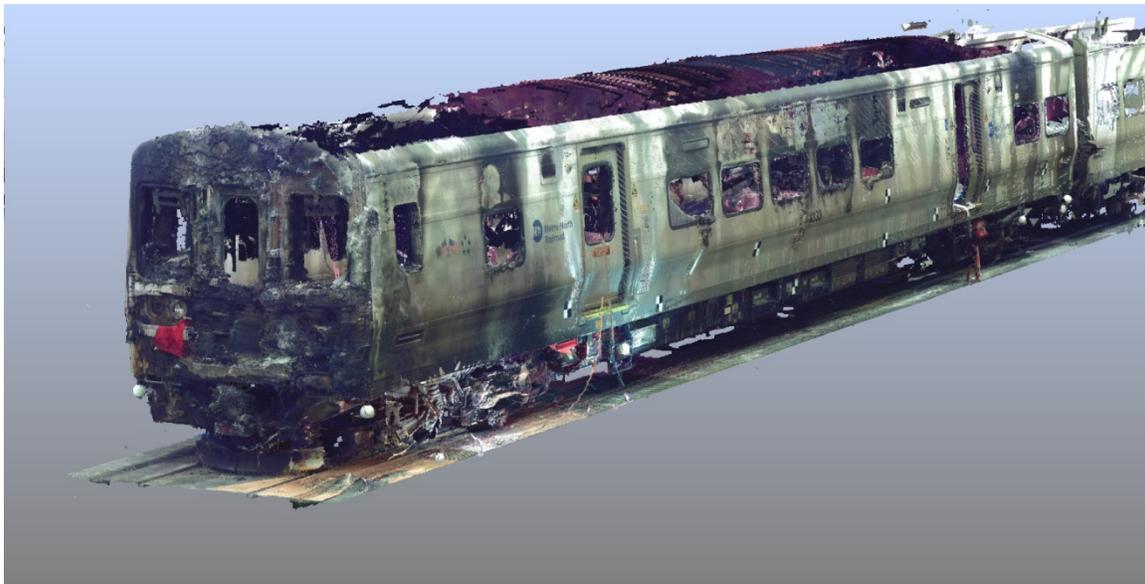
Figure 1: An image from the 3D laser scanner point cloud showing left side of the lead rail car - 4333.

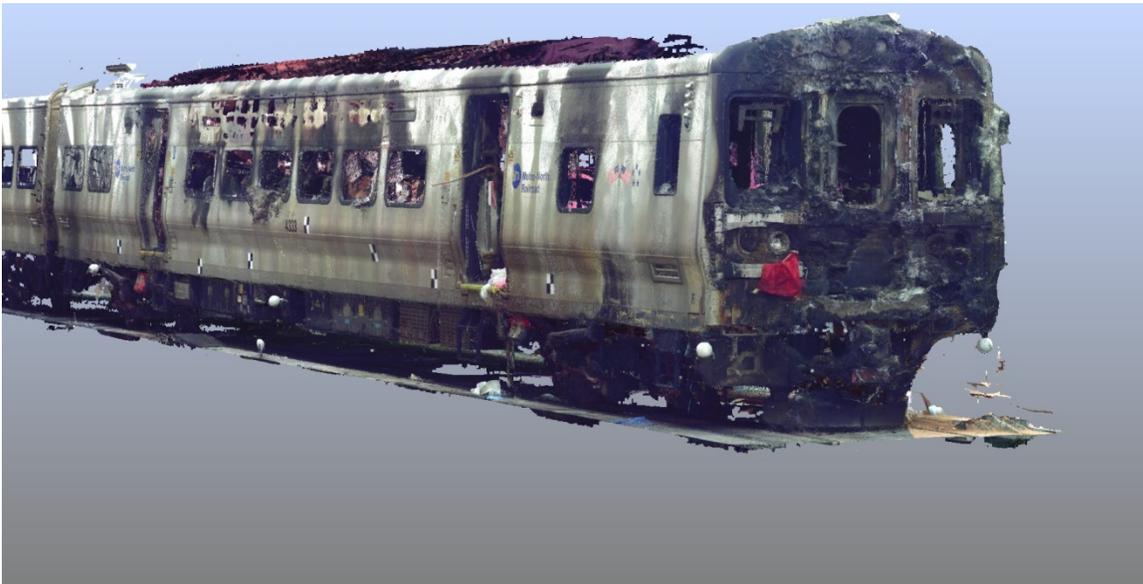
Figure 2: An image from the 3D laser scanner point cloud showing the right side of the lead rail car - 4333.

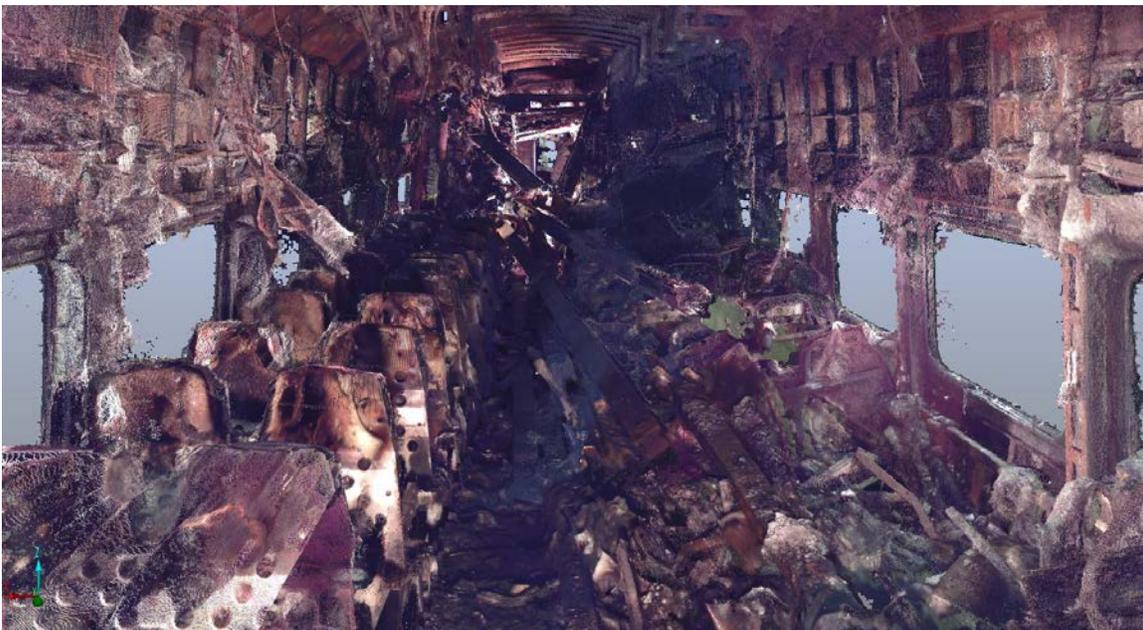
Figure 3: An image from the 3D laser scanner point cloud showing the interior of the lead rail car - 4333.

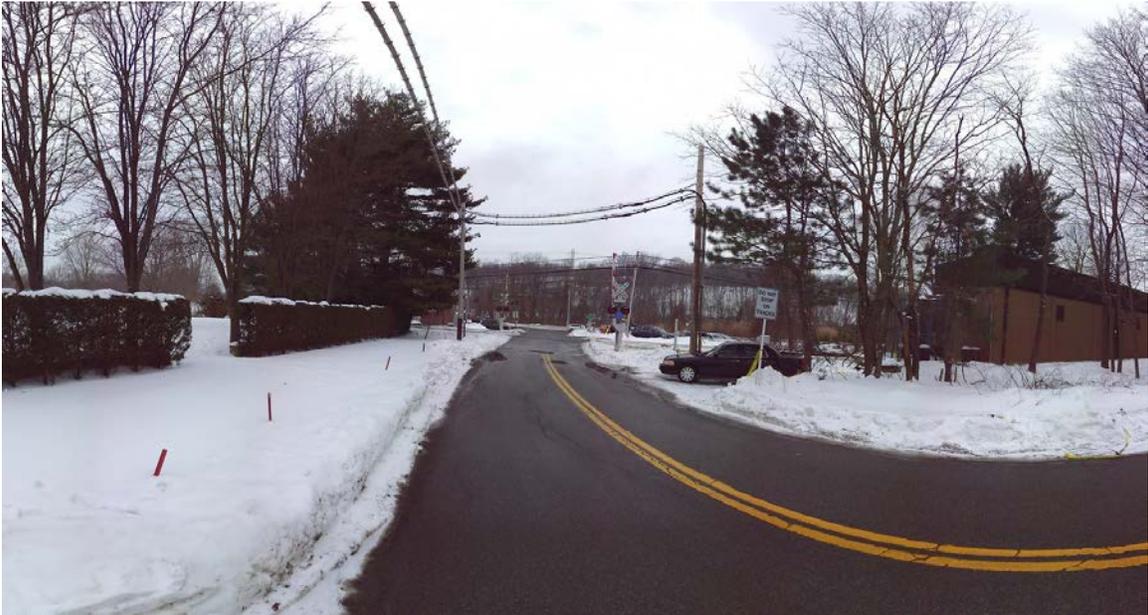
Figure 4: An image from the 3D laser scanner showing the grade crossing approach from the west side, in the direction traveled by the Mercedes SUV driver.

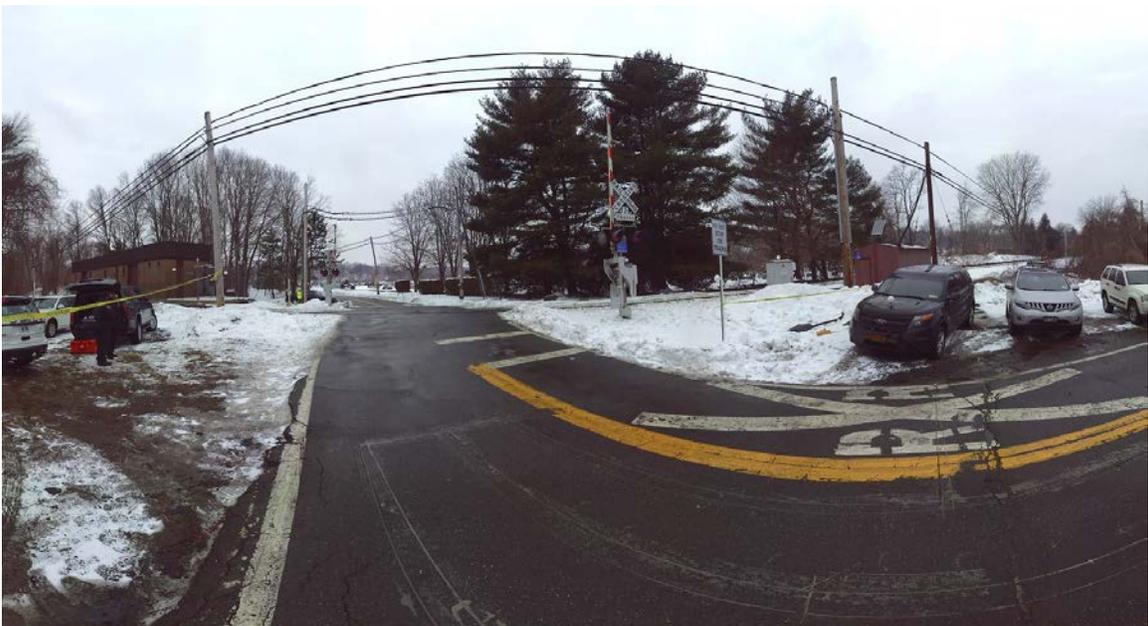
Figure 5: An image from the 3D laser scanner showing the grade crossing approach from the east side.

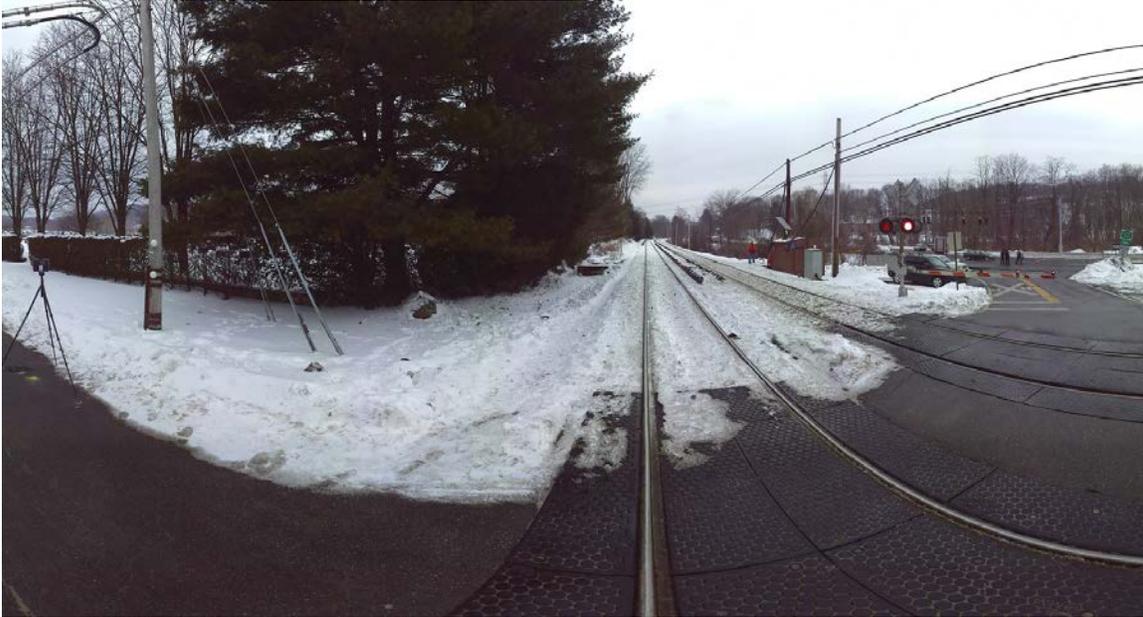
Figure 6: An image from the scanner looking north-bound from the grade crossing on track 2.

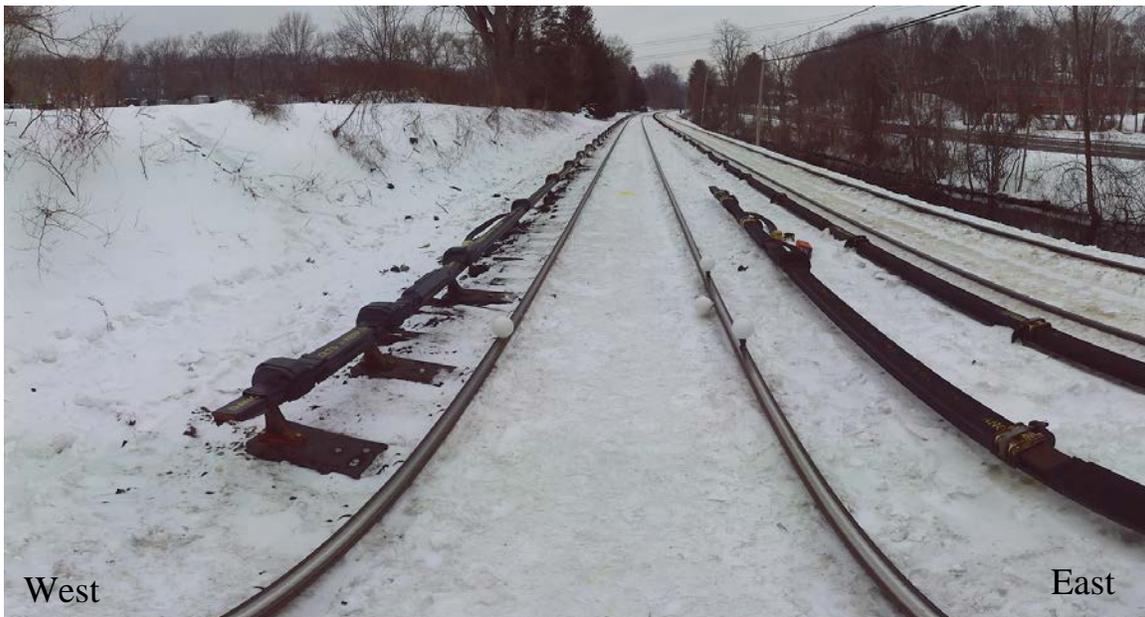
Figure 7: An image from the scanner, looking north-bound, showing the nose piece of the 3rd rail and the 3rd rail switching from the east side to the west side on track 2. (Note that the 3rd rail has been repaired on track 2.)

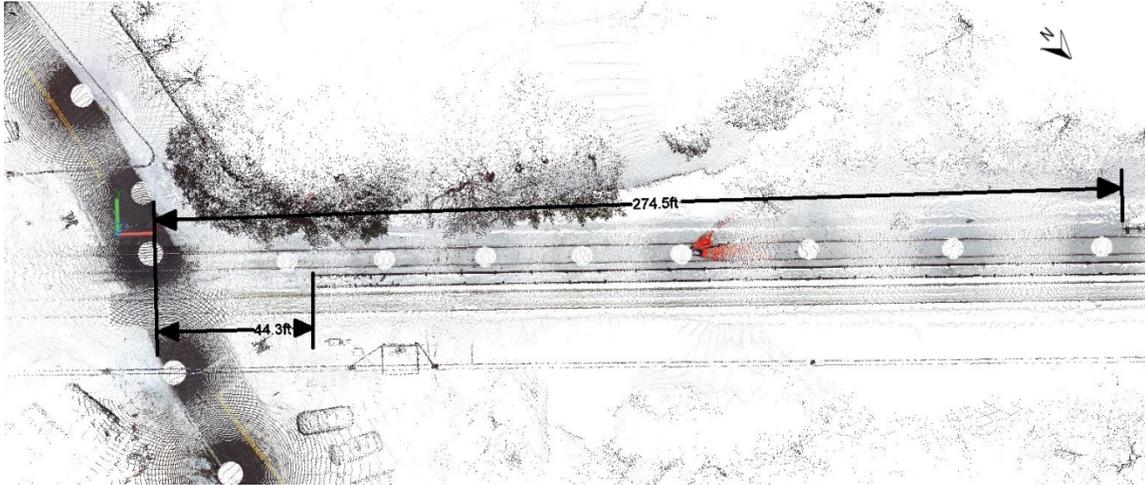
past the point where the 3rd rail switched from the east side to the west side of the track. Views from the scanner of the approach to the crossing are shown in Figure 4 and Figure 5.⁴ Images from the scanner showing the northbound track are shown in Figure 6 and Figure 7. The distance from the center of the grade crossing to the start of the 3rd rail on the east side of the track past the crossing (44.3 feet) and the distance from the center of the crossing to the start of the 3rd rail on the west side of the crossing (274.5 feet) are shown in Figure 8.

Figure 8: The locations of the start of the third rail measured from the center of the grade crossing. The third rail switched from the east side to the west side of the crossing.

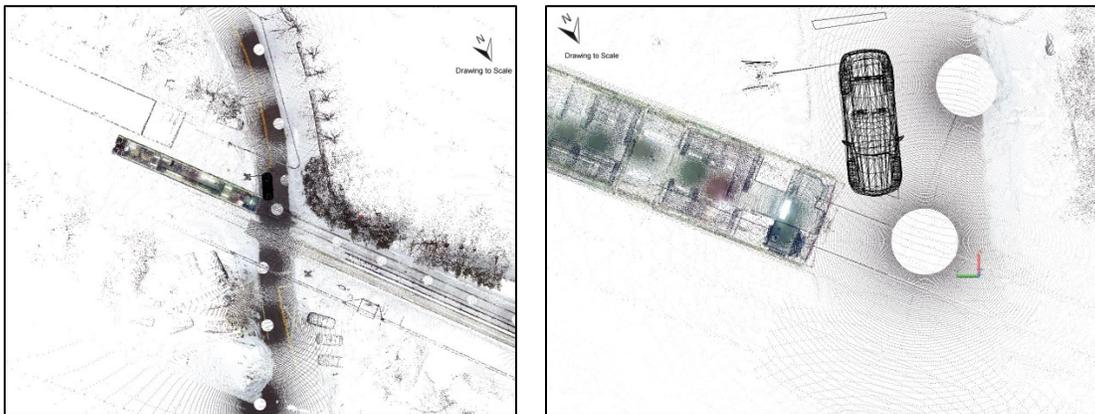
According to witnesses, the SUV was initially positioned between the grade crossing gate arm and the tracks.⁵ Based on these witness reports, this initial position of the SUV relative to the eventual position of an exemplar train was reconstructed in the computer for visualization purposes (see Figure 9). This visualization, based on the scan data and a model of an exemplar SUV, assumes a best-case scenario with the SUV as far aft from the crossing based on the position of the crossing arm and as close to the centerline of the roadway as possible. This position, Figure 9, places the SUV in a position where it is fouling the tracks the least, while still assuming that the SUV is in position to travel across the tracks into the appropriate lane on the opposite side.

Figure 9: Images of the estimated position of the SUV relative to the approaching train, assuming the least amount of fouling, prior to the SUV moving forward onto track 2. On the left, the image shows the surrounding roadway and tracks. On the right, the image shows a close-up view. Images are to scale.

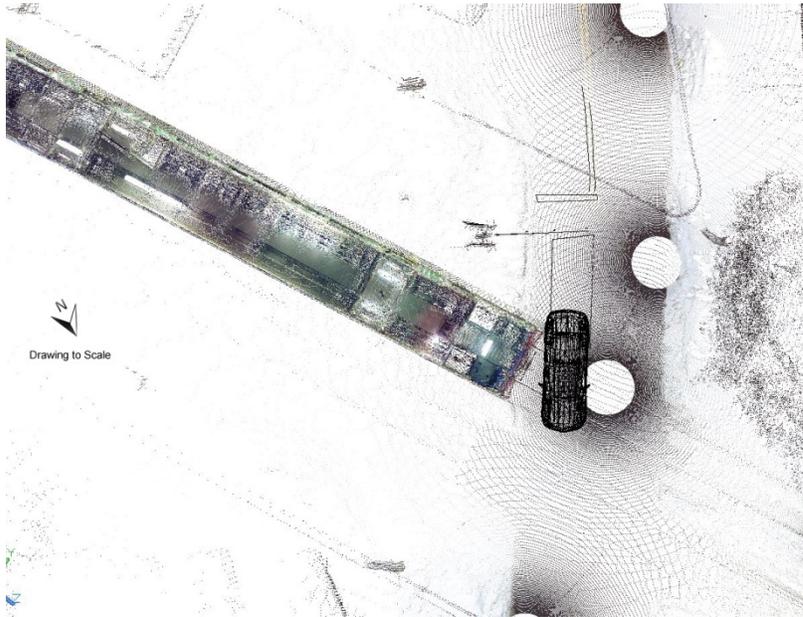
Eyewitness reports indicate that the driver then moved the SUV forward onto the crossing immediately prior to the train's arrival at the grade crossing. A position of the train and SUV immediately prior to impact, consistent with the damage to the SUV, is shown in Figure 10.

Figure 10: A position of the train and a model of the SUV immediately prior to impact, consistent with the damage to the SUV. Images are to scale.

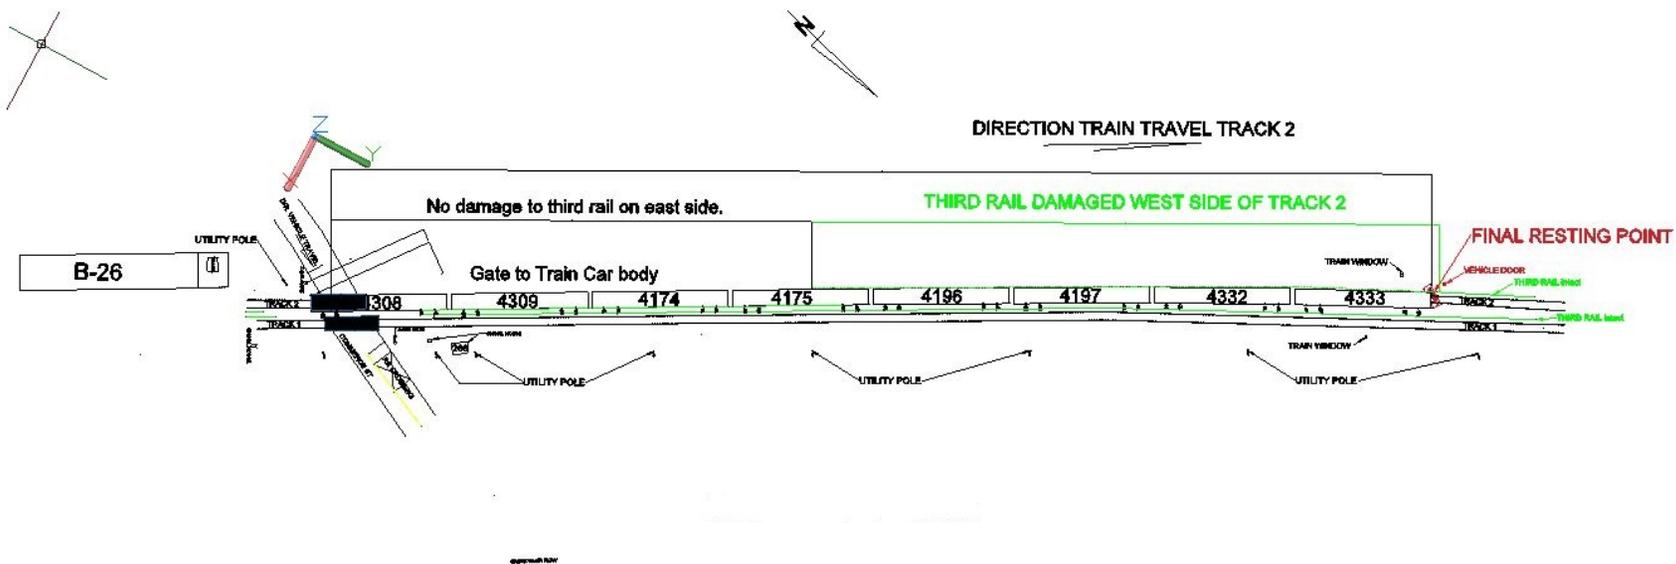
Figure 11: The Metro-North survey data showing the grade crossing, the tracks, and the final rest position of the train.

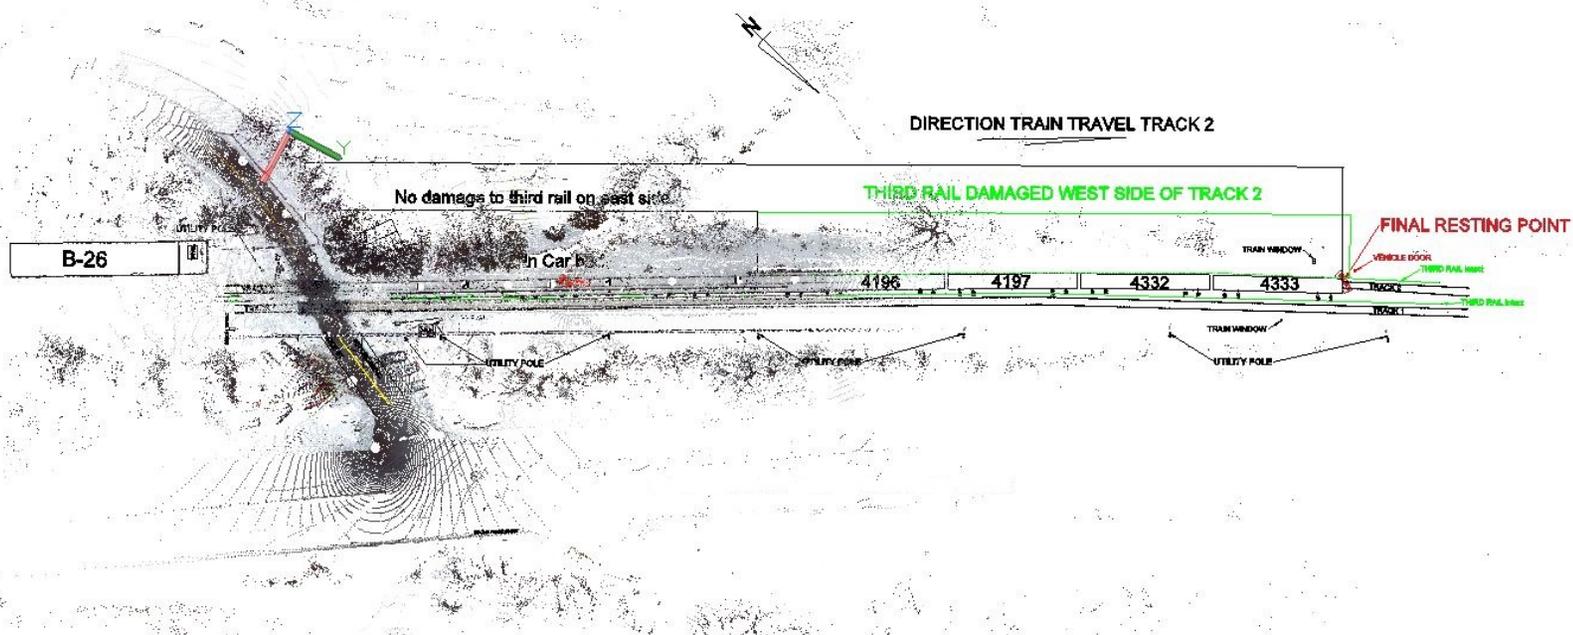
Figure 12: The Metro-North survey data overlaid on top of the laser scanning point cloud data.

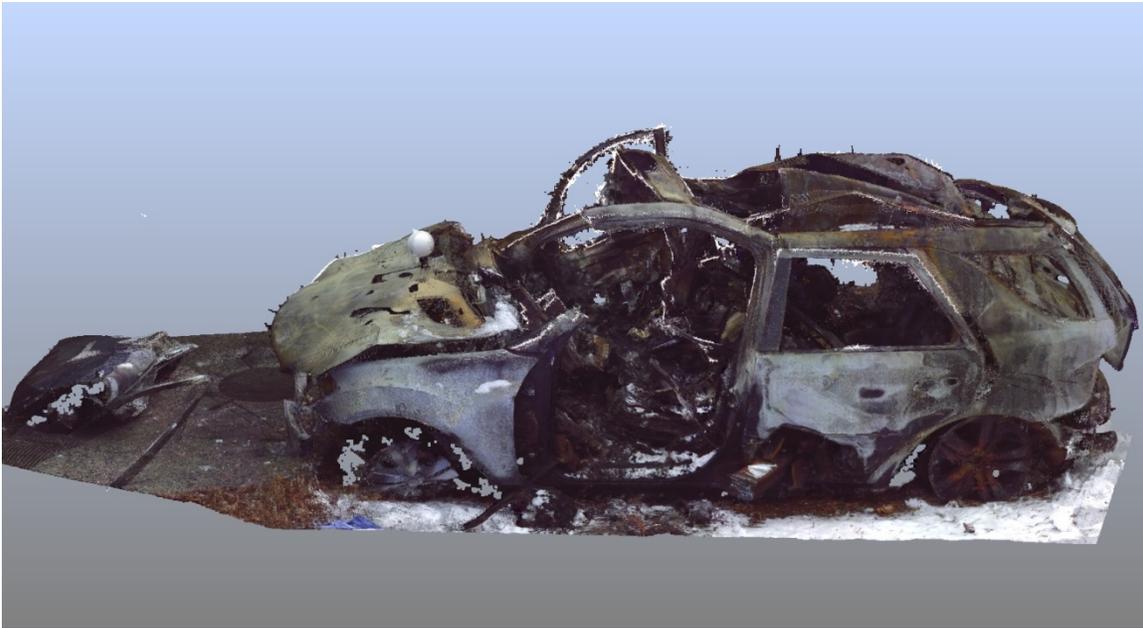
Figure 13: An image from the 3D laser scanner point cloud showing the left side of the Mercedes SUV.

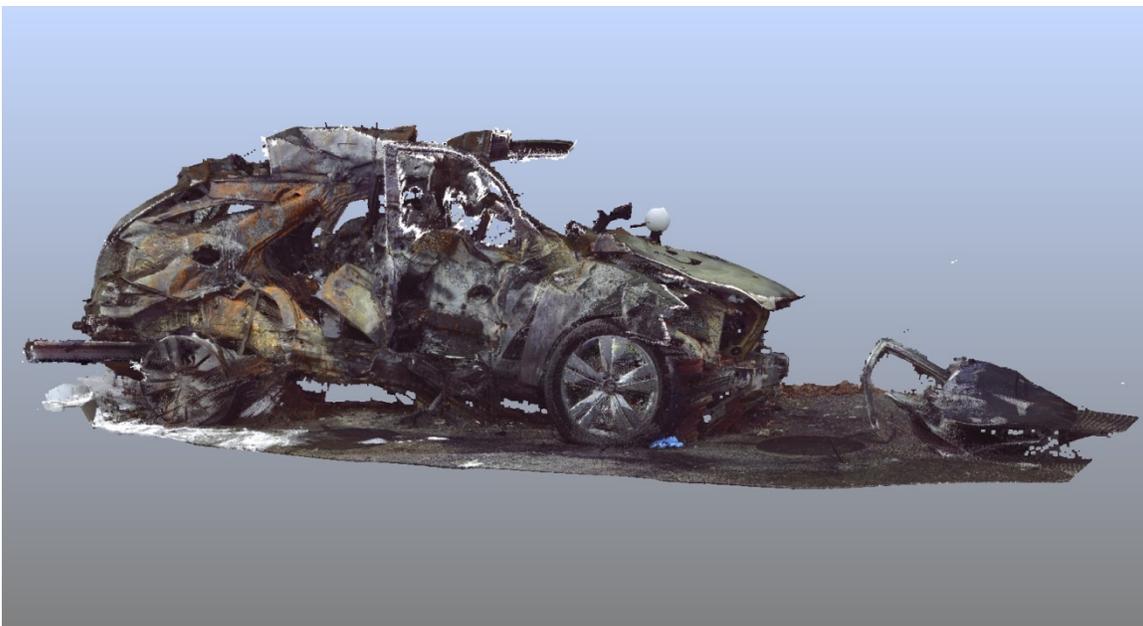
Figure 14: An image from the 3D laser scanner point cloud showing right side of the Mercedes SUV.

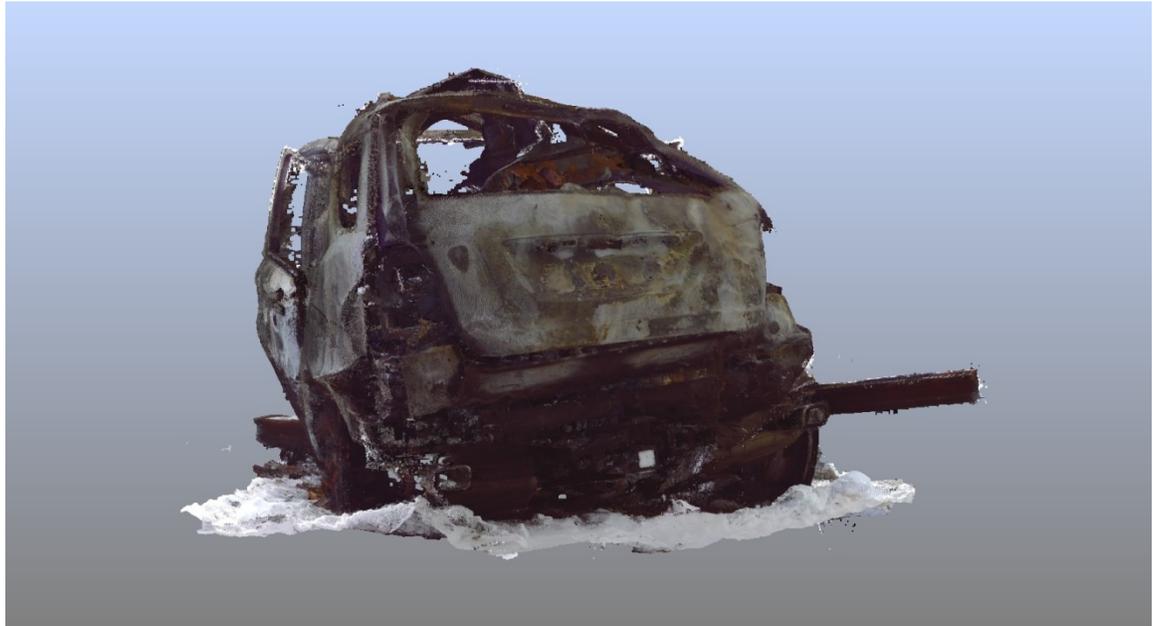
Figure 15: An image from the 3D laser scanner point cloud showing the back of the Mercedes SUV and a portion of the 3rd rail.
