Harding Safety AS Seimsvegen 116 5472 Seimsfoss, Norway Telephone: +47 53 48 36 00 Telefax: +47 53 48 36 01
Document no.: 4922		
Document title: <b>REPORT ON THE M/V CARIBBEAN FANTASY</b>

- 1.2. At the request of the United States Coast Guard (USCG) Cruise Ship Center of Expertise (CoE), a HARDING SAFETY representative attended onboard the M/V CARIBBEAN FANTASY to conduct an investigation into the causal factors that affected the correct performance of the LSA during the evacuation process.

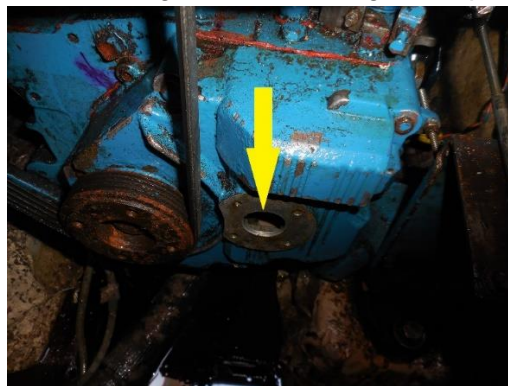
- 5.6. On September 16<sup>th</sup>, 2016, when the HARDING SAFETY representative attended to carry out an investigation, all bolts surrounding the engine compartment in lifeboat #1 were found removed and the brackets holding various cables and tubes were unfastened.

- 5.7. The end cover was missing, suggesting that lifeboat #1 engine was undergoing repairs at the time of the incident thus rendering the lifeboat engine inoperable (see picture below).

- 6.1. Operators should ensure that critical life-saving appliances such as lifeboat motors are ready for use at all times. Where it is known that equipment is not operable as required, Operators should obtain an exemption from the flag administration subject to an acceptable contingency plan or equivalent arrangement being put in place.

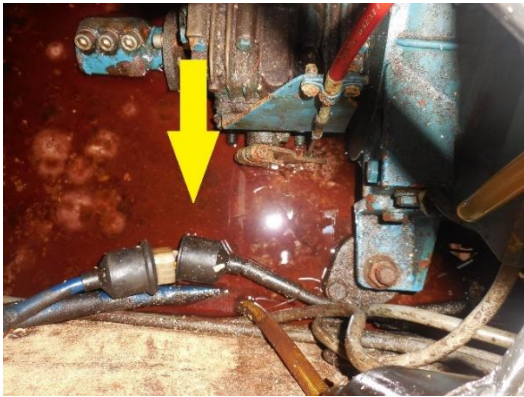
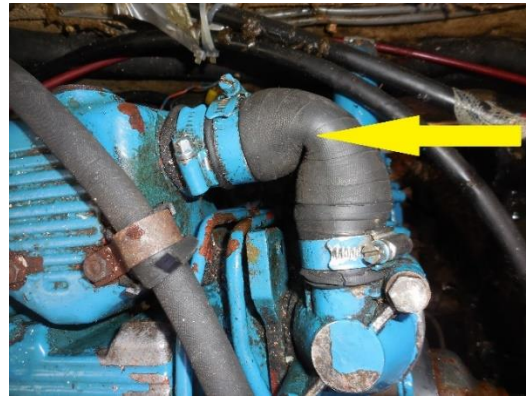
- 5.8. Lifeboat #1 engine's oil level was excessively high and water was present mixed with the engine oil. Further, the engine coolant tank was empty.

- 5.9. Lower portion of the engine compartment in Lifeboat #1 was full of oily water. The coolant hose from the manifold to the pump is not the original elbow type and is excessively kinked.

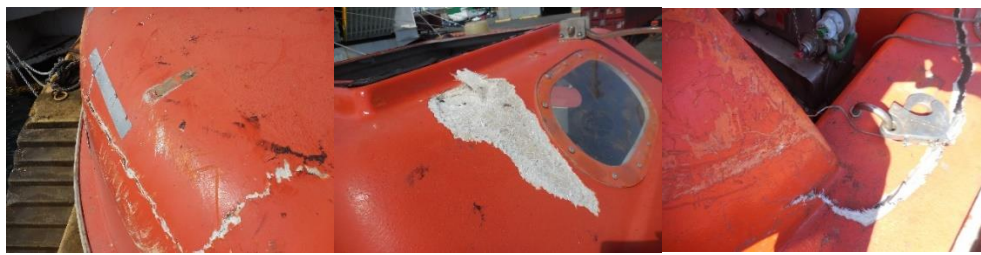
- 5.15. There was no evidence that CARIBBEAN FANTASY had such an exemption.
- 5.16. During the independent assessment, the HARDING representative observed considerable GRP, hand rails and hatch damage on Lifeboats #1, #2 and #3 that included fractures and laminate shearing.

- 5.17. The observed damages are considered repairable, however, it may not be feasible depending on the estimated cost of repair when compared against the purchase of a new lifeboat.

- 6.8. The lifeboats, davits and winches should only be put back into service, following a satisfactorily full inspection equivalent to that of a five yearly being conducted on all the equipment with the issuance of a certificate deeming them fit for service.

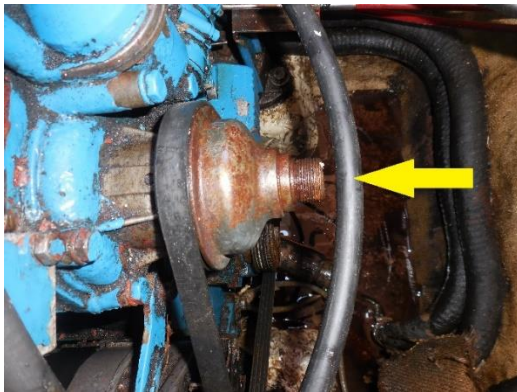
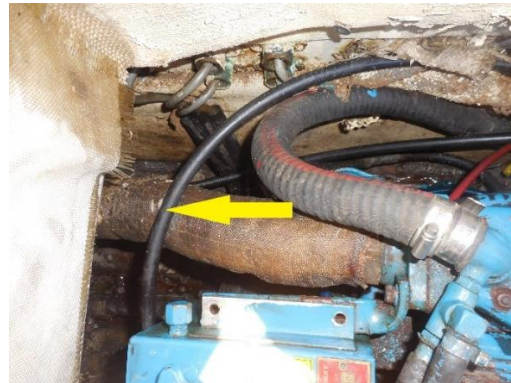
- 5.20. It is unclear if the hook damage was sustained before or after the incident.
- 5.21. One possible causal factor that may have resulted in the crew being unable to open the hooks once waterborne is that the aft release cables; as installed; on Lifeboats #1 and #2 were considered too long. The excessive length increased the resistance in the push pull cables.

- 5.22. Another causal factor is that release cables should not be installed near moving part or element that may affect the release cables integrity. The aft cable was considered to be too close to the engine belt pulley and directly over the insulated exhaust pipe. See pictures below (yellow arrow indicating the release cable).

- 6.6. Careful attention should be given to the installation of release cables and the routing thereof to prevent unnecessary resistance in the push pull cables.
