# VIKING Technical Dept.

8D report – Caribbean Fantasy

RP 2016.11.30

M/F Caribbean Fantasy, IMO: 8814263

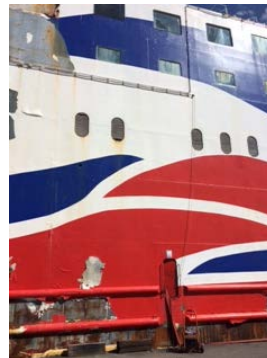
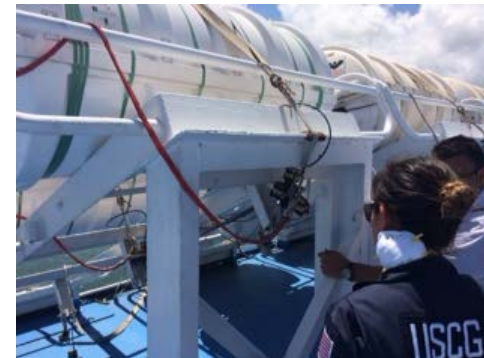
- Connection lines were out of the split tubes as expected.
- All drop rafts deployed on starboard side.
- Only one drop raft deployed on port side.
- The repair yard installed the liferafts with acceptance from the class. The liferafts were not installed by authorized VIKING service technicians.

The drop rafts deployed were not installed by authorized VIKING service technicians and it is not possible for us to find out why they were found floating not connected.

- incorrect connection during installation
- Incorrect handling by the crew during evacuation.
