# National Transportation Safety Board

Group Chairman's Factual Report

Survival Factors

DCA16FM052

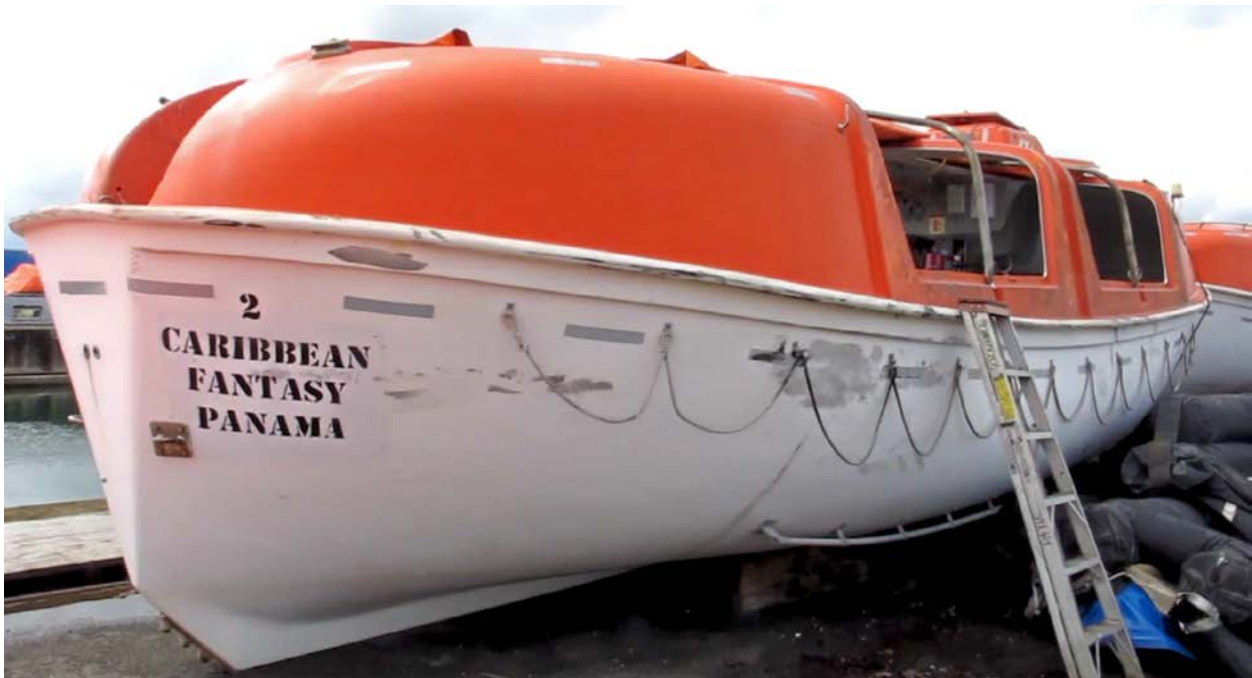
10  
11 **Figure 1. *Caribbean Fantasy* lifeboat no. 2 on the pier in San Juan after the accident. Canvas tarps**  
12 **hinged on the top of the lifeboat were designed to cover the entrances on each side of the boat.**

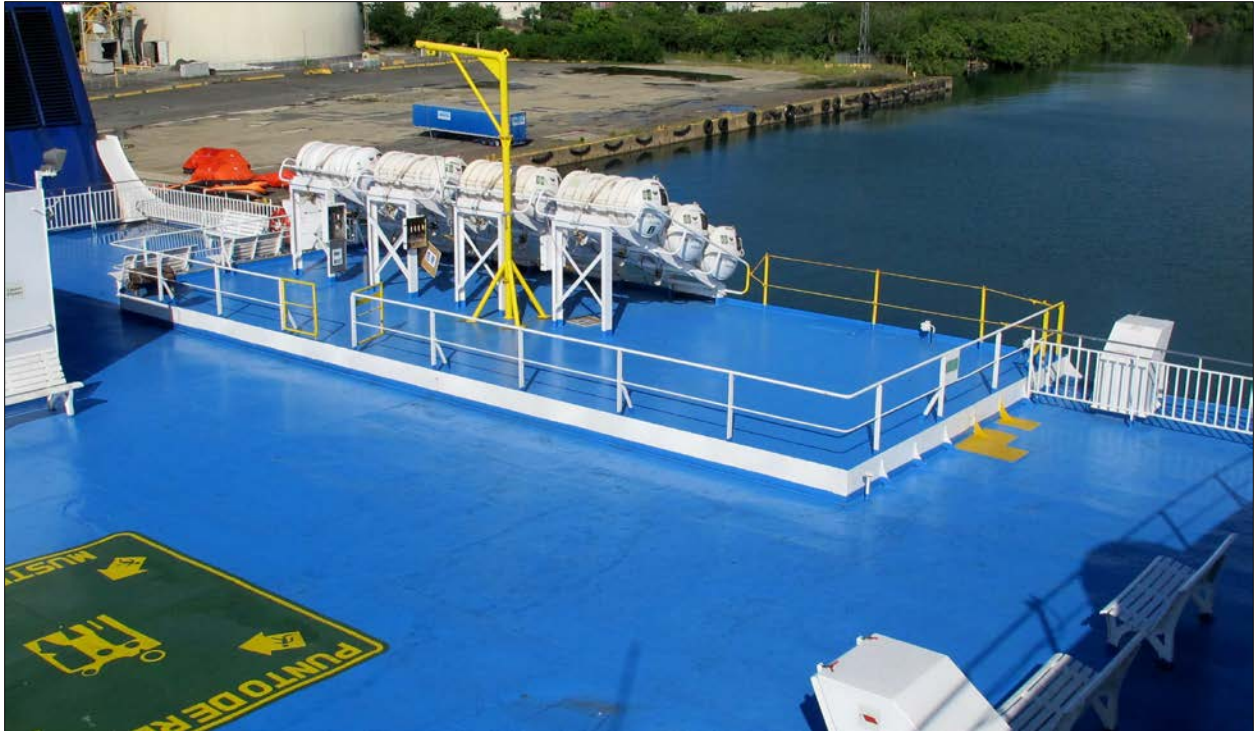
1  
2 **Figure 7. Postaccident photo of the life raft containers and storage racks for the**  
3 ***Caribbean Fantasy's* port side marine evacuation system.**

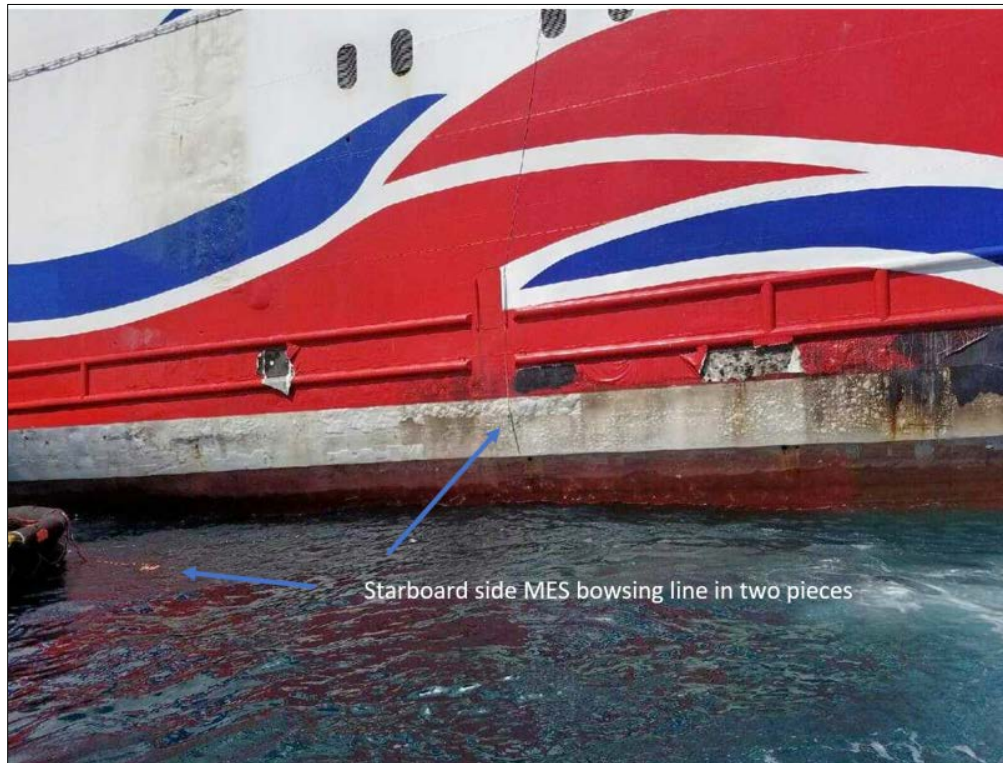
2 The staff captain told investigators the starboard side MES deployed well but the crew  
3 could not use the bowsing line because it was “cut.” One of the ABs assisting with the starboard  
4 side MES also noted that “the line where to keep it on the ship was broken.” A Coast Guard  
5 photograph of the MES taken during the evacuation show the bowsing line in two pieces, with a  
6 slack bowsing line on the starboard side of the ship (see figure 12).

7  
8 **Figure 12. From left to right: A piece of the bowsing line attached to the starboard side MES**  
9 **platform; and the rest of the bowsing line, hanging slack on the side of the *Caribbean Fantasy***  
10 **(Photo by Coast Guard)**

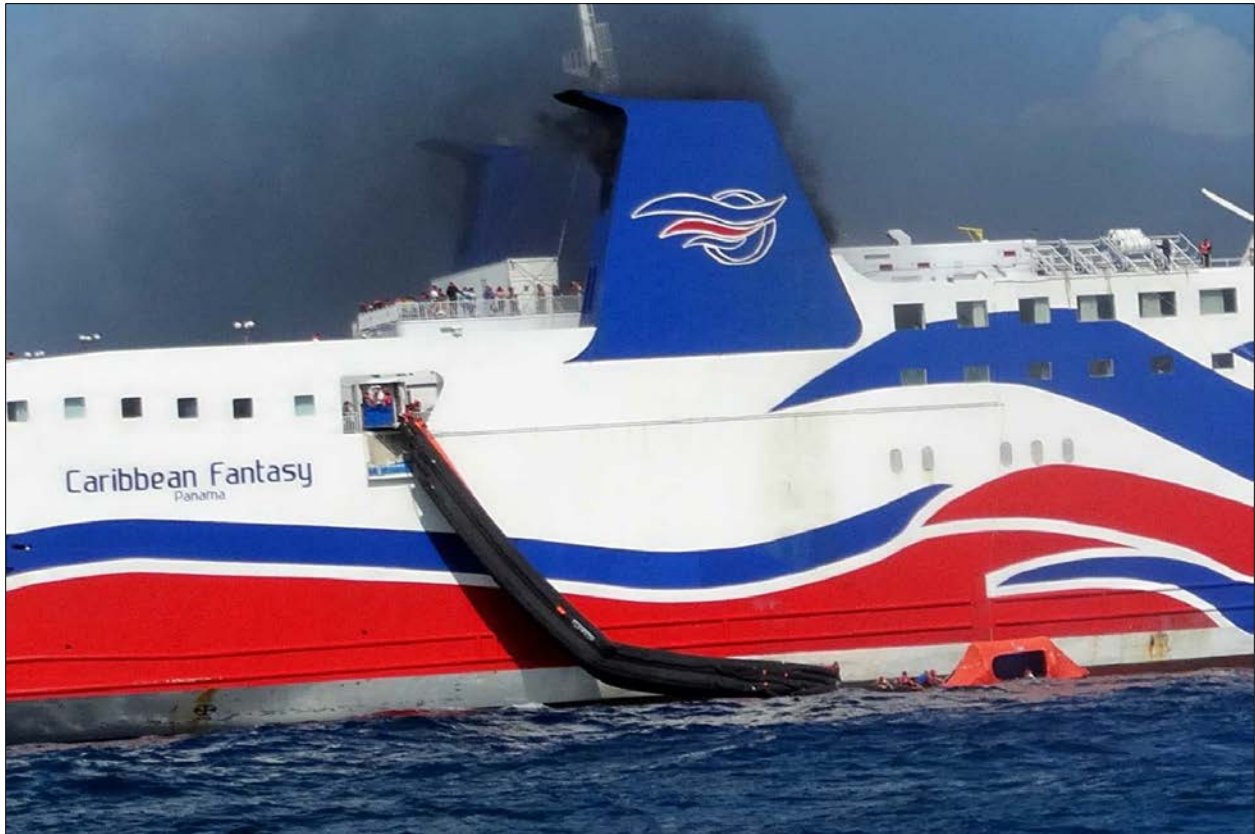
11 The staff captain said that they added nitrogen from the spare pressure refilling valve to  
12 overcome the effects of the wind, which was causing the slide to collapse, and sent passengers  
13 down the slide even though the side deployed with a steep angle (See figure 13). Eventually, when  
14 about 70 passengers and crew remained on board, a Coast Guard small boat crew, at the *Caribbean*  
15 *Fantasy* captain’s request, used a line attached from the MES platform to the bow of the small boat  
16 to pull the platform forward and improve the alignment of the slide (See *Group Chairman’s*  
17 *Factual Report - Operations* figures 14 and 16).

1  
2 **Figure 13. Caribbean Fantasy starboard side MES deployed with steep angle. Note the large opening**  
3 **of the liferaft is turned away from the MES platform. (Photo by US Coast Guard)**

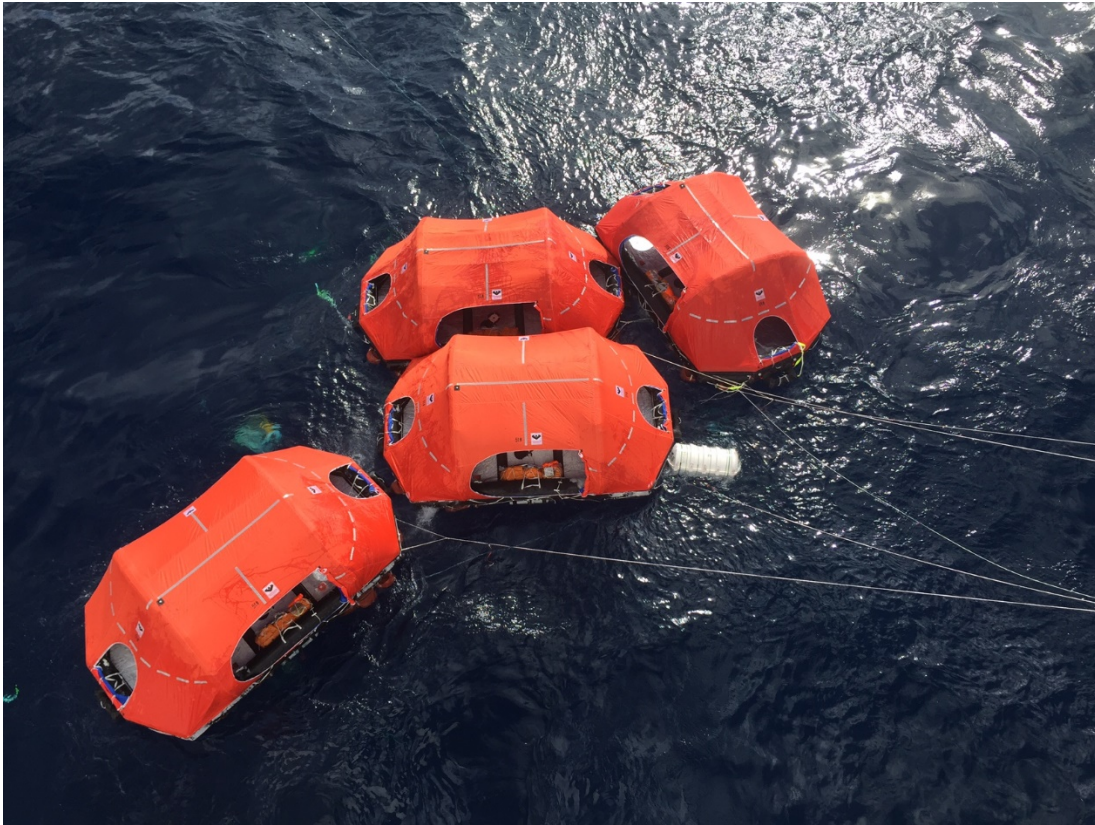
11 Also noted previously, the liferafts were designed to be inflated by crewmembers once they  
12 were pulled alongside the MES platform. But some of the starboard side liferafts inflated early.  
13 The housekeeper said he saw four rafts inflate before being pulled to the platform, the captain and  
14 staff captain also referred to more than one raft inflating early, and a passenger took a photograph  
15 showing four empty liferafts with lines still connected to the ship (see figure 14). In addition to  
16 being manually deployed and inflated in conjunction with an MES deployment, the liferafts were  
17 also designed to automatically deploy and inflate if the vessel sank. If the vessel sank, the liferaft

6 The Hammar remote release operation at the rack cut a line to free the container and at the  
7 same time disconnected the painter from the container rack. When released manually, by using  
8 either the release bar or securing link as was done on all but two of the starboard side rafts, the  
9 painter remained attached to the rack and payed out. To prevent early inflation, the platform crew  
10 must pull the container to the platform before the raft container drifts far enough away to put  
11 tension on the painter line and prematurely inflate the raft.

12  
13 **Figure 14. Inflated liferafts without passengers and a liferaft container that had not**  
14 **deployed. (*Caribbean Fantasy* passenger photo provided by Coast Guard)**

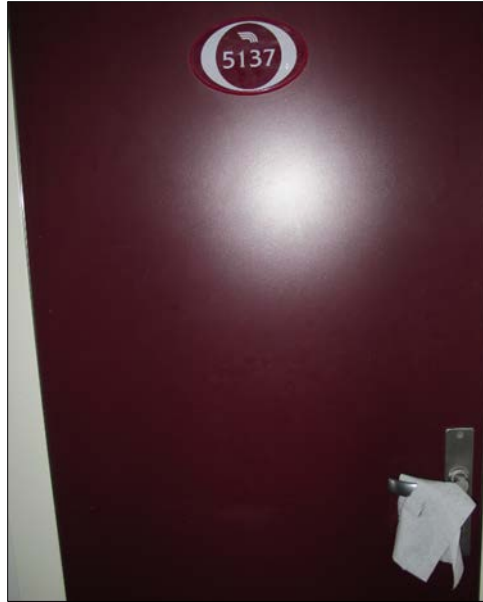
2 **Figure 19. Caribbean Fantasy passenger cabin door. Door handle marked with toilet paper.**

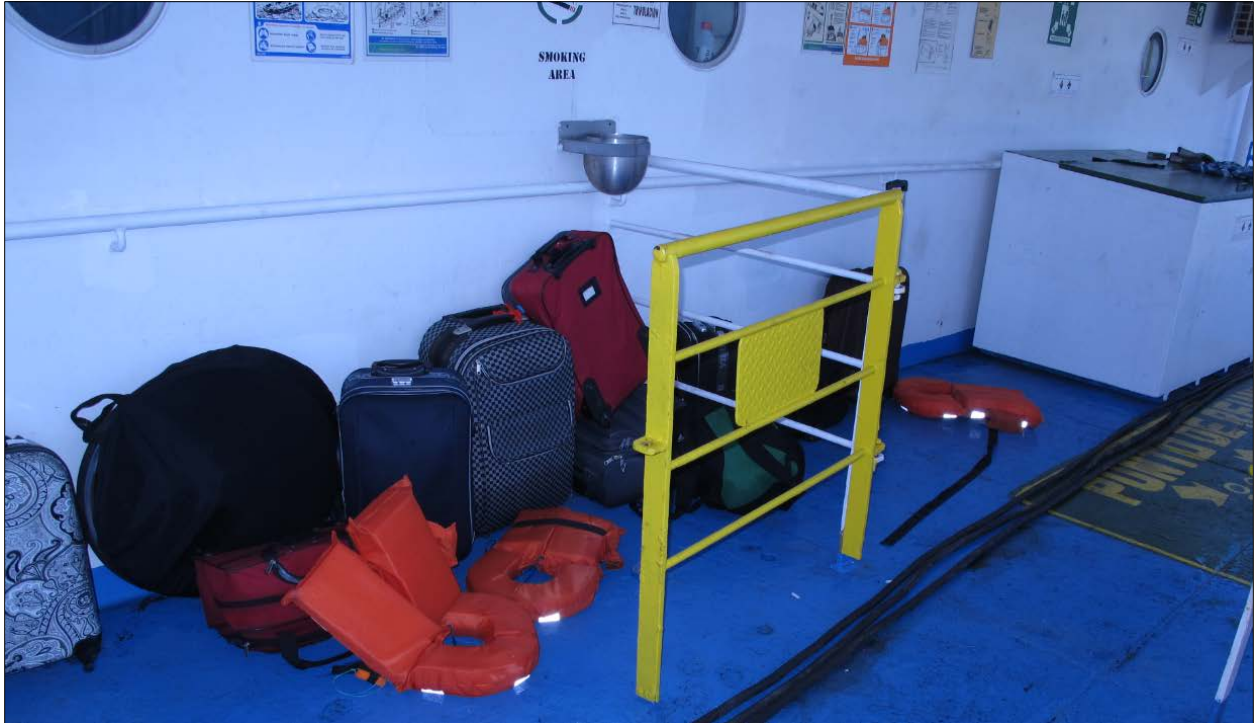
26 Because the *Caribbean Fantasy* was to arrive in the port of San Juan on the morning of the  
27 accident, many of the passengers were waiting in public spaces with their personal effects. When  
28 the announcement was made to abandon the ship, many passengers brought their personal effects  
29 with them to the muster stations. Some crew members also did the same. When at the muster  
30 stations, crewmembers managing those stations and the embarkation of survival craft and the MES  
31 had to instruct the passengers leave their effects behind.

1  
2 **Figure 23. Some personal effects left behind at muster station A, near lifeboat no. 3.**

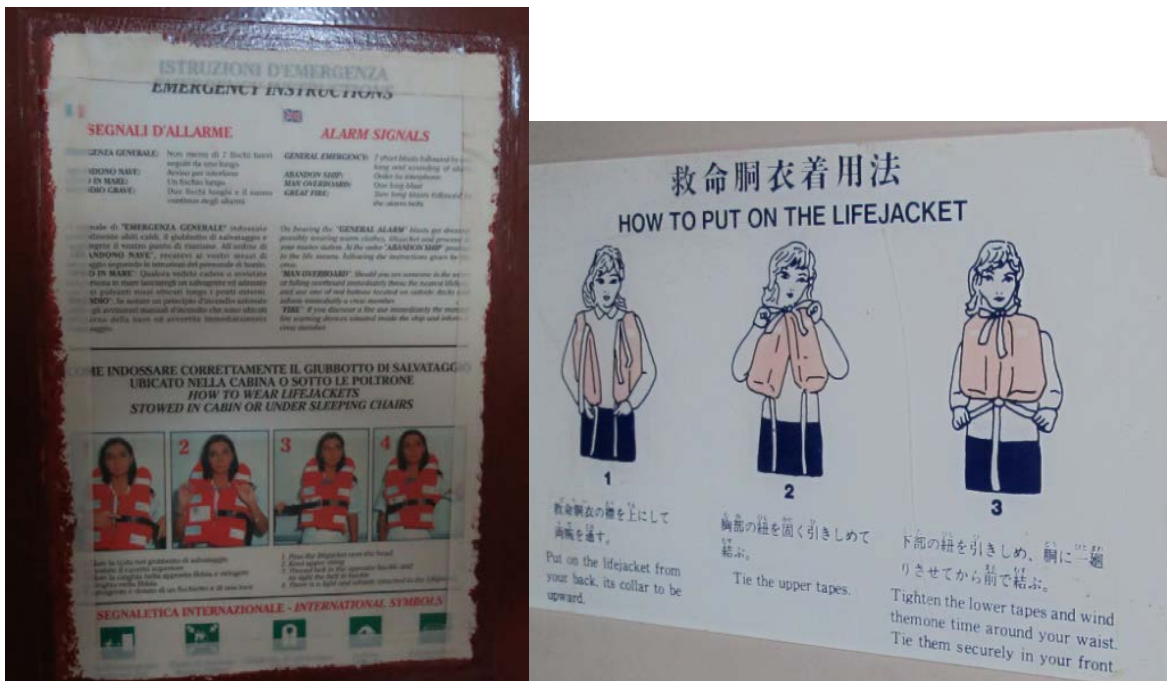
1  
 2 **Figure 24.** Left image from the back of a passenger cabin door. Instructions were in Italian and  
 3 English and stated that the signal for a “great fire” was “two long blasts followed by alarm bells,”  
 4 which was not a signal used on board. Right image from a public space on deck 7 describing  
 5 lifejacket donning instructions in English and Japanese for a type of lifejacket not found on board.

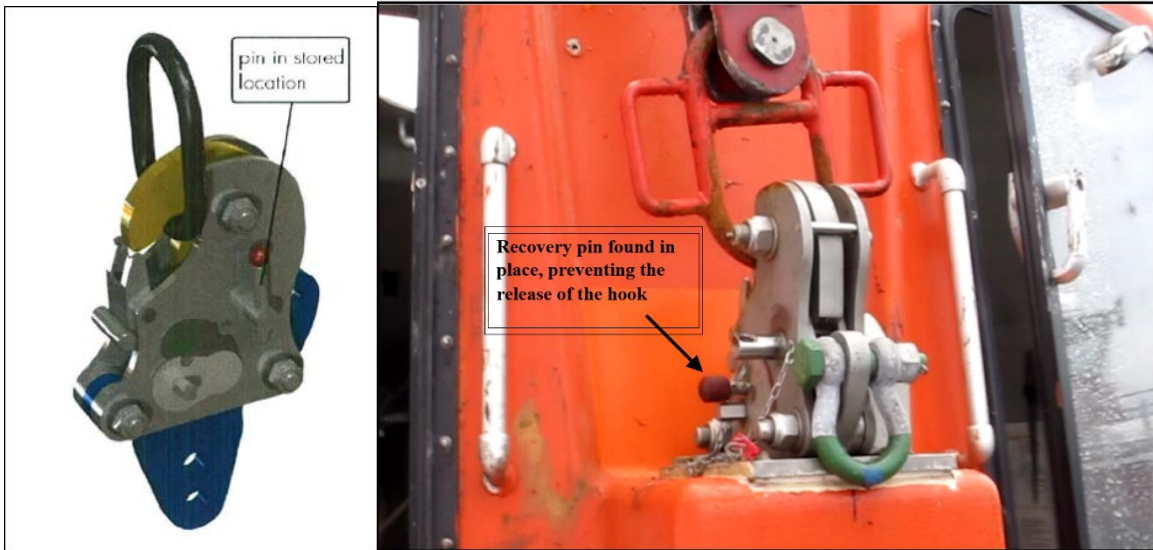
1 normally be kept in its stored position in preparation for lowering and launching lifeboats in an  
2 emergency. According to the commander of lifeboat no. 3, the pins were put in the recovery  
3 position prior to their attempted hoist of the lifeboat back to the embarkation deck. It could not be  
4 determined if the pins were in the stowed or recovery position prior to the boat being lowered.

5  
6 **Figure 25. At left, the U-hook with recovery pin in stored position. (Source: U-Hook 3 – 6 – 10 – 15**  
7 **ton Operation and Maintenance Manual) At right, Caribbean Fantasy lifeboat no. 3 aft hook with the**  
8 **recovery pin inserted in the hook mechanism.**

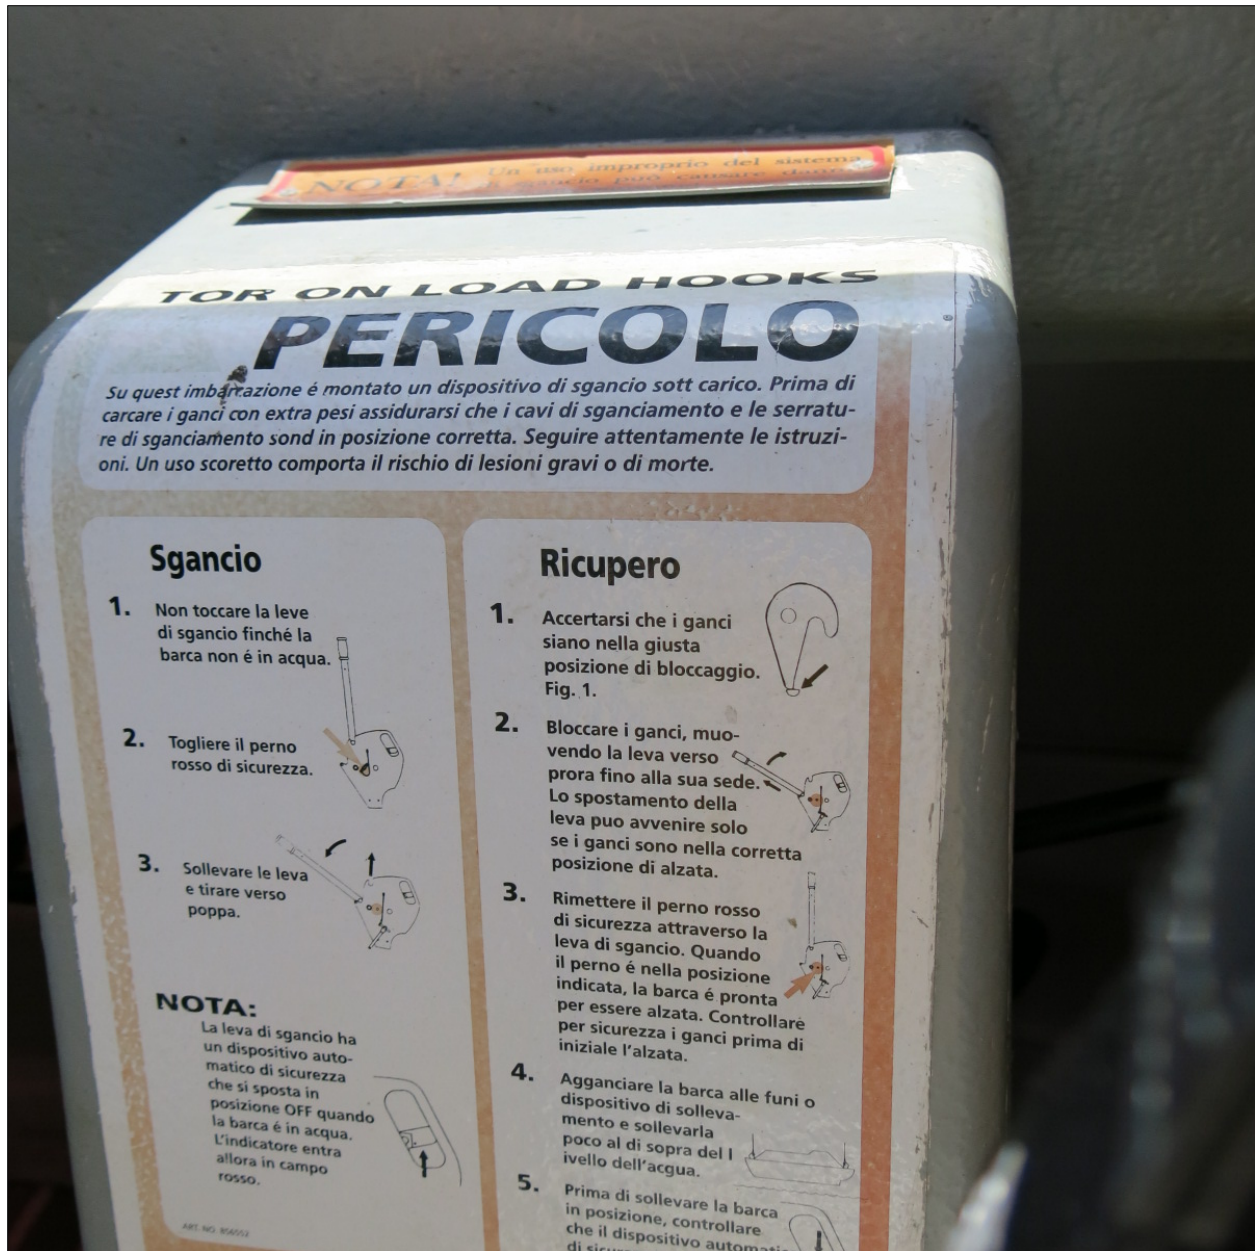
9 All lifeboat manuals contained instructions for the operation of the old release hooks that  
10 had been replaced in the shipyard. SOLAS Regulation III/B/I/9.2.1 requires posters or signs  
11 containing the relevant instructions and procedures for operating the hooks to be placed in the  
12 vicinity of survival craft launching controls. After the accident, investigators found posted  
13 instructions in lifeboat no.3 that explained how to release the newly installed U-hooks. However,  
14 instruction sheets in lifeboats no. 1 and no. 2 were for the previously removed release hooks. Step  
15 36 of the U-hook installation procedure directs the technician is to apply a hook instruction poster  
16 in the boat. The instruction did not specify where to place the poster in the boat, but U-hook  
17 instructions were not found anywhere in either lifeboat no. 1 or 2.

1  
2 **Figure 26. Instructions (Placard) for TOR On load release hooks posted in lifeboat no. 1 in English**  
3 **and Italian.**

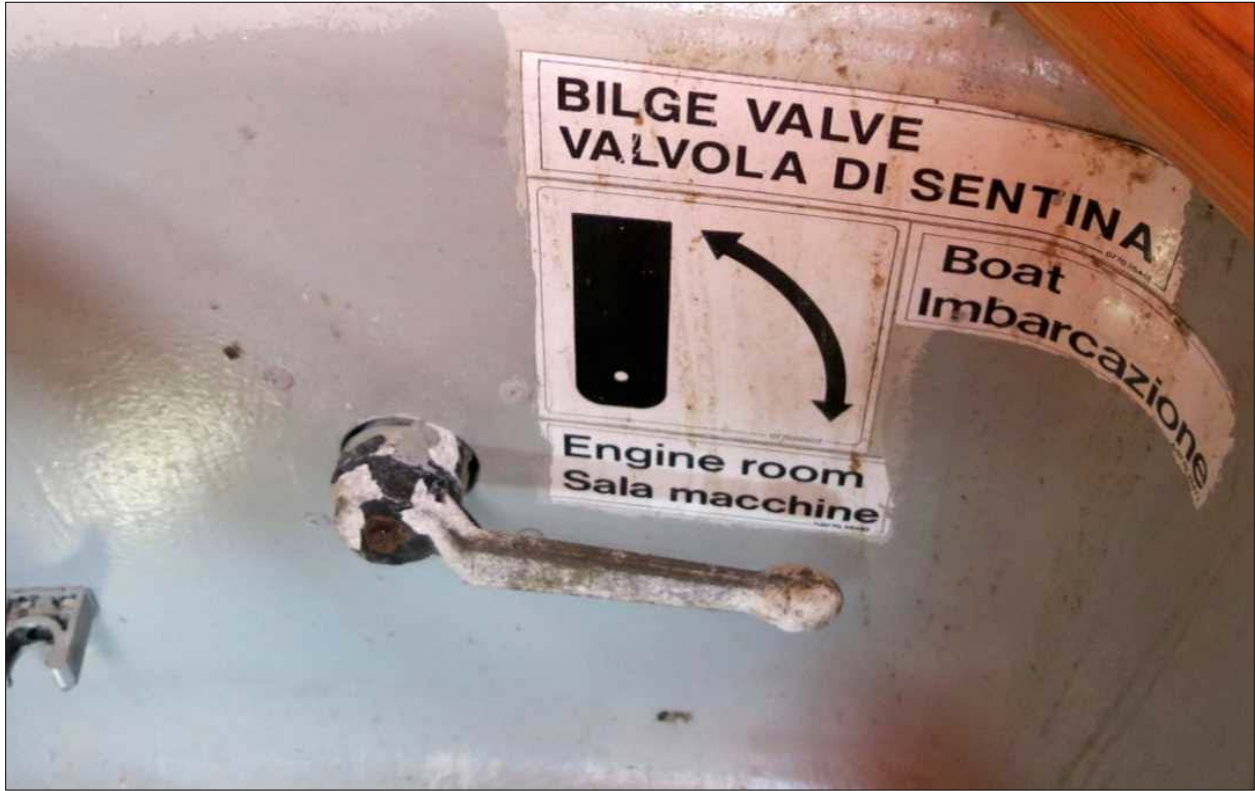
1 did not contain any instructions for operating the fixed hand bilge pump on the forward end of  
2 lifeboat no. 1. Investigators found the pump functioned and used only one hose - to bail the boats  
3 main compartment.

4  
5 **Figure 27. Caribbean Fantasy lifeboat no. 1 bilge pump valve handle in position to remove water**  
6 **from the engine compartment. Note labels are in English and Italian.**

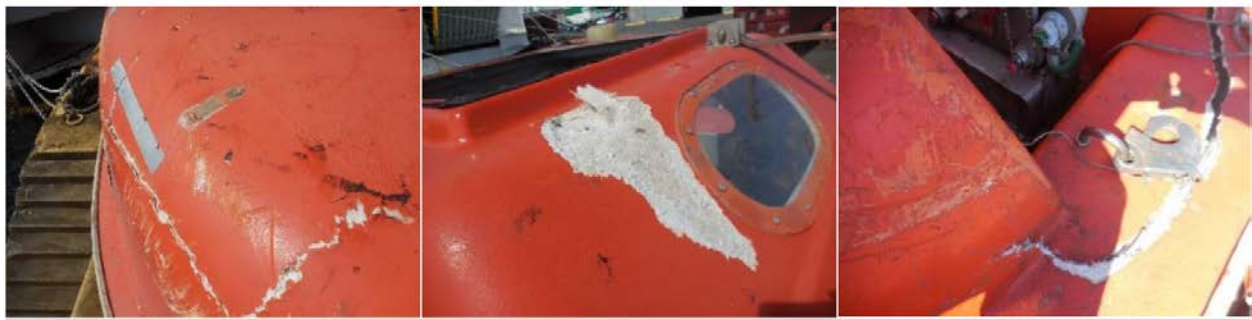
- 17 • Lifeboats no. 1, no. 2, and no. 3 incurred GRP, hand rail, and hatch damage that included  
18 fractures and laminate shearing.

19  
20 **Figure 28. Damage to lifeboats (Photos courtesy of Palfinger Marine)**

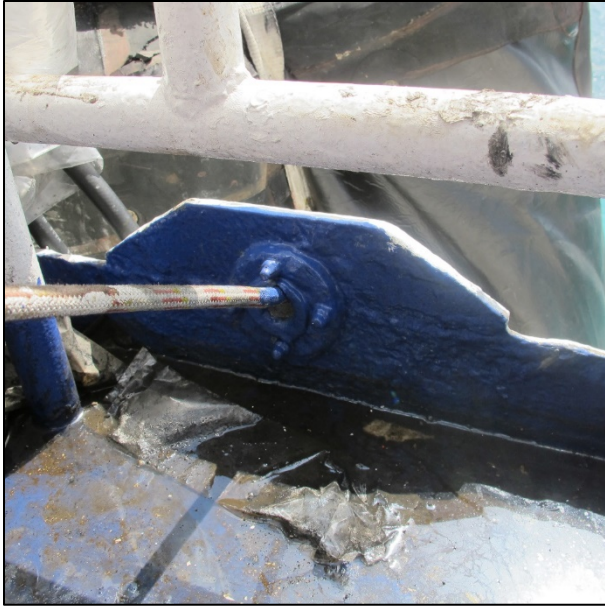
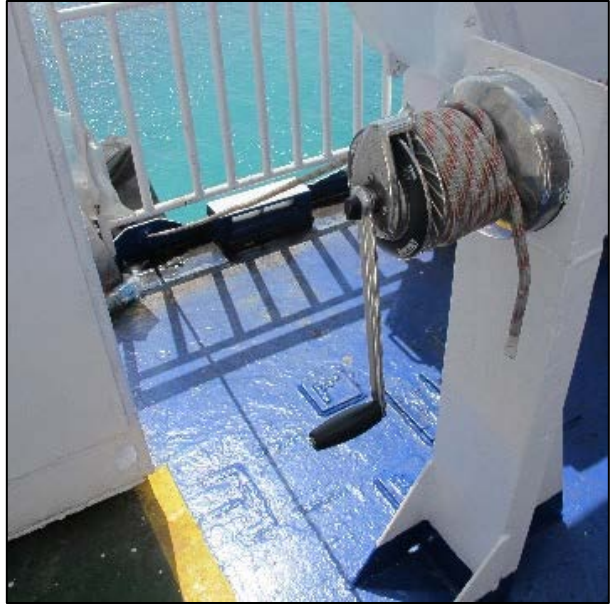
**Figure 30. Port side MES bowsing line and winch.**

23 Investigators found the port bowsing line as shown in figure 30. The bowsing line is neatly  
24 coiled on the winch drum, and blue paint is on the line at the deck—the same blue paint used for  
25 the deck, deck edge, and chock in the vicinity of the line.

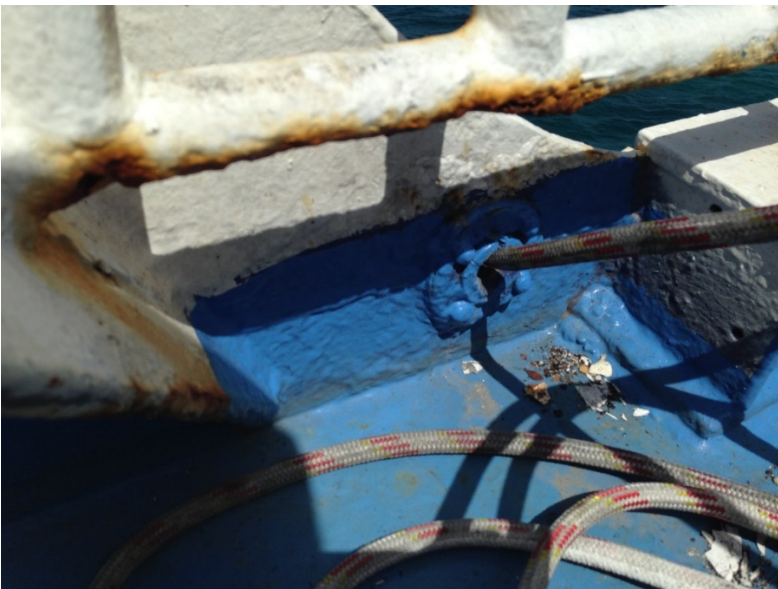
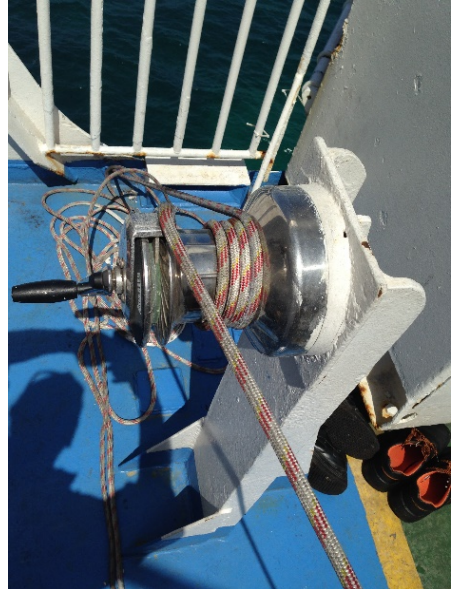
**Figure 31. Starboard side MES bowsing line and winch.**

Investigators found the starboard bowsing line and winch as shown in figure 31, with bowsing line slack, lying on the deck. The starboard side MES had been cut away from the vessel before investigators arrived. None of the witnesses interviewed by investigators said that they operated the starboard winch during the evacuation. VIKING representatives noted slack in the starboard bowsing when they viewed videos of the evacuation.

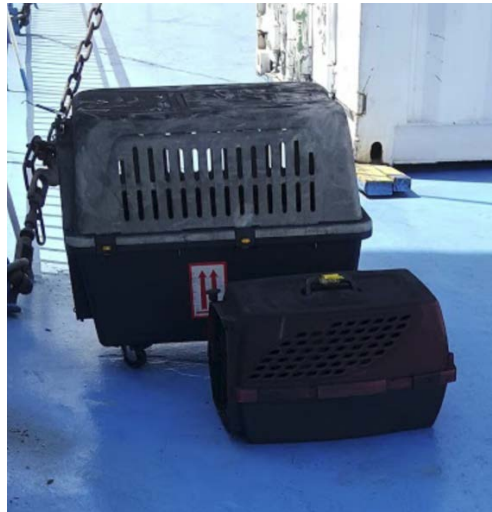
6 Two of seven dogs on board the *Caribbean Fantasy* during the accident died as a result of  
7 smoke inhalation. Salvage teams found both in their plastic crates in Garage B near the aft ramp  
8 at and starboard stairway at frame no. 5. Investigators learned that the dogs had been placed there  
9 by crewmembers who were positioning them on the vehicle decks for their owners in advance of  
10 debarkation.

11  
12 **Figure 32. Photo of the two dog crates recovered from Garage B (Photo by San Juan Fire**  
13 **Department)**
