NATIONAL TRANSPORTATION SAFETY BOARD
Office of Marine Safety
Washington, D.C. 20594

SURVIVAL FACTORS GROUP FACTUAL REPORT

DCA10FM017

Vessel: *Andrew J. Barberi*
Date: May 8, 2010
Time: 0919 EDT
Location: Slip 5, St. George terminal, Staten Island, NY,
Owner: New York City Department of Transportation

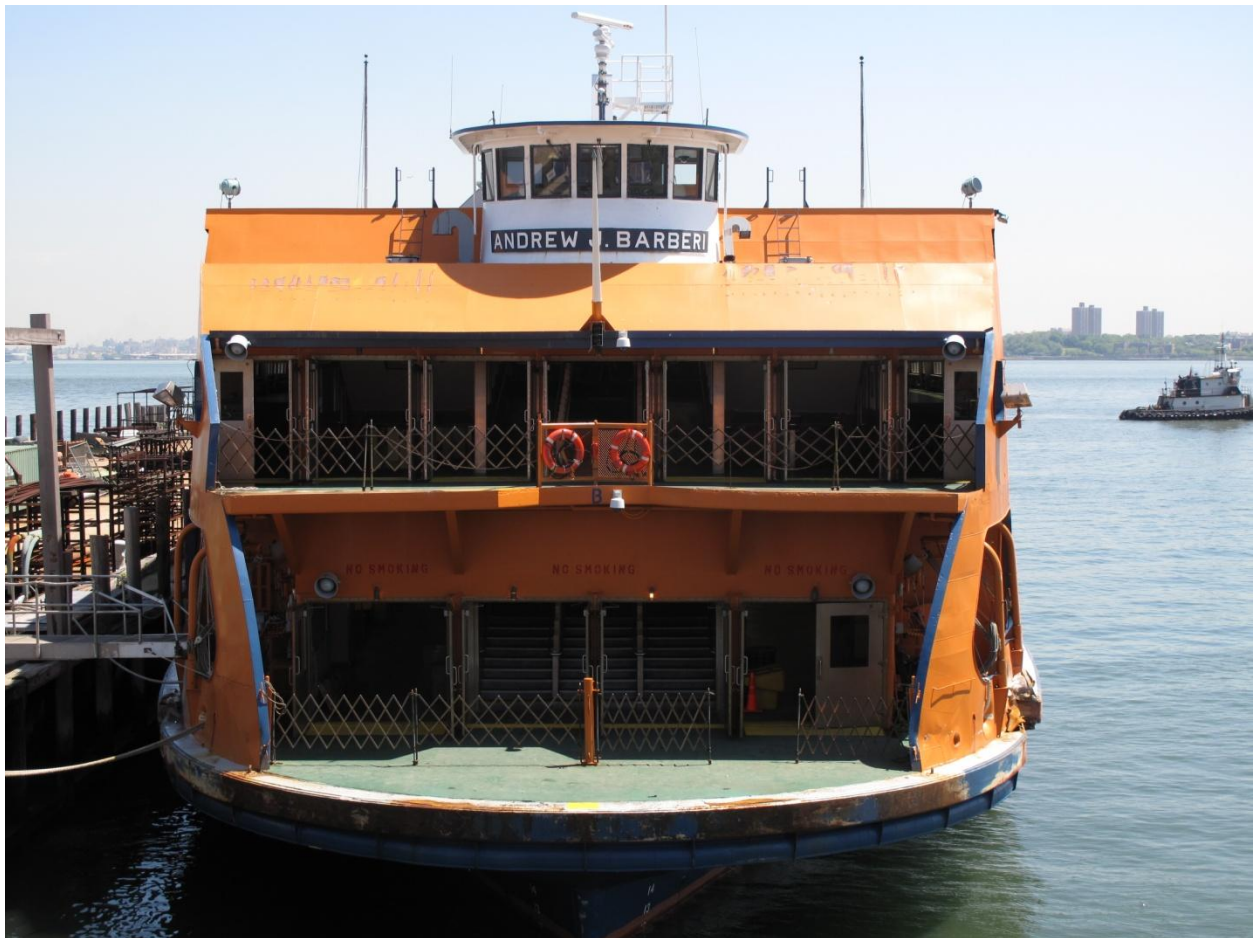
16
17 *Picture shows the Staten Island end of the Andrew J. Barberi ferry that allided with the*
18 *pier. This photo was taken at the Ferry Maintenance Facility, Staten Island, NY,*
19 *following the May 8, 2010 collision.*
