National Transportation Safety Board

Group Chairman's Factual Report

Human Performance Group

Caribbean Fantasy

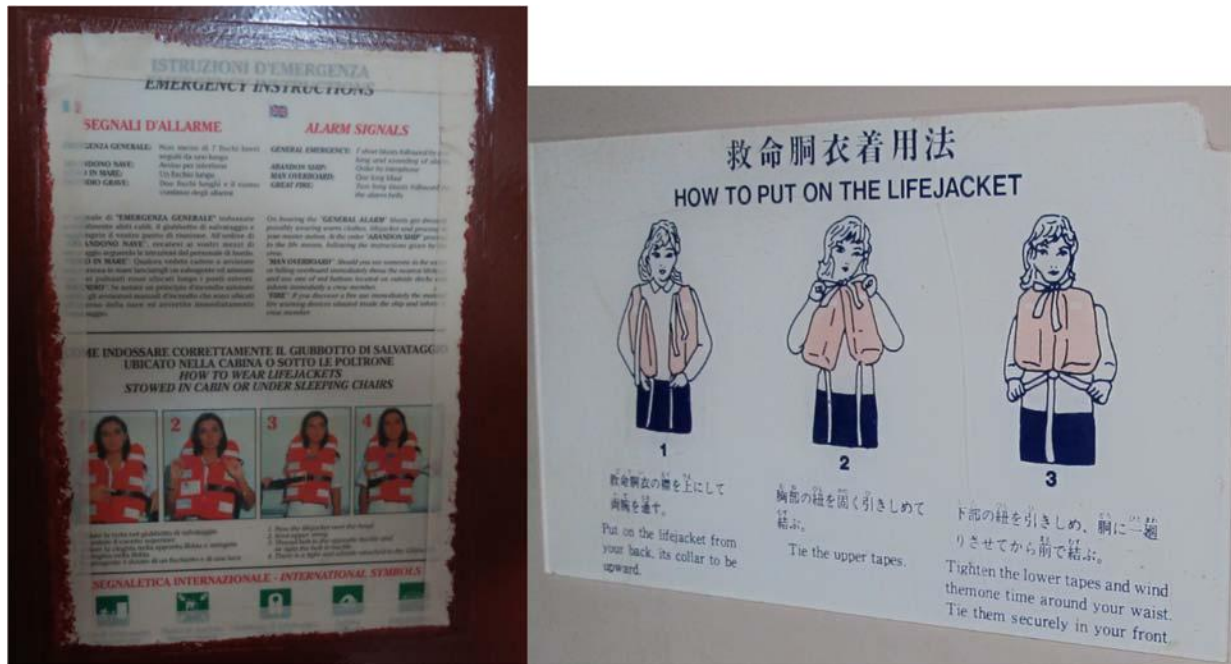
7 Most of the crew and passengers spoke Spanish, yet instructions for emergency equipment
8 and procedures were primarily in English. Moreover, upon examination of the vessel, investigators
9 found multiple cases of drawings, instructions, placards, and emergency equipment manuals in
10 other languages. Ship drawings were in Japanese and engineering drawings were in both Italian
11 and Japanese. Old lifeboat hook operating instructions, which were still onboard after the hooks
12 had been replaced, were in English and Italian. The water-mist fixed firefighting system manual,
13 as well as the operating instructions in the CO₂ room, were written in English and Italian. The
14 SOLAS training manual aboard the vessel was from previous ownership; the content had not been
15 updated when the ship changed hands to Baja Ferries ownership (although it had a new stamp and
16 a title change to "*Caribbean Fantasy*"); and the languages were in Italian and English.

- 5 replaced and were in English and Italian.
- 6 • Lifeboat engine start instructions were in English and Italian.
- 7 • The CO₂ instruction manual was in Italian and the drawings were in Italian and English.

15
 16 **Figure 1. Left: Emergency instruction sign, in English and Italian, on the back of a deck 6 cabin**
 17 **door. The fire instructions are also incorrect as they state in case of a “great fire” the signal is “two**
 18 **long blasts followed by the alarm bells.” Also note the masking tape covering the outer edges of**
 19 **the emergency instructions. Right: Lifejacket donning instruction sign, in English and Japanese,**
 20 **found on deck 6 near fire locker no. 2. The instructions are not for the lifejacket types carried on**
 21 **board at the time of the accident.**
