NATIONAL TRANSPORTATION SAFETY BOARD

SURVIVAL FACTORS GROUP FACTUAL REPORT

ACCIDENT NUMBER: DCA10MM025

Vessel 1: *DUKW 34*
Vessel 2: *T/V Caribbean Sea*
Vessel 3: *The Resource* (Barge)

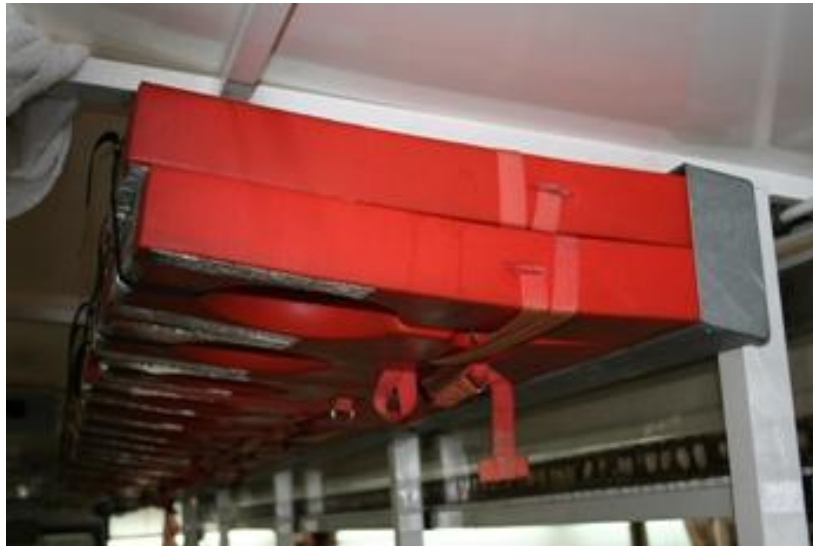
Lifejackets were stowed in the overhead on both sides of the vessel. Adult lifejackets were stowed in stacks of two on the starboard side above all but the last row of seats. Child-size lifejackets were stowed similarly on the port side and were above all but the last three rows of seats. The bottom end of each lifejacket was resting in a metal channel just below the canopy on each side (figure 1).

Figure 1. Adult Lifejacket stowage on APV boats

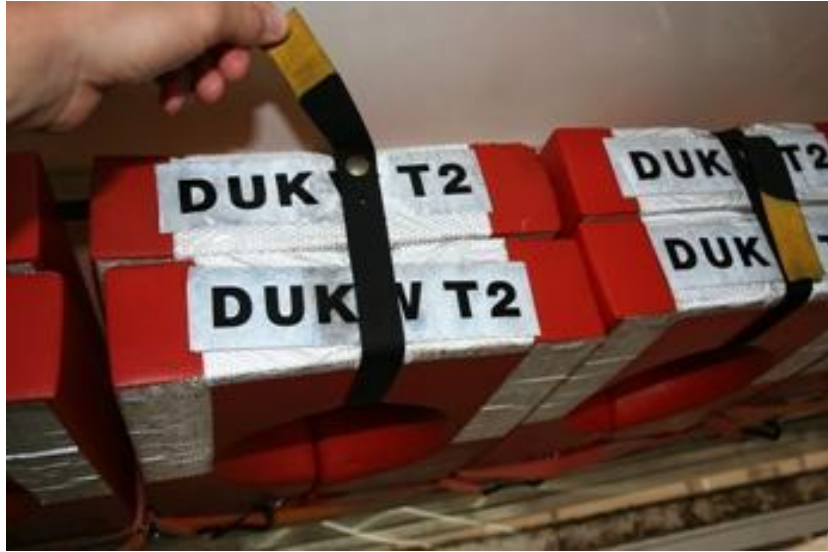
The top end of each lifejacket pair was secured to the overhead using a black nylon strap with a yellow tip, and button-type snap (figure 2). Passengers needed only to pull the yellow strap end to release the snap and free the lifejackets from the overhead.

Figure 2. Securing strap for lifejackets
