National Transportation Safety Board

Group Chairman's Factual Report

Survival Factors

Stretch Duck 7

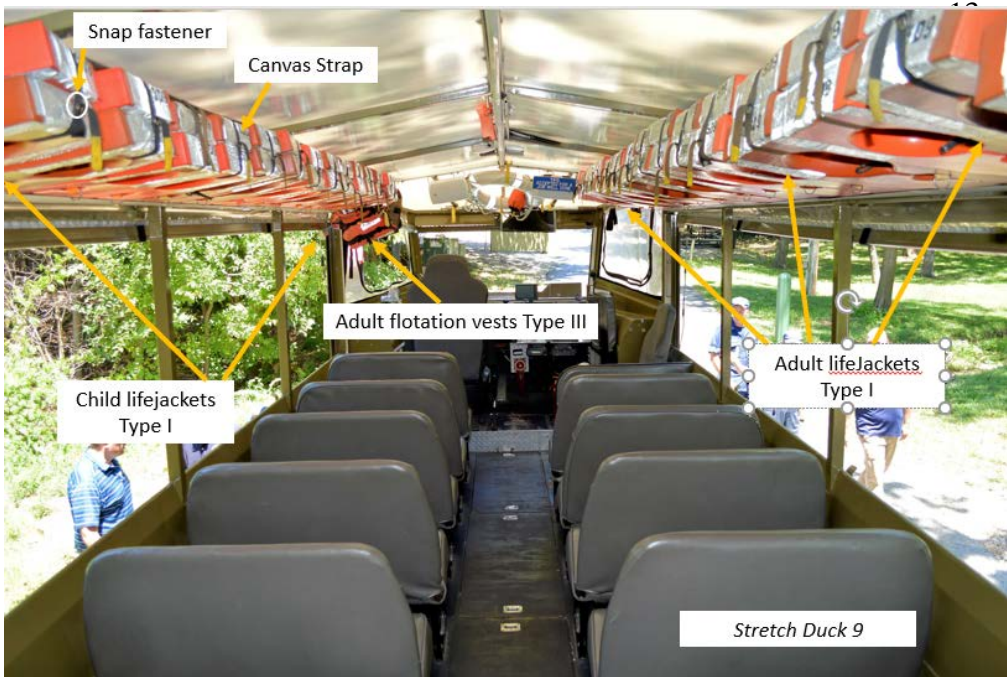
23 **Stowage of lifejackets on board a similar vessel *Stretch Duck 9***

27 opening for the head. The infant lifejackets were not secured in pairs. The four different lifejackets
28 on board the vessel were grouped along the port and starboard sides and their locations marked on
29 the metal channel. The starboard side stowage was all adult type I lifejackets. On the port side,
30 the stowage was organized from forward to aft as follows: Adult flotation vests type III; child type
31 I; and infant type II.

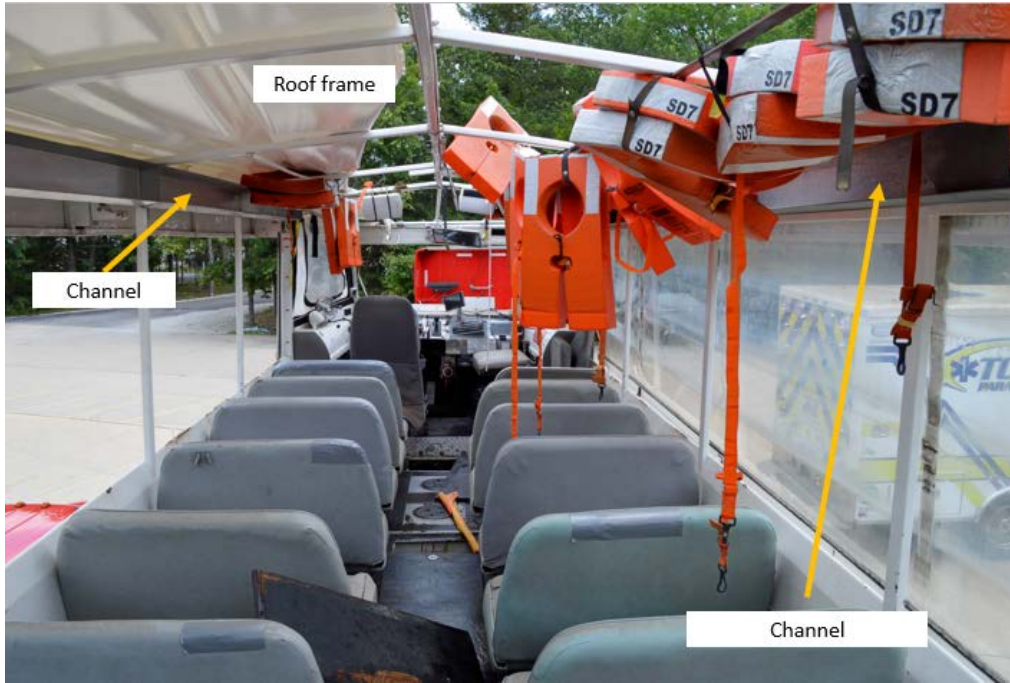
Stretch Duck 7 shortly after salvage.

11 Operators were encouraged to store life jackets so they float free if the vessel sank. The
12 Coast Guard Navigation and Inspection Circular (NVIC) 1-01, providing guidance for the
13 certification of amphibious vessels carrying passengers like the *Stretch Duck 7*, reads, "If
14 practicable, the stowage should allow the life jackets to float free." Following recovery of the
15 vessel from underwater, investigators counted 38 adult and 14 child lifejackets, some of which
16 remained in their stowage location. 30 adult (starboard side), 8 child (port side) and 3 infant

1 lifejackets (port side) were still connected to the vessel by their straps. The remaining life jackets
2 were recovered from the lake's surface or within the vessel outside of their storage locations.

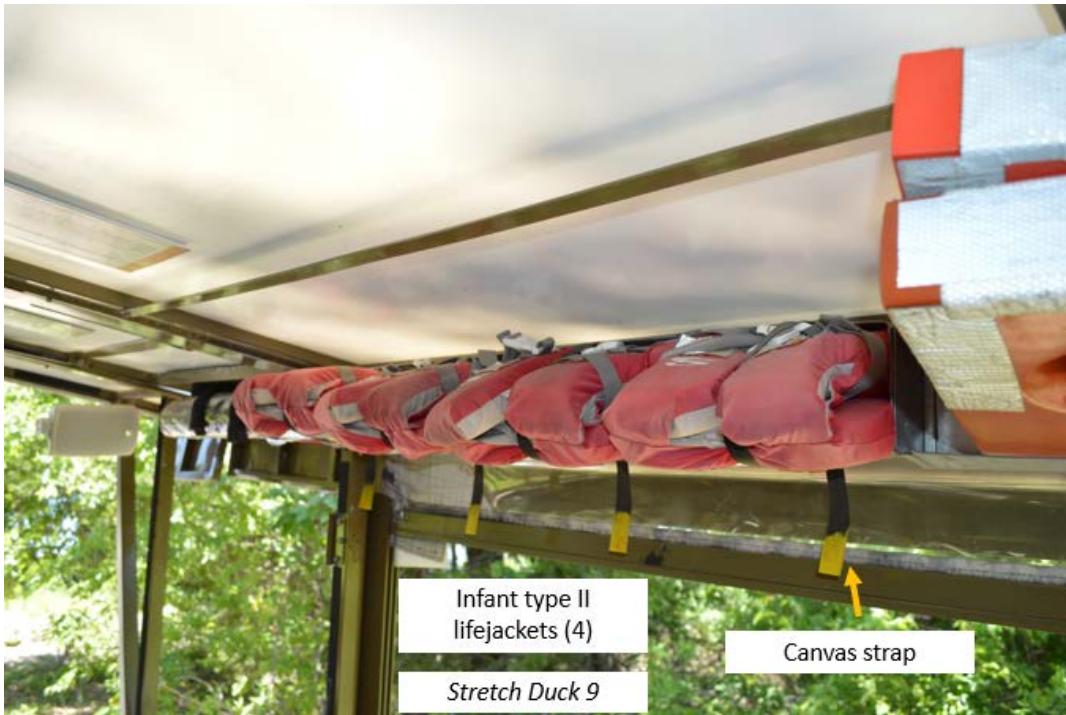
Stowage of infant lifejackets on the port side aft on the exemplar vessel Stretch Duck 9

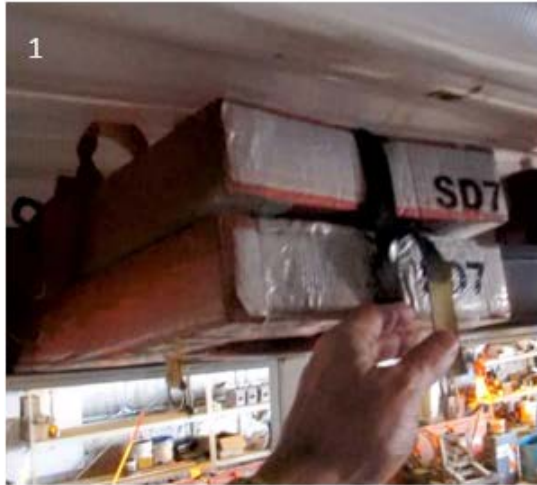
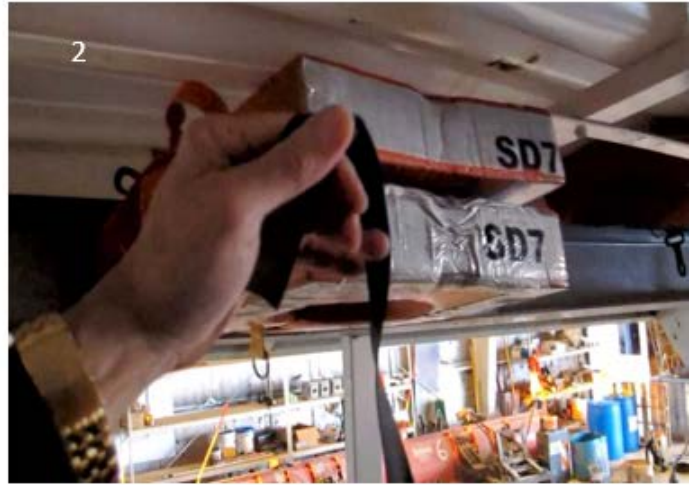
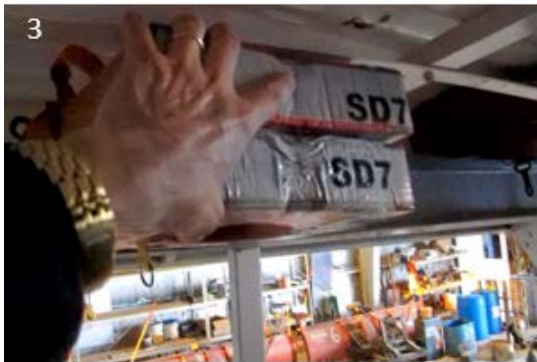
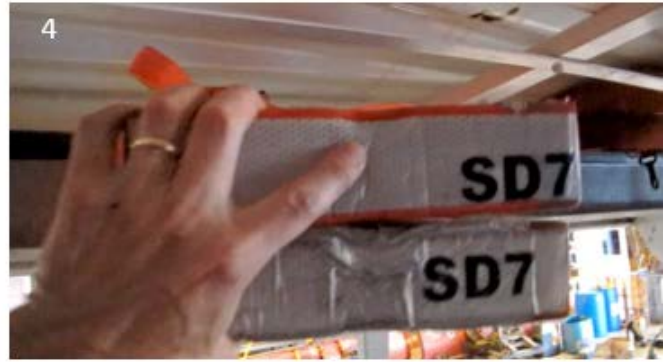
1 Releasing the life jackets involved a person pulling on each strap to release the snap
2 fastener which freed the top portion of the lifejackets while the bottom remained wedged in the
3 channel. A person would then reach for the lifejacket and pull it out of the channel.

6 **Removing two child Type I lifejackets from their stowage location. (1) Two lifejackets are wedged**
7 **and held by a canvas strap and an investigator is about to release the strap' snap fastener. (2) The**
8 **two lifejackets remained wedged in place after removing the strap. (3) An investigator grabs the top**
9 **of the two lifejackets to remove them from the channel. (4) The investigator holds the two lifejackets**
10 **after removing them from the channel.**

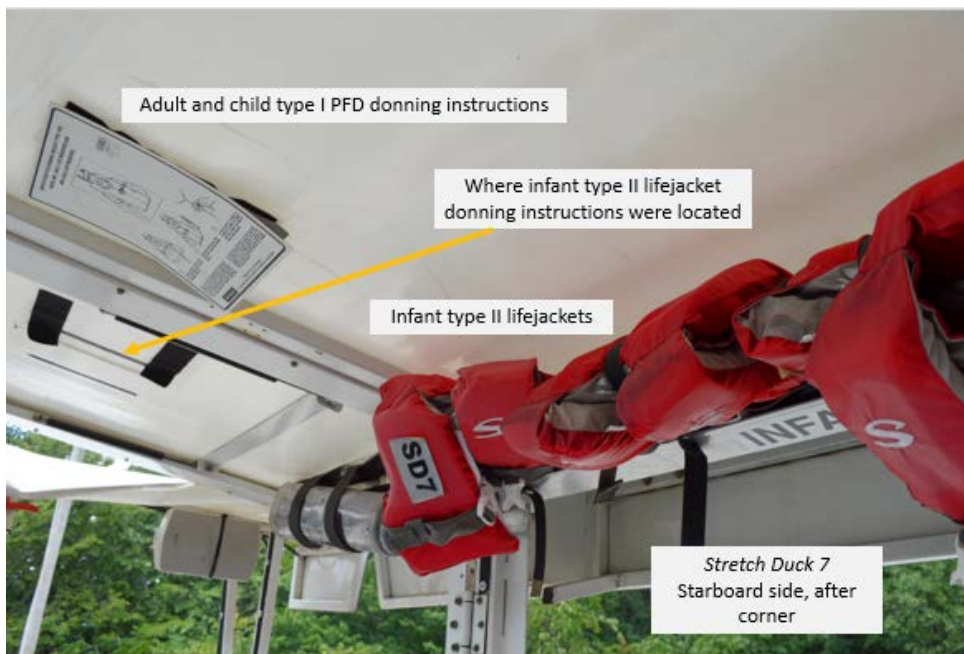
4 The placards containing instructions for donning and use of the lifejackets on board the vessel
5 required by 46 CFR §185.516 were posted on the underside of the canopy near the stowed infant
6 life vests and the passenger entry. Investigators examined the vessel after its recovery and found
7 Velcro still held the laminated adult and child donning instructions in place and noted only Velcro
8 where the infant lifejacket donning instructions would have been located.

Interior of the Stretch Duck 7 shortly after salvage. (Photo: MSHP)

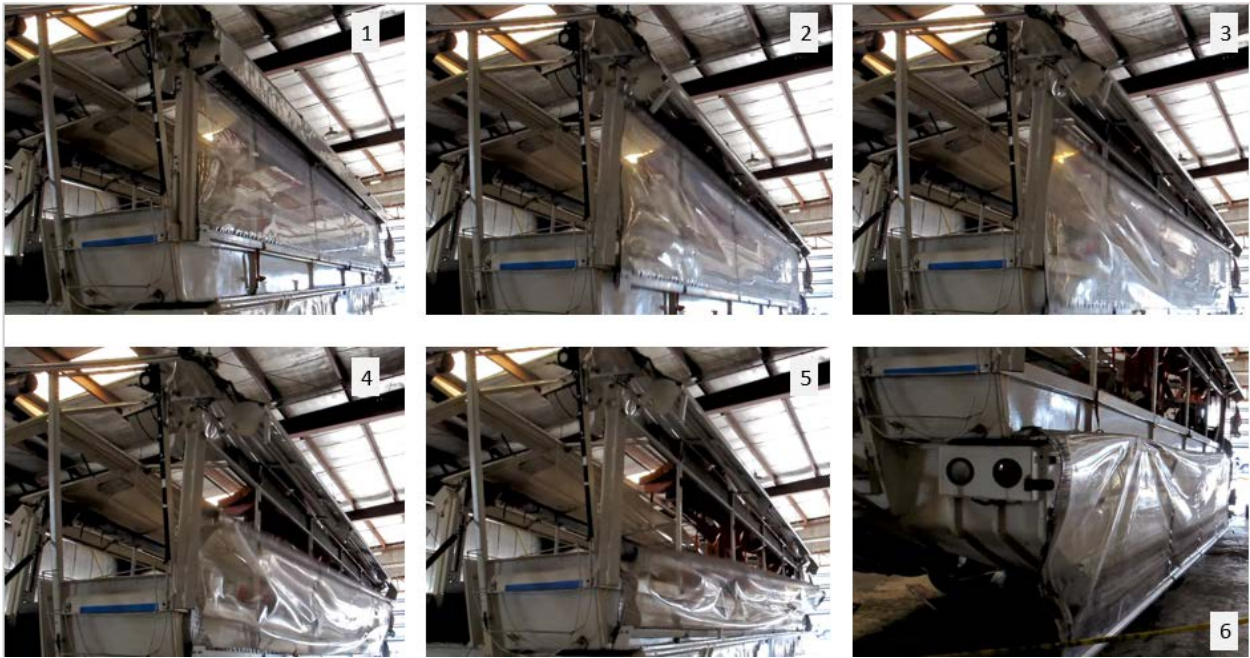
23 When investigators examined the recovered *Stretch Duck 7*, they found the main starboard
24 curtain in the passenger area in place and the main port side curtain in the passenger area
25 disconnected and released. The Captain of the *Stretch Duck 7* informed investigators he had
26 released one of the side curtains, and this account was corroborated by passenger statements. On
27 July 25, 2018 investigators conducted a test of the starboard curtain release and found the handle

1 easy to operate and watched the curtain drop away from the side of the vessel in less than one
2 second.

3
4 **Release test of the starboard side curtain on the *Stretch Duck 7*. (1) Curtain in lowered position**
5 **before release. (2) Curtain is shown dropping after the release handle was pushed towards the bow.**
6 **Photographs 3-5 show progressive dropping of the curtain. (6) Curtain fully dropped.**

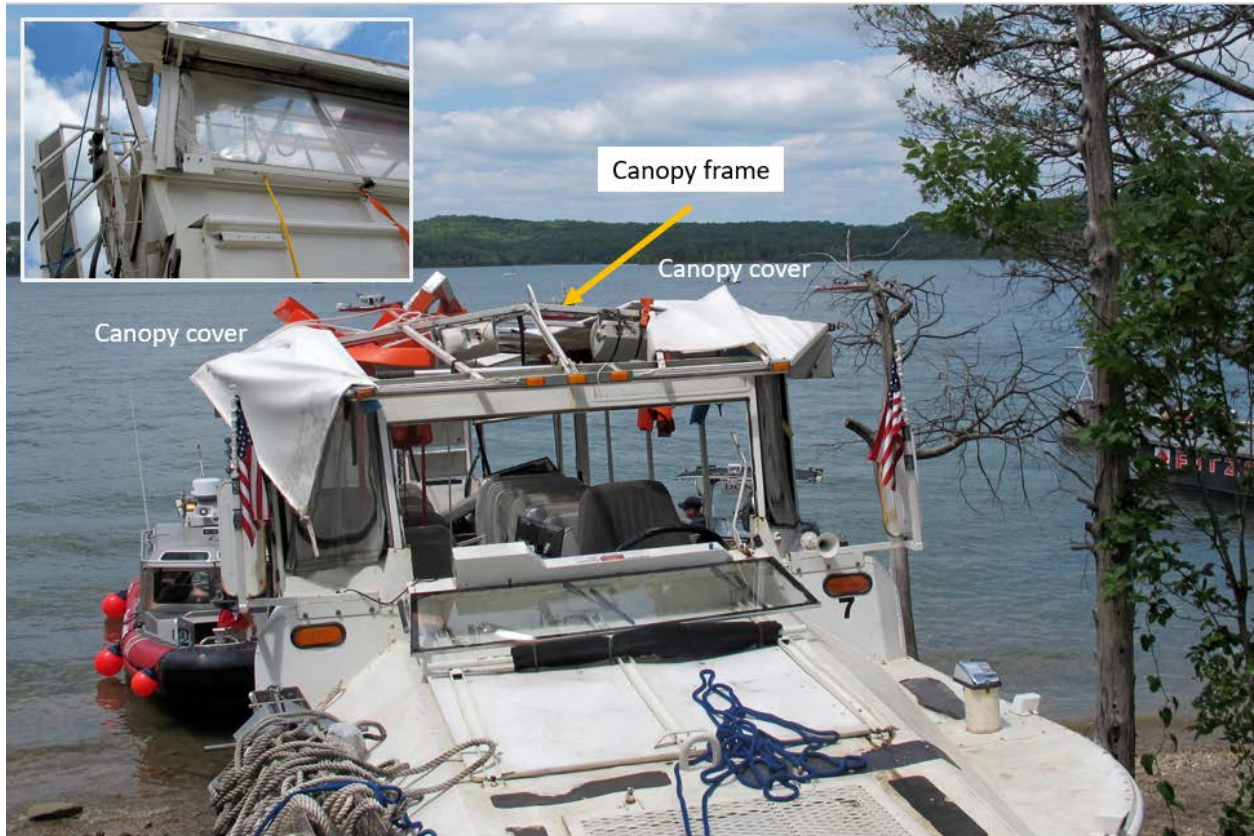
7 The canopy consisted of a fixed metal frame fitted with a vinyl cover measuring 1/32 of an
8 inch thick. When investigators viewed the *Stretch Duck 7* as it was hauled from the bottom of
9 Table Rock Lake, they saw the canopy separated down the center of the vessel and folded off to
10 the sides. Some of the passengers told investigators that they had escaped the vessel “through the
11 roof” and had thought that the captain had released the roof as the vessel went below the water.

3 **Stretch Duck 7 during recovery at Table Rock Lake showing a separated canopy cover. Insert:**
4 **Looking up from the after starboard corner of the vessel.**
