# NATIONAL TRANSPORTATION SAFETY BOARD

## Furuno FELCOM 15 Mobile Earth Station

Specialist's Factual Report  
by Douglas Mansell

Location: 40 Miles NE of Crooked Islands, Bahamas  
Date: October 1, 2015  
Aircraft: Cargo Ship  
Registration: IMO: 7395351  
Operator: Tote Services  
NTSB Number: DCA16MM001

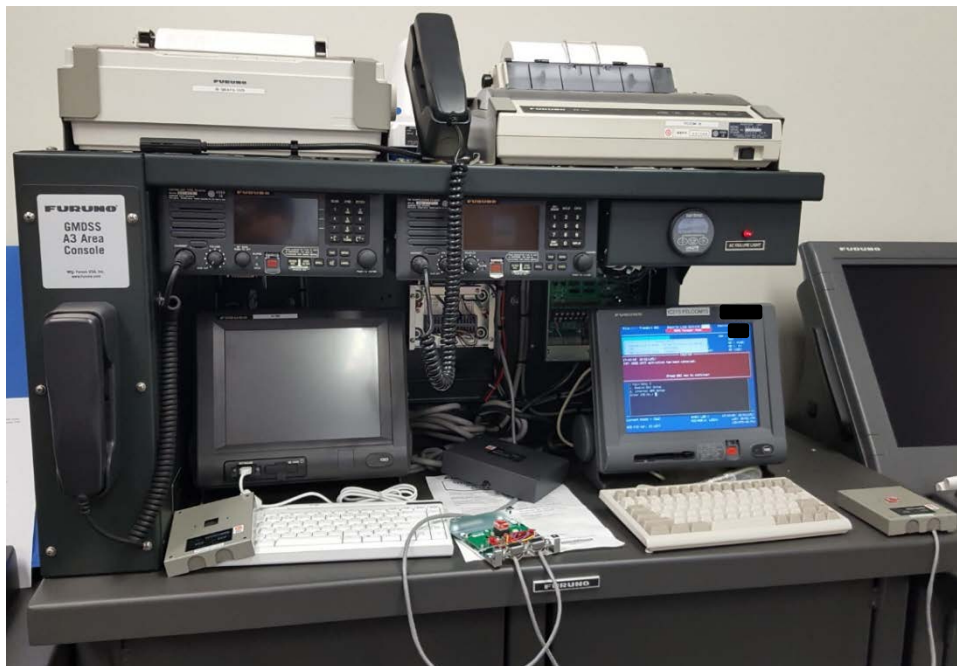
Figure 1 is a photo of a representative GMDSS console installation, which includes a Furuno FELCOM 15 terminal (lower right) and associated printer (upper right). As indicated in the picture, the equipment is commonly installed alongside telex, single side band radio, and VHF radio equipment.

**Figure 1.** The Furuno FELCOM 15 terminal (lower right) and printer (upper right) used during test.

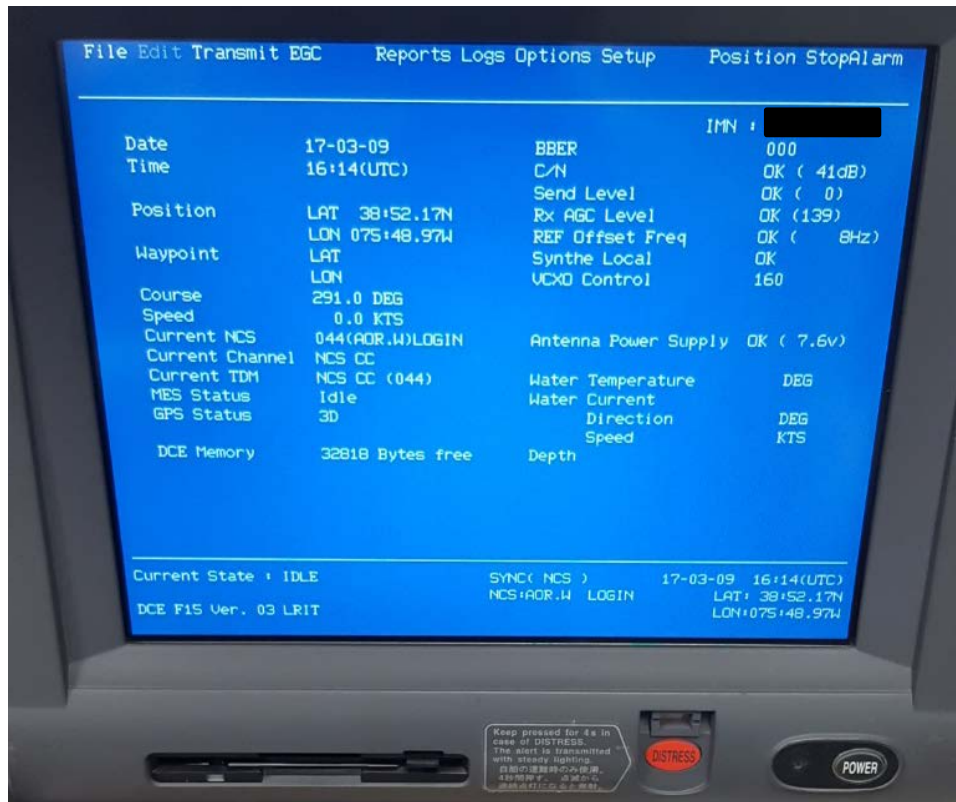
Figure 2 shows the FELCOM 15 terminal's standby display, which indicates date and time, ship's position, and various system status indications. When equipped with an internal GPS navigator, as was installed on *El Faro*, the date, time, and ship position are automatically updated, unless manual inputs by the user override the autonomous entries.

**Figure 2.** Furuno FELCOM 15 standby display.

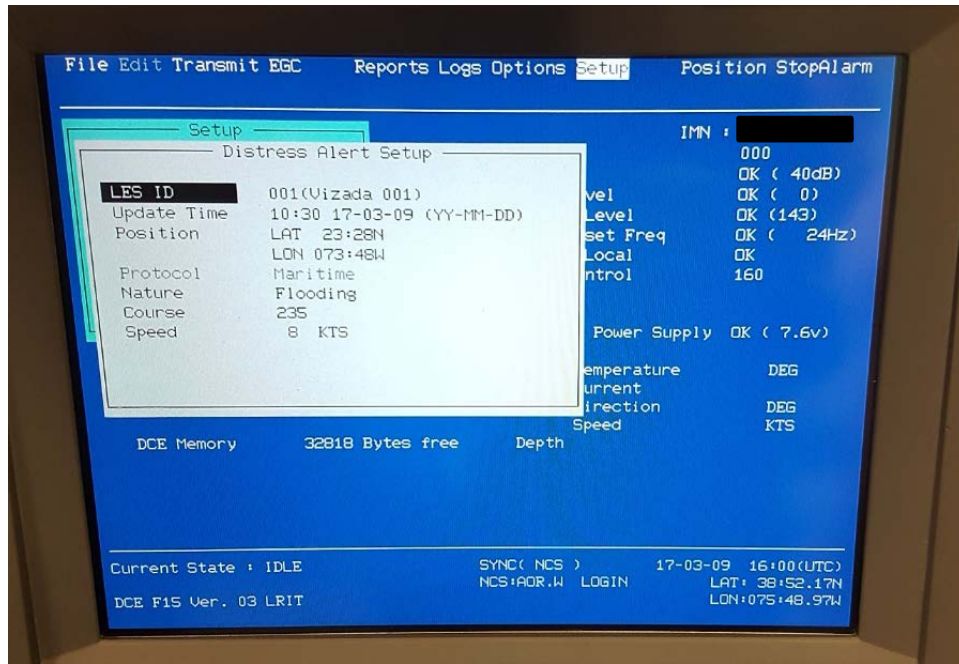
Figure 3 shows the Distress Alert Setup display, which allows the user to modify the properties of the distress alert message, if desired. The modifiable properties include: LES ID, Update Time, Position, Nature, Course, and Speed. Ship's Position may be manually updated from this Setup display, or directly from the Position menu, visible near the upper right of the standby display. Values displayed in Figure 3 were manually entered during testing to match distress alert values received from *El Faro*.

**Figure 3.** Furuno FELCOM 15 Distress Alert Setup display.

Testing confirmed that the position reported in Inmarsat-C distress alerts from the FELCOM 15 terminal was the LAT and LON position manually entered by the user in the Distress Alert Setup page, not the unit's present location at the Furuno service facility. Even though the system was equipped with an internal GPS receiver, manual entries superseded automatic position reports. If a manual entry differs from the actual position, the system does not provide a warning or prompt the user of potential discrepancies. After a single manual entry, automatic tracking is disabled for the remainder of the given power cycle.

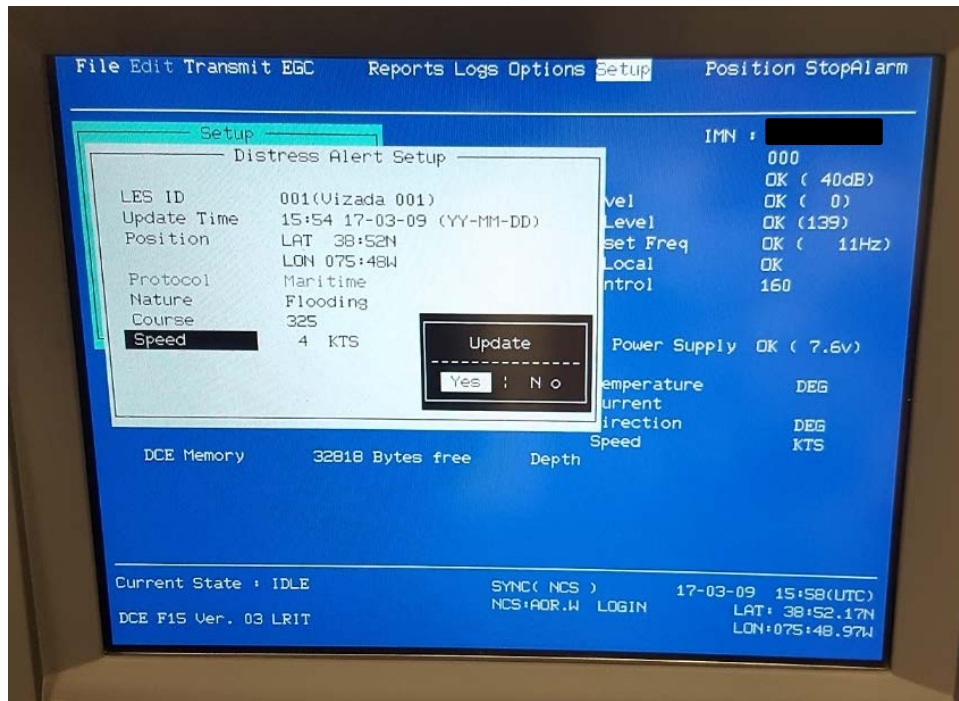
When exiting the Distress Alert Setup page, the user is prompted to select Yes or No, to either update the manually-entered settings or not. Figure 4 shows the user prompt.

**Figure 4.** Furuno FELCOM 15 prompt to update manual entries upon exiting Distress Alert Setup.

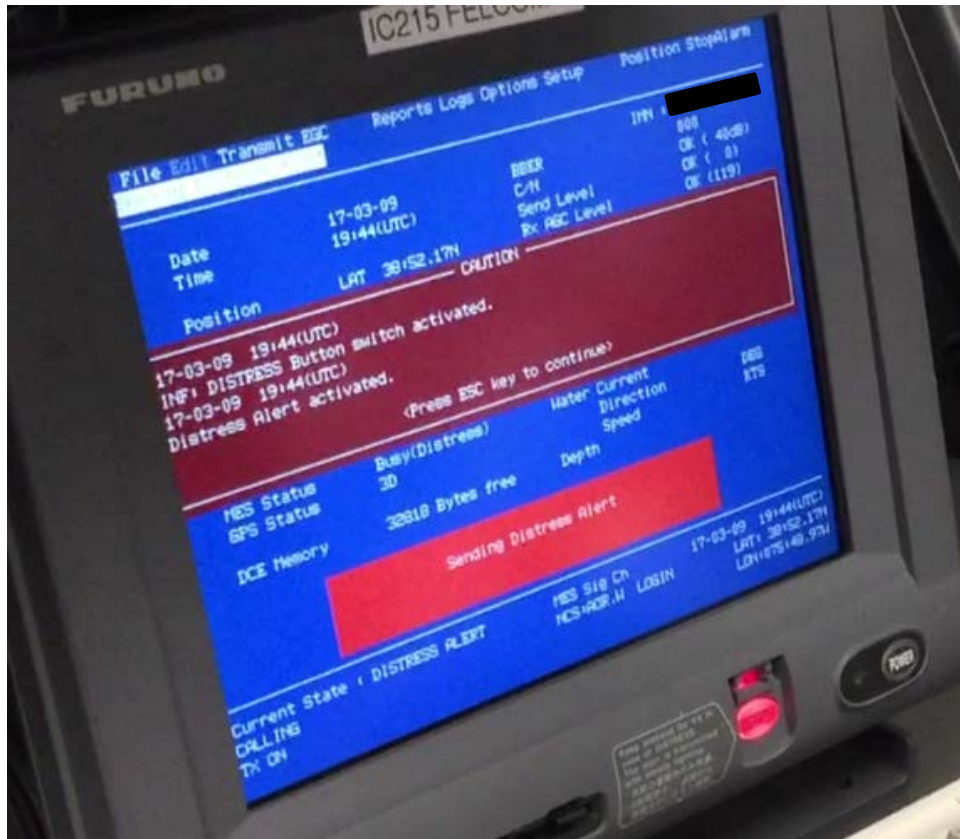
At any time, the user can activate the distress alert by pressing the red distress alert button on the FELCOM 15 display. Figure 5 shows the unit's indication of a distress alert activation, stating the date and time, "Distress Alert activated" and "Sending Distress Alert." The time noted in the activation is the current time given in UTC and is different from the Update Time entered manually by the user on the Distress Alert Setup screen. In addition to the visible indications of message transmission on the display, the unit also provides audible indication that a message is being sent. After successfully sending a distress alert, positive confirmation is displayed on the screen, and logged by the associated printer.

**Figure 5.** Furuno FELCOM 15 distress alert activation.
