NATIONAL TRANSPORTATION SAFETY BOARD

MATERIALS LABORATORY FIRE FACTUAL REPORT

Report No. 17-055

Place : San Juan, Puerto Rico
Date : August 17, 2016
Vehicle : RO/RO Passenger Vessel *Caribbean Fantasy*
NTSB No. : DCA16FM052
Investigator : Nancy B. McAtee
Fire Group Chairman
RE-30

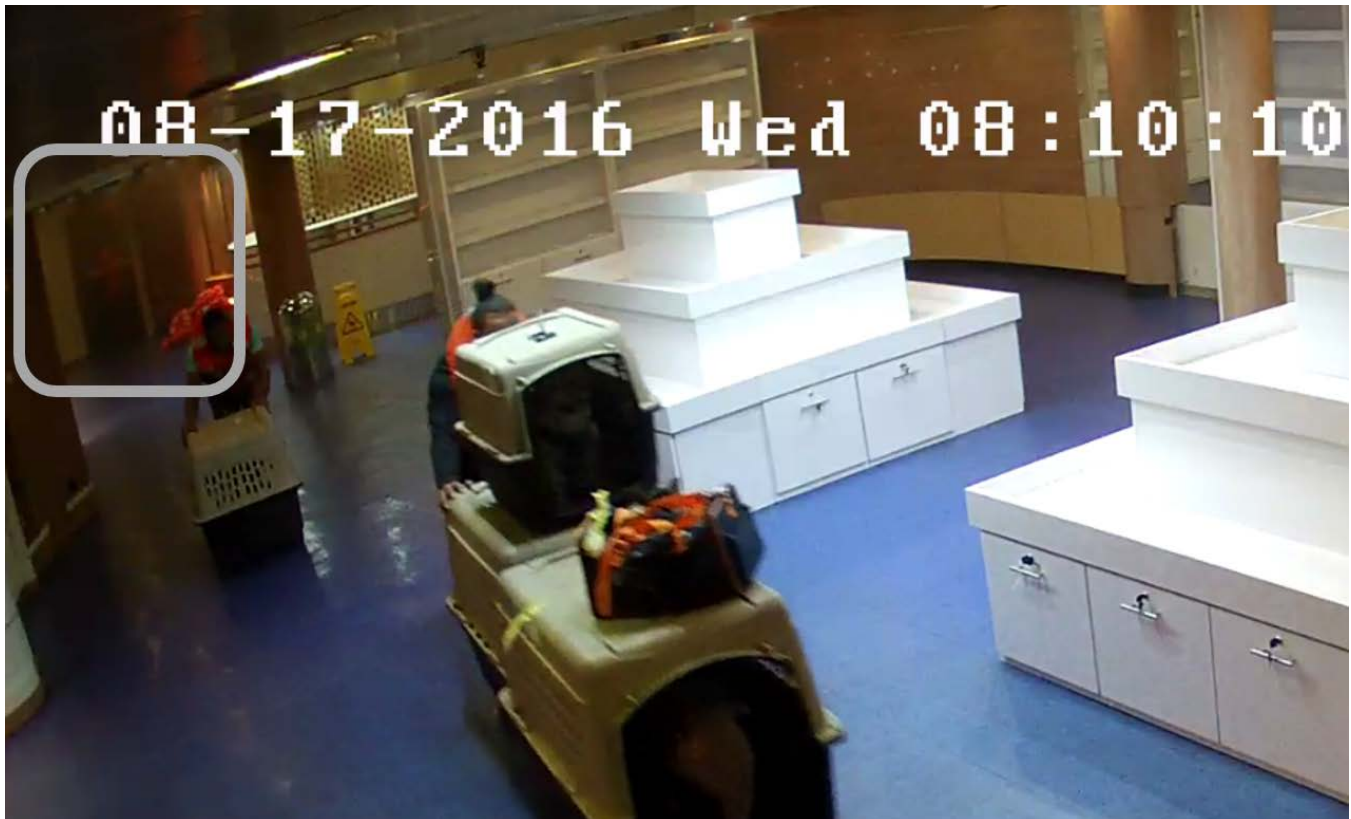
Figure 3. Frame taken at 0810 from a CCTV camera in the duty-free shop looking aft. The grey box in the upper left corner shows a crew member passing through fire door 619 from a smoke-filled space aft with lifejackets in hand.

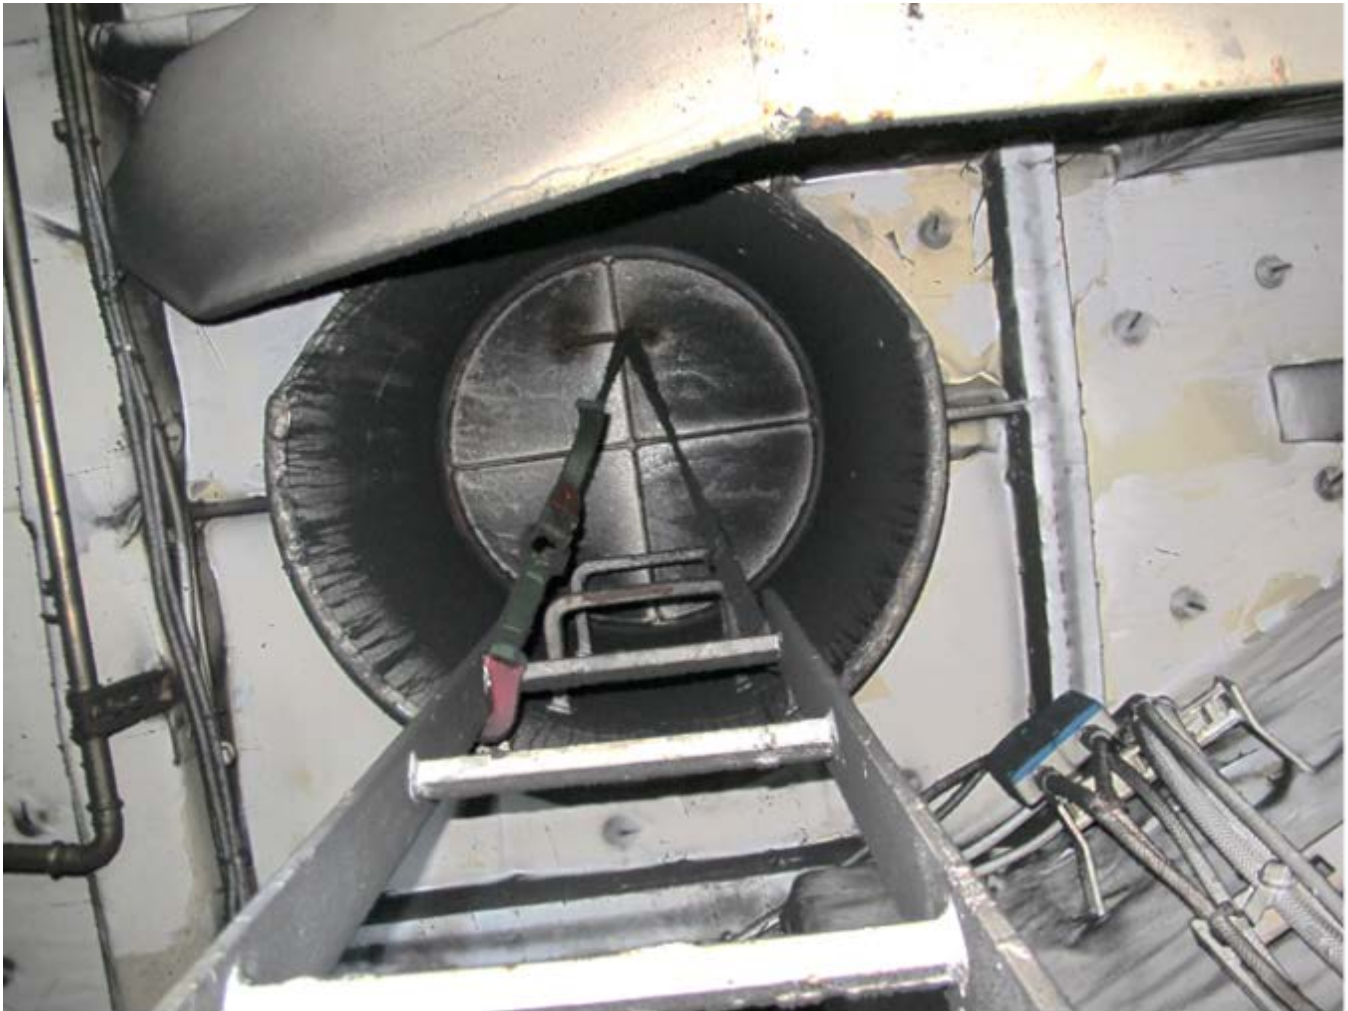
Figure 8. Photograph of upper hatch of CO₂ room to the deck 4 aft mooring deck with strap securing hatch from inside the space.

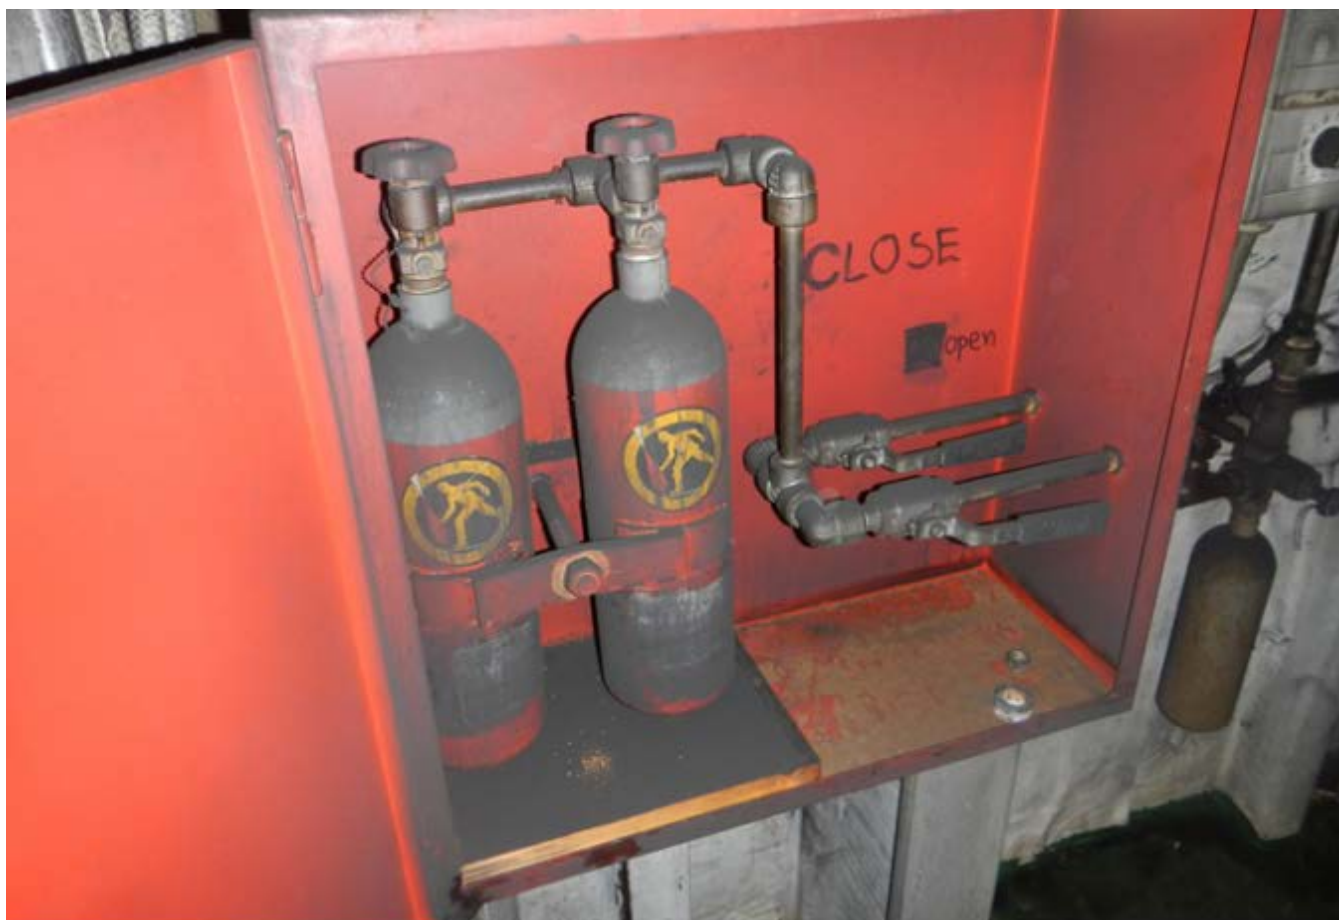
Figure 14. Photograph of interior of pilot cabinet. Both valves are in the open position.

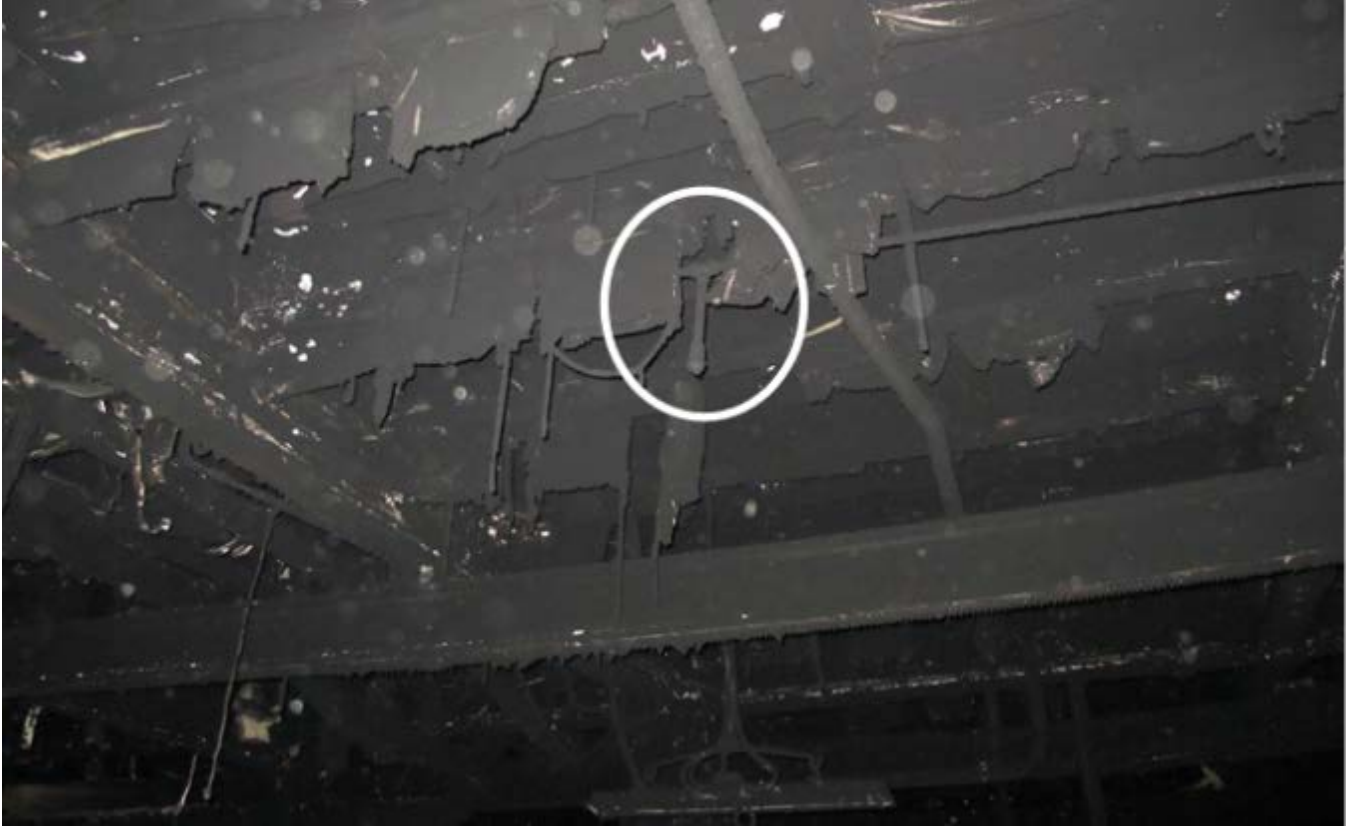
Figure 17. Photograph of water mist system nozzle after the fire. The nozzle is circled.

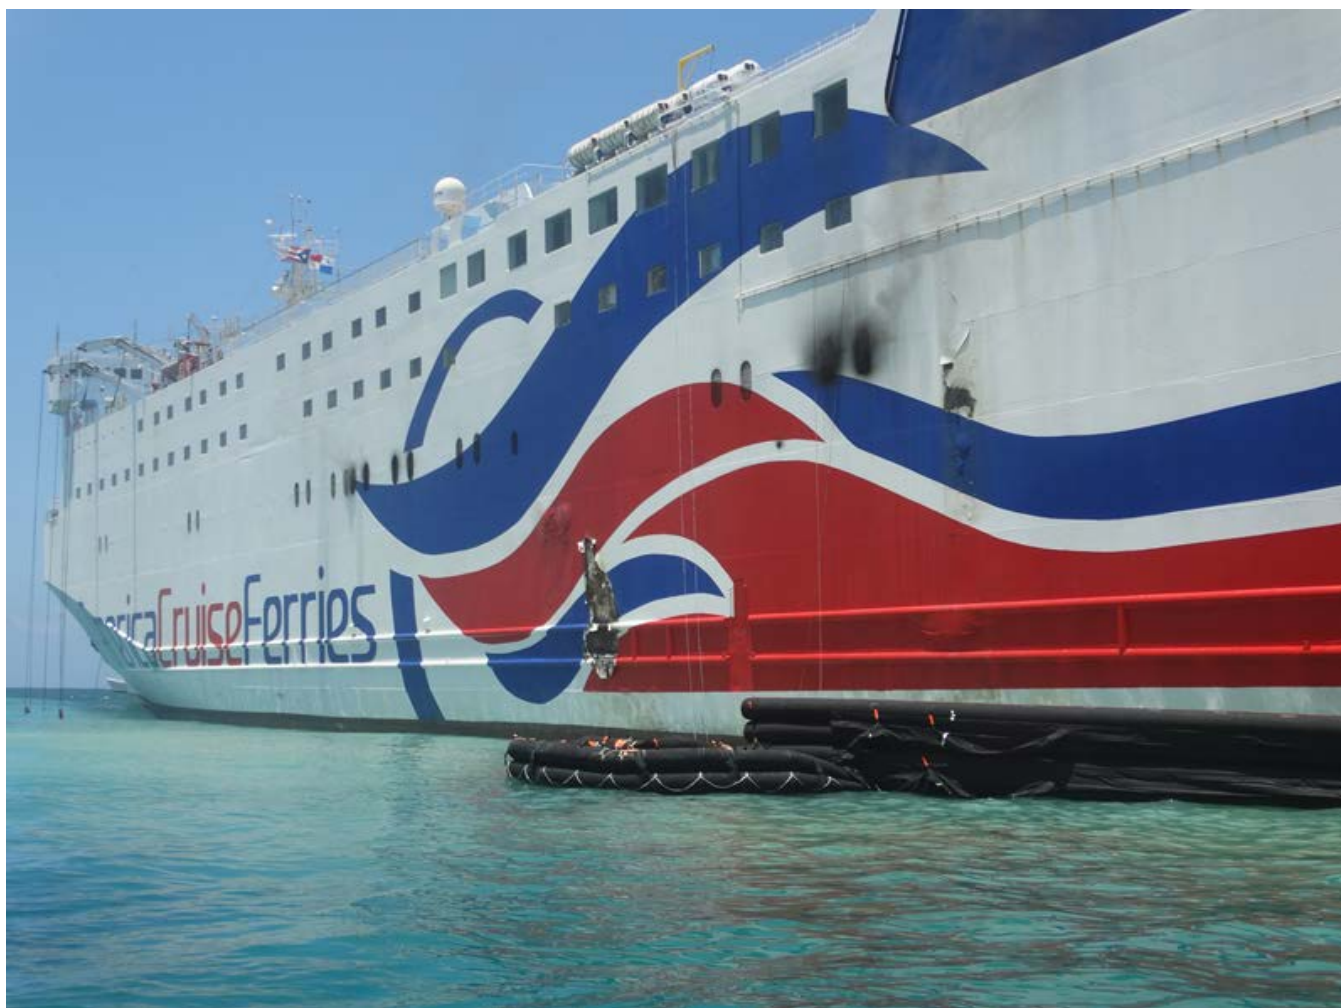
Figure 23. Photograph of port side of ship at 1308 on 8/17/16. No hull damage shown. Paint starting to discolor forward of bunker stations door.

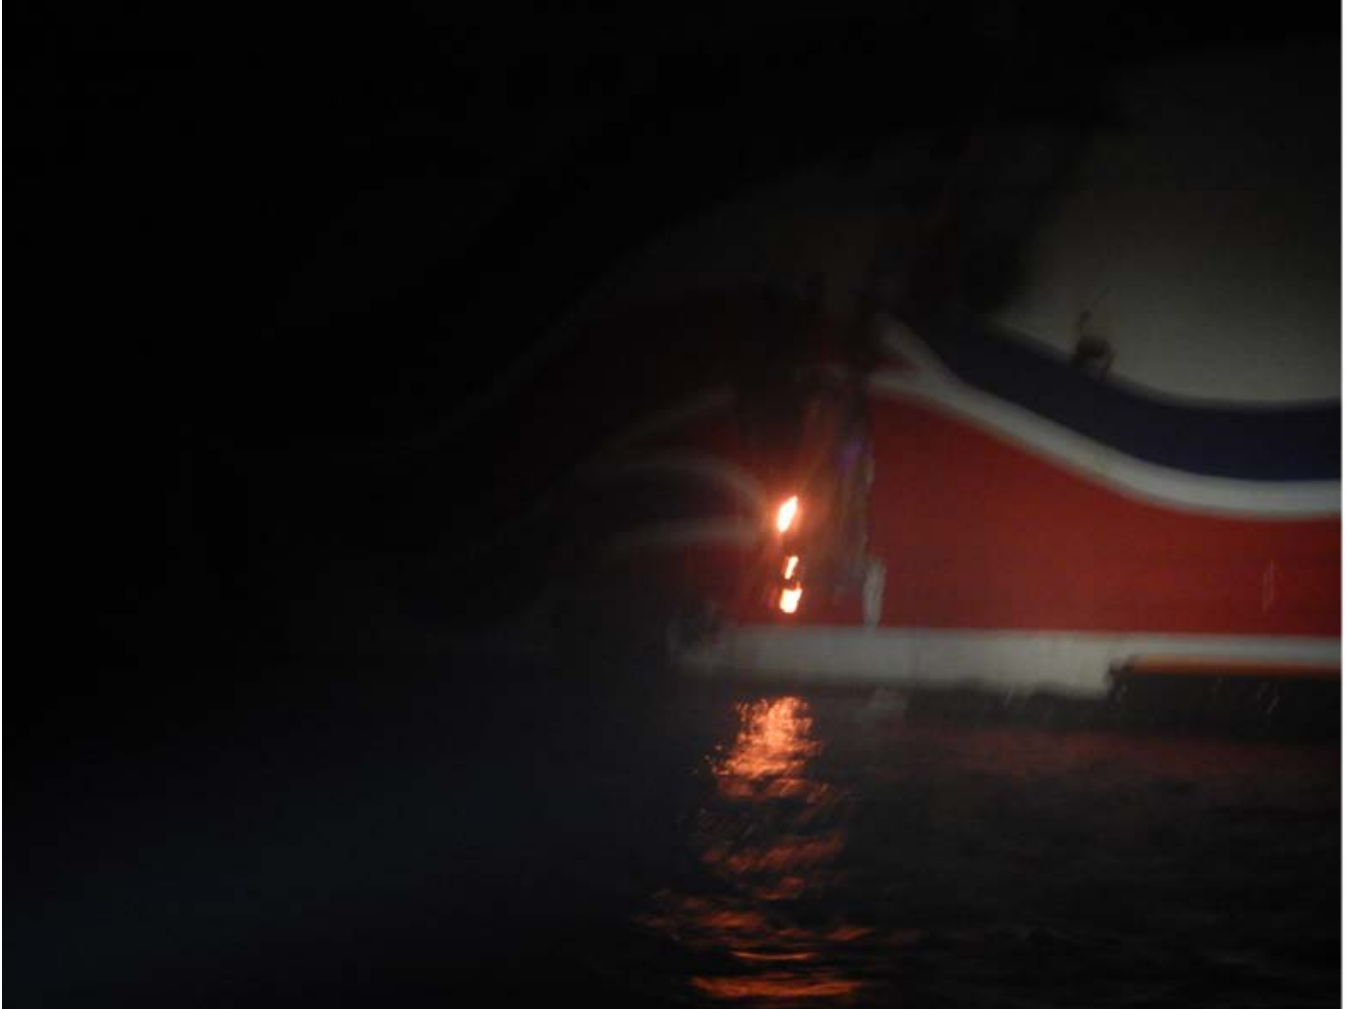
Figure 24. Photograph of port side of ship at 2119 on 8/16/17. Flames are visible through the shell of the bunker station door.

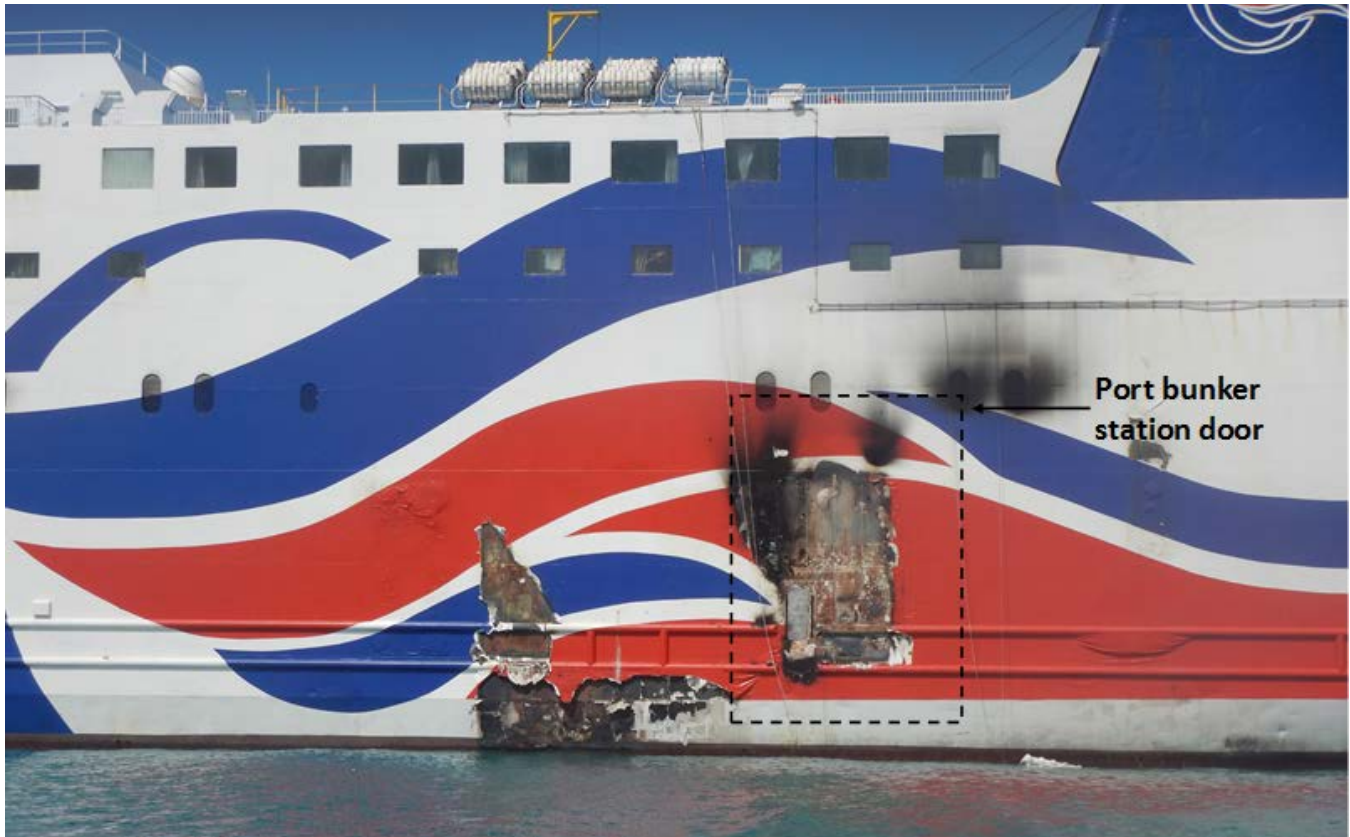
Figure 4. Photograph of port side of ship at 1512 on 8/18/16. Paint on bunker station door has burned away.

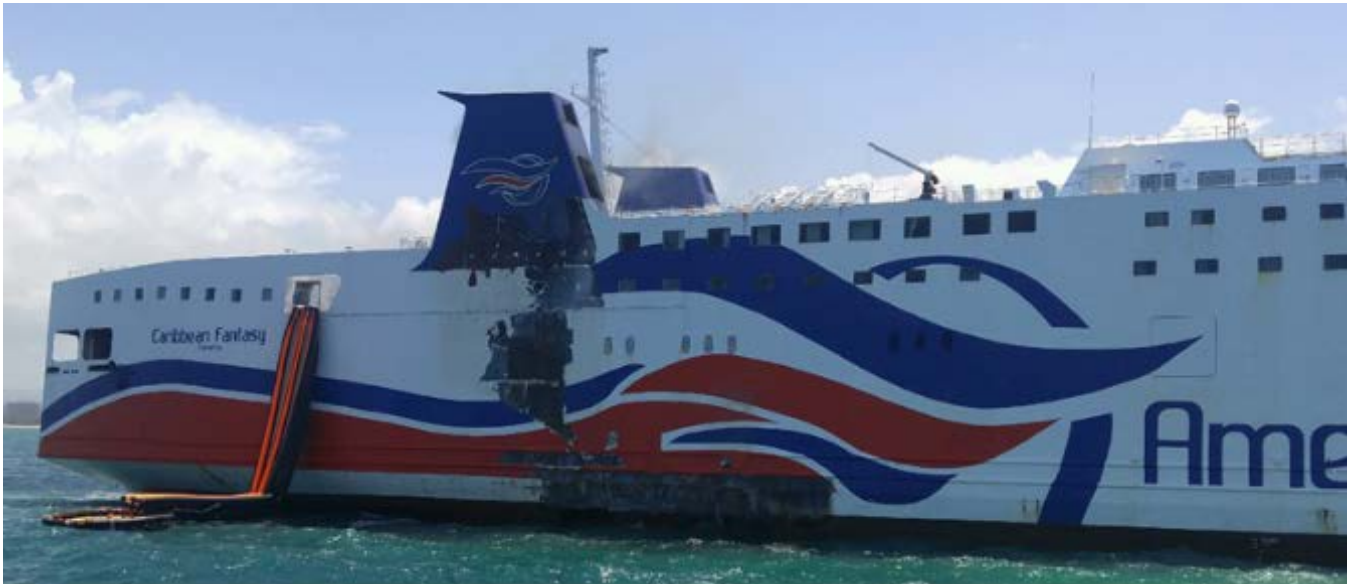
The exterior hull exhibited thermal related damage in areas adjacent to the engine casings (both port and starboard) and the main engine room. These areas exhibited blistered and burned paint with large areas of missing paint¹⁹. The damage extended from the level of the upper engine room up the entire height of the engine casing/exhaust stack. The damage to the exterior both port and starboard is shown in Figures 26 and 27. There was also exterior hull damage around frame 70 in the area of the port fuel bunker station.

Figure 26. Photograph of starboard side of ship on August 19. Smoke can be seen coming from the exhaust stacks on the upper deck.

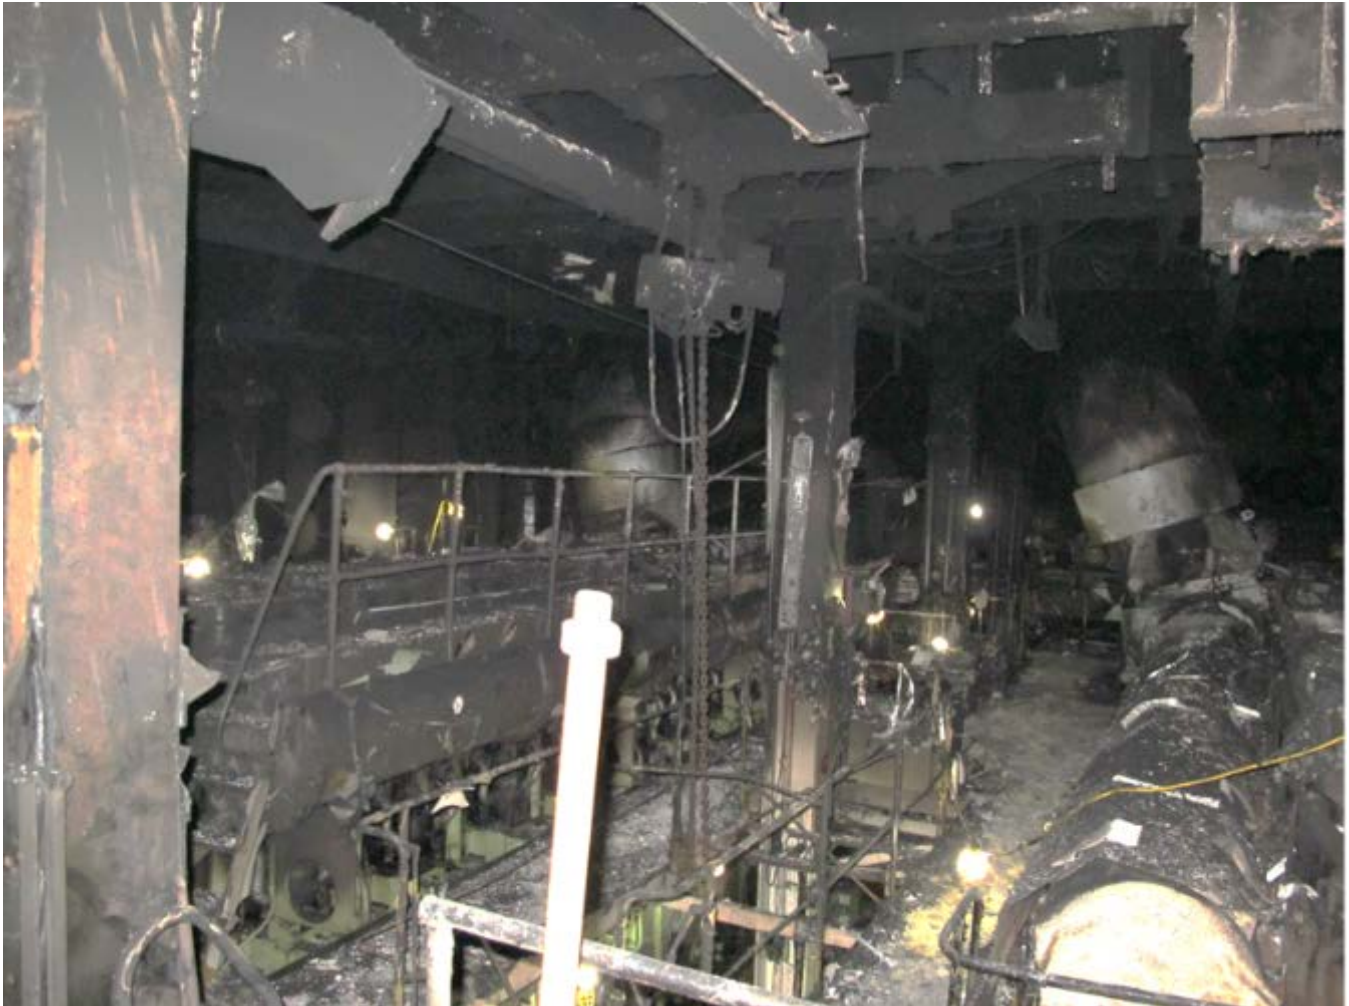
The upper main engine room sustained heavy fire damage. All exposed surfaces exhibited charring of paint and heavy sooting. The upper surface of both engines exhibited missing paint and thermal related oxidation of the metal underneath. An area of clean burn was evident on the port engine exhaust manifold. A photograph of the upper level of the engine room is shown in Figure 28.

Figure 28. Overall photograph of upper deck of main engine room looking from forward to aft. The port main engine is on the right of the photograph. The starboard main engine is on the left.

According to the class survey report, the upper deck longitudinals, located over the aft portion of the port main engine, were deformed but intact. The transverse deck girders 6–8 (counting from aft watertight bulkhead at frame 54) were deformed but intact. The upper portion of the forward transverse watertight bulkhead (port side) at frame 83 was deformed from deck 2 to deck 10 longitudinally. This damage was approximately 2 meters long with a maximum depth of deformation approximately 35–40 mm.

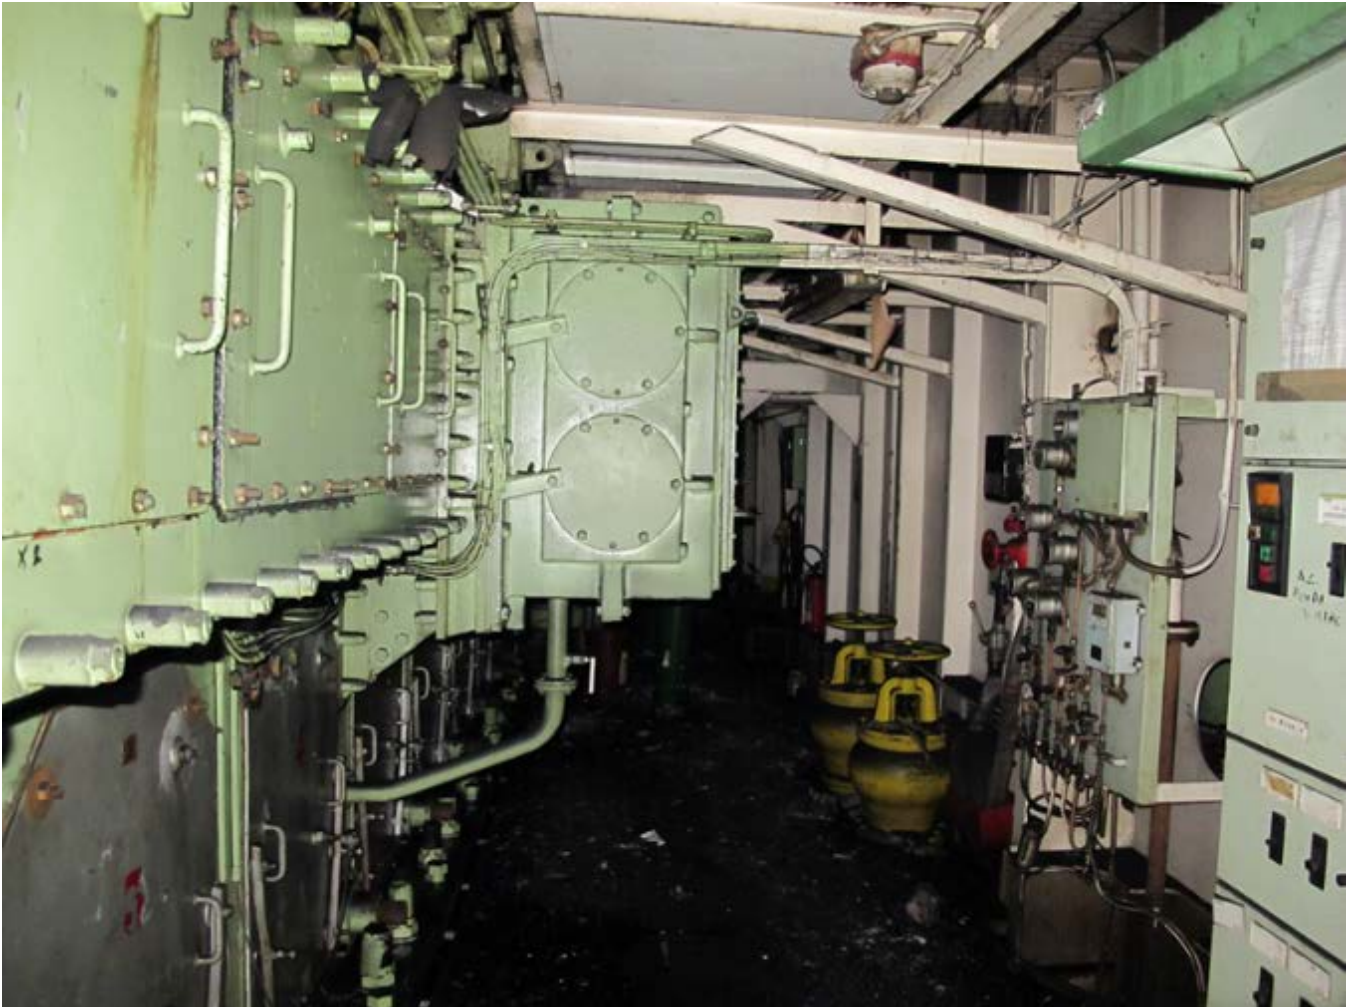
The lower main engine room exhibited heavy sooting with some burned areas due to drop down debris burning. Otherwise, the lower level was relatively undamaged. A photograph of the lower engine room is shown in Figure 29.

Figure 29. Photograph of portion of lower engine room.

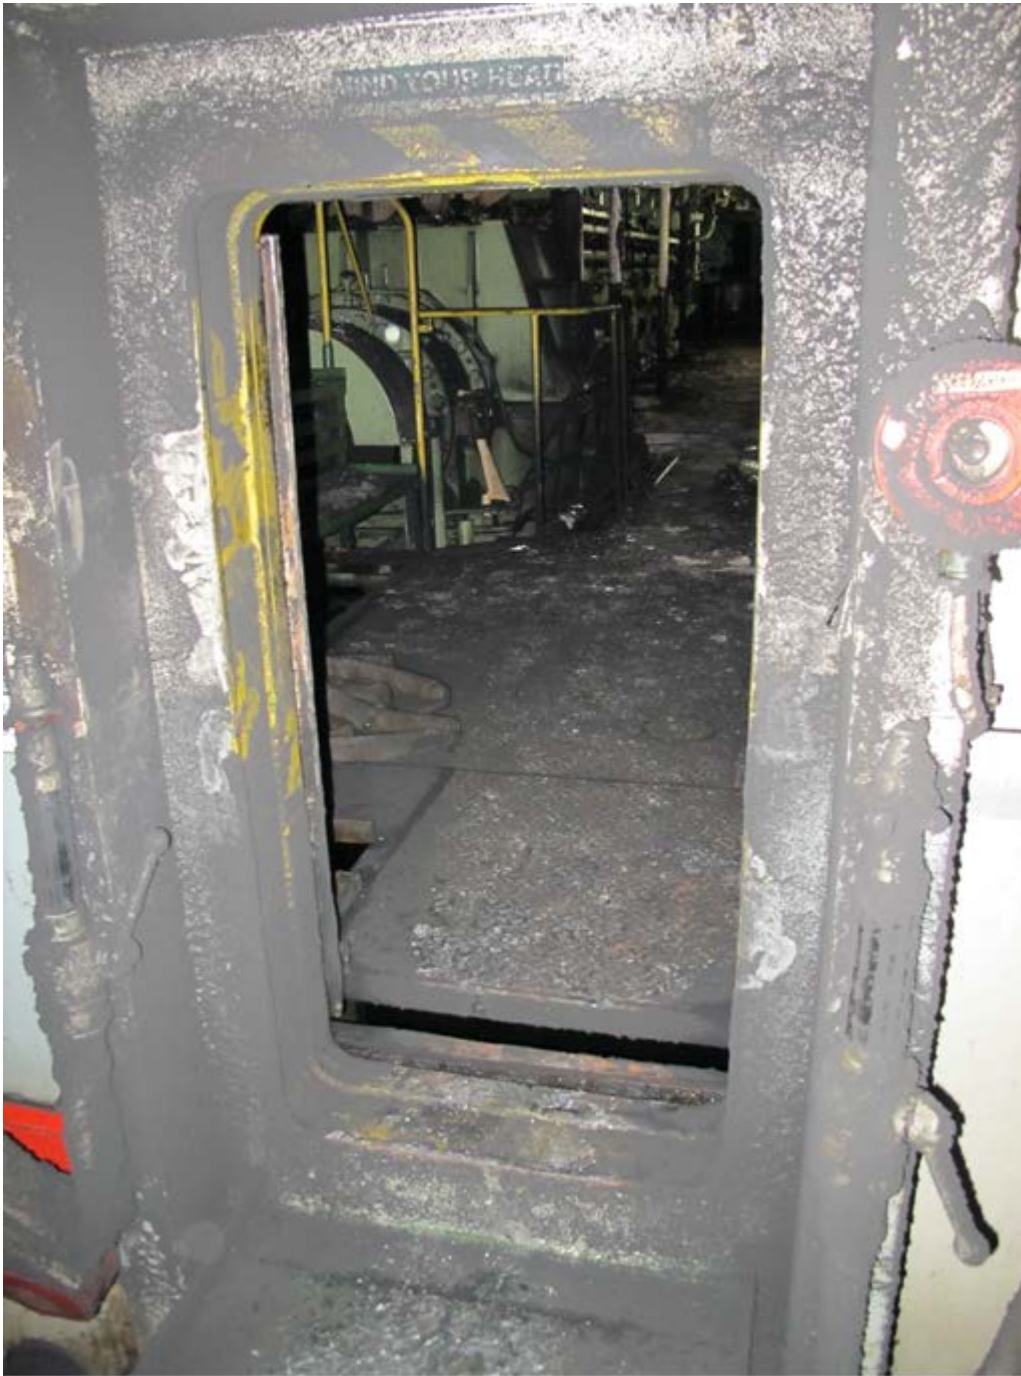
Watertight door no. 6 (aft engine room to auxiliary engine room) door was found open during the initial on scene examination. The door was sooted and the sooting pattern extended on to the

frame on the door frame interior on the auxiliary engine room side. The fire patterns on the door and doorframe, as shown in Figure 30, were consistent with the door being left opened at some point during the fire.

Figure 30. Photograph of watertight door 6 (facing aft into auxiliary engine room).

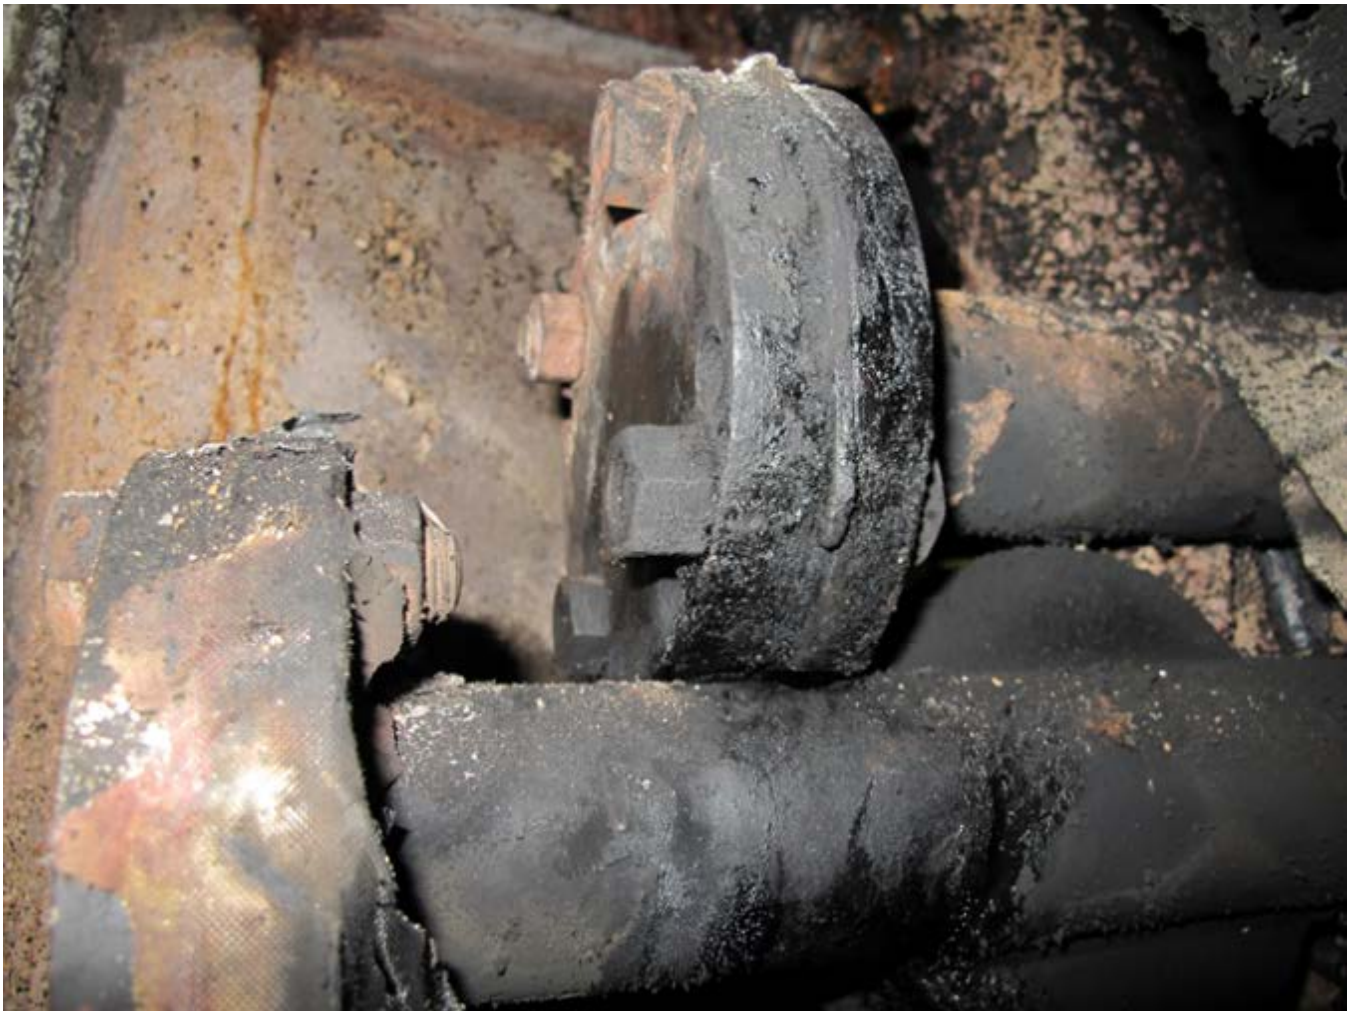
According to the engineering crewmembers present at the time of the fire's ignition, the port main engine fuel oil supply pipe was leaking at the end flange that was capped with a blanking plate. The end flange, located on the aft end of the engine near the exhaust manifold, was heavily sooted and was still covered with fuel after the fire was extinguished. A photograph of this flange and blanking plate is shown in Figure 31. The end flange, blanking plate, and a section of fuel supply pipe were removed and sent to the NTSB Materials Laboratory for further examination.²¹

Figure 31. Photograph of flange on fuel supply line for portside main engine.

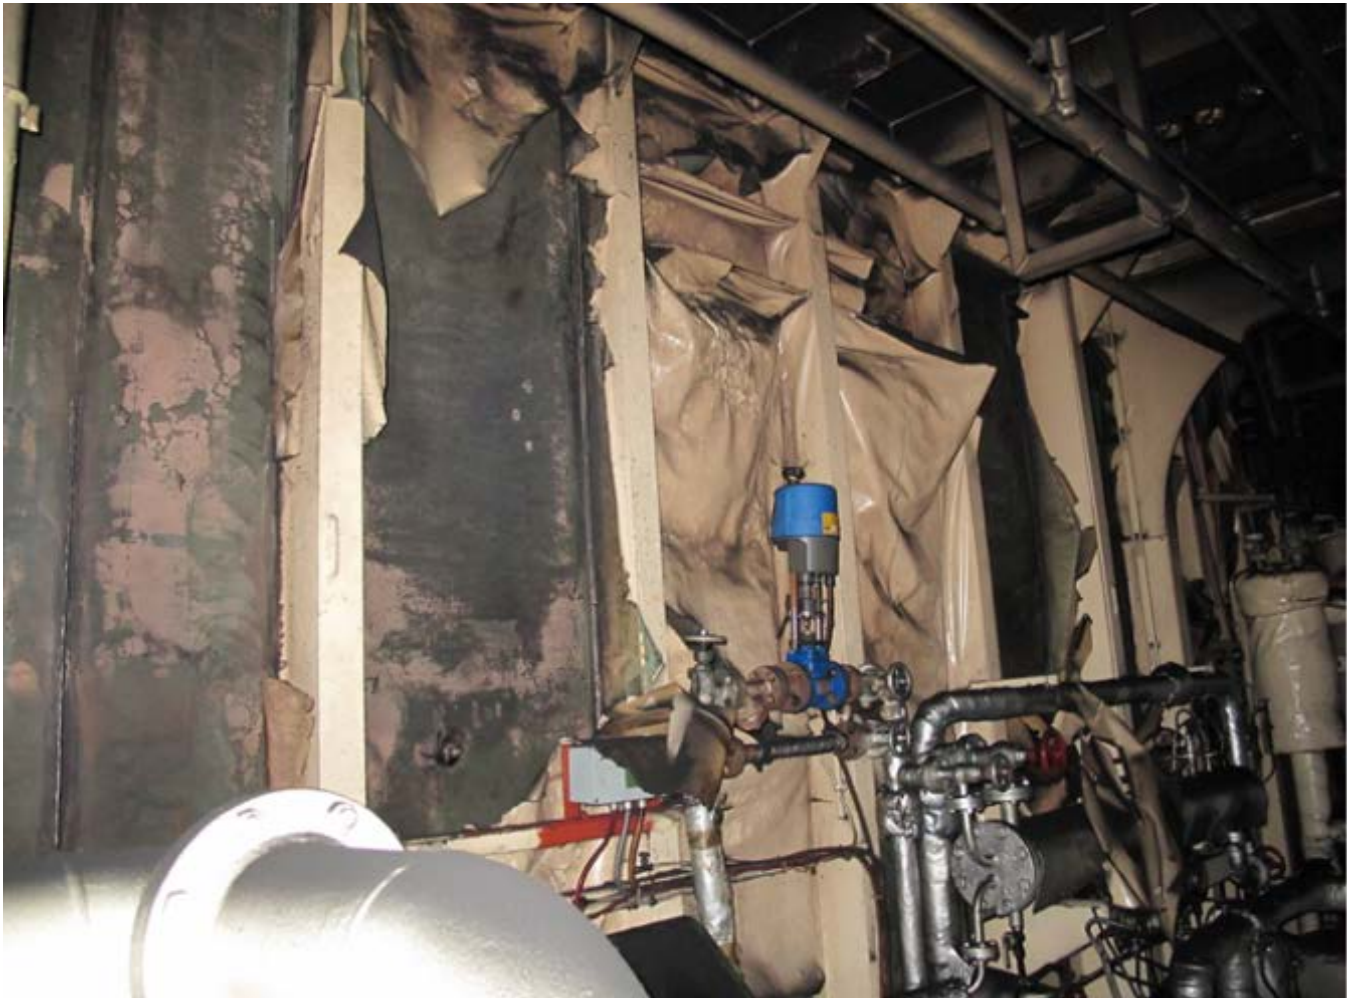
The auxiliary engine room, also called the generator room, was relatively undamaged. The generator equipment was undamaged and covered with a layer of soot. The bulkhead between the main engine room and the auxiliary engine room sustained heavy thermal damage. Large sections of paint were missing on the auxiliary engine room side, particularly around watertight door no. 6. The remaining paint was bubbled off the bulkhead or was hanging in large sections from the bulkhead. A photograph of the paint damage on the bulkhead is shown in Figure 32.

Figure 32. Photograph of bulkhead between main engine room and auxiliary engine room (auxiliary engine room side).

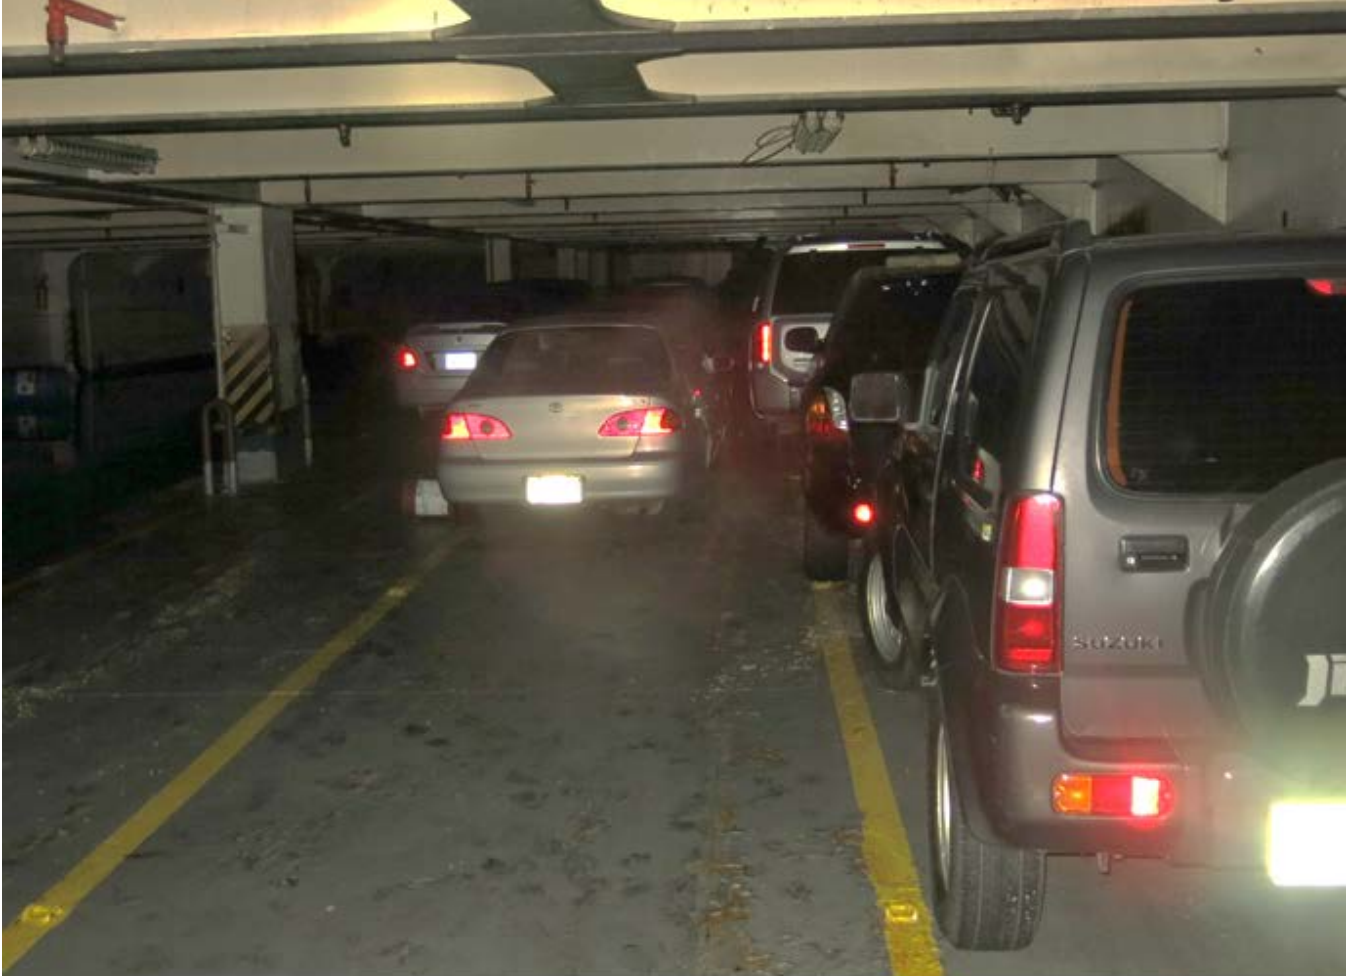
There was no evidence of thermal damage on Garage Deck A. There was no sooting or evidence of smoke. There were several inches of standing water on the port side during the initial on-scene examination. The collection of water on the port side was due to the ship listing to port.

There was no evidence of broken fire main piping or hoses left open; the water appeared to be water from the drencher system. A photograph of garage A is shown in Figure 33.

Figure 33. Overall photograph of Garage Deck A (Deck 2) facing forward. Water can be seen on deck on the left side of the image.

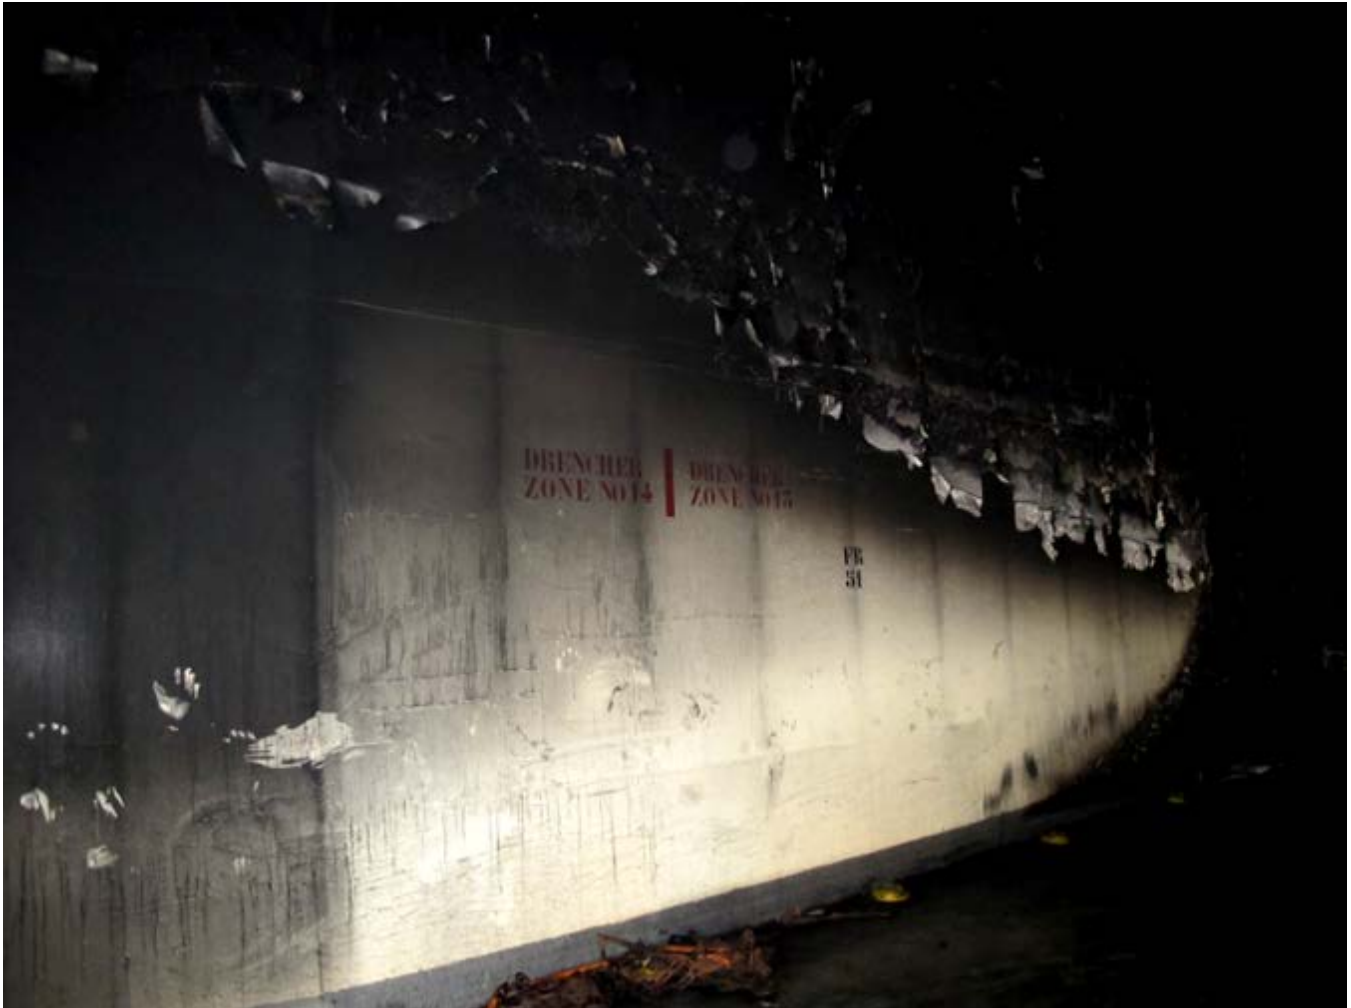
Garage deck B was heavily sooted over the entire length of the deck. The port side sustained more sooting and thermal damage than the starboard side. In the area located directly over the engine room, the bulkheads and decking had significant thermal damage. The decking was warped. Upper deck plating and internal structures at frame 84 were warped/pushed up approximately 150 mm. The warpage ran from the port side to the center line. Additional deformations in deck plating began on the portside near bunker station at frame 68 to about center line. A low burn pattern was located on the port bulkhead between frames 44 and 87 as shown in Figures 34 and 35.

Figure 34. Photograph of forward section of damage (approximately frames 44–55) on the port side of Garage Deck B. The left side of the photograph is aft, and the right side is forward. Frame 51 and drencher zones 13 and 14 are painted on the bulkhead.

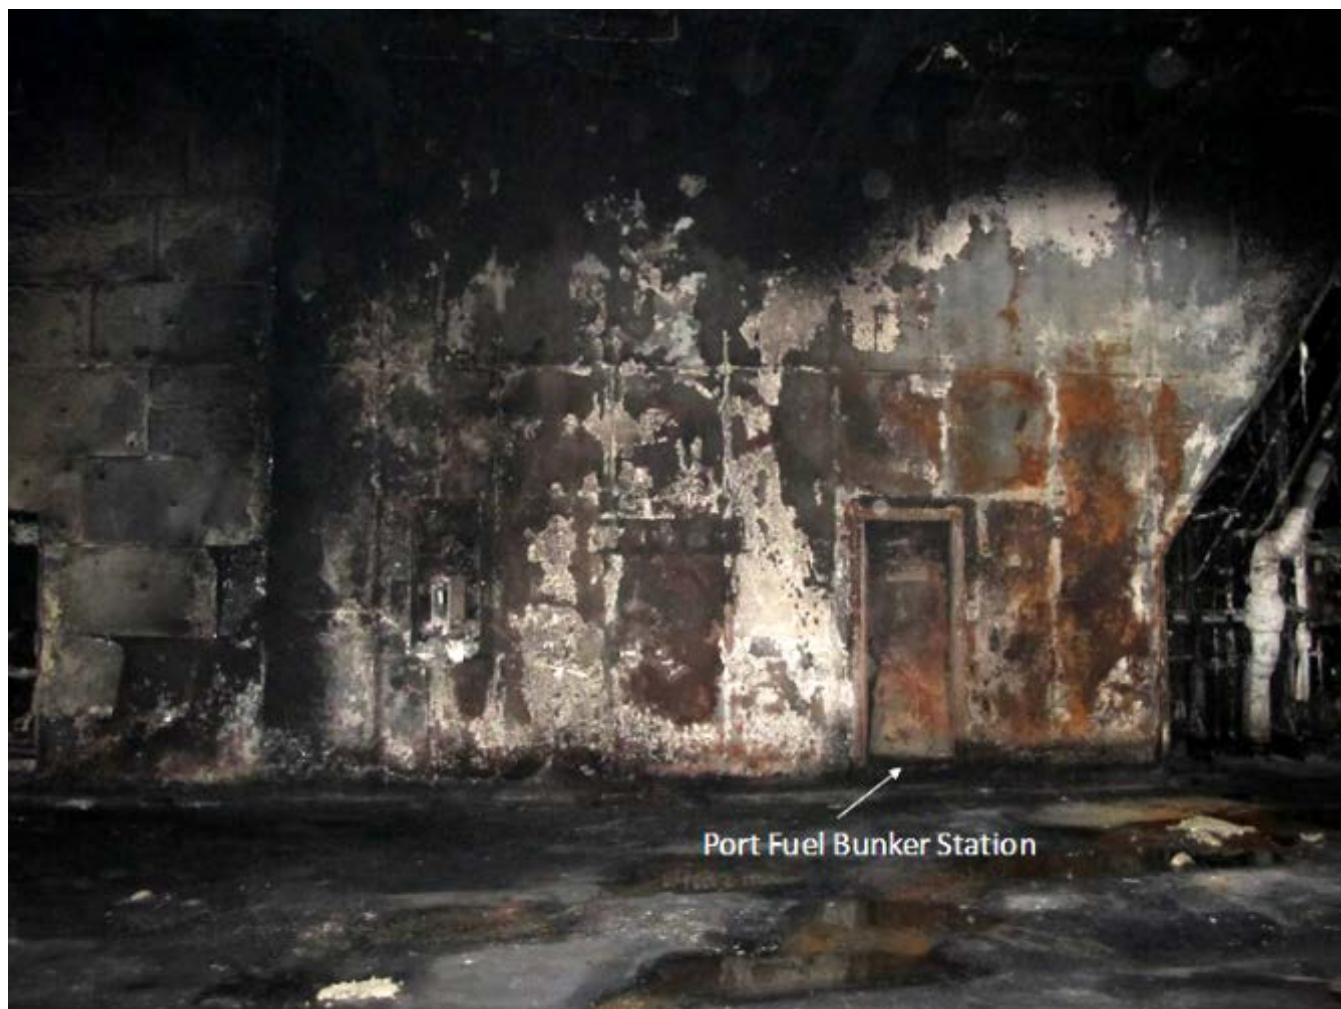
Figure 35. Photograph of bulkhead damage on port side of Garage Deck B taken after the cargo was removed. The left of the photograph is aft and the right is forward.
