NATIONAL TRANSPORTATION SAFETY BOARD

MATERIALS LABORATORY FIRE FACTUAL REPORT

Report No. 17-055

Place : San Juan, Puerto Rico
Date : August 17, 2016
Vehicle : RO/RO Passenger Vessel *Caribbean Fantasy*
NTSB No. : DCA16FM052
Investigator : Nancy B. McAtee
Fire Group Chairman
RE-30

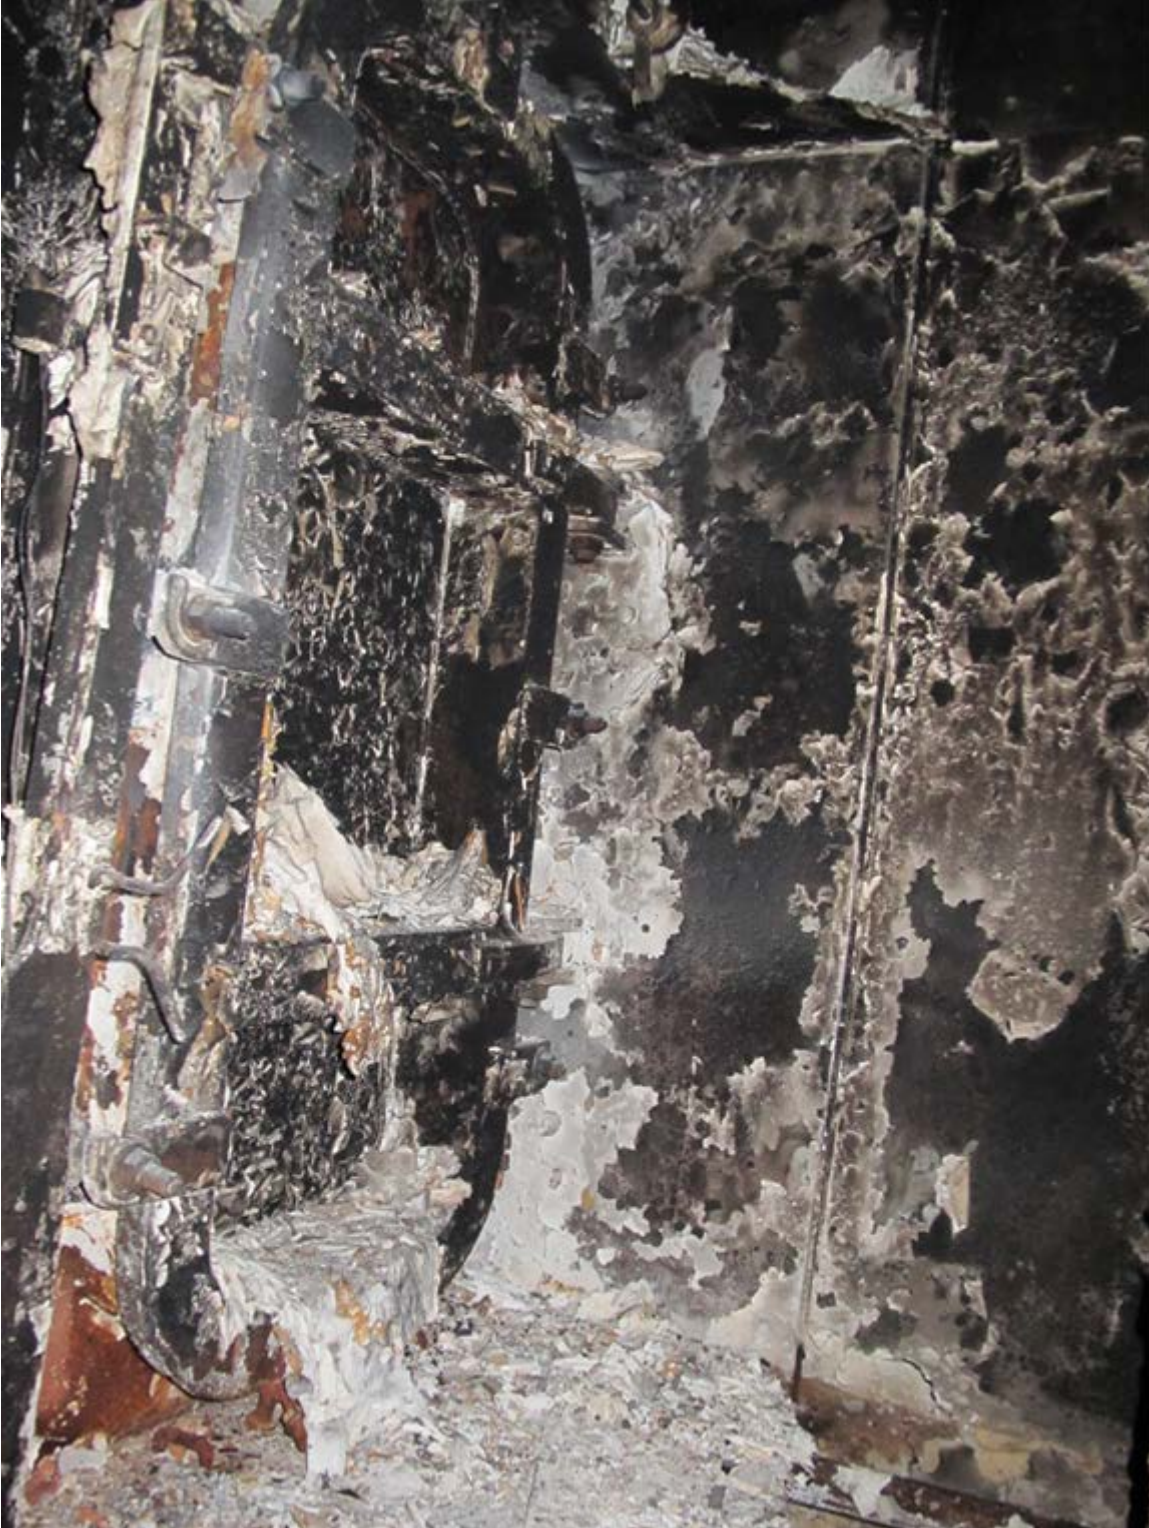
There was severe fire damage in the area of the port side bunker station. Inside the garage, the station door at frame 70 was pushed out and torn off the hinges. The corresponding longitudinal bulkhead of the bunker station was outwardly deformed from frames 72 to 83. The interior had heavy thermal damage. Most of the paint was missing. The paint that remained was thermally discolored black. Aluminum components present in the locker melted. The end cap on the fuel fill pipe in the station was found missing. The damage to the interior of the station is shown in Figure 36. The shell door in the port side bunker station had its door seals burned away. The paint was burned away from the exterior of the bunker station shell door and the area above it.

Figure 36. Photograph of the interior of the port fuel bunker station. The side shell door can be seen at the left of the photograph.

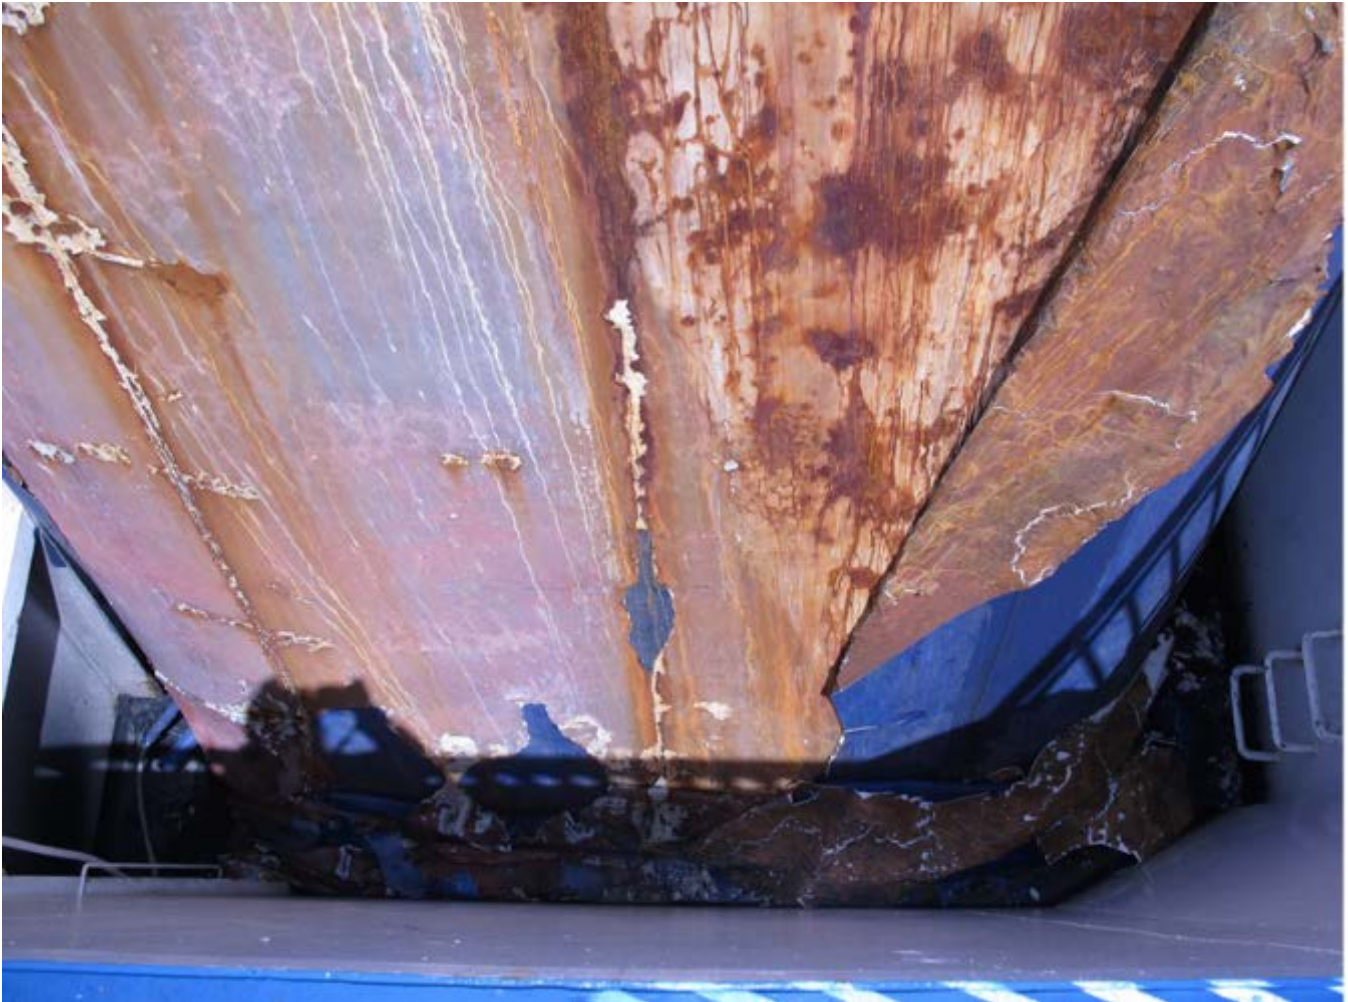
As stated above, the engine casings were located between Frames 45 and 65 on the port and starboard side. The casings started on deck 2 and rose the entire height of the ship up through the exhaust stacks. In addition to the exterior hull damage mentioned above, the stacks exhibited heavy sooting on the interior where visible. The stacks also exhibited thermal damage to the exterior paint at the top. A large portion of the paint was missing on the aft side, and the metal underneath was oxidized as shown in Figure 38.

Figure 38. Photograph of the port aft side of the exhaust stack casing.
