**NATIONAL TRANSPORTATION SAFETY BOARD**

**MATERIALS LABORATORY FIRE FACTUAL REPORT**

Report No. 18-060

Place : Port Richey, Florida  
Date : January 14, 2018  
Vehicle : MV Island Lady  
NTSB No. : DCA18FM010  
Investigator : Brian Young  
IIC-OMS

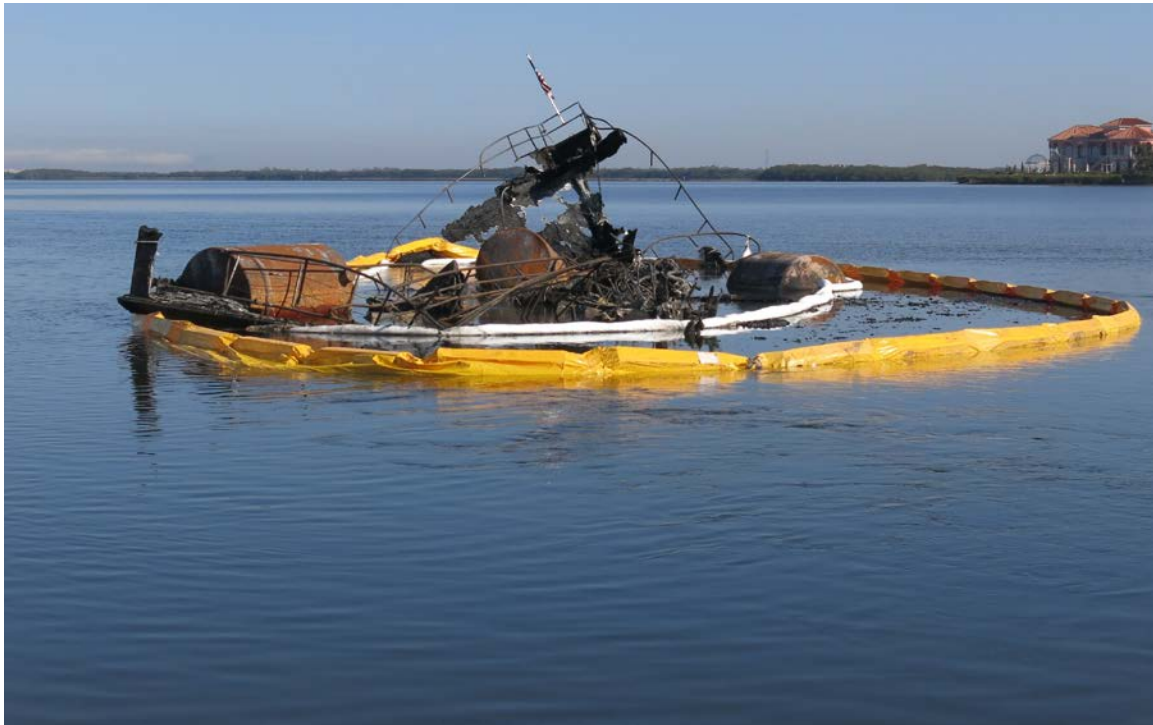
The vessel was completely destroyed by fire as shown in Figure 1. The engines, generators and any remaining metallic components including pieces of the fixed firefighting system were removed from the river and stored at the Pasco County Sherriff Department. Portions of the engines and other metallic items are shown in Figures 2 and 3.

**Figure 1. MV *Island Lady* postfire prior to removal from the river.**

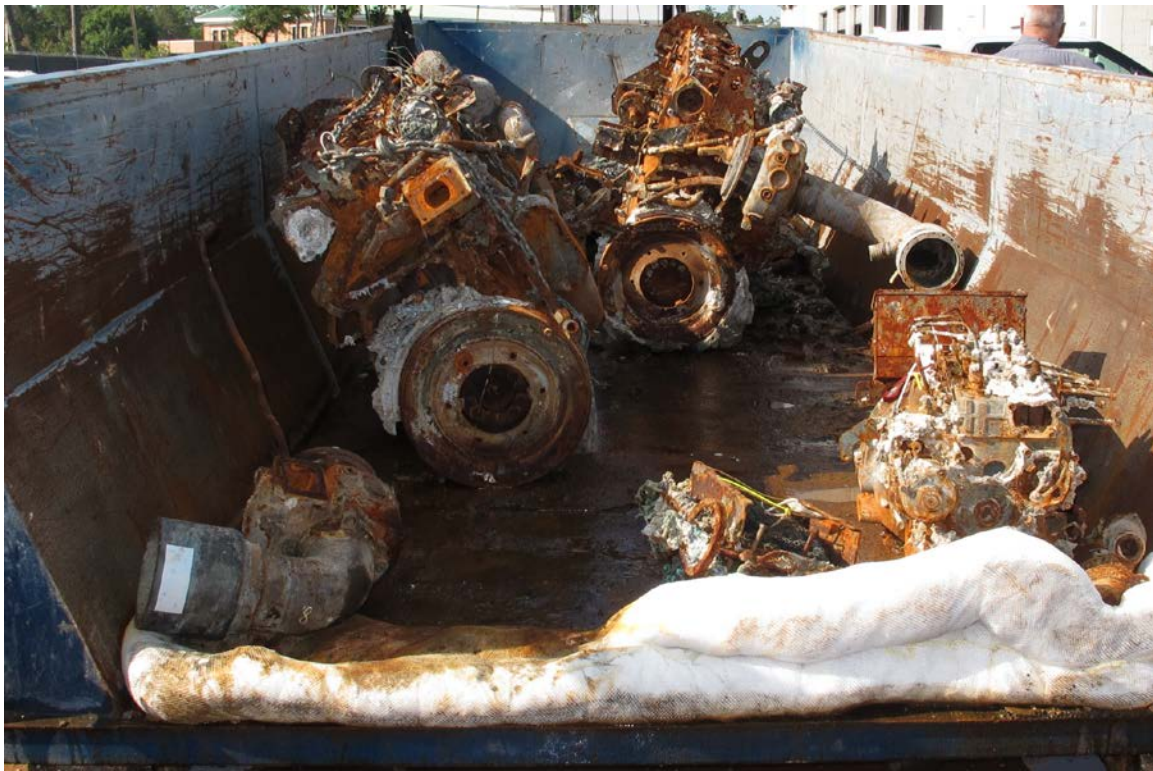
**Figure 2. Portions of the starboard (right) and port (left) engines after recovery.**

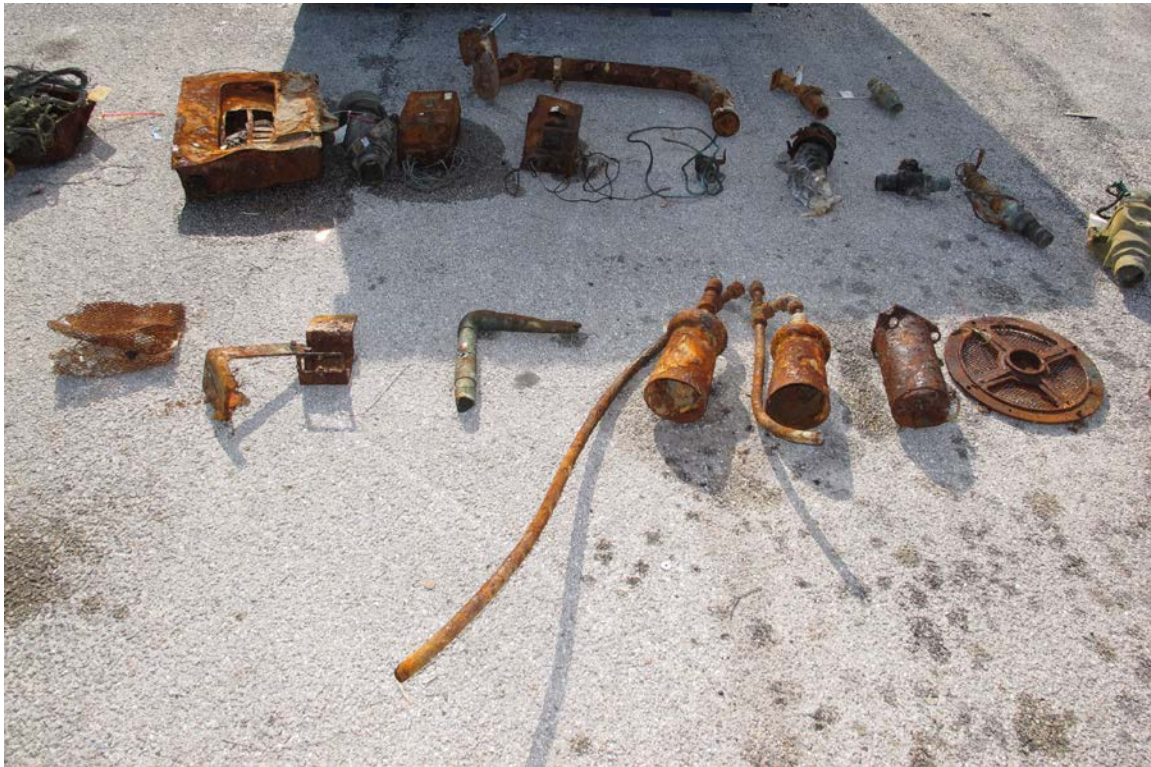
**Figure 3. Other metallic components recovered from accident site.**

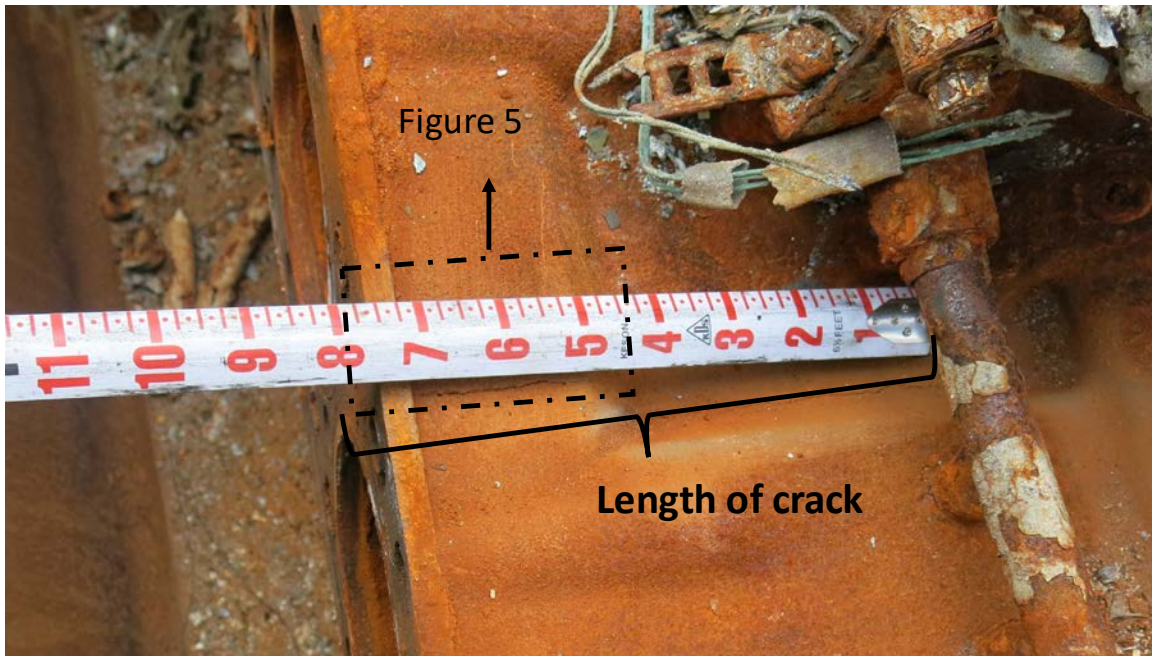
**Figure 4. Crack in starboard engine block at cylinder #5.**

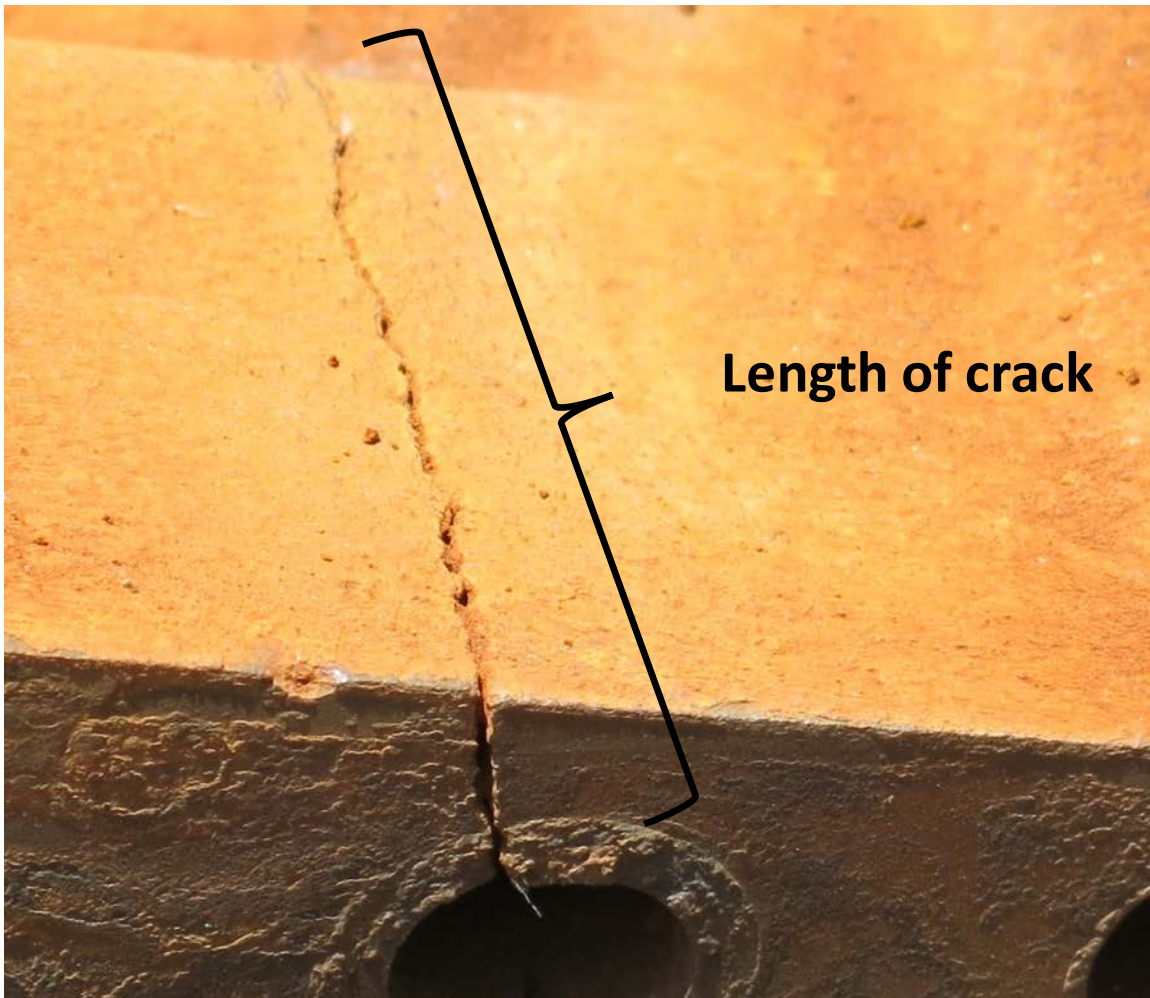
**Figure 5. Closeup photograph of full thickness crack in starboard engine block at cylinder #5.**

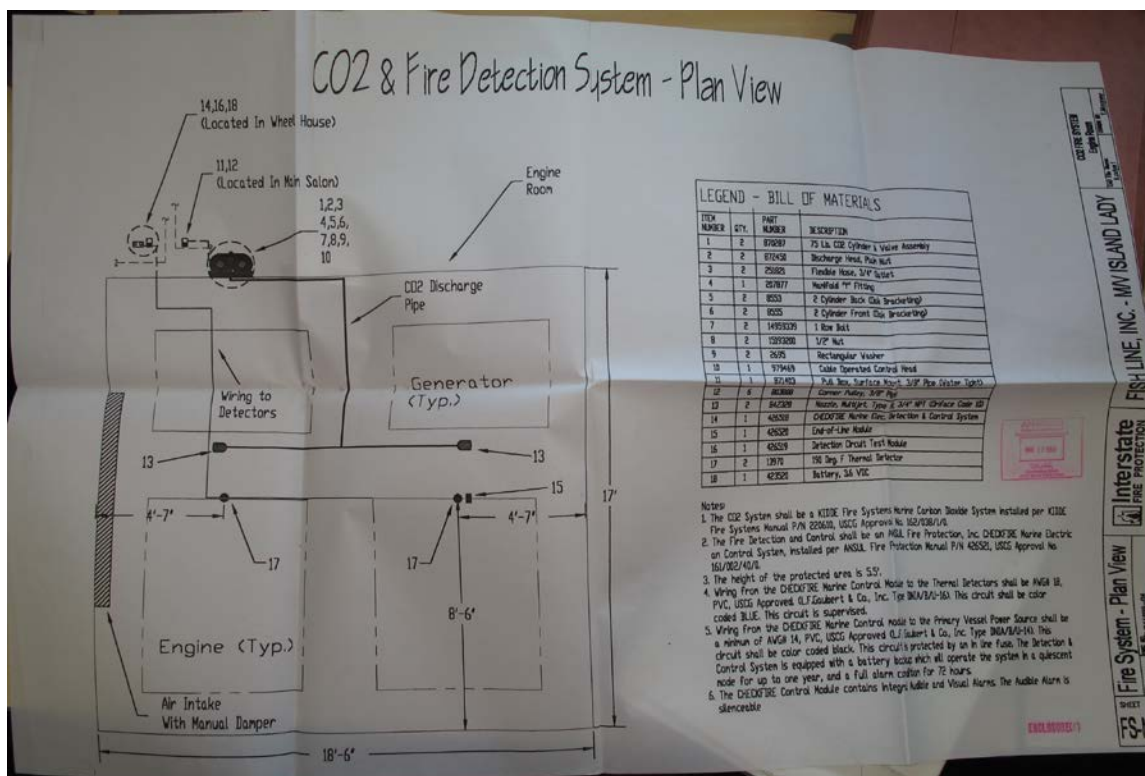
**Figure 6. Fire suppression system installation drawing.**

The system consisted of two 75-pound cylinders of carbon dioxide (CO<sub>2</sub>) located in a compartment aft of the engine room<sup>5</sup>. A distribution line from the cylinders penetrated through the aft engine room bulkhead, traveled down the centerline of the engine room to a tee that terminated in two bell shaped discharge nozzles over the aft end of each engine.

According to the drawings, a pull box located in the Main Salon was used to remotely actuate the suppression system<sup>6</sup>. The ventilation dampers were manually operated and could be remotely closed from a pull station also located in the Main Salon.

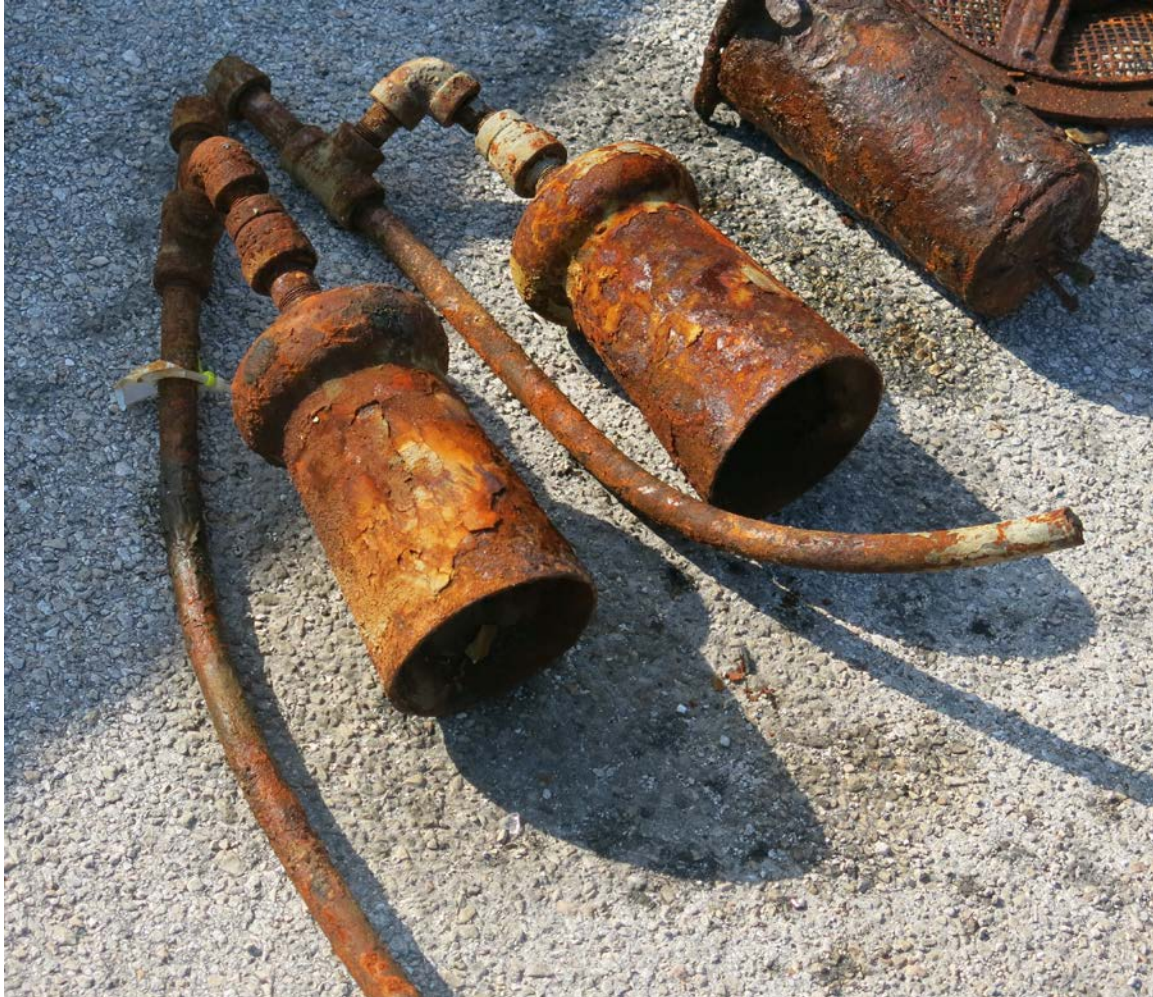
The discharge nozzles and portions of the distribution lines were accounted for during the postaccident examination as shown in Figure 7.

**Figure 7. Discharge nozzles for fixed fire suppression system.**

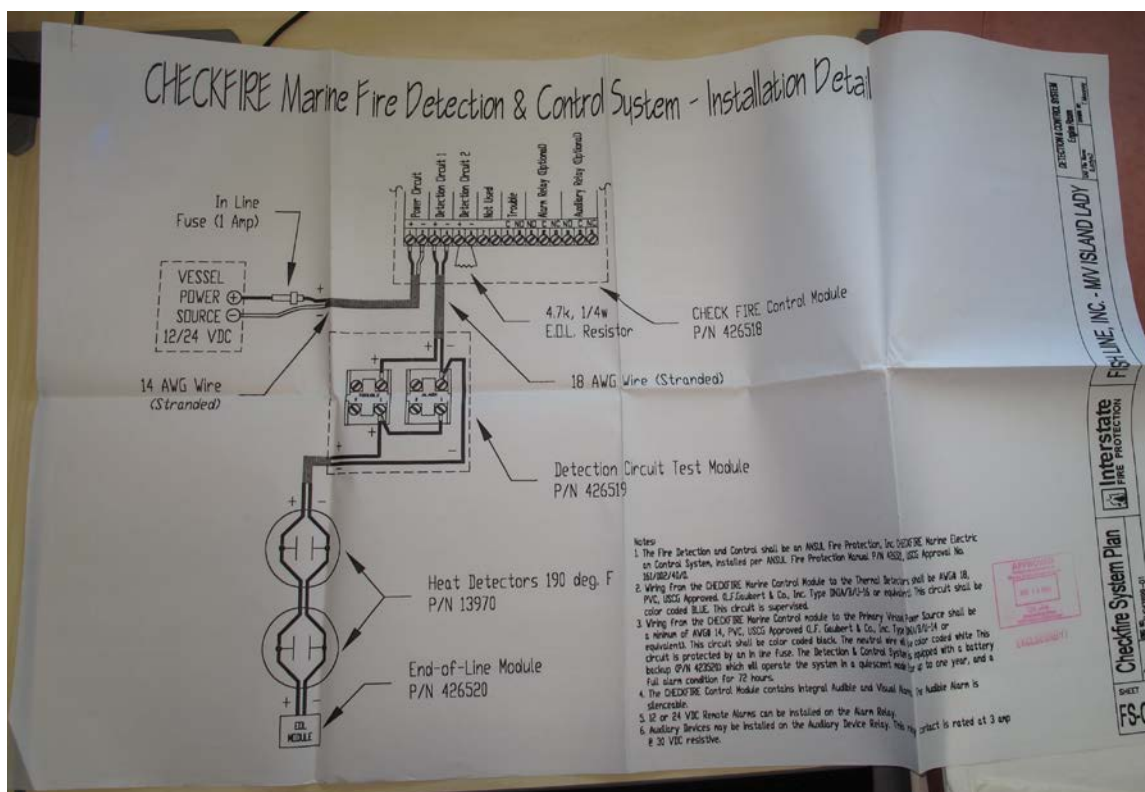
**Figure 8. Installation drawing for fire detection system.**

According to the drawing, an end of line device was installed at the end of a circuit to “supervise” the circuit.<sup>7</sup> 46CFR161.002-10 requires circuits extending from a control unit to the fire detectors to be electrically supervised.

This system was required to be tested yearly. No record of the last test was found. The system was not mentioned in the last USCG inspection. Firefighting system/equipment was listed as “Inspected Satisfactory” on the November 2015 inspection report. The fire detection system was not specifically listed in that report.

No heat detectors were found in the debris. In addition, the alarm panel was not found in the debris. These components were assumed consumed by the fire.
