## MEMORANDUM

Subj: POST SINKING STABILITY ANALYSIS OF BOUNTY, O. N. 960956

**USCG MARINE SAFETY CENTER (MSC) POST SINKING STABILITY ANALYSIS**  
**OF BOUNTY, O. N. 960956**

**EXPLANATION OF ANALYSIS & ASSUMPTIONS**

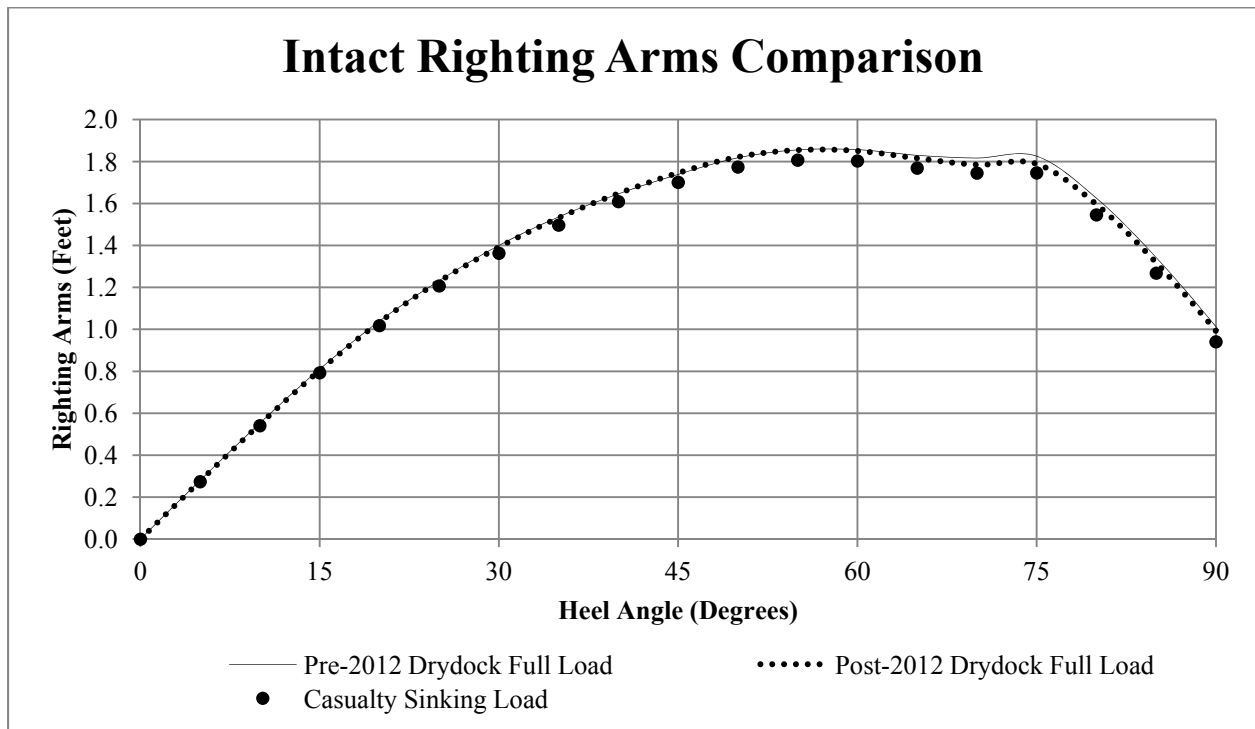
Figure 3 - Comparison of Intact Righting Arms

The righting arm curves in Figure 3 indicate that the reported modifications and unreported 16 ton weight change had minimal effect on the BOUNTY's stability. The righting arm at each angle of heel and the range of positive stability were virtually unchanged.

Our analysis showed BOUNTY met the intact stability standards in 46 CFR 170.170, 46 CFR 170.173, and 46 CFR 171.050 in all three load conditions. In contrast to the results of the 2011 stability analysis, we found that BOUNTY did not meet the sail stability criteria of 46 CFR 171.055. This inconsistency is due to the discrepancies between the wind profile calculated values from reference (d), and the sail area listed in reference (e). The significantly greater wind heeling moment that we calculated caused the vessel to fail the criteria in 46 CFR 171.055.

The stability letter, dated June 15, 2011, placed a limitation on the sail plan that the royals and mizzen topgallant sail were never to be set. Our analysis indicates that even with this limitation, BOUNTY probably did not meet the sailing vessel stability requirements in 46 CFR 171.055.

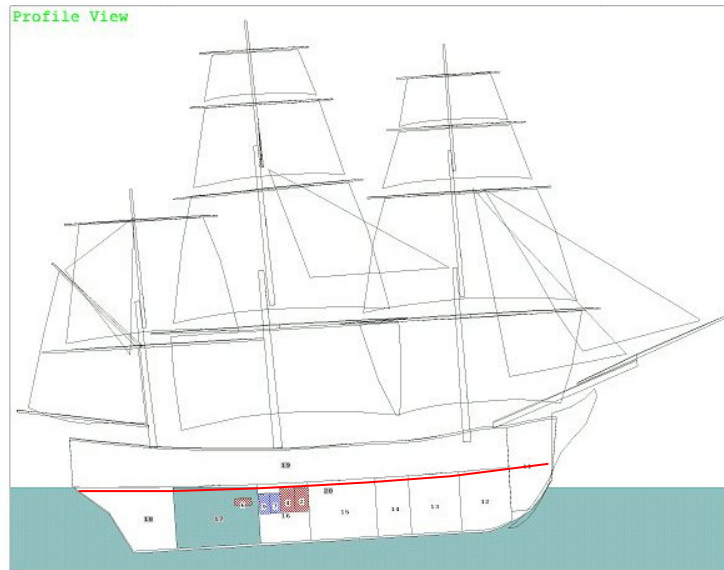
BOUNTY would not meet these subdivision or damage stability criteria because damage to either the engine room or lazarette would result in submergence of the margin line.

Figure 4 - Profile of BOUNTY with engine room flooded. Margin line, shown in red, is partially submerged.

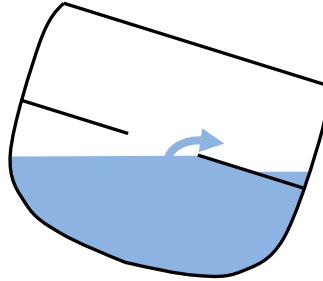
We performed static stability analyses of multiple stages of flooding, assuming that water from the lower deck compartments could spill into the ‘tween deck as the vessel heeled, as shown in Figure 5.

Figure 5 - Example of flood water spilling to the 'tween deck

As our model of the BOUNTY initially floods, the negative impact from free surface effects are offset by the weight of the floodwater, which acts as ballast, lowering the center of gravity. As the vessel heels, most of the water remains entrapped in the lower decks. The plot of righting arms versus heel angle in Figure 6 shows a distinct reduction in stability when the flooding reaches a depth of 12 feet. We attribute this reduction in righting arms to a significant amount of water spilling from the lower deck to the 'tween deck as the model heels.

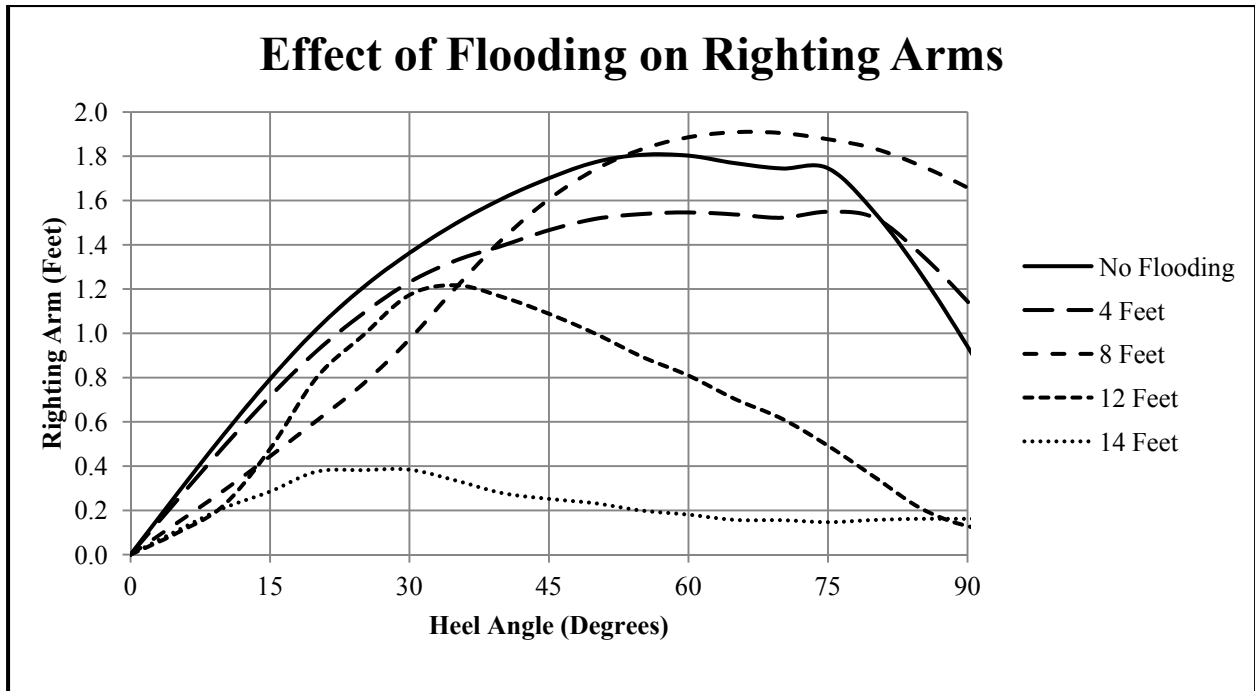
Table 10 displays the reduction in several key stability parameters as the floodwater increases from 4 feet to 14 feet.

Figure 6 - Righting arms at various stages of flooding, assuming bulkheads are watertight

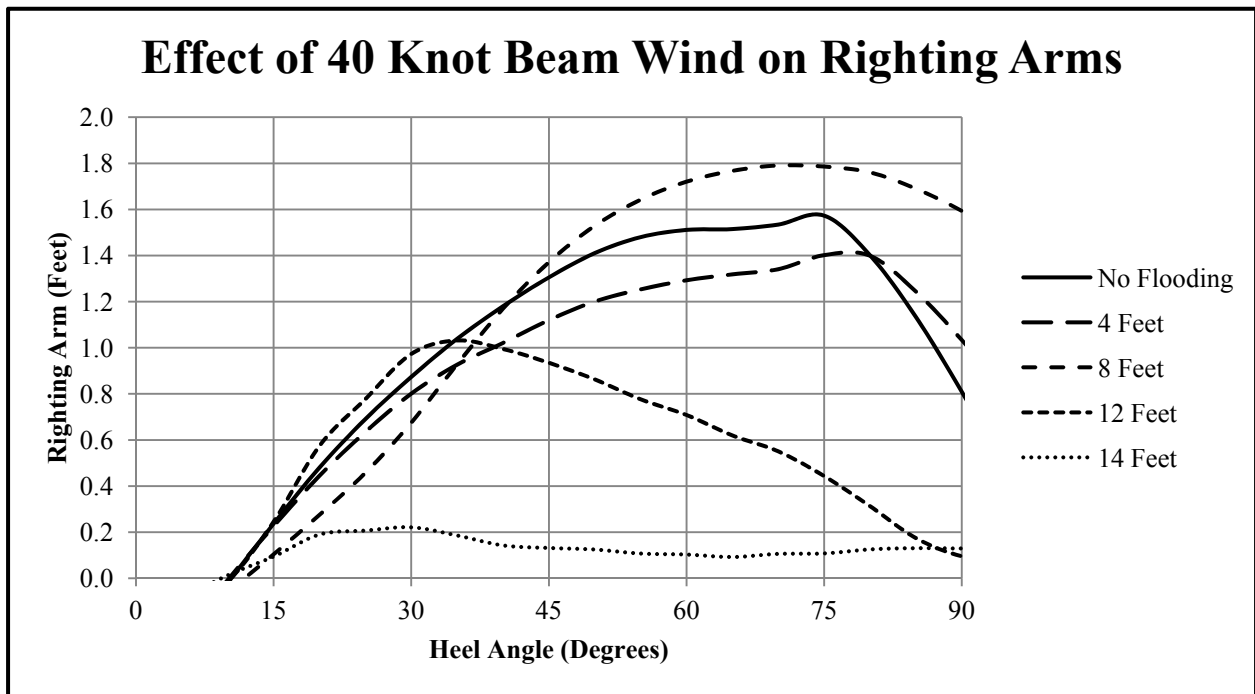
Figure 7 - Righting Arms at various stages of flooding, assuming bulkheads are watertight, with a 40 knot beam wind

Figure 7 shows that, at any level of flooding below the ‘tween deck, a steady 40 knot beam wind acting on the model flying only the main staysail would result in an equilibrium heel angle of

approximately 9° to 12°. Further, with an assumed 40 knot beam wind, righting energy would have been significantly reduced, particularly at the later stages of lower deck flooding.

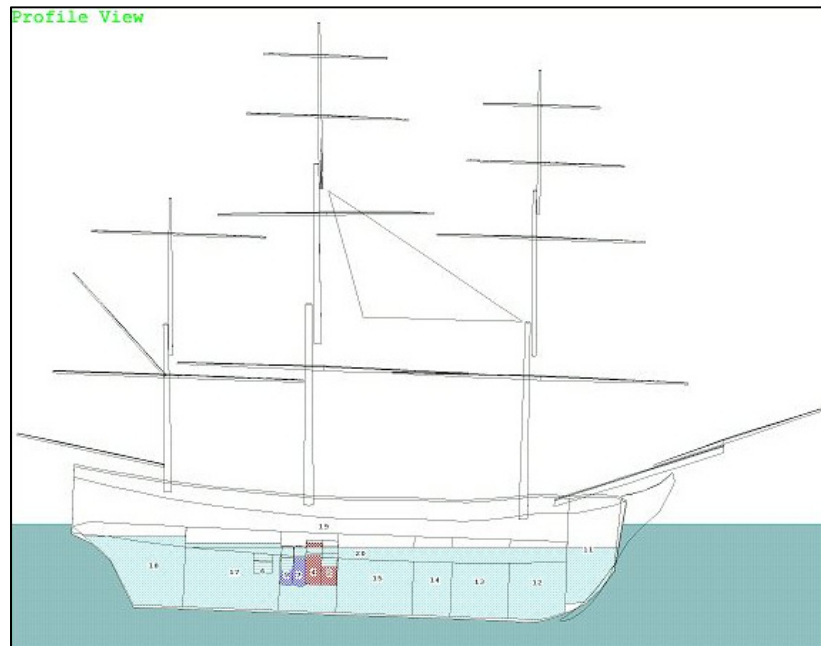
Figure 8 - BOUNTY with lower deck compartments flooded, 'tween deck flooded to 5%, and a 40 knot beam wind
