**NATIONAL TRANSPORTATION SAFETY BOARD
Office of Research and Engineering
Vehicle Recorder Division
Washington, D.C. 20594**

GROUP CHAIRMAN'S FACTUAL REPORT OF INVESTIGATION

***S.S. El Faro* Wreckage Examination Report**

DCA16MM001

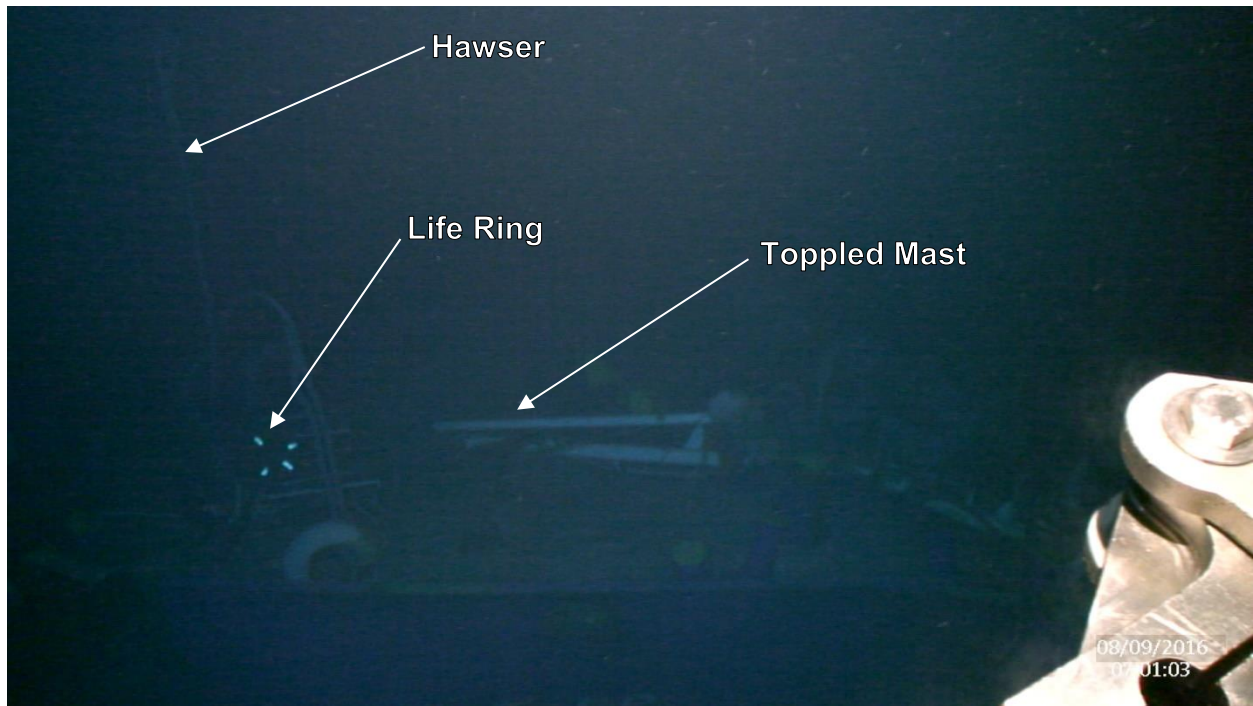
Figure 10. Region: Bow Source: Mission III Vehicle: CURV 21

The port bow is shown from just above the level of the port bulwark. The foremast is shown toppled from its mounting position. An intact life ring, still circular in shape, but the SOLAS tape on the life ring is no longer in the shape of a cross. The life ring is mounted on a railing in close proximity to the hawsepipe. There is a loose hawser² streaming upwards from an area of debris.

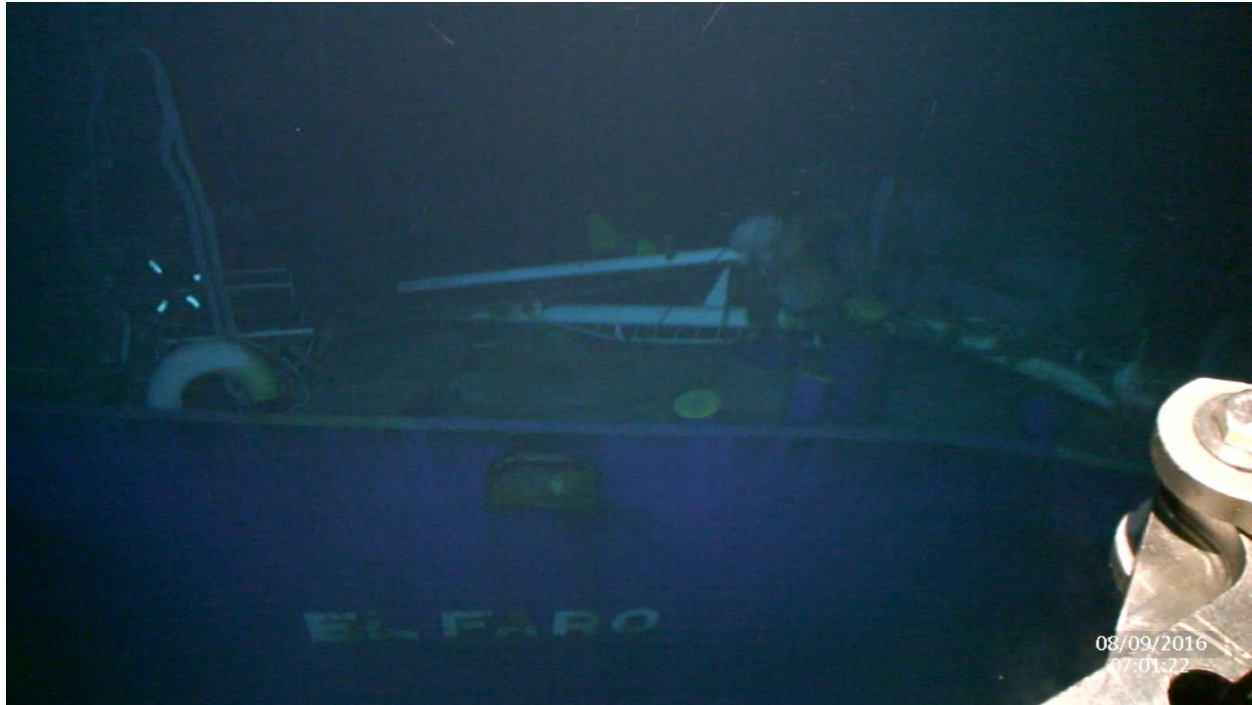
Figure 11. Region: Bow Source: Mission III Vehicle: CURV 21

An additional view of the port side bow, captured from just above the port side bulwark.

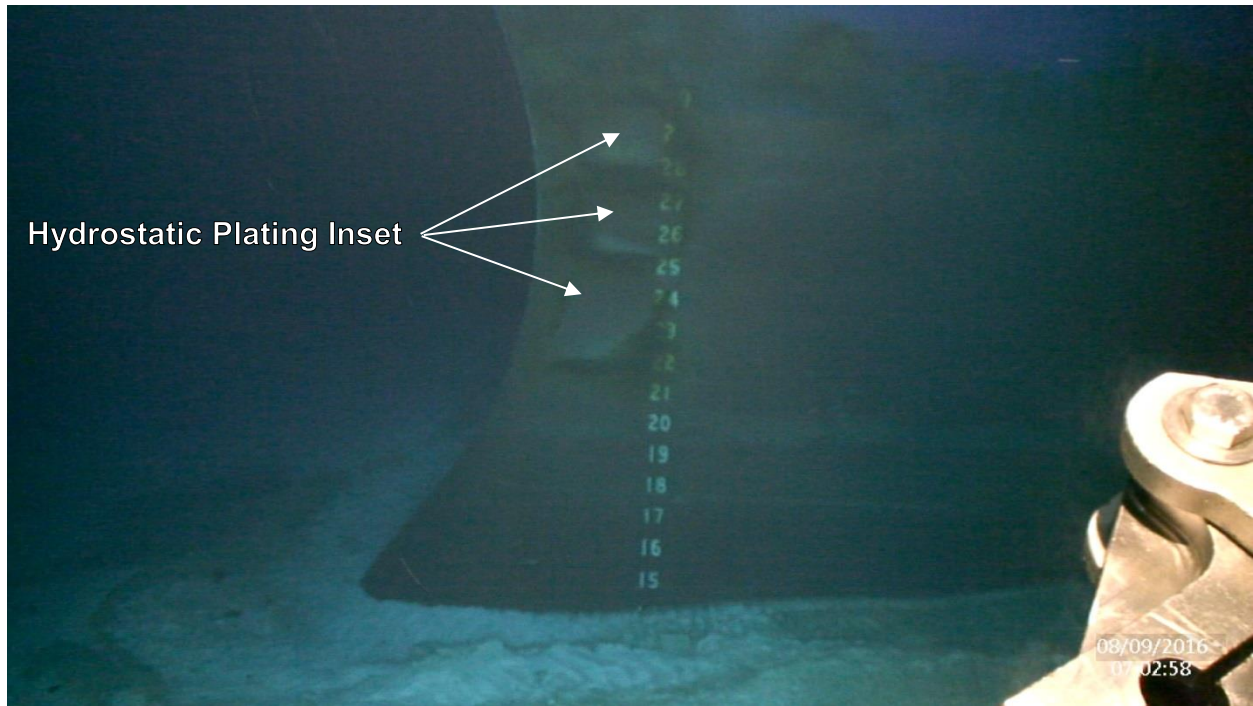
Figure 12. Region: Bow Source: Mission III Vehicle: CURV 21

Hydrostatic plating inset over the cast stem bar is visible between and forward of the 22 and 25 foot draught marks and between and forward of the 28 and 30 foot draught marks.

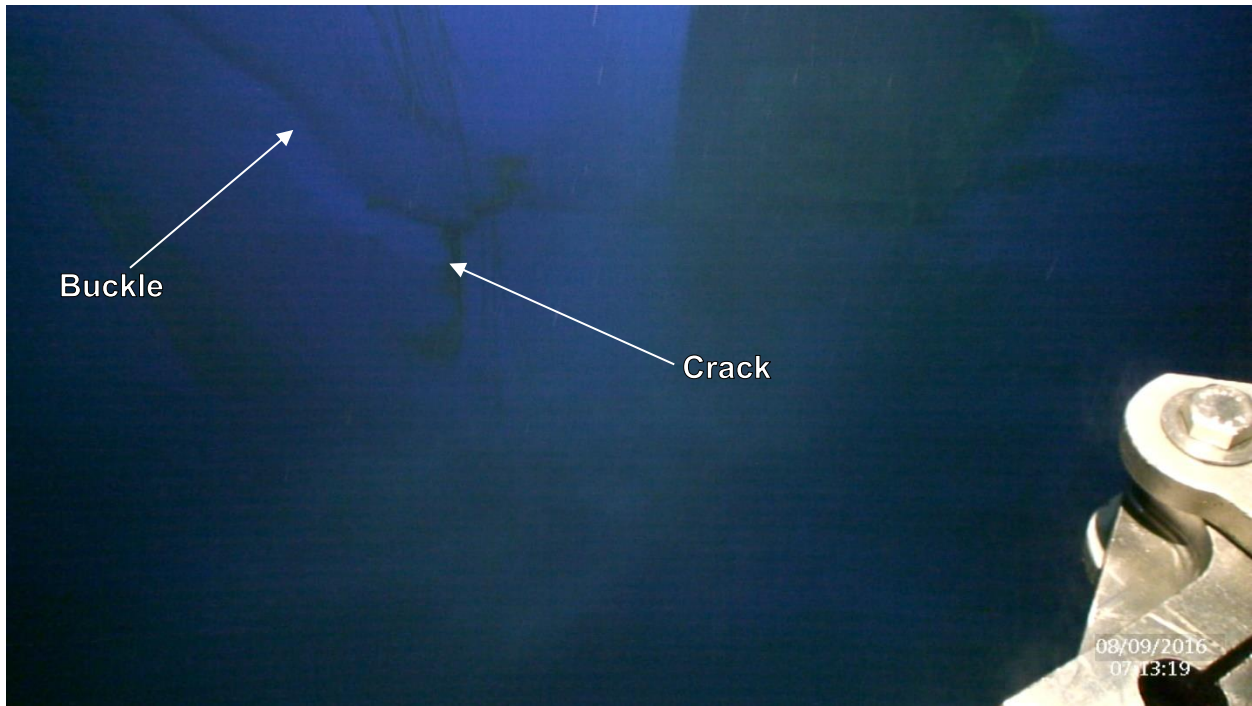
Figure 16. Region: Port – Aft Frame 20 Source: Mission III Vehicle: CURV 21

A buckle and crack in shell plating forward of vent opening, in the vicinity of frame 20.

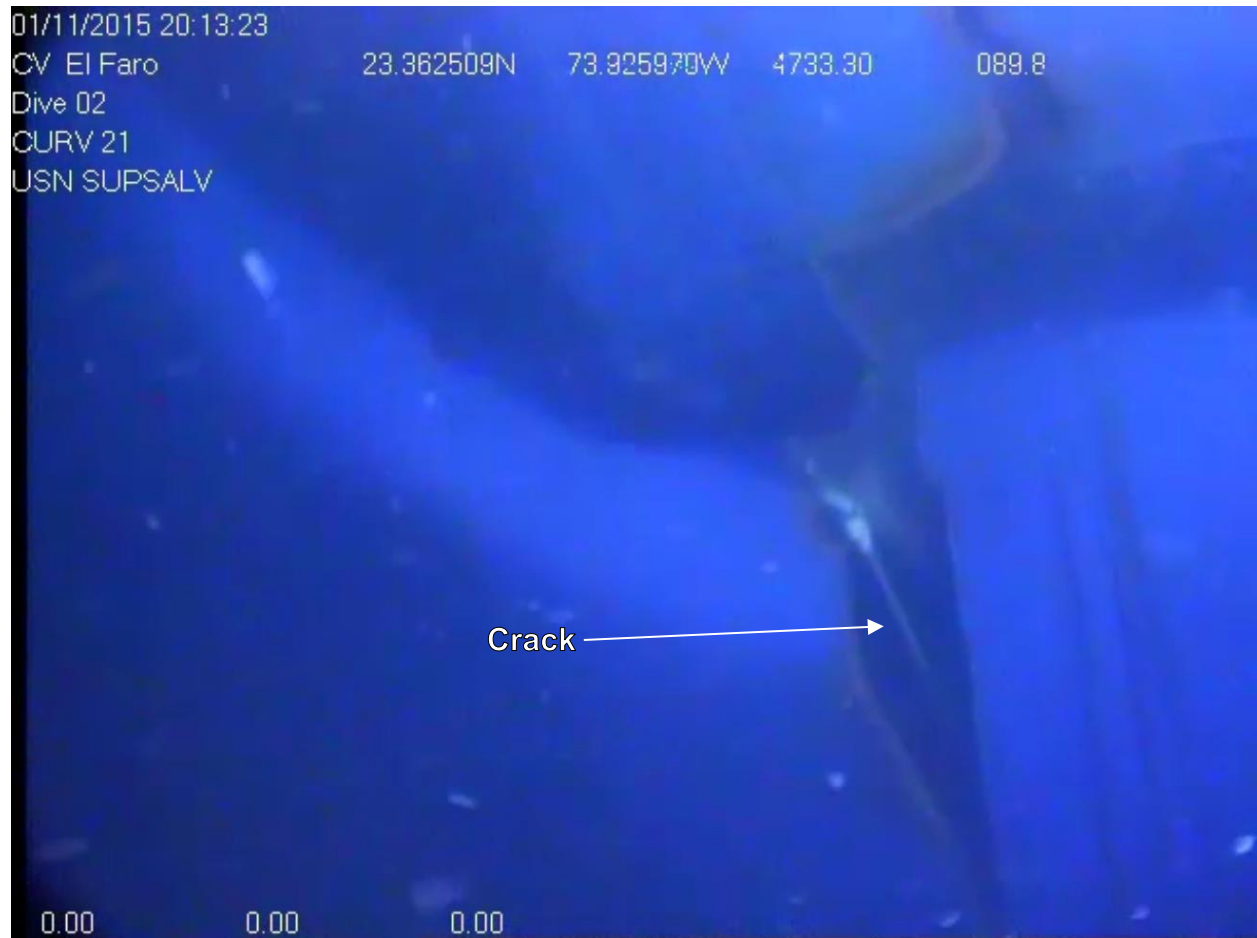
Figure 17. Region: Port – Aft Frame 20 Source: Mission I Vehicle: CURV 21

An alternate, closer view of the buckle and crack in shell plating forward of vent opening, in the vicinity of frame 20.

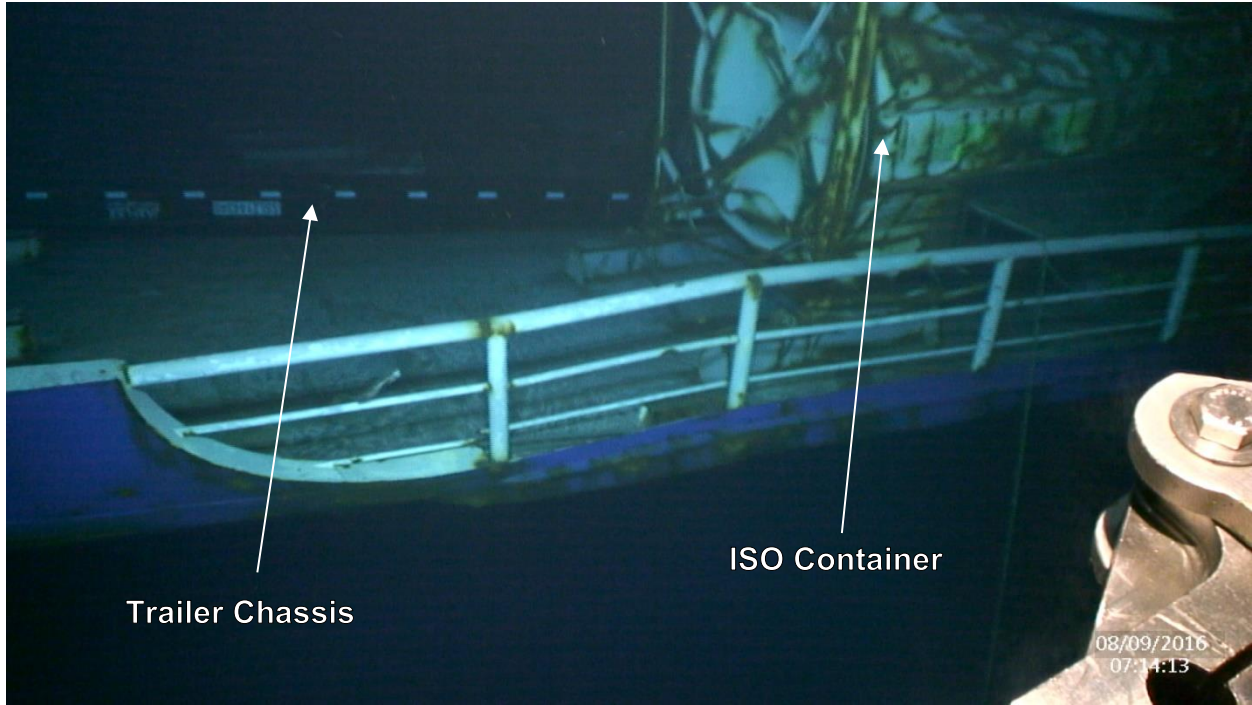
Figure 18. Region: Port – Bay 2 (outboard) Source: Mission III Vehicle: CURV 21

Port side bay 2, outboard most location. A 20 foot ISO tank container crushed between internals but still mounted to stowage location. A trailer chassis is visible behind the ISO container. The trailer chassis is upside down and the ID number reads 55112144340.

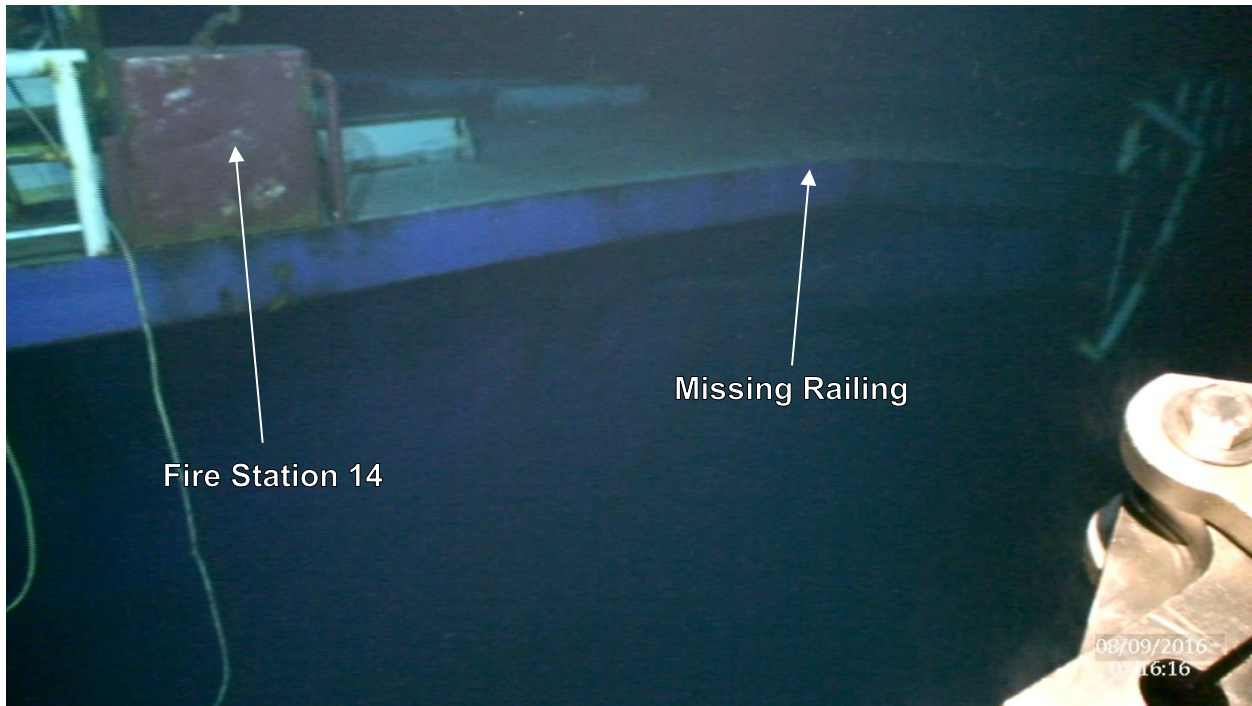
Figure 19. Region: Port – Frame 50 Source: Mission III Vehicle: CURV 21

Fire station 14 is visible and mounted. The ship's port side railing is missing between approximately frames 45 to 50.

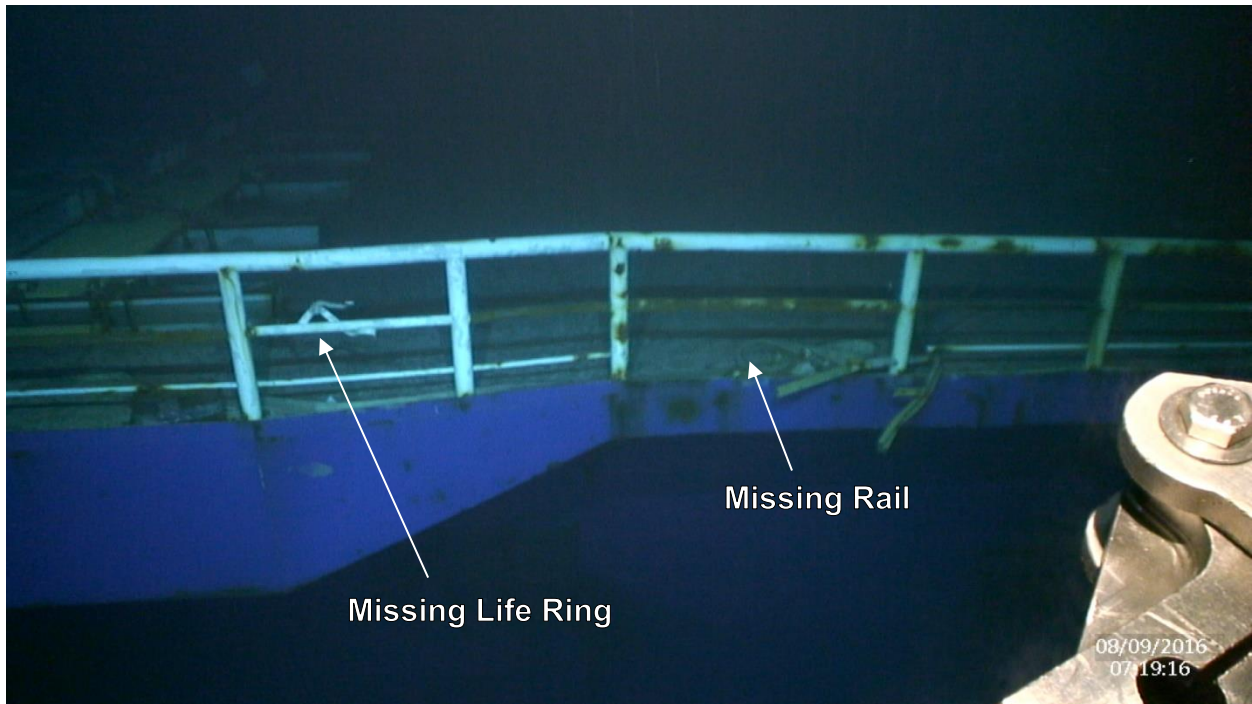
Figure 20. Region: Port – Frame 62 Source: Mission III Vehicle: CURV 21

A life ring is missing from its mounting location near frame 62 on the port side of the vessel. A small portion of railing is missing. Railing is estimated to still be seen in this location and is visible in subsequent figures up to approximately frame 70.

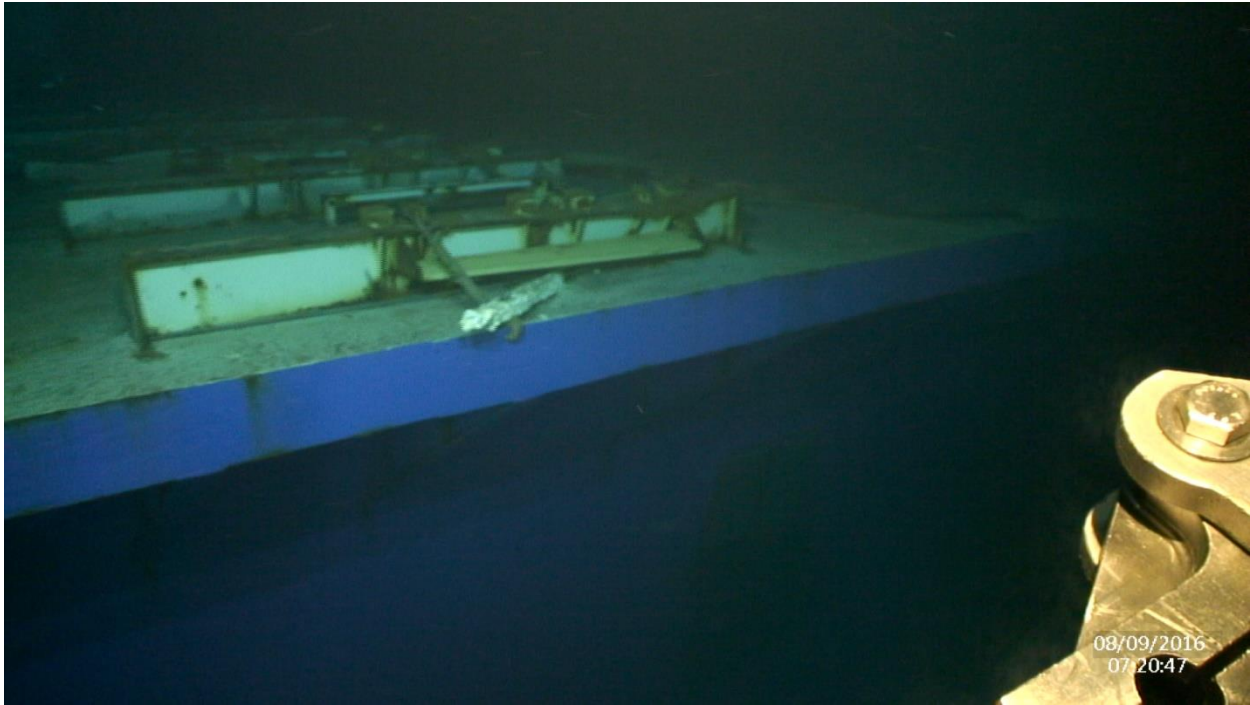
Figure 21. Region: Port – Frames 85-90 Source: Mission III Vehicle: CURV 21

Imagery shows deck rail missing aft of frame 70. Frames 85-90 is shown here with the deck rail missing.

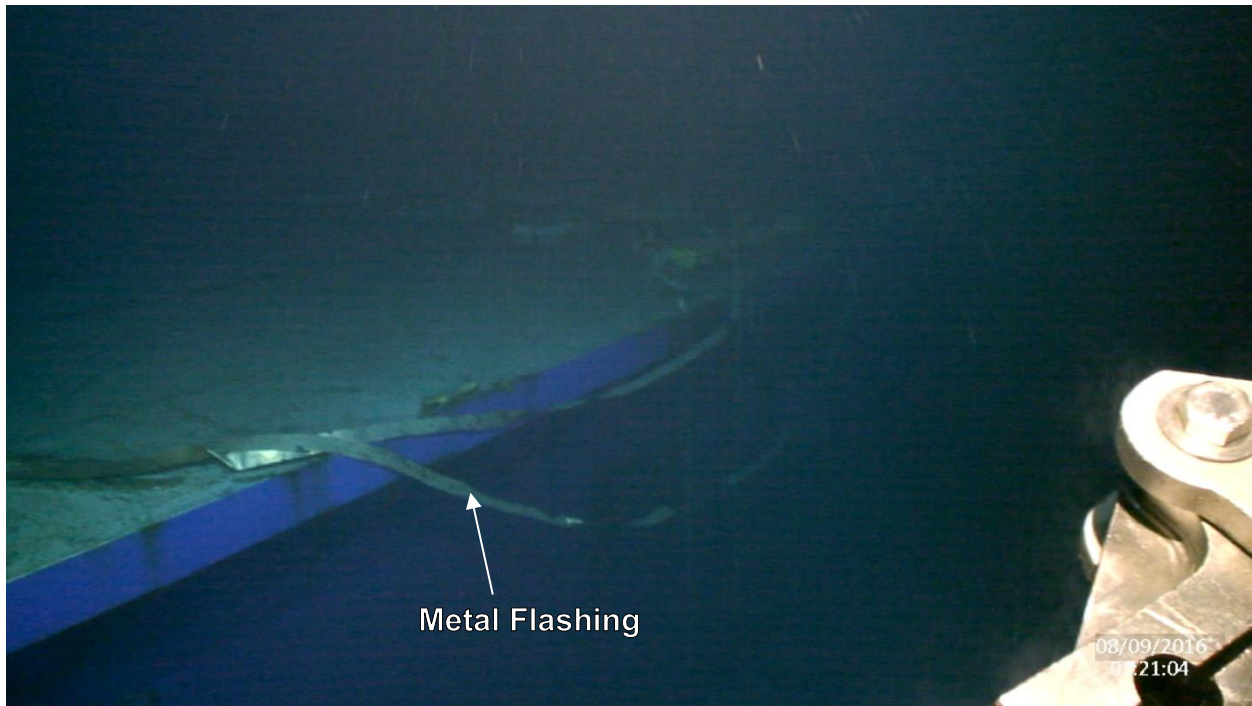
Figure 22. Region: Port – Frames 95-100 Source: Mission III Vehicle: CURV 21

Approximately 4 inch wide metal flashing hanging over the ship's deck between approximately frames 95 and 100 on the port side. The metal flashing was determined to be part of the ship's cargo. The deck rail is missing in this area.

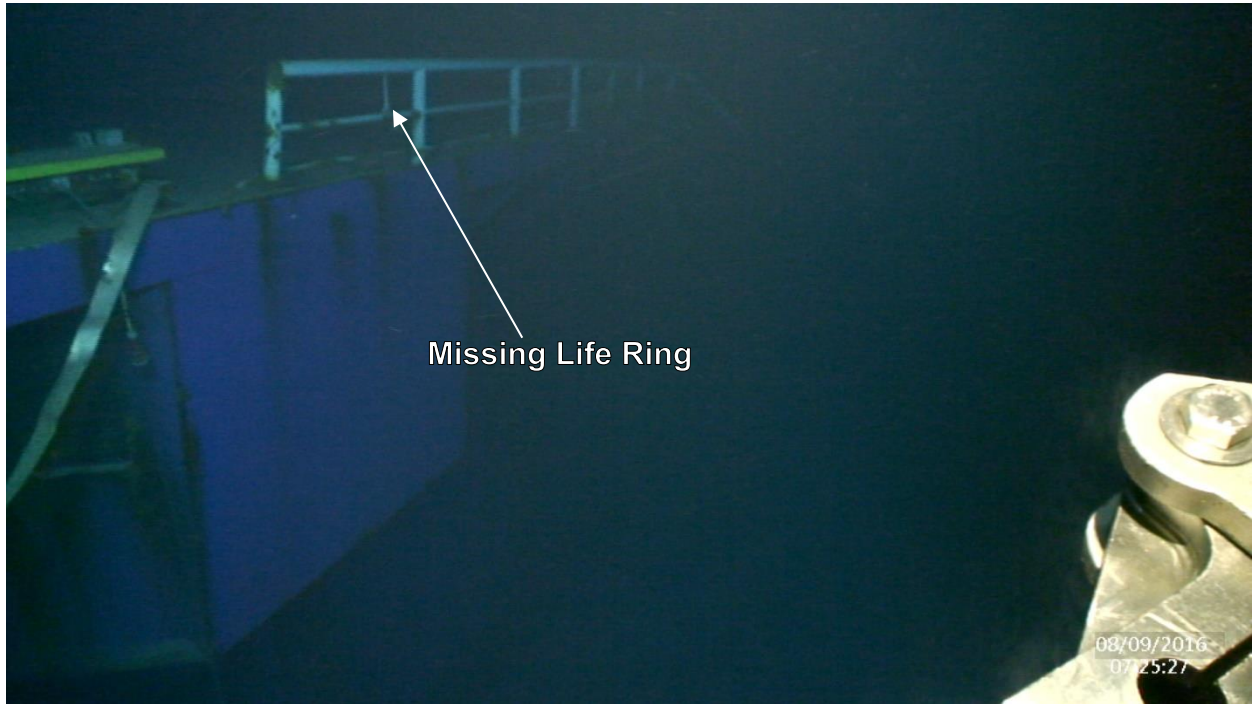
Figure 27. Region: Port – Frame 110. Source: Mission III Vehicle: CURV 21

Intact deck railing from frame 110 aft to frame 123. A missing life ring in the vicinity of life ring holder is noted.

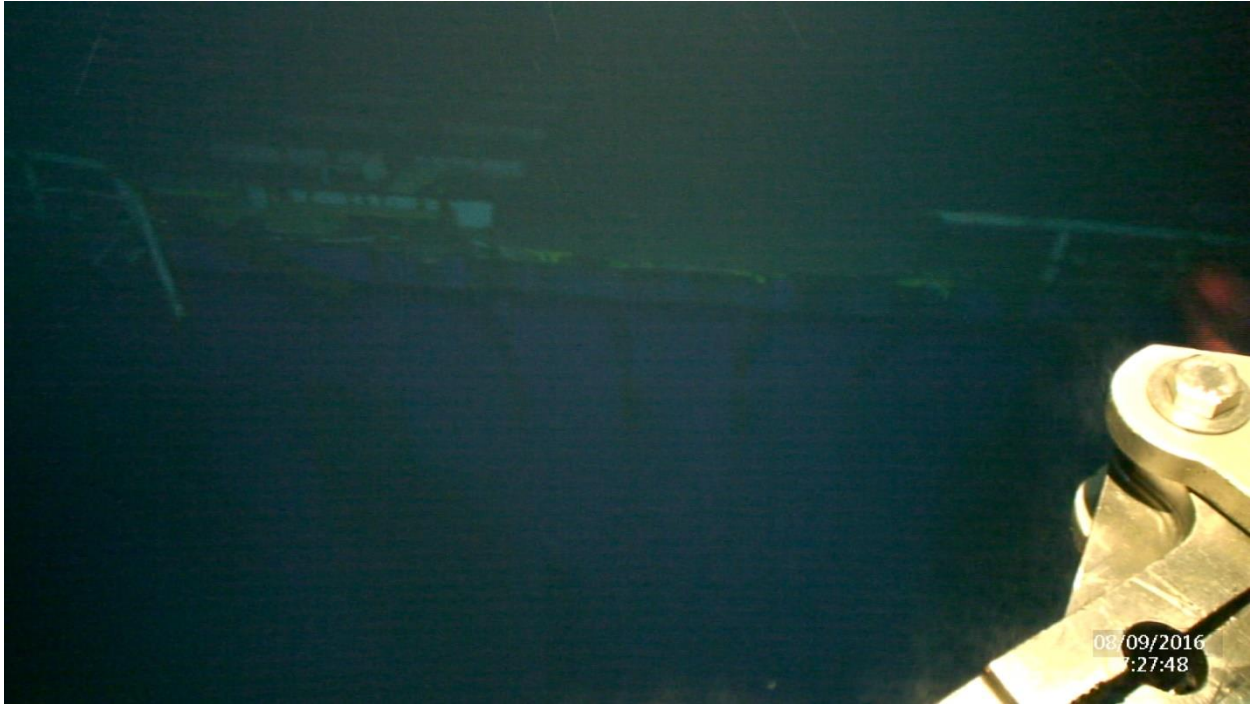
Figure 29. Region: Port – Frames 123 -130. Source: Mission III Vehicle: CURV 21

Hand rail missing between approximately frames 123 and 130.

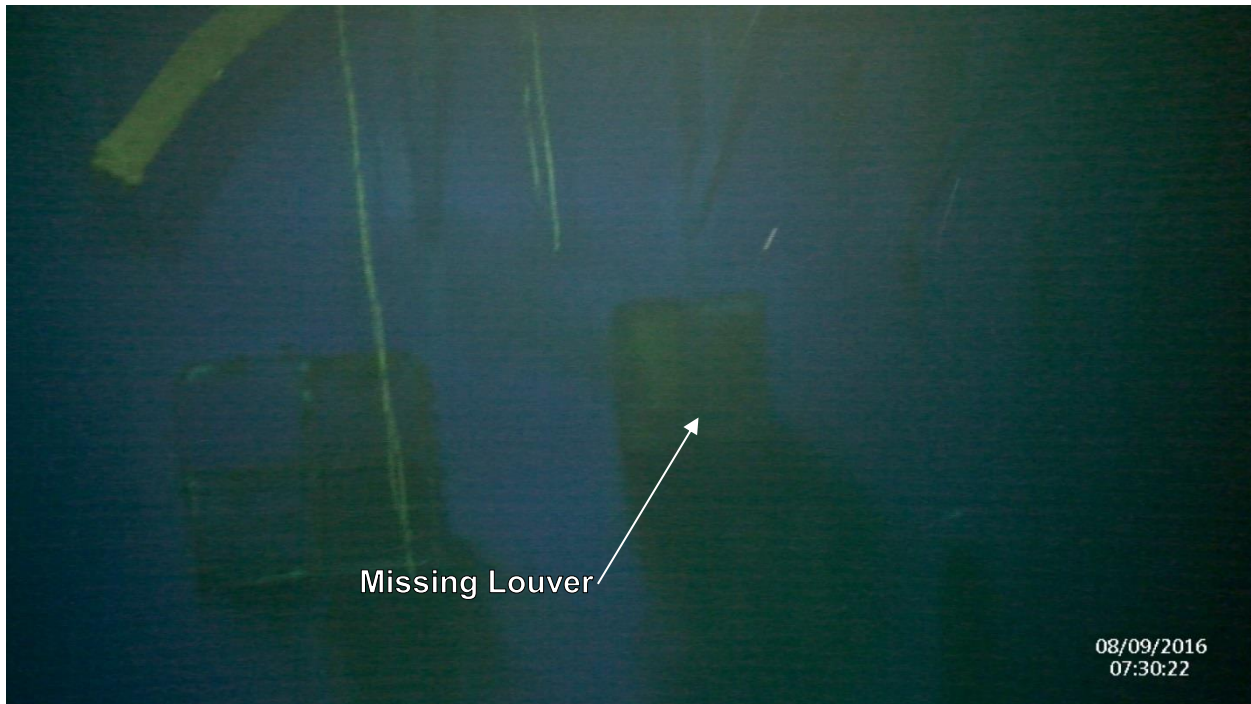
Figure 32. Region: Port – Frames 123 - 125. Source: Mission III Vehicle: CURV 21

Forward louver between approximately frames 123 and 125 is blown outward. Upper two thirds of louver are missing.

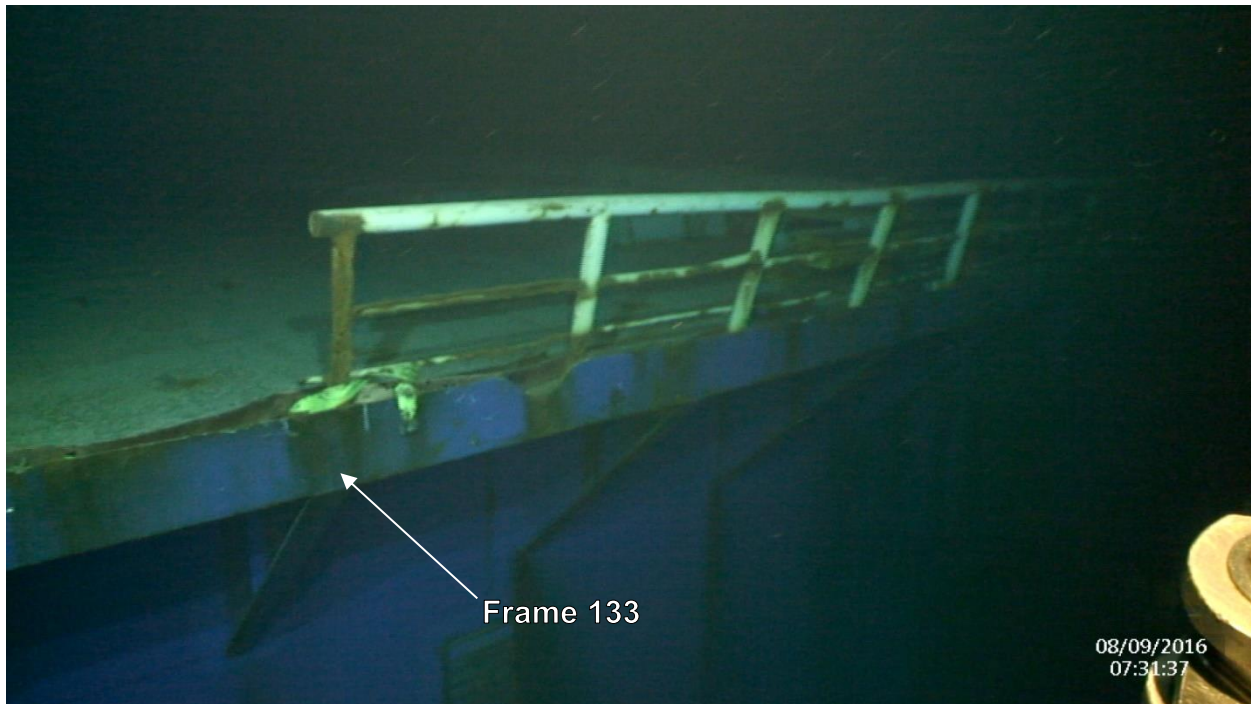
Figure 33. Region: Port – Frame 133. Source: Mission III Vehicle: CURV 21

Missing fire station number 20. Deck rail begins again at approximately frame 133.

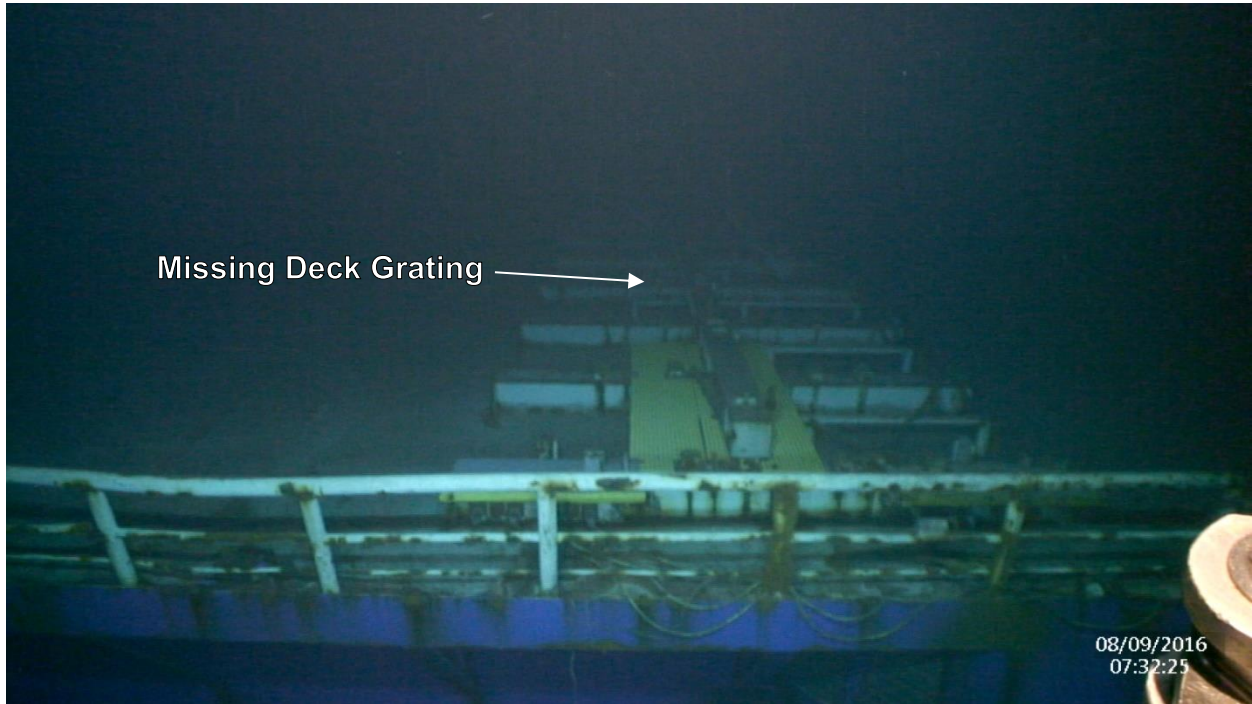
Figure 35. Region: Port – Frame 134/10. Source: Mission III Vehicle: CURV 21

Fiberglass deck grating missing from container support beams. Condition of missing grating is typical of the El Faro wreck and across most of the ship's deck. Transfer beam is intact in this area and does not appear twisted.

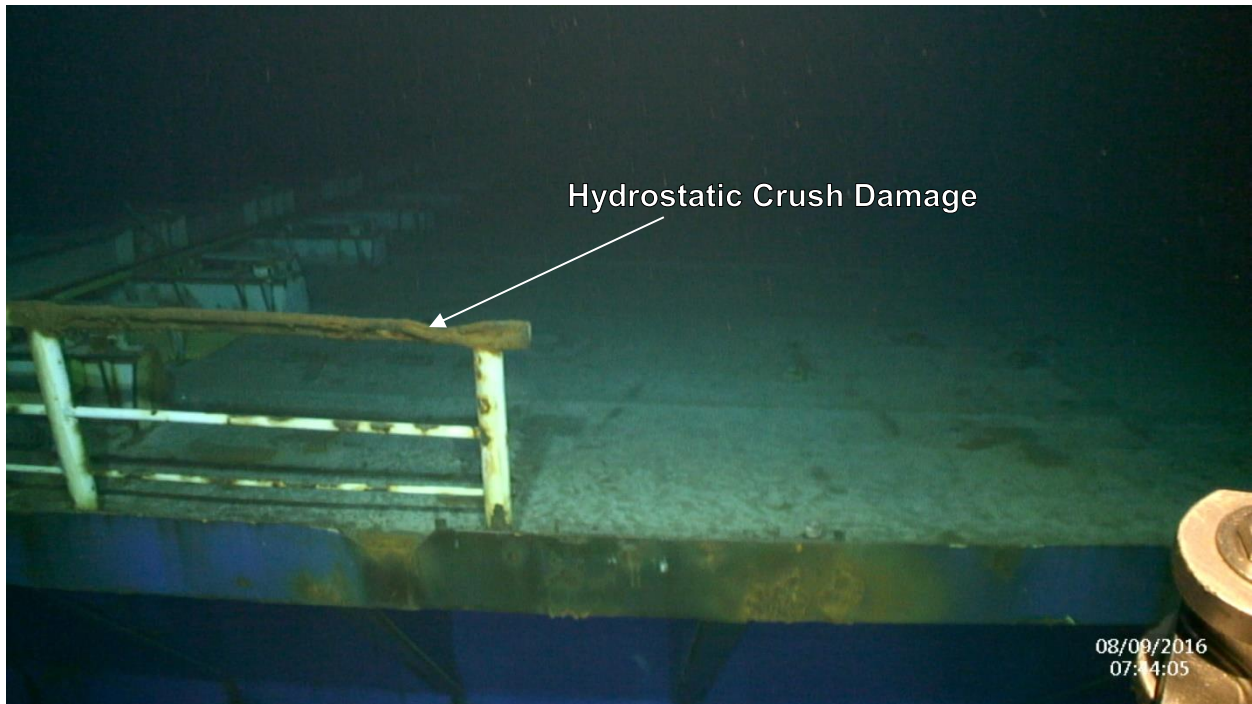
Figure 37. Region: Port – Frame 134/28. Source: Mission III Vehicle: CURV 21

Handrail missing from frame 134/28 aft. Handrail exhibits a hydrostatic crush. Fire station no. 40 is missing at frame 134/30.

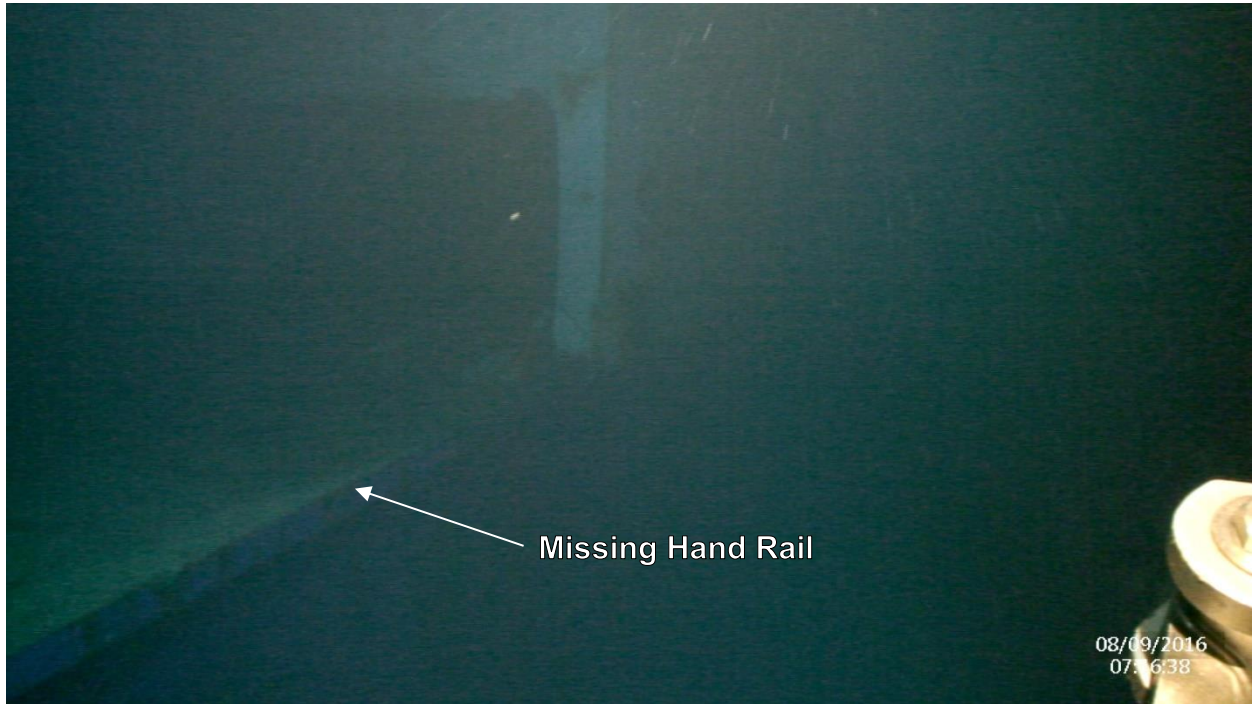
Figure 38. Region: Port – forward of house Source: Mission III Vehicle: CURV 21

Handrail missing between frame 134/30 forward face of house.

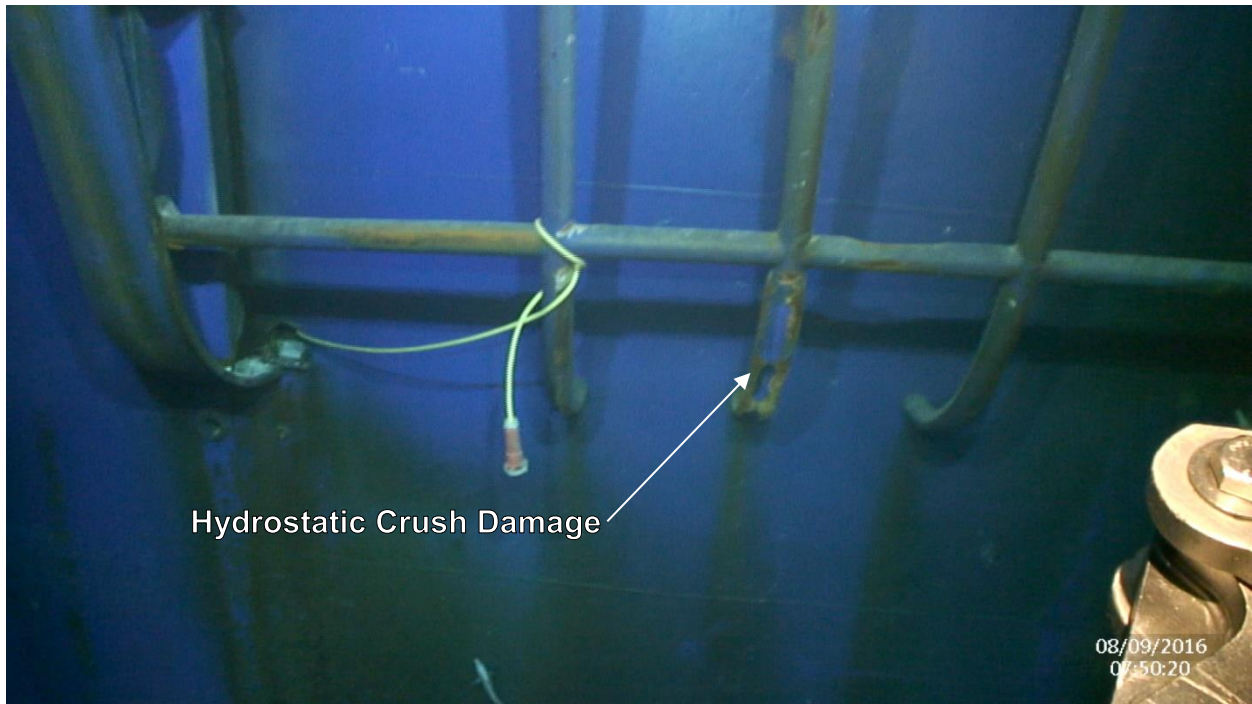
Figure 42. Region: Port – Frame 173 Source: Mission III Vehicle: CURV 21

Hydrostatic crush damage to life boat launch skid piping. The port side of the ship between the superstructure and the transom was not covered with high definition imagery during mission III. Only low definition video and a few photographs show this region of the ship. Video from mission I was referenced for this area, but the area was unable to be imaged in a continuous stream due to entanglement hazards.

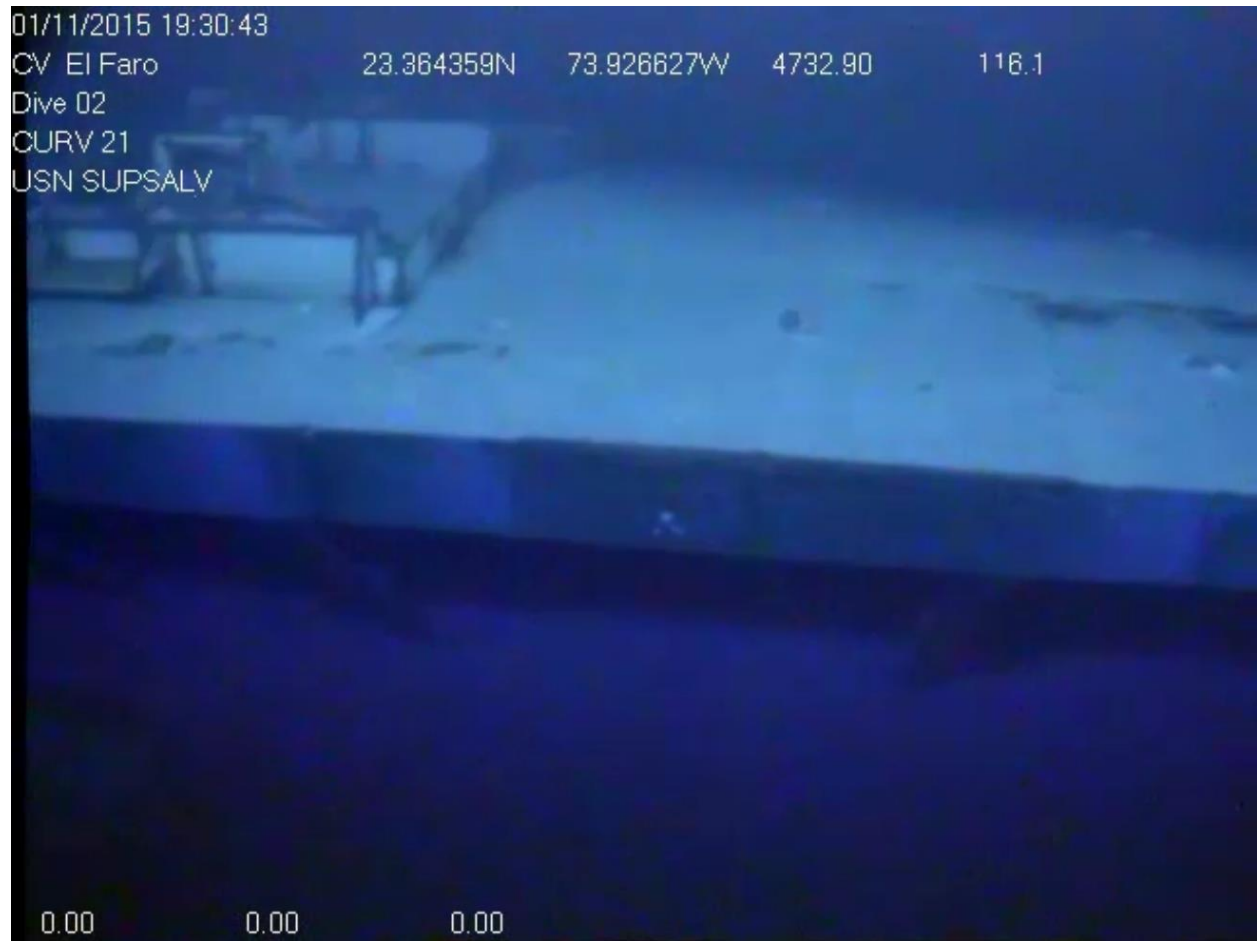
Figure 47. Region: Port – Frame 217-220 Source: Mission I Vehicle: CURV 21

Handrail is missing from the superstructure aft to the port stern quarter.

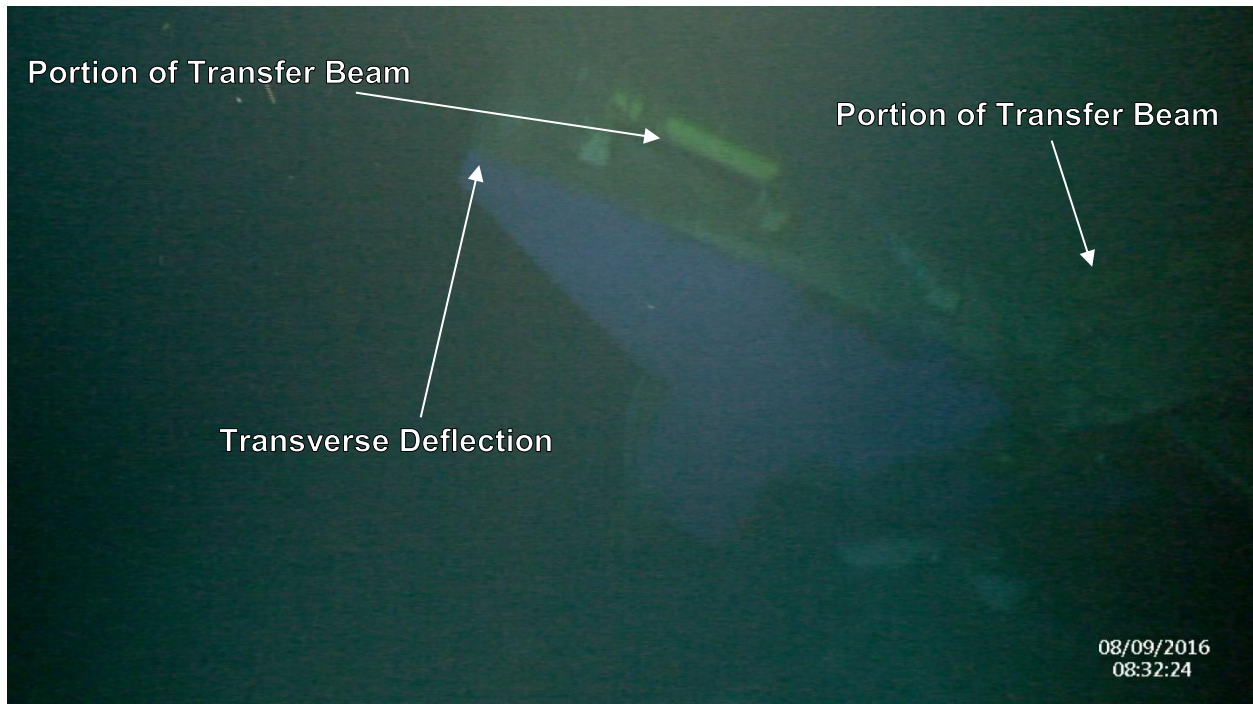
Figure 51. Region: Port – Stern Quarter Source: Mission III Vehicle: CURV 21

The port stern quarter showing substantial transverse deflection upward at the deck edge, twisting and possible shear. The outboard section of a transfer beam is present. The centerline section of the transfer beam is missing. A separate piece of a transfer beam is also seen to the right of image.

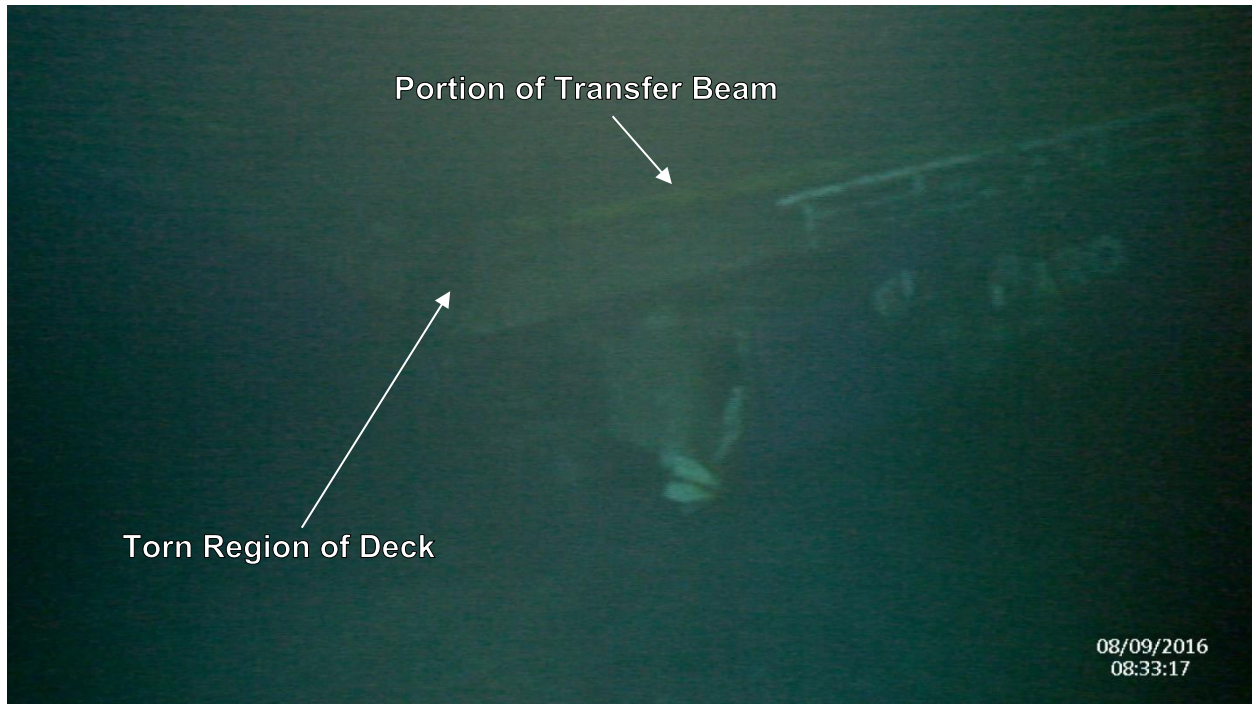
Figure 52. Region: Port – Stern Source: Mission III Vehicle: CURV 21

A wide shot of the ship's transom. Approximately 20 feet of handrail is visible on the transom above the ship's name. A portion of the transfer beam is visible. The aft port corner of the main deck is deflected upward approximately 16 feet relative to the main deck at the transom where the deck is fractured inboard. The deck is torn and bent upwards.

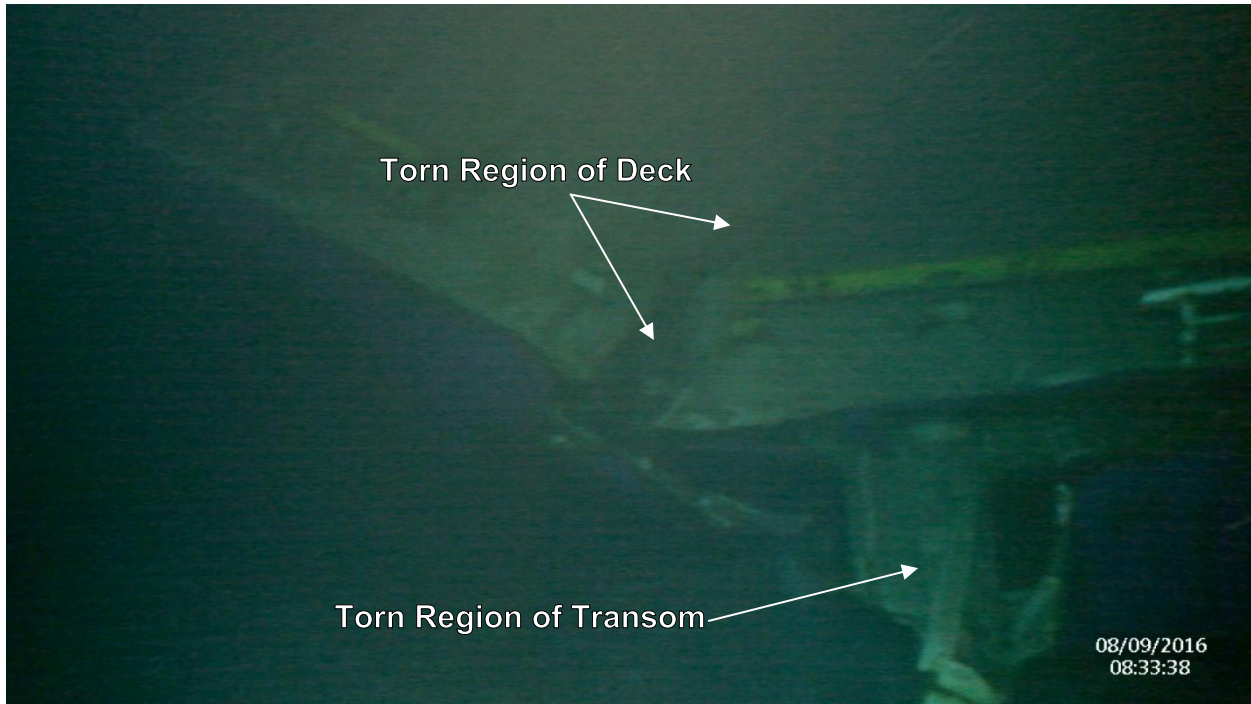
Figure 53. Region: Port – Stern Source: Mission III Vehicle: CURV 21

The tear that began approximately 16 feet inboard from the port deck edge extends an estimated 20 feet in length forward (longitudinally) from the ship's transom. The fracture in the ship's stern is seen in greater detail. The ship's transom is torn open below this area down to the ship's second deck.

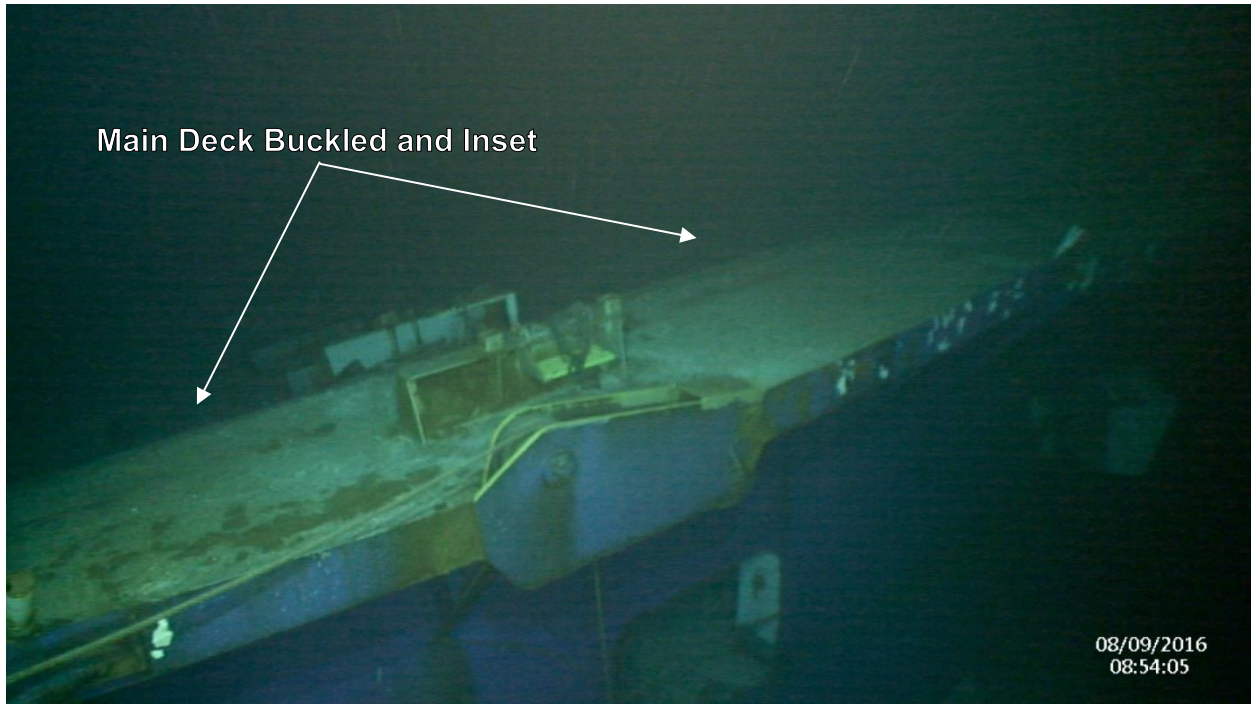
Figure 61. Region: Starboard – Frame 234 Source: Mission III Vehicle: CURV 21

Handrail is missing from bay 18 forward. Main deck is severely buckled and inset inboard about 8 feet from the starboard deck edge. The deformation begins at the junction between the main deck and the side shell plating, where the plating meets the underside of the deck overhang.
