**NATIONAL TRANSPORTATION SAFETY BOARD
Office of Research and Engineering
Vehicle Recorder Division
Washington, D.C. 20594**

GROUP CHAIRMAN'S FACTUAL REPORT OF INVESTIGATION

***S.S. El Faro* Wreckage Examination Report**

DCA16MM001

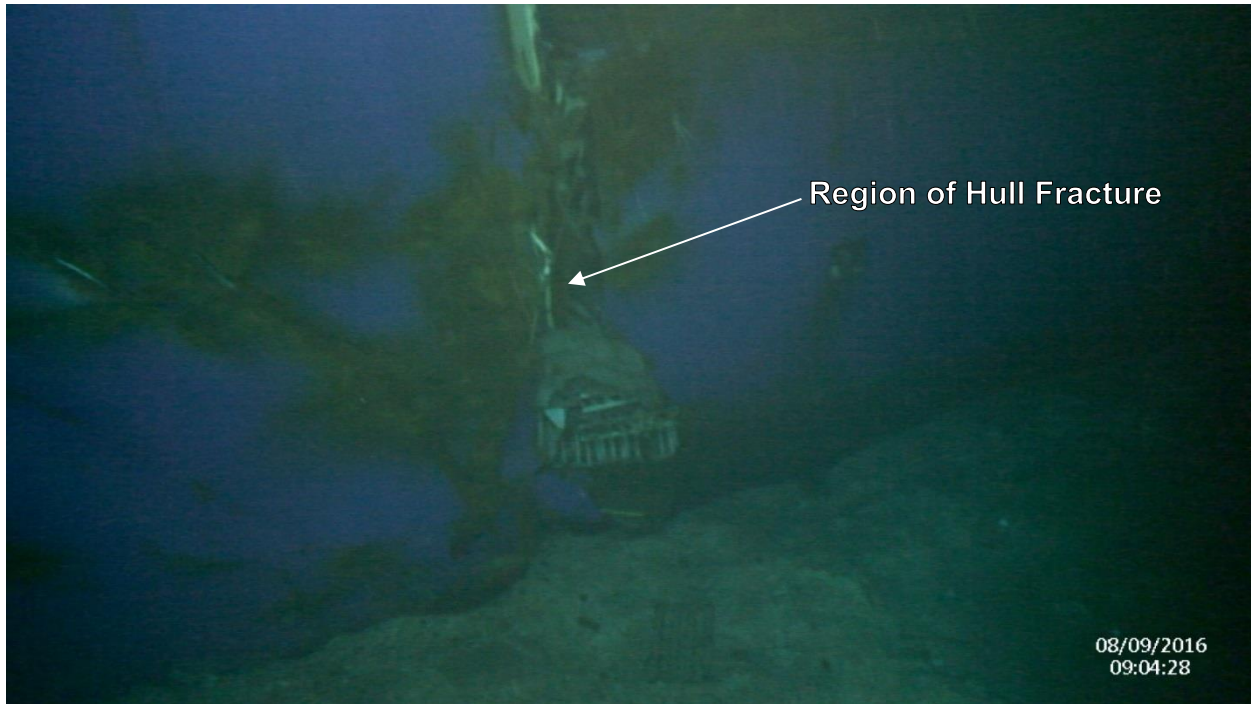
Figure 63. Region: Starboard – Frame 200 Source: Mission III Vehicle: CURV 21

Large hull fracture extending vertically from the mudline just forward of frame 200 in the vicinity of bay 16.

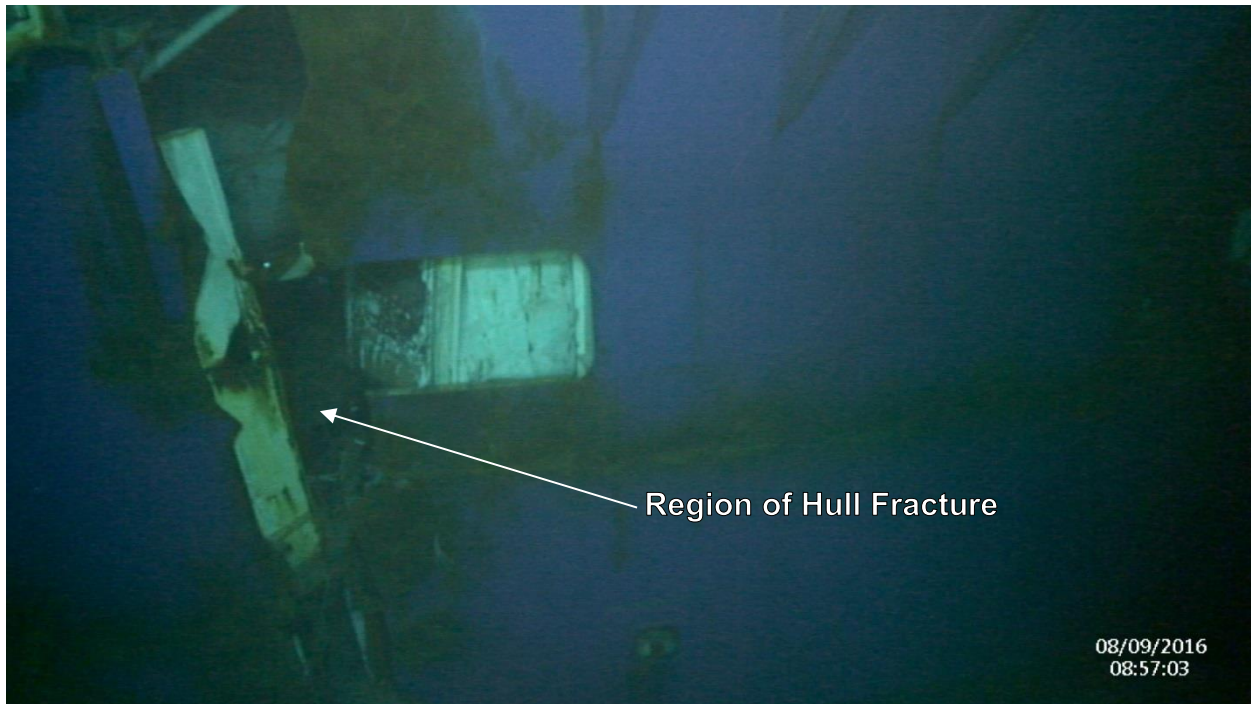
Figure 64. Region: Starboard – Frame 200 Source: Mission III Vehicle: CURV 21

Crack in the region of bay 16, just forward of frame 200. The full height side shell crack extends from the mudline up to the main deck. The estimated width of the crack at the main deck is approximately three feet.

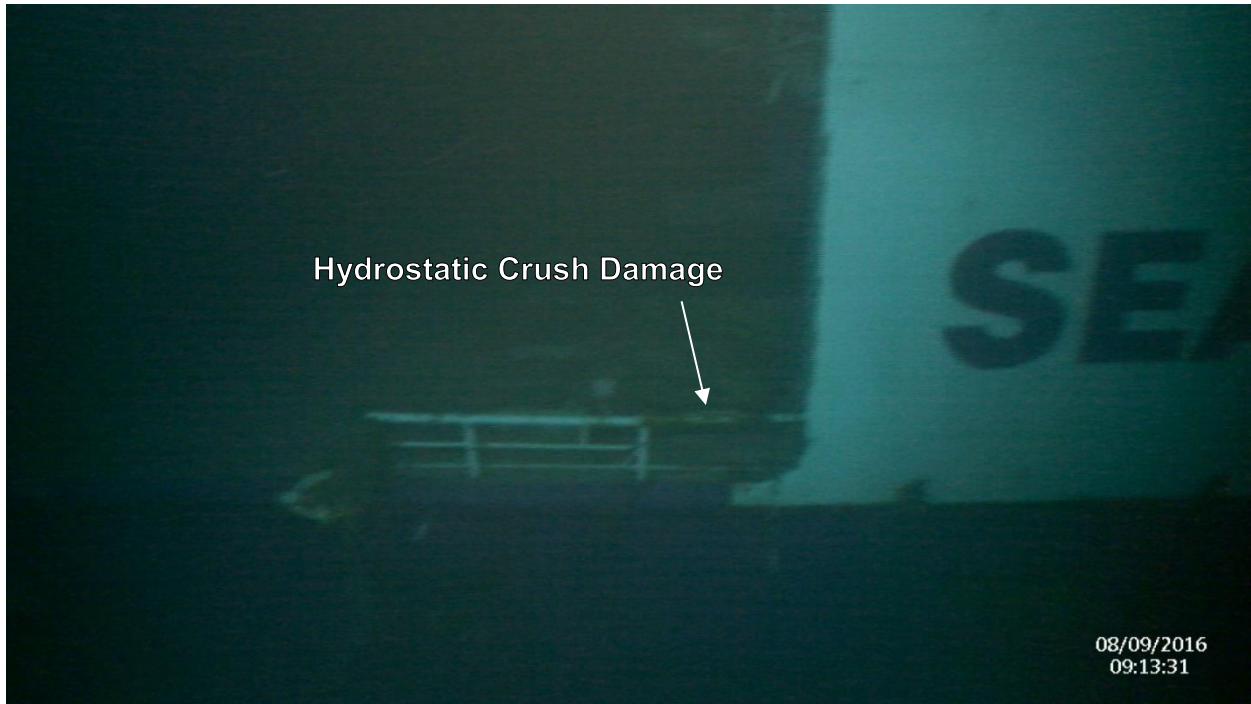
Figure 73. Region: Starboard – Frame 190 Source: Mission III Vehicle: CURV 21

Deck rail present forward to frame 190. Forward portion of the top rail exhibits hydrostatic implosion damage on the pipe section.

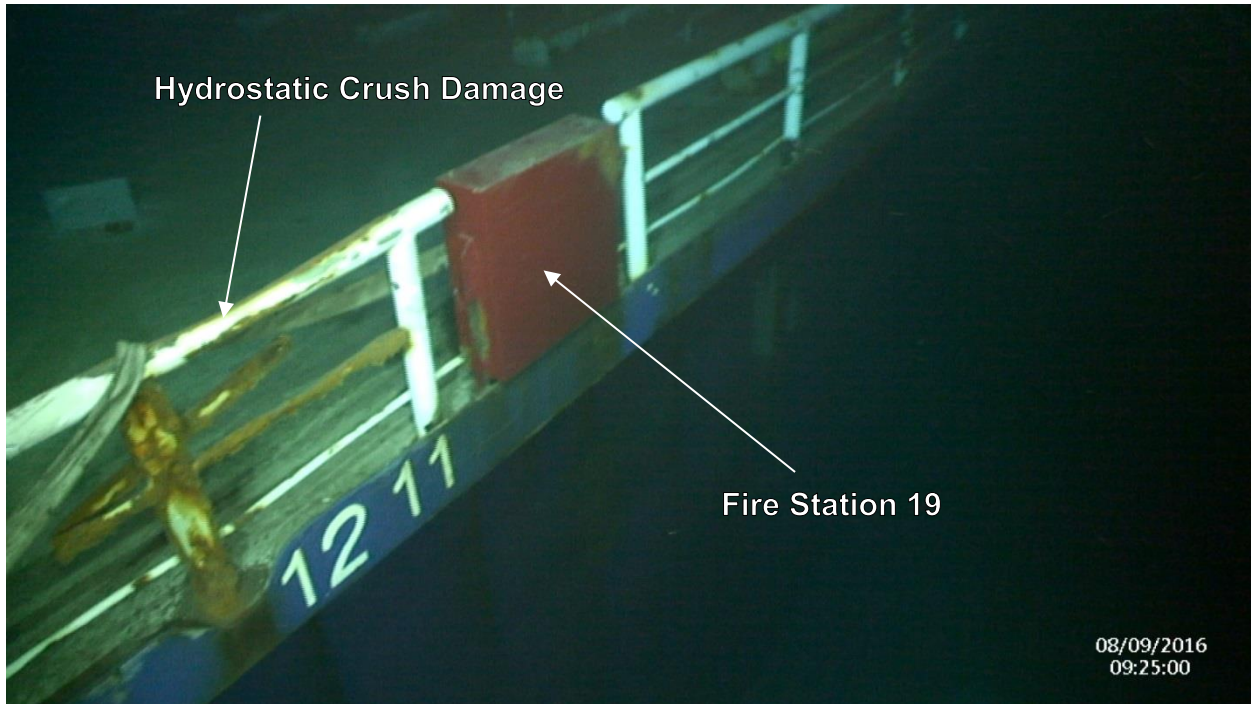
Figure 82. Region: Starboard – Frame 133 Source: Mission III Vehicle: CURV 21

Fire station no. 19 and railing intact at frame 133. Note hydrostatic crush damage to railing pipe just above the number "12."

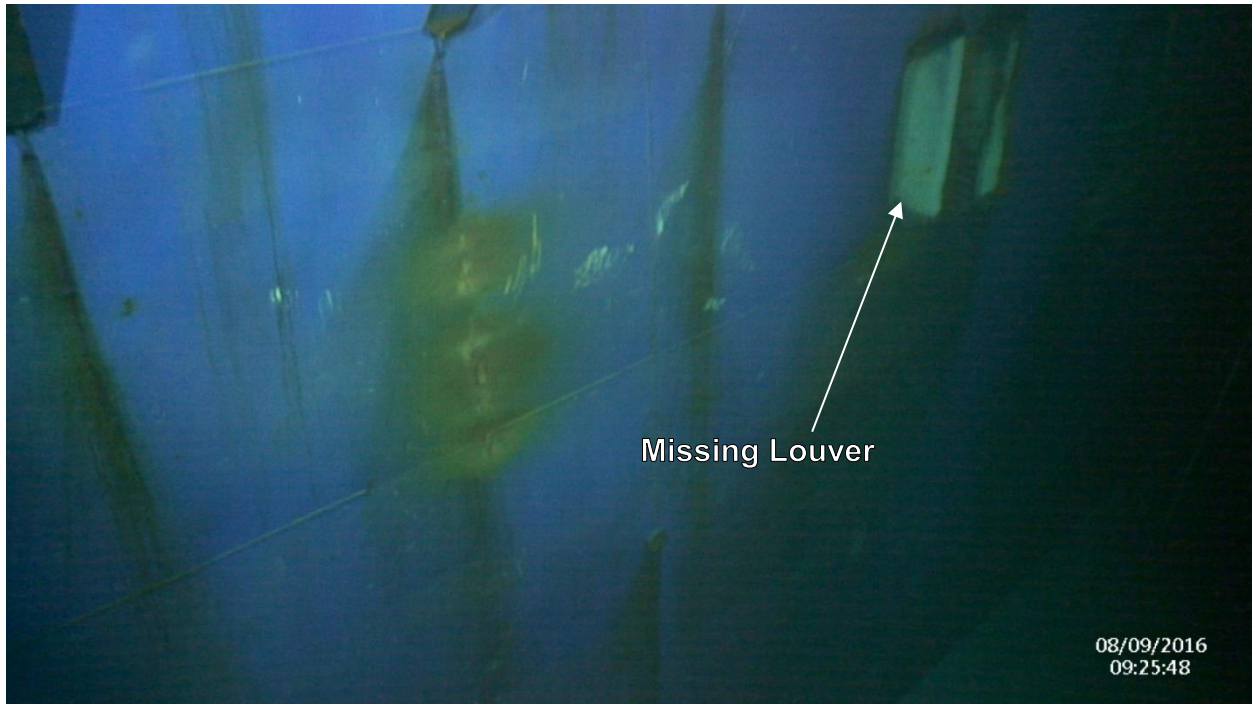
Figure 83. Region: Starboard – Frame 123 Source: Mission III Vehicle: CURV 21

Missing cargo hold exhaust ventilation louvers at frame 123.

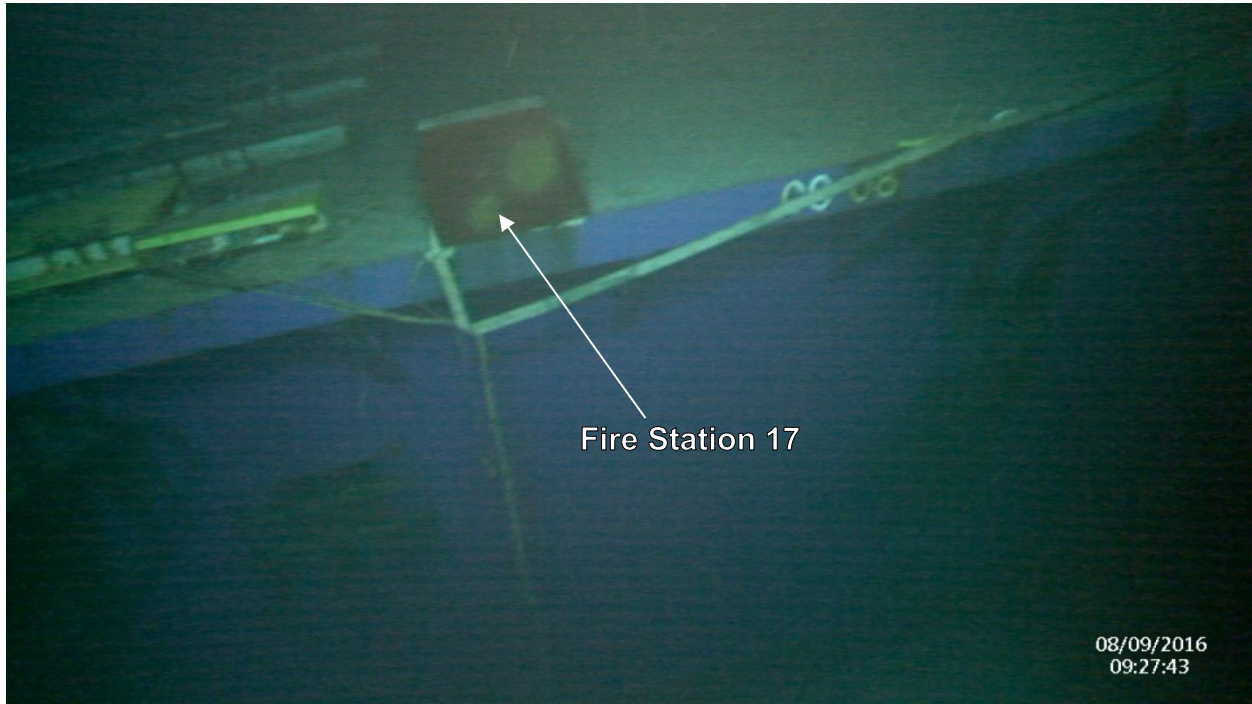
Figure 86. Region: Starboard – Frame 100 Source: Mission III Vehicle: CURV 21

Fire station no. 17 intact at frame 100. Deck railing to each side is missing.

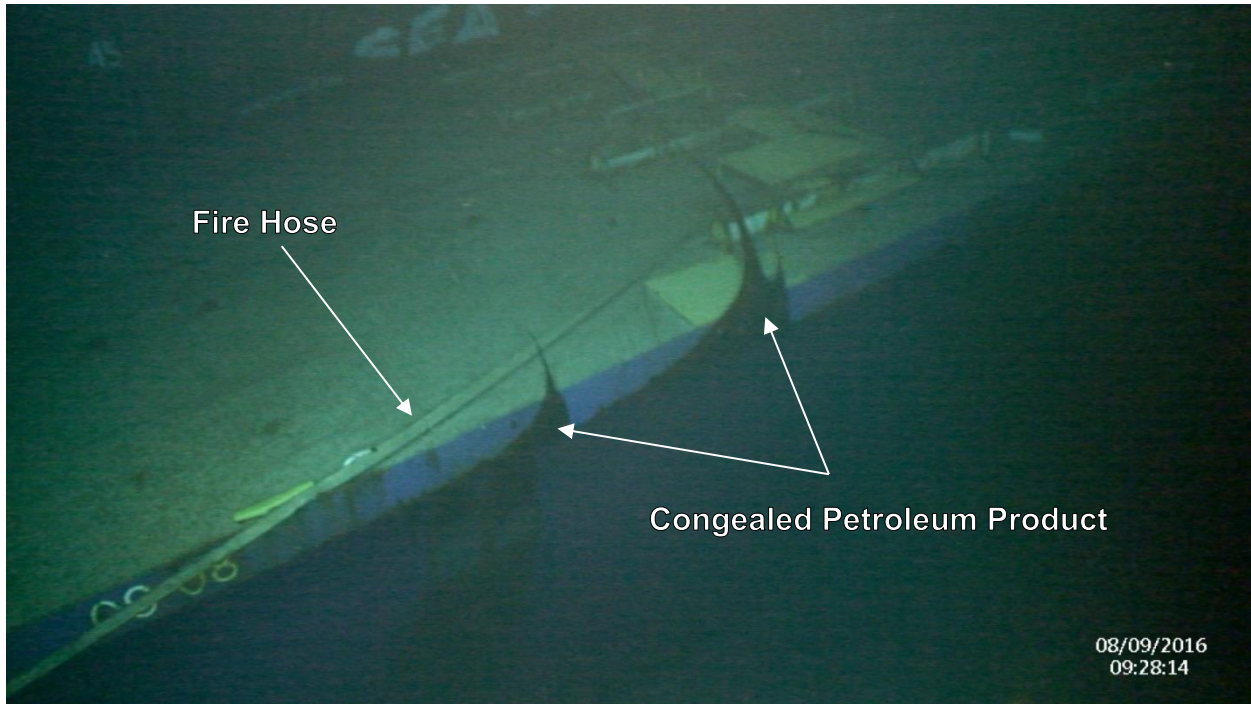
Figure 87. Region: Starboard – Frame 100 Source: Mission III Vehicle: CURV 21

2.5 inch firehose from fire station no. 17 streamed forward above bays 09 and 08. Visible congealed petroleum product plumes from second deck out through side vent alongside main deck. 45-foot container exhibiting hydrostatic crush damage resting on deck above bay 08.

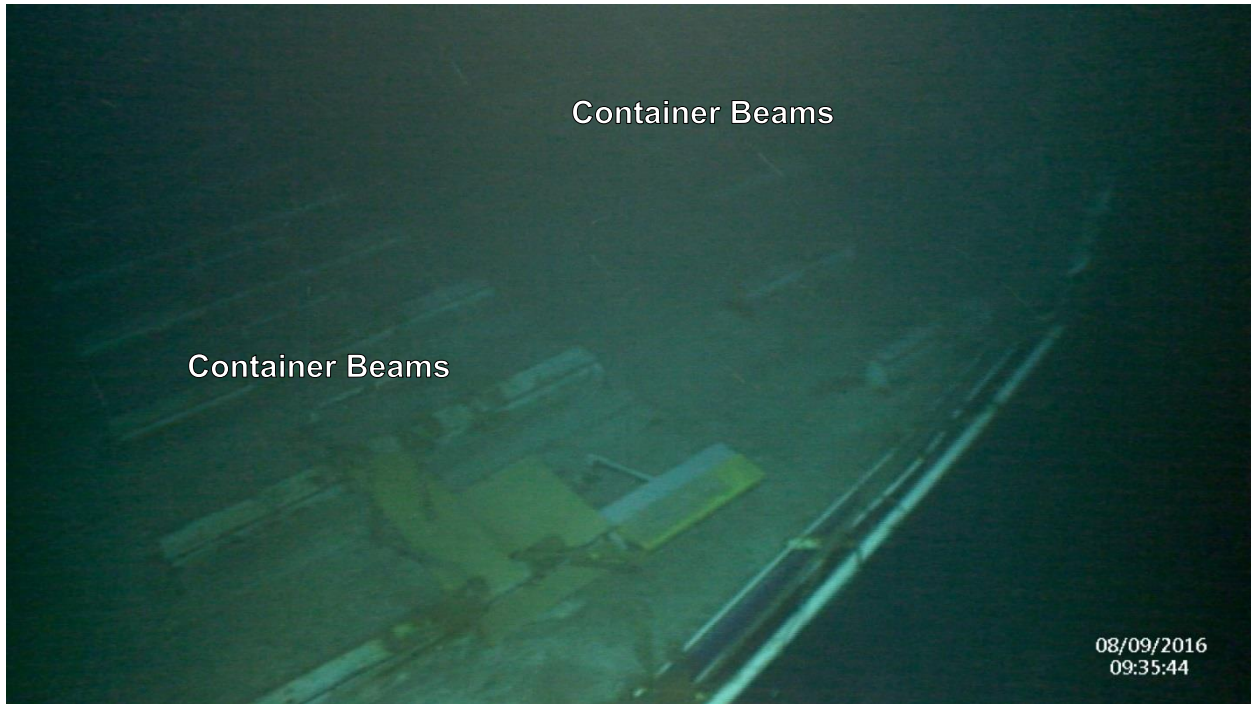
Figure 90. Region: Starboard – Frames 40 - 45 Source: Mission III Vehicle: CURV 21

The container beams in the vicinity of bay 02 and 03 appear to be undisturbed. The starboard side deck railing appears to be bent outward. The deck rail appears to begin around frame 45 where fire station no. 15 is missing.

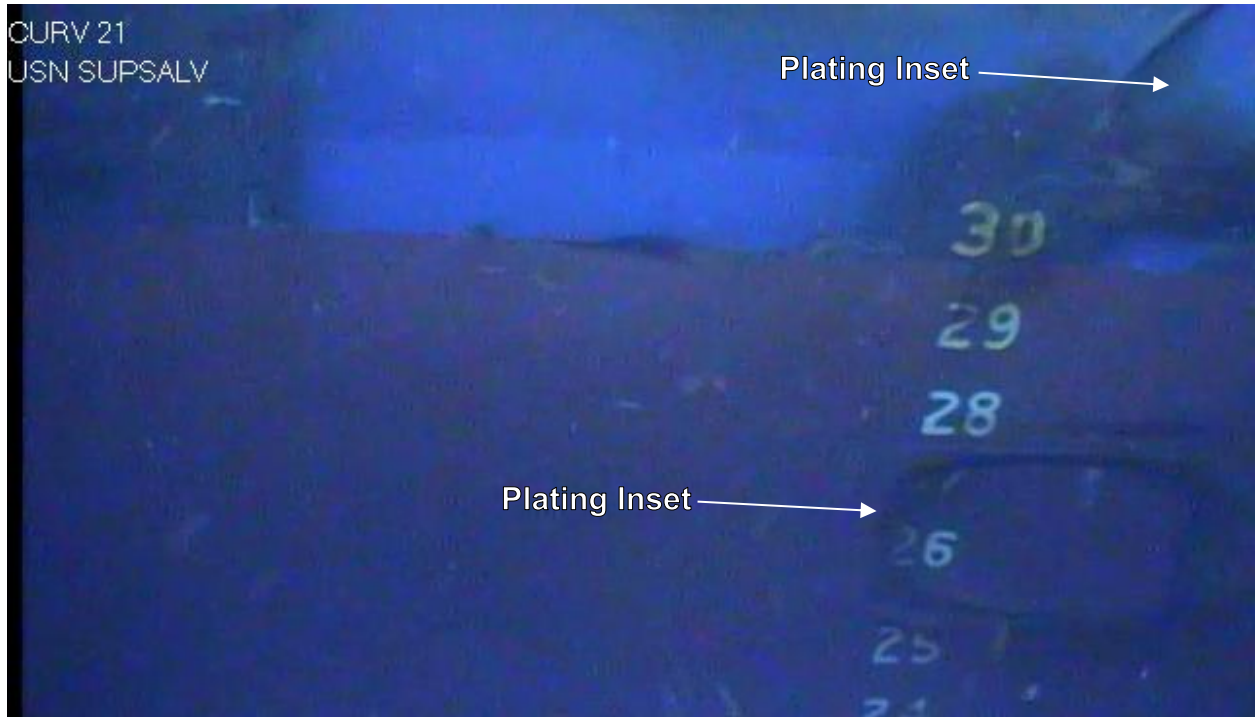
Figure 97. Region: Starboard – Bow Source: Mission I Vehicle: CURV 21

Hydrostatically inset plating from stem bar to frame 2 near 26-foot draught mark.

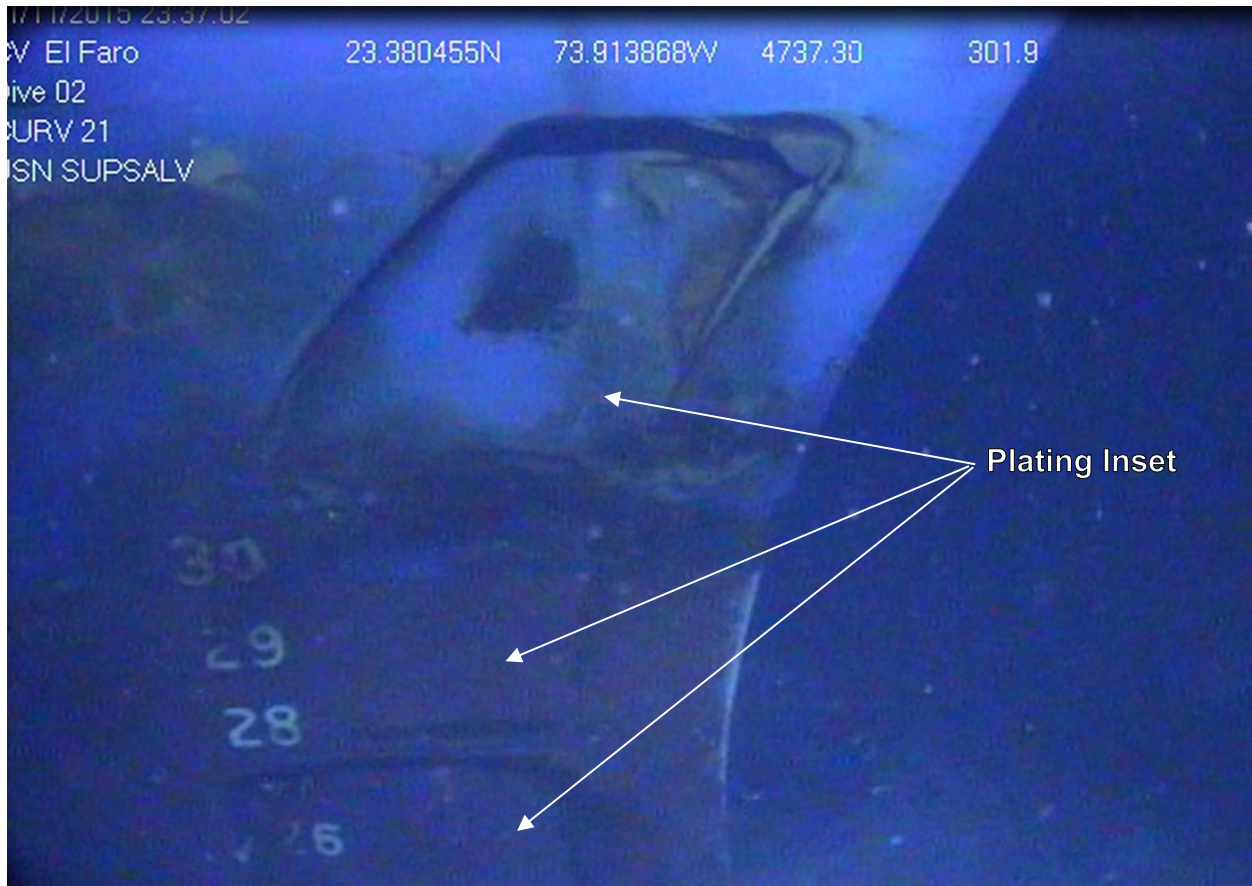
Figure 99. Region: Starboard – Bow Source: Mission I Vehicle: CURV 21

Alternate view of hydrostatically inset plating in region determined from structural drawings to be a stem casting void space. The damage in the upper portion spans from the forward stem to frame 2.

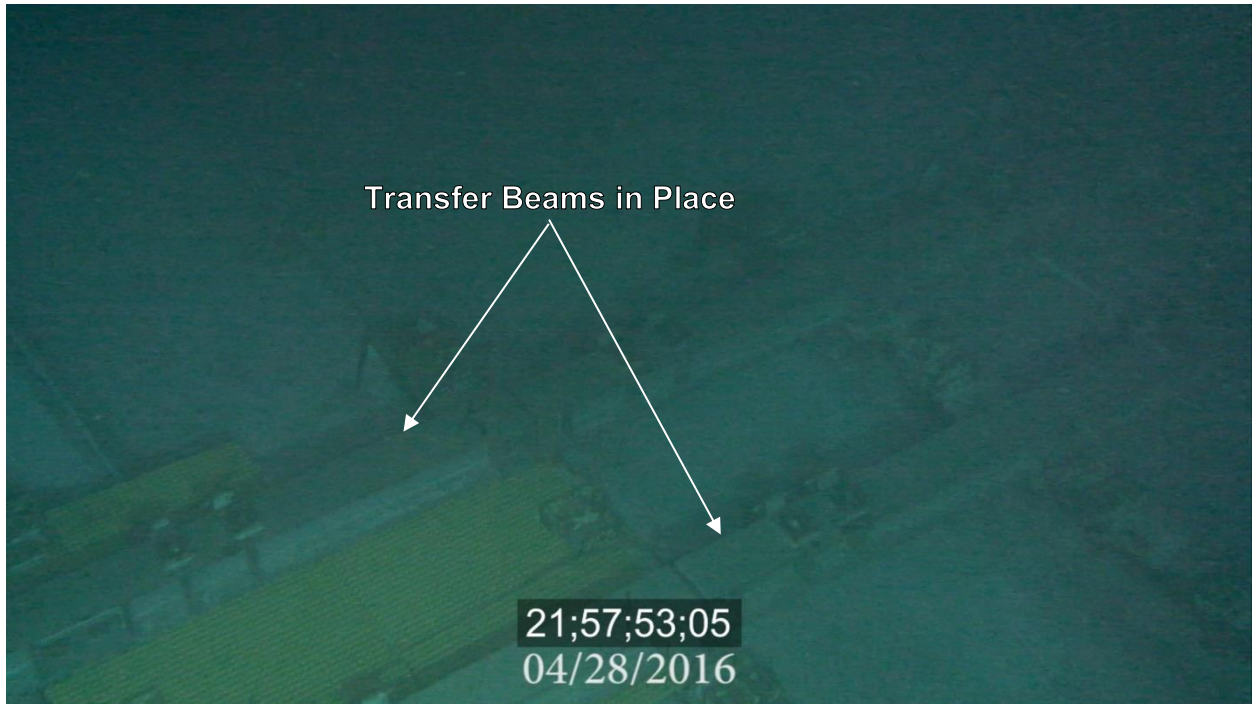
Figure 102. Region: Main Deck (forward) – Bay 14 and 15 Source: Mission II Vehicle: AOV

Transfer beams in place and undamaged in the vicinity of bays 14 and 15.

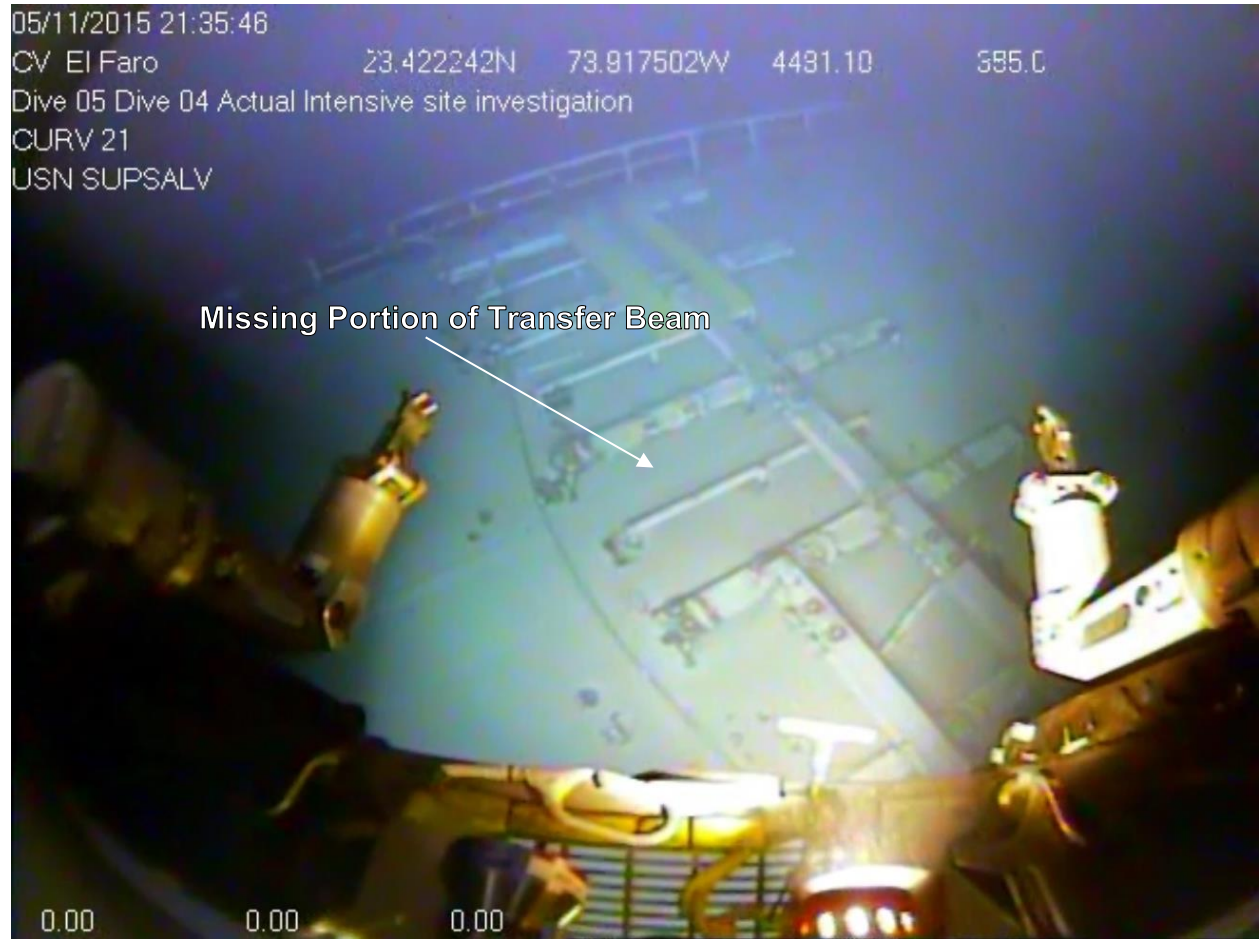
Figure 103. Region: Main Deck – Bay 13 Source: Mission II Vehicle: AOV

Frame 134/10 looking toward the port side. The outboard section of transfer beam on the port side is missing. From the review of the recordings, bays 12, 13, 14 and 15 do not have containers remaining on deck.

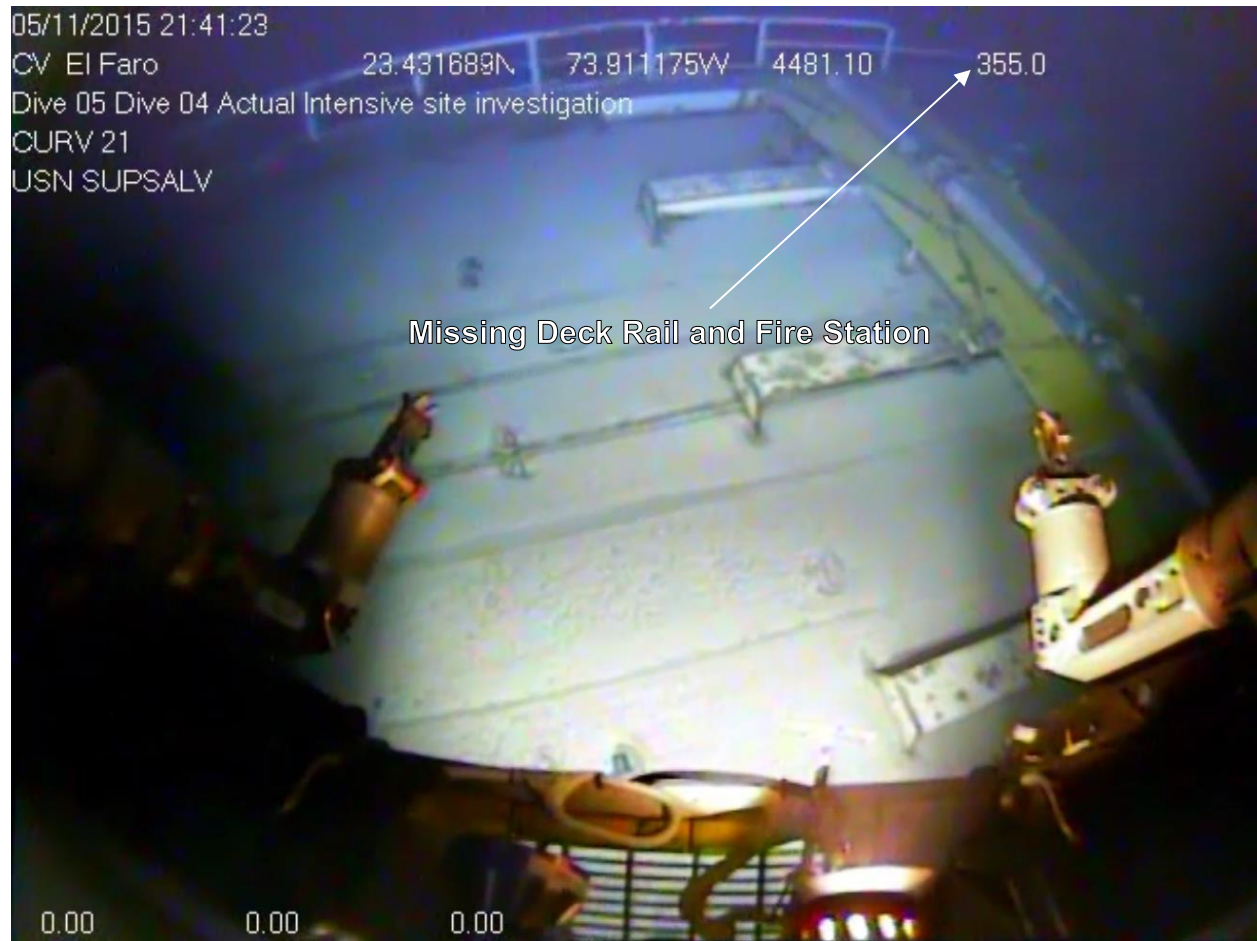
Figure 104. Region: Main Deck (forward) – Bay 13 Source: Mission II Vehicle: AOV

Absence of starboard side main deck rail aft of frame 134/28. Fire station no. 39 is missing.

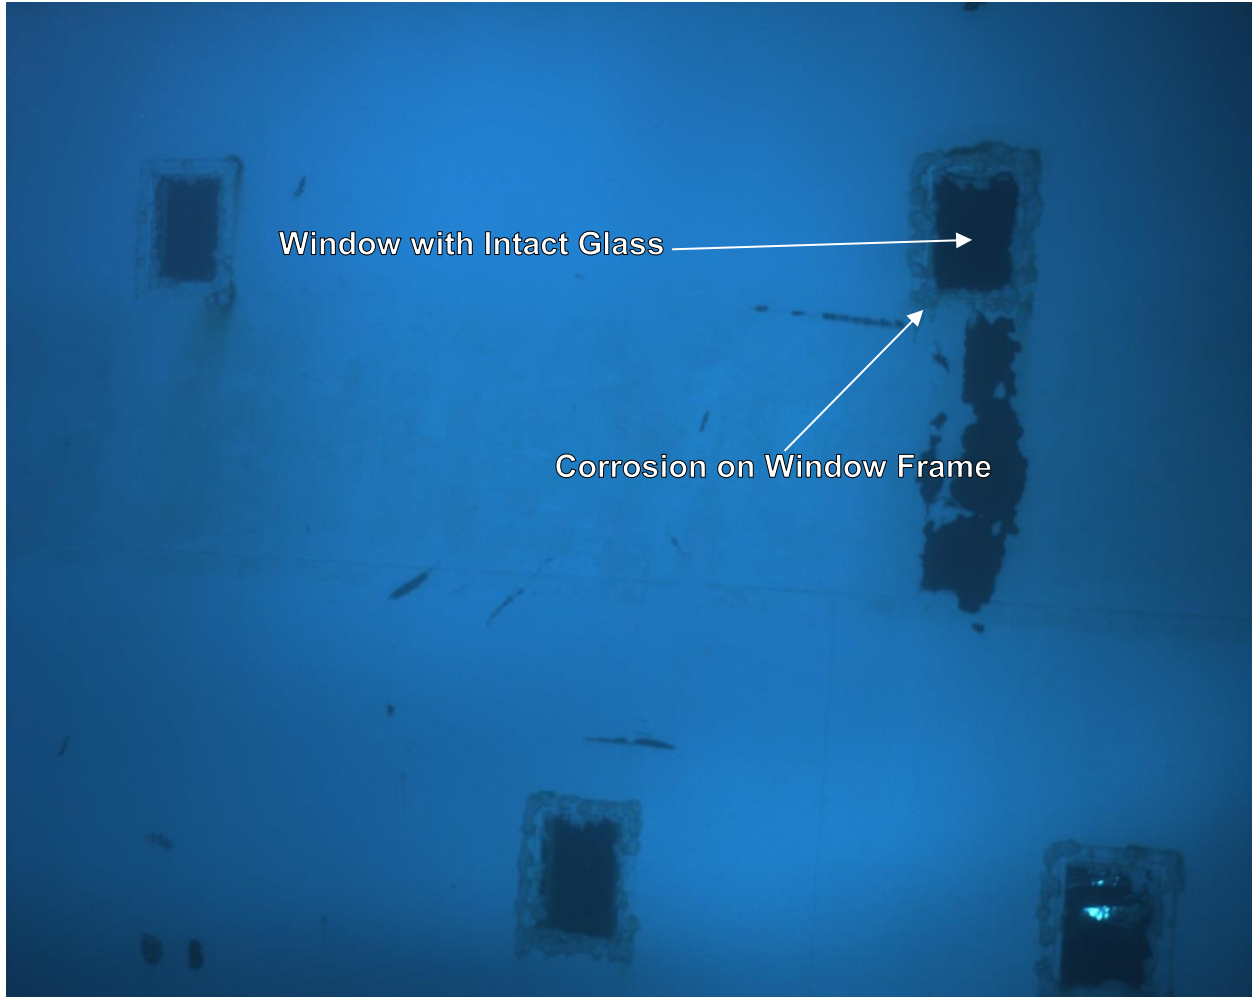
Figure 107. Region: Deck House – Fwd Source: Mission II Vehicle: AOV

A close up image of windows on the forward portion of the deck house. All window glass throughout the deck house appears to be intact. Corrosion is exhibited around the windows on the aluminum window frames.

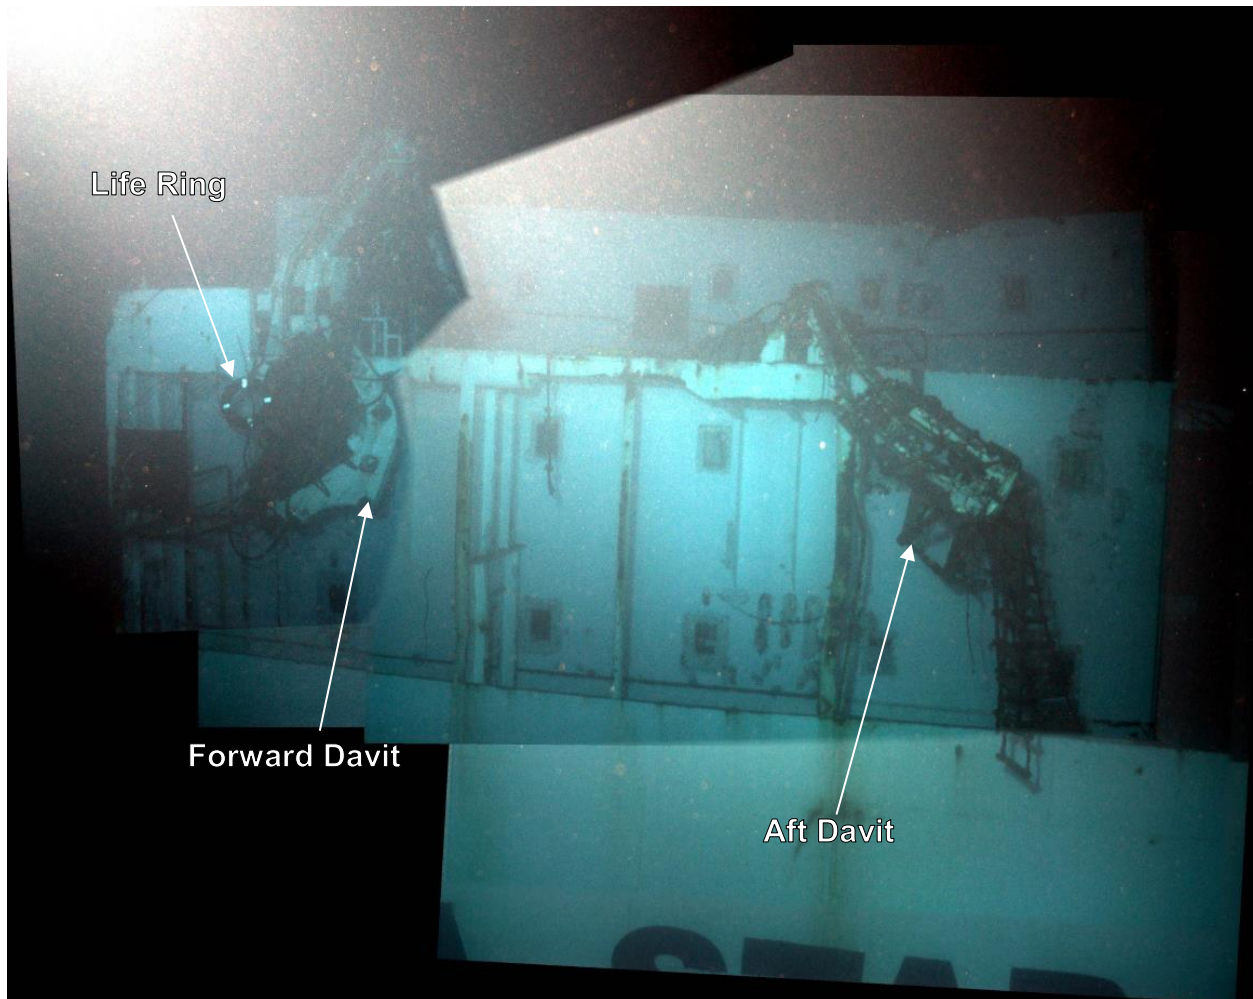
Figure 111. Region: Deck House – PORT Source: Mission II Vehicle: AOV, MOSAIC Compilation

The port side of the deck house showing the life boat launch area. The left side of the image is forward. To the left of the image, an intact life ring is present. The forward davit track is in place but the forward davit is down and turned aft. The aft davit track is broken loose and pulled aft and over the port side.

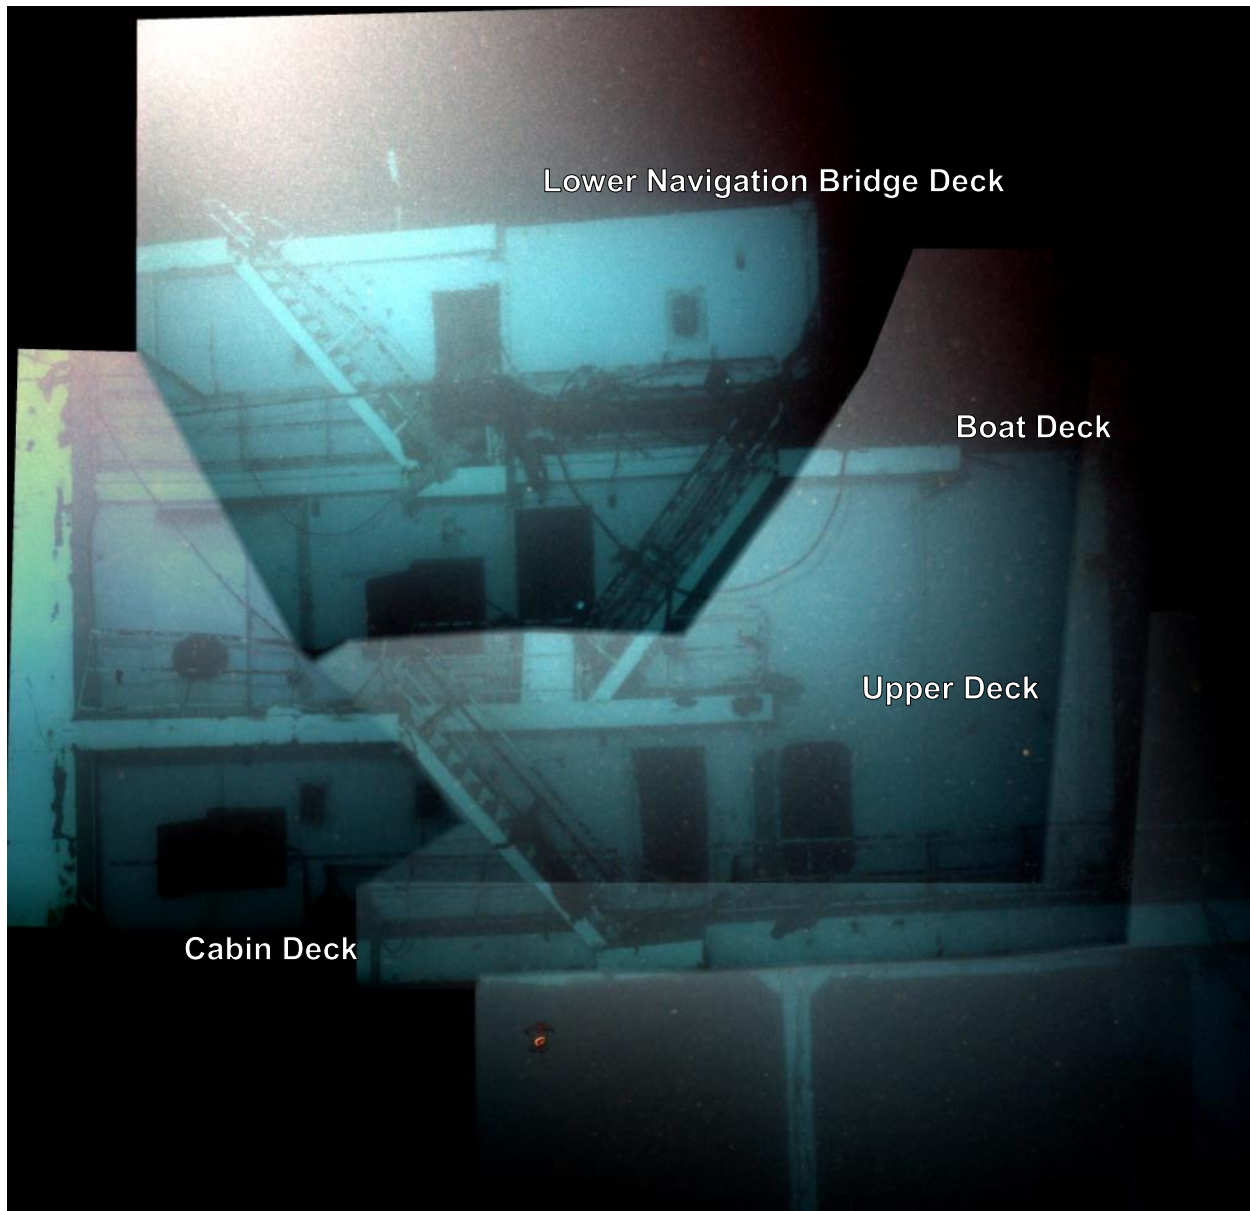
Figure 124. Region: Deck House – AFT Source: Mission II Vehicle: AOV Mosaic Image

A mosaic image of the aft starboard side of the deck house. The aft deck house ladders are intact. The uppermost ladder is from the lower navigation bridge deck to the boat deck, the 2nd ladder from top is from boat deck to cabin deck, the third is from cabin deck to upper deck and the main deck is at the bottom of the image. All exterior passageway doors are missing with the exception of a water tight door that forms a passageway to the reefer storage space on the upper deck/mess deck.

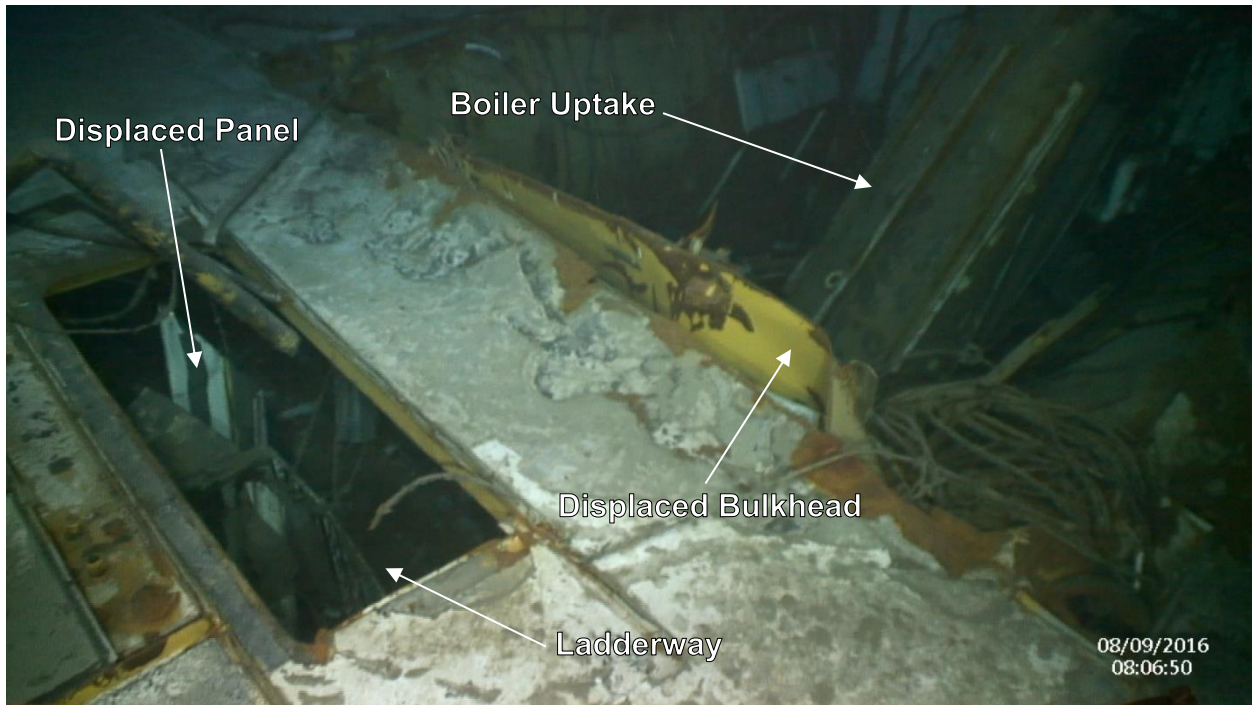
Figure 137. Region: Deck House – Top Source: Mission III Vehicle: CURV 21

Close up image of ladderway, going down from lower navigation bridgedeck, at frame 169 (rectangle cut-out at left). Ladder is missing from the ladderway passage. Interior panel with green and white stripes visible through the passageway is displaced from its original position.

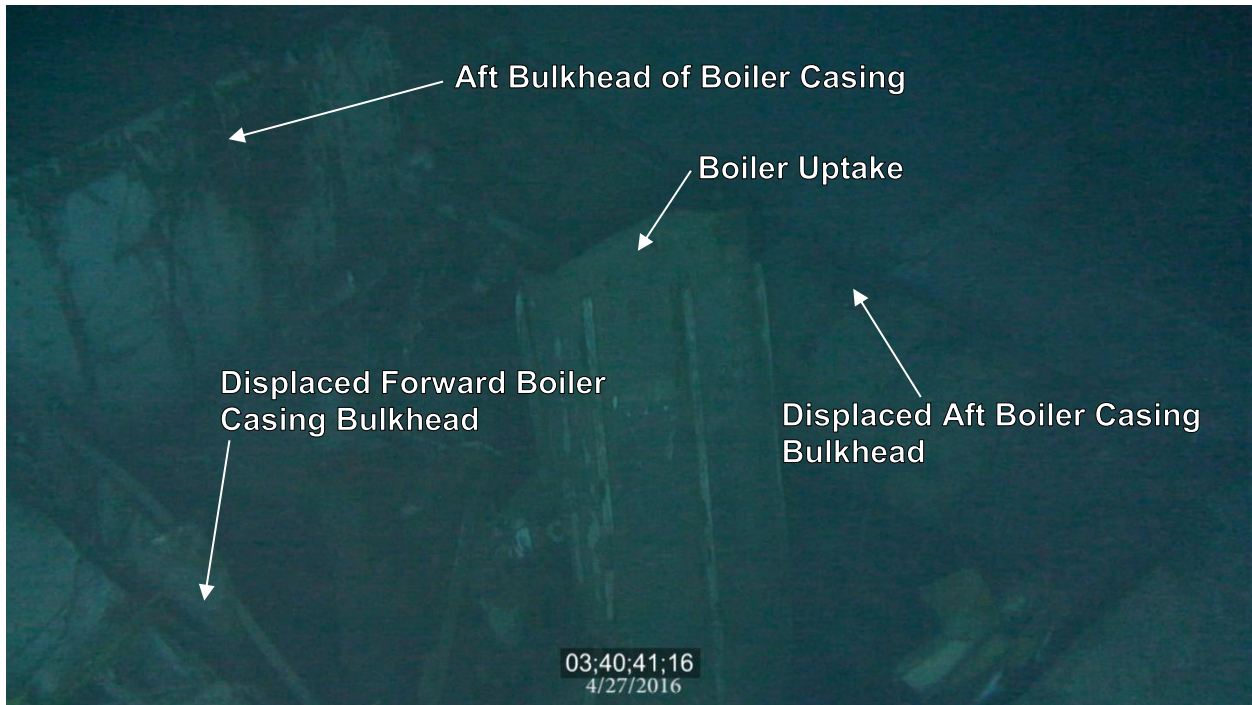
Figure 138. Region: Deck House – Top Source: Mission II Vehicle: AOV

An alternate view of the boiler uptake displaced aft. The view is looking from starboard to port and aft, just above the lower navigation bridge deck. The white bulkhead in the upper left corner of the image is the aft bulkhead of the boiler casing. The bulkheads surrounding the boiler casing are bulged inward on the starboard, aft and port sides. The boiler uptake is broken off at the lower navigation bridge deck. Aft of the boiler uptake, the top of the direct contact (DC) heater is visible.

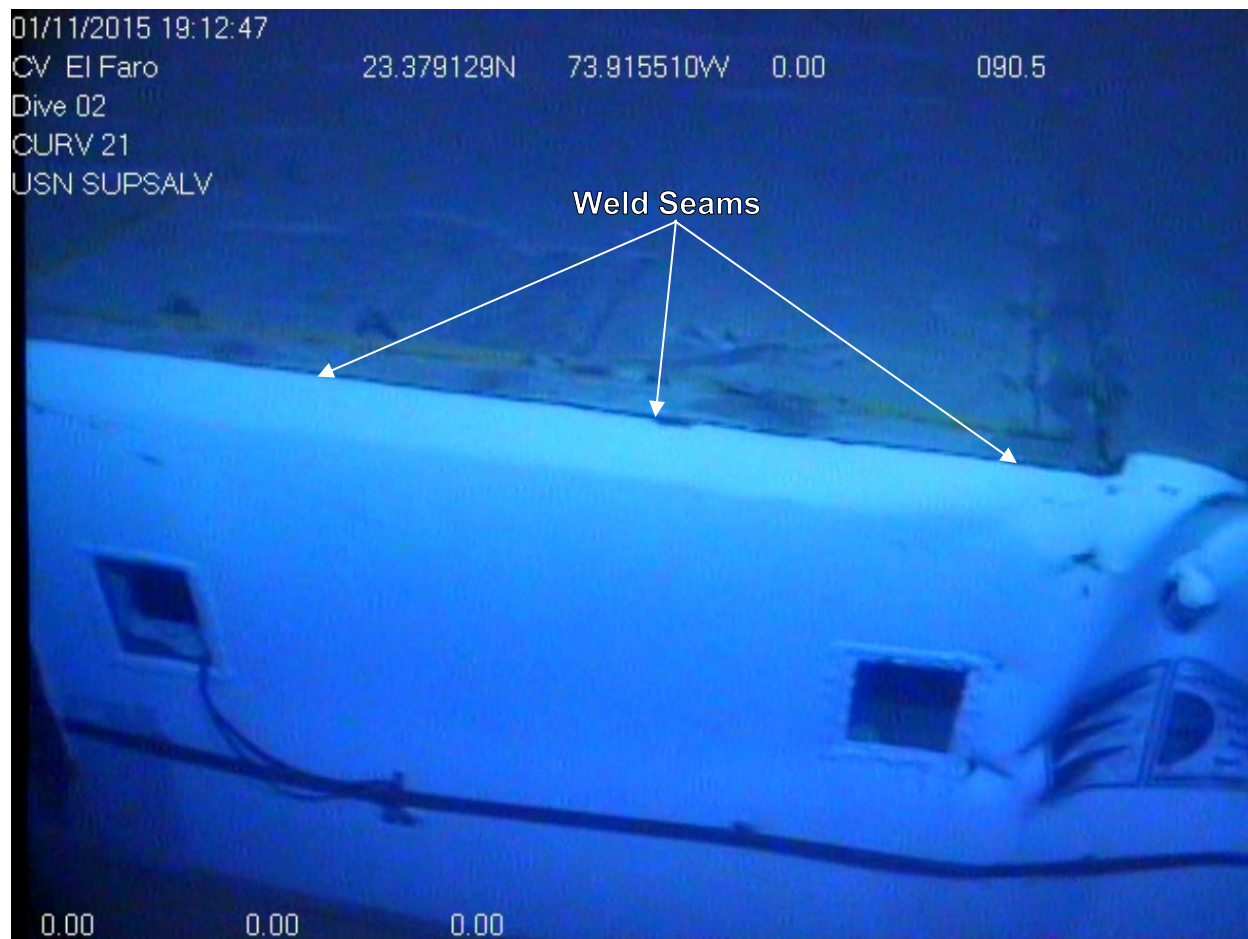
Figure 140. Region: Deck House – Top Source: Mission I Vehicle: CURV 21

The aft port side of the lower navigation bridge deck looking toward starboard. The weld seams to the exterior bulkheads of the lower navigation bridge deck appear to have failed evenly and cleanly along the examined perimeter of the vertical exterior bulkheads.

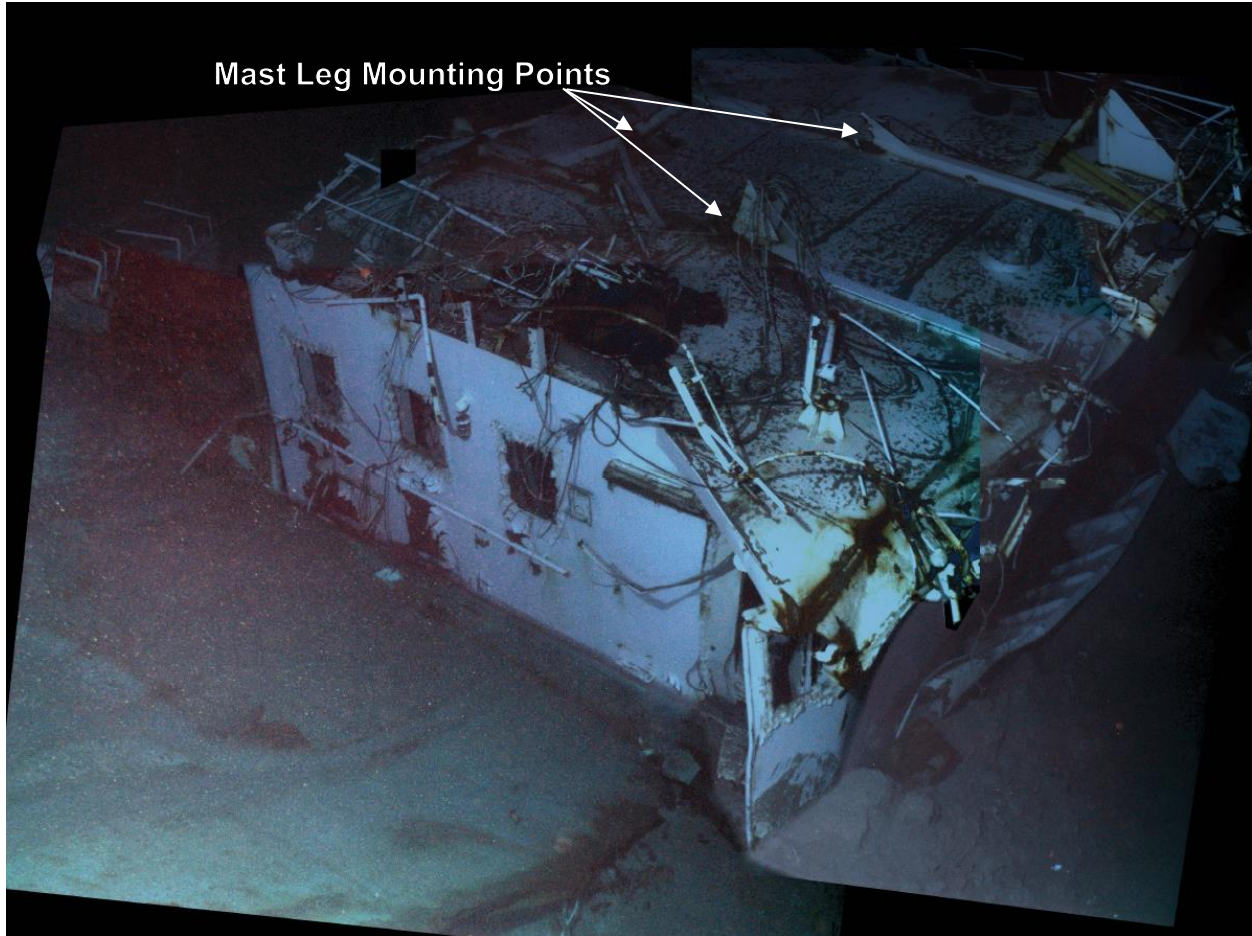
Figure 142. Region: Bridge Source: Mission II Vehicle: AOV Mosaic Image

The forward starboard corner of the wheelhouse and navigation bridge deck looking down and aft. All the windows are missing. The starboard forward corner (lower center of image) has seabed mud mounded forward of the corner. The windscreen bulwark is bent inward at the deck level and has mud pushed forward of it. The three mast legs have been severed from the wheelhouse top. The railings around the perimeter of the house top are missing or severely bent and broken. The stack is missing from the aft side of the wheelhouse.
