NATIONAL TRANSPORTATION SAFETY BOARD
Office of Research and Engineering
Washington, DC

Wind Component Study

El Faro

DCA16MM001

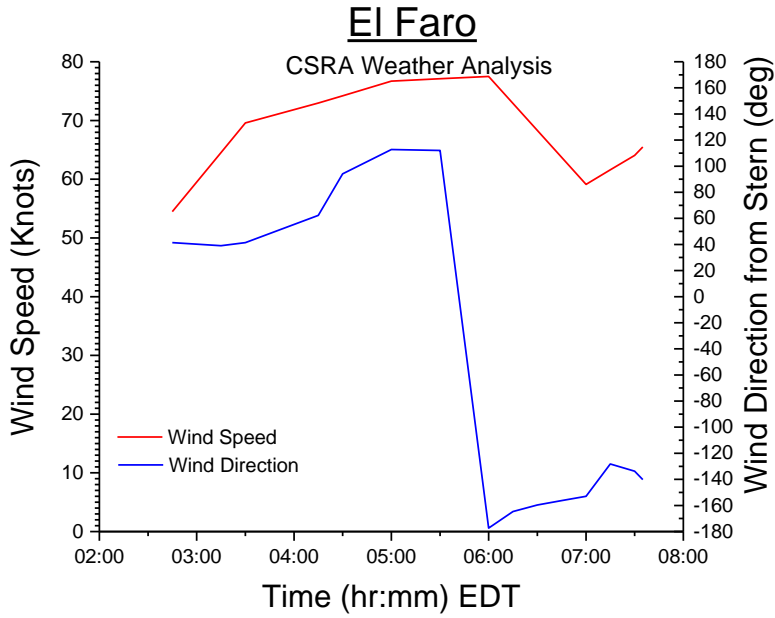
Figure 1 CSRA wind estimate

The wind speed and direction from the CSRA report are given in figure 1 while the wind speed and direction from the Tote submission is given in figure 2. Note that wind direction in figure 1 from the CSRA report is relative to the stern where wind direction in figure 2 from the Tote submission is relative to true North. Ship's speed and heading needed for the study were available on the VDR and are presented in figure 3.

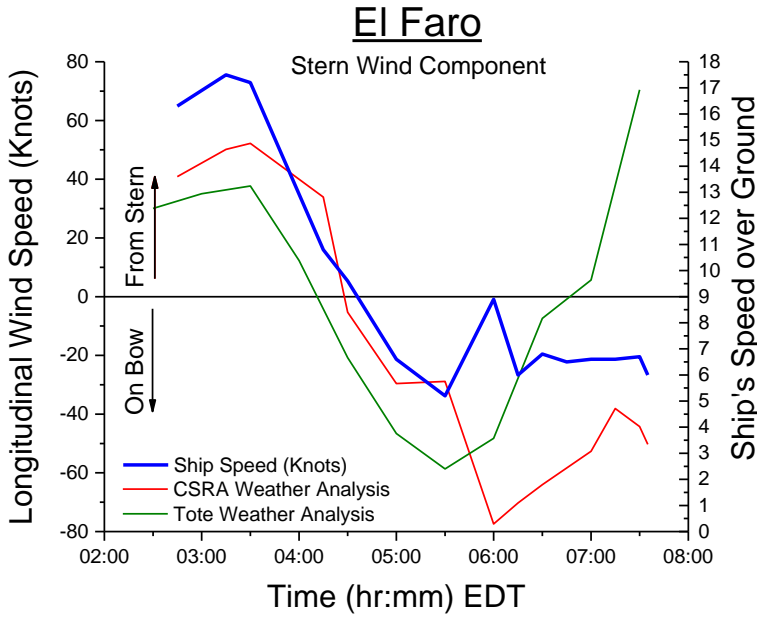
Figure 4 Stern wind component

Since the Tote submission wind direction was relative to North, relative wind was first obtained by combining the heading with Tote’s wind direction. The resulting relative wind direction was then used in the equations above to obtain the stern and side wind components. The stern wind components using Tote and CSRA wind estimates are compared with ship’s speed in figure 4 while the side wind components compared with ship speed are presented in figure 5. Both components are presented together in figure 6 with VDR comments added in figure 7.

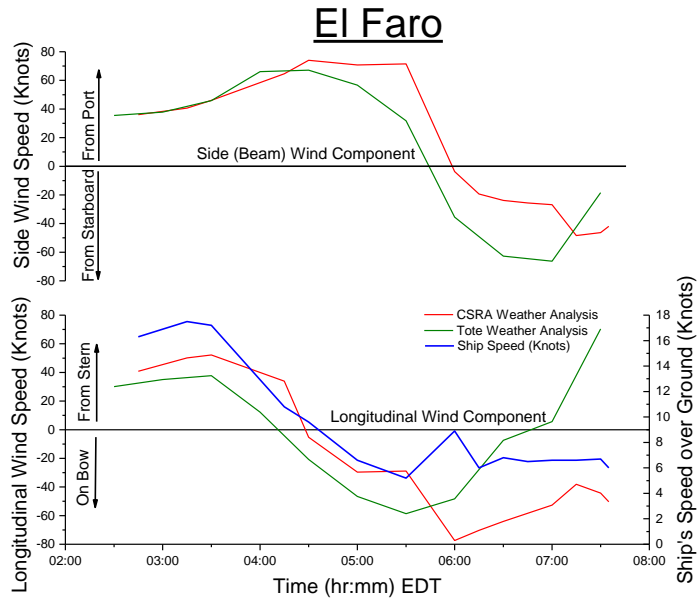
Figure 6 wind components

The ship experienced a strong growing side wind component from the port side as the component from the ship’s stern decreased until the ship turned to Port shortly before losing the plant. This wind would contribute to the starboard heel during this period. As the ship reversed course the wind shifted from the bow and from the starboard side. Using the CSRA wind estimate the port side wind peaked at 74 knots. Using the Tote Submission wind estimate the port side wind peaked 67 knots.
