National Transportation Safety Board

Group Chairman's Factual Report

Engineering Group

DUKW 34 - Caribbean Sea

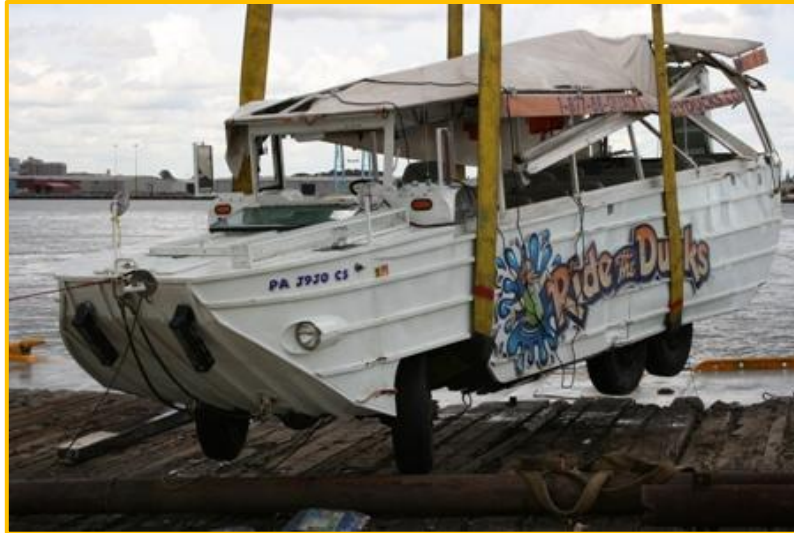
4.5.1. DUKW 34. Damage to the APV was principally to the port side of the hull and the aft port side of the canopy (figures 6 and 7). The damage to the hull consisted of scrapes and indentations along the hull external support members and hull shell, and to the “Ride The Ducks” sign attached to the side of the hull. The scrapes to the “Ride The Ducks” sign were at an approximate angle of 45 degrees and they indicated the relative movement between the APV and barge during their period of contact. Damage to the canopy framing system consisted of bending and buckling of the square and rectangular steel tubing and tearing of the canopy awning, principally at the aft portion. The two aftermost port side vertical frames of the canopy were bent over approximately 45 degrees, and other support members were similarly damaged. The port side roller curtain was damaged and detached from its mountings, and the passenger-loading ladder indicated distortion and impact damage. The left front wheel was slightly displaced from its axis of rotation and a subsequent teardown examination showed that its drive axle was slightly distorted (bent).

Figure 6. View of damaged DUKW 34, photo taken after was raised from river bottom.

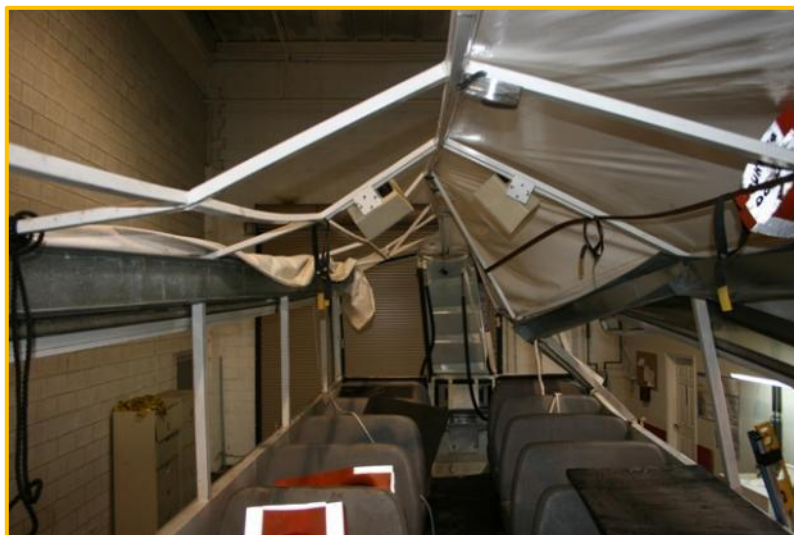
Figure 7. View of damage to canopy of APV from inside the cabin, looking aft.

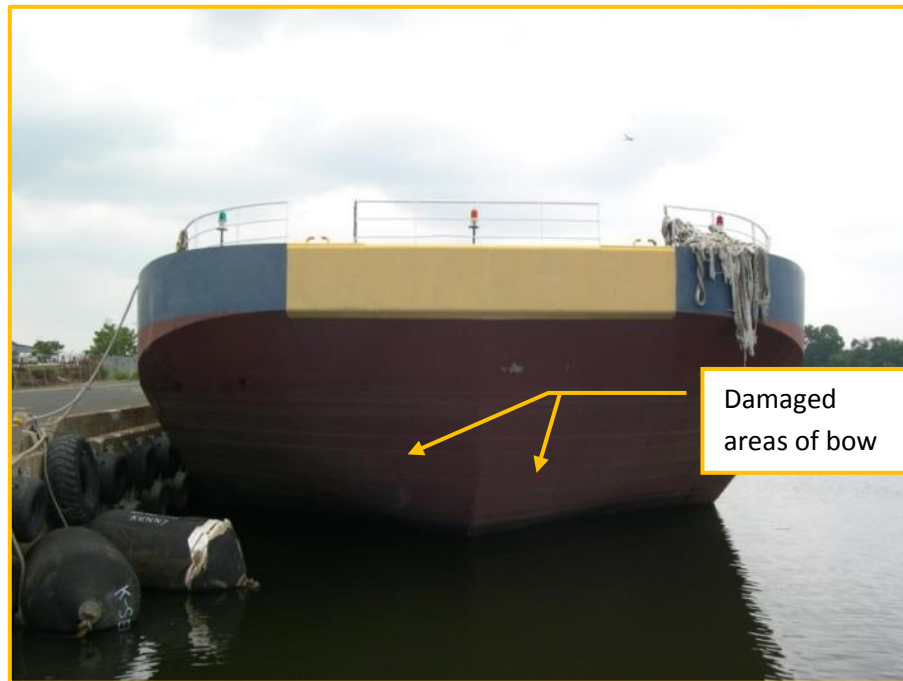
4.5.2. Caribbean Sea and The Resource. The barge resource showed minor damage at its bow area (rake), and the *Caribbean Sea* was not damaged. The damage to *The Resource* bow consisted of contact scrapes to the “stem” and to the port and starboard side of the bow area adjacent to the stem (figure 8). The contact scrapes affected the hull coating only, and there was no sign of damage to the hull plating or interior framing.³³ According to a representative from the City of Philadelphia, the minor damage to the barge hull coating had not been repaired after the accident.³⁴

Figure 8. View of damage to the bow of *The Resource*. Photo by the Coast Guard.

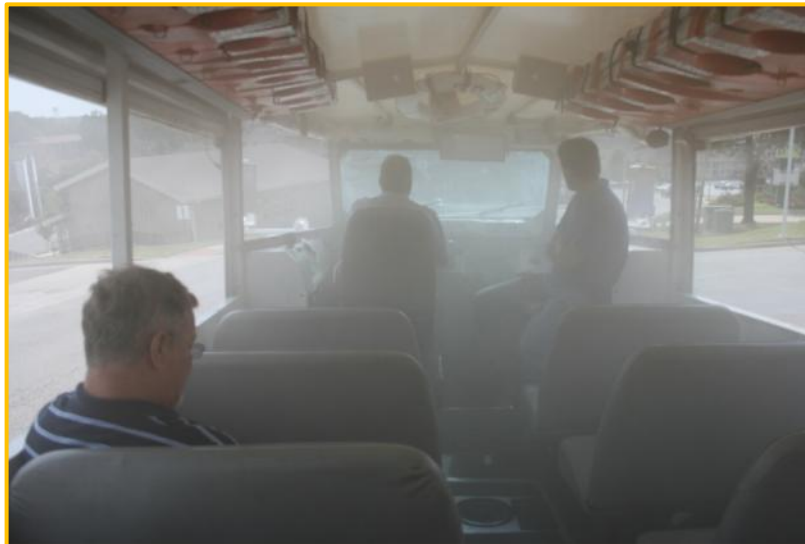
The second trial was performed in Branson, Missouri, on September 1 and 2, with a similar RTDI APV. In this trial run, the pressure cap was removed from the radiator surge tank, and the port side fire damper was closed after the engine cooling water temperature had stabilized. The trial consisted of only on-road travel⁴² and no attempt was made to match the trial load to the passenger load on the *DUKW 34* at the time of the accident. At the time of the trial, the ambient air temperature was about 72° F. The engine cooling water temperature was observed to increase to about 220° F after about 10 minutes of on-road travel. Steam was seen around the engine compartment when the engine water temperature reached 220° F (figures 9 and 10).

Figure 9. View of steam resulting from engine cooling water temperature about 220 degrees F, pressure cap removed.

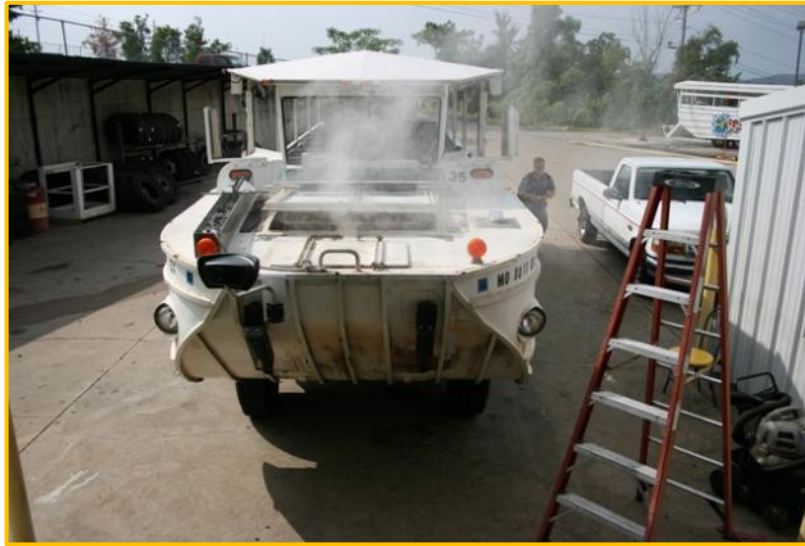
Figure 10. View of steam from engine compartment with engine temperature of about 220 degrees F, pressure cap removed.

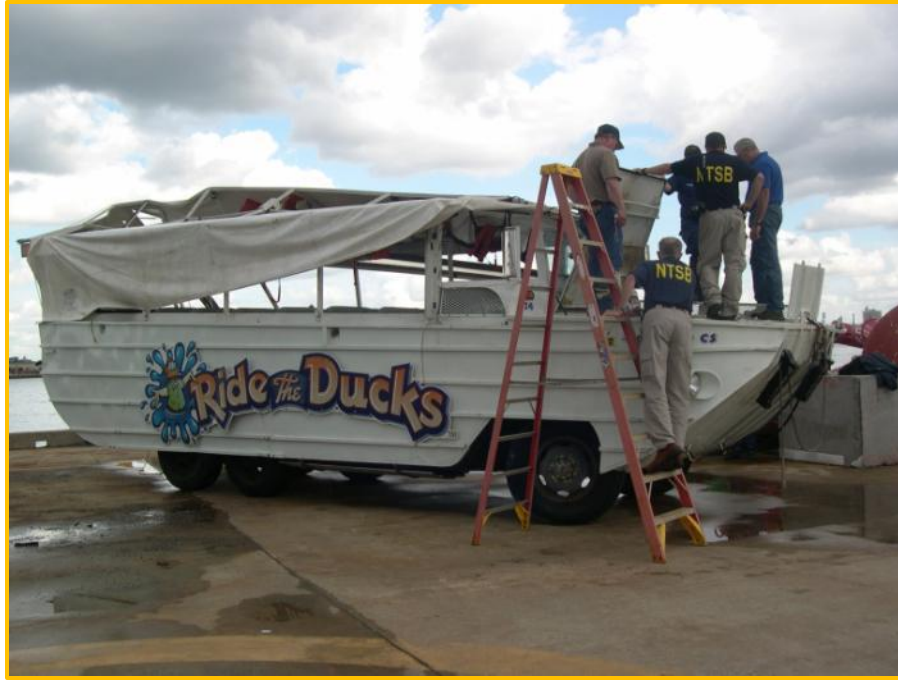
Figure A-2- 2. Initial examination of *DUKW 34* on day of salvage. Photo by the Coast Guard.

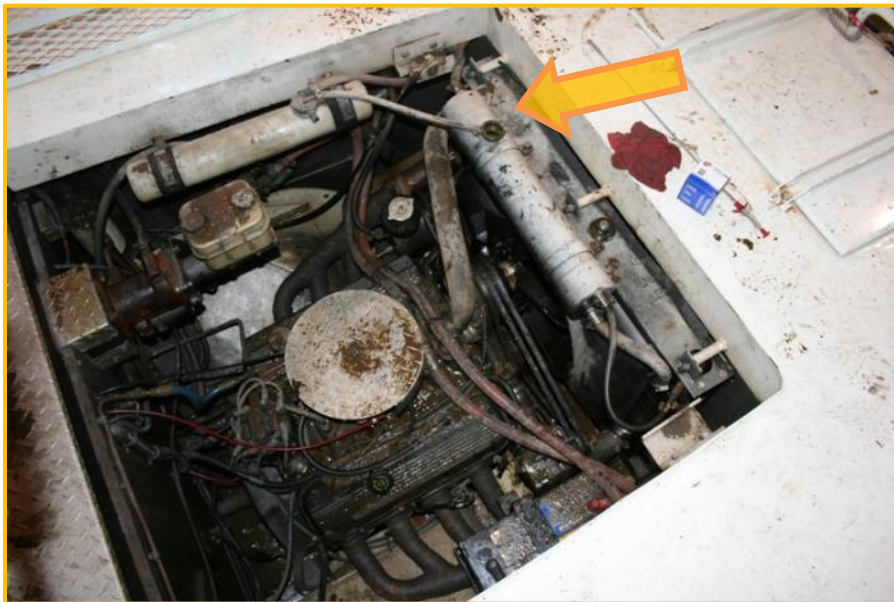
- 4.6.2.3. Radiator. After the APV was salvaged from the river, it was noted that the pressure cap, normally fitted to the surge tank, was missing. The pressure cap was subsequently found in the lower part of the engine compartment, and it and the surge tank fill neck were noted to be undamaged. The pressure cap was tested and was shown to open at 11 to 13 psi. The pressure cap was rated at 13 psi.³⁷

Figure A-2- 3. View of forward part of engine compartment, *DUKW 34*. Gold arrow indicates missing pressure cap at surge tank.

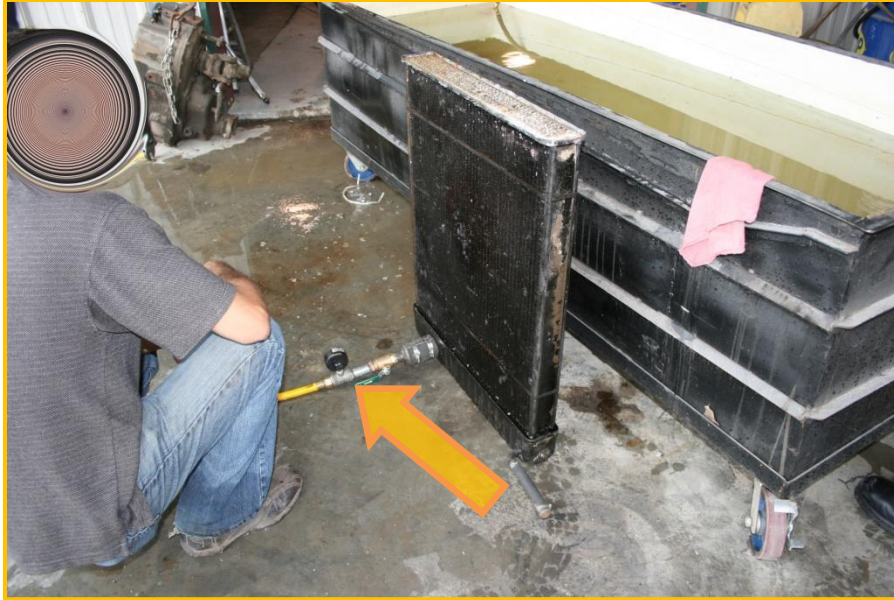
- During the teardown inspection of selected engine components, the radiator was removed from the engine and its top cover (header) was removed, which exposed the ends of the heat exchanger tubes. A water flow test of the radiator was normal, and no significant deficiencies were noted with the radiator.

Figure A-2- 4. Examination of radiator from *DUKW 34*. Gold arrow shows water hose connected to lower end of radiator for water flow test.
