# National Transportation Safety Board

## Group Chairman's Factual Report

*Seastreak Wall Street*

DCA-13-MM-005

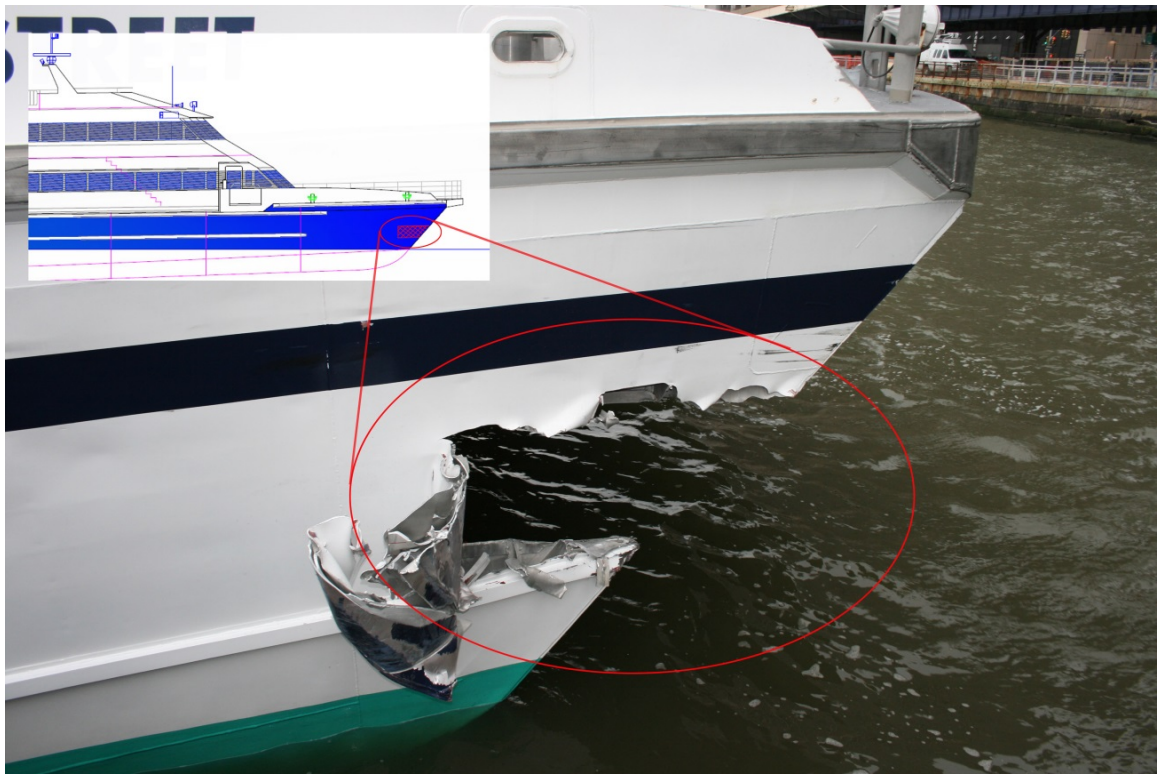
4.5.1. SSWS. Damage to the vessel hull was principally to the stem of starboard bow and to forward area of the cross member connecting the two hulls. The damage to the starboard hull consisted of a 30 inch-high trapezoid shaped inset into the stem, beginning about 30

inches above the waterline. The torn stem area extended about 45 inches at its lower side and 76 inches at its upper side. In this area of damage to the hull, the side shell was crushed and peeled away from the hull, and internal frames were displaced. Figure 9 shows the damage at the stem of the starboard bow.

Figure 9. Damage to stem of starboard hull

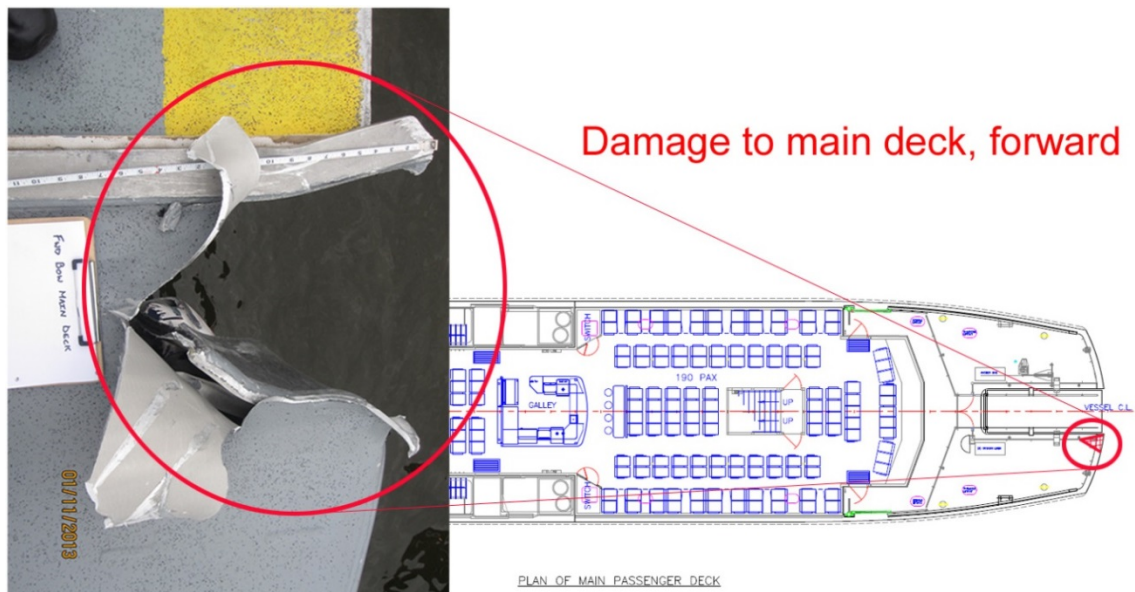
A second area of hull damage was to the connecting structure between the two hulls at the main deck level. This area of damage was at the forward main deck level, just to the starboard side of the forward loading ramp. The plating and frames in this area of the structure (about 18 wide by 19 inches by deep) were torn and displaced. Figure 10 shows this area of damage. Figure 11 shows both areas of the damage to the hull - the starboard bow stem and the starboard main deck.

Figure 10. Damage to main deck, near bow loading ramp.

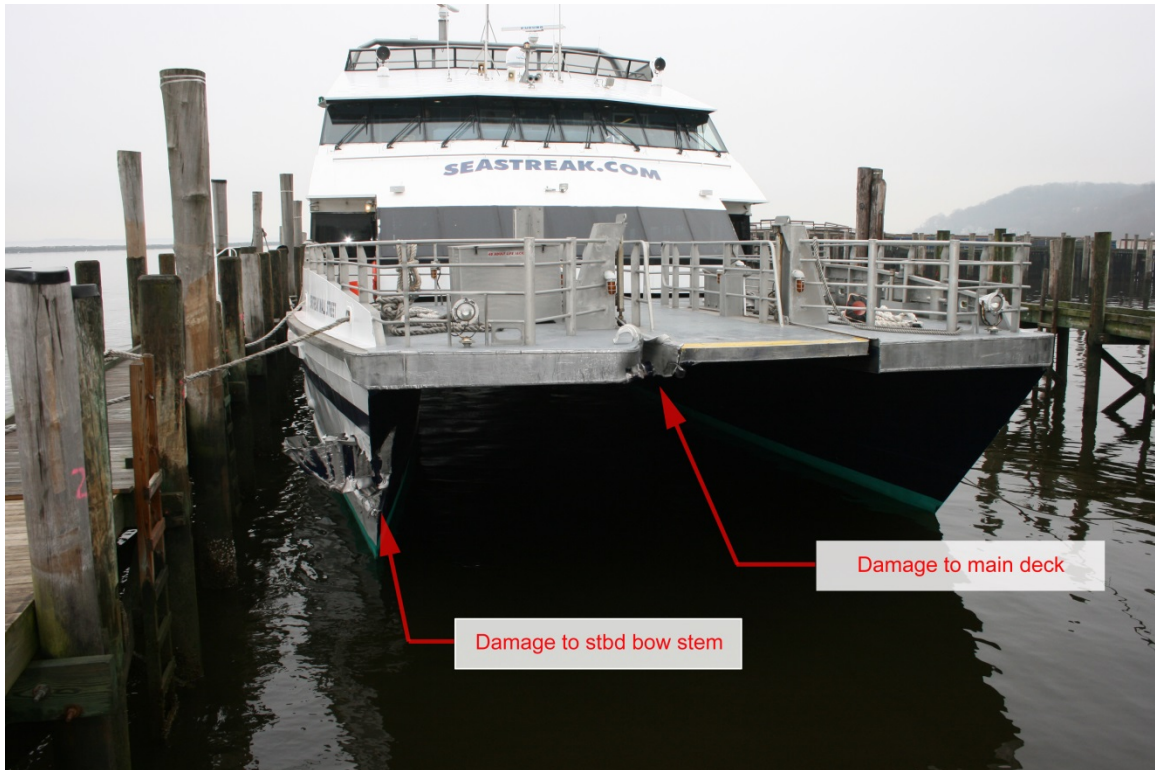
Figure 11. Damage to starboard bow stem and main deck.

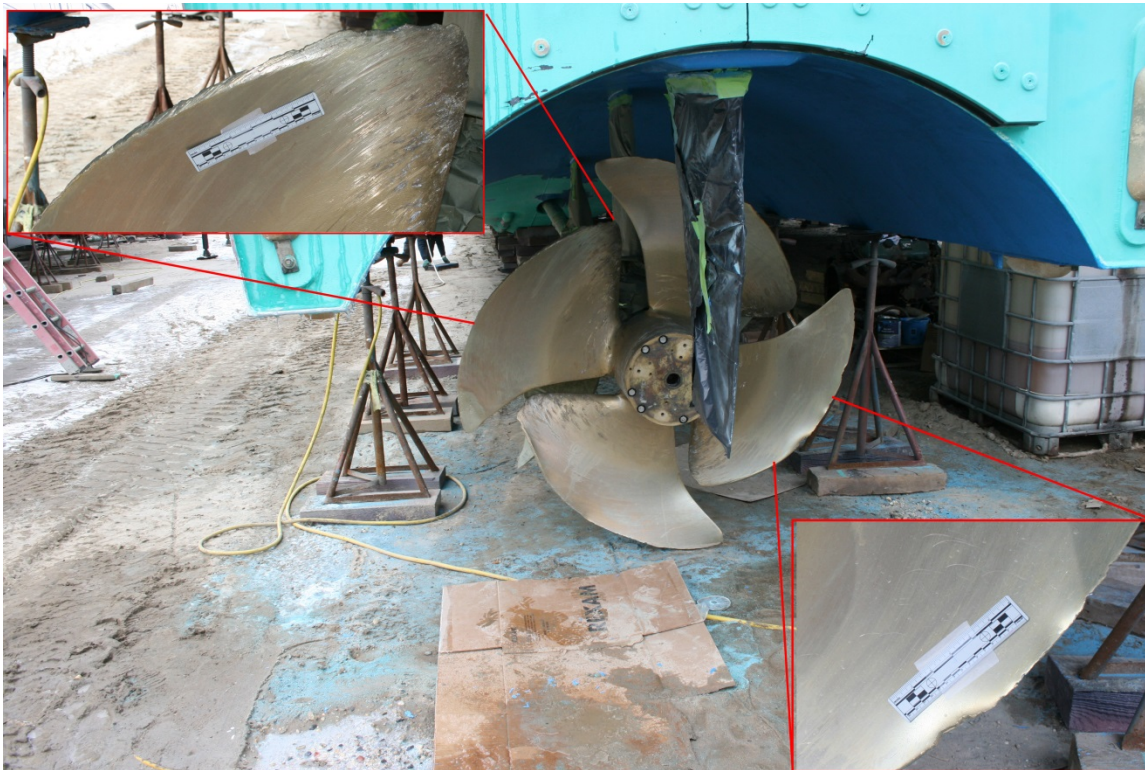
After the accident, a diver found the port propeller to be fouled with a 4-foot length of solid steel bar and a 3-foot length of stranded wire rope (cable). Additionally, when the vessel was hauled out of the water for hull repairs, both the port and starboard propellers were found to be damaged, and the port propeller cone was missing. The damage to the port propeller consisted of gouges and dents at the tips of all blades, along with significant deep scratches on the faces of the blades near their leading edges (figure 12). The starboard propeller damage was less severe than the port propeller and consisted of similar bending and gouging at the tips of all four blades, as well as some limited scratching of the blade faces.

Figure 12. Port propeller blade damage. Photo insets show the close up view of the damage to two of the propeller blades.

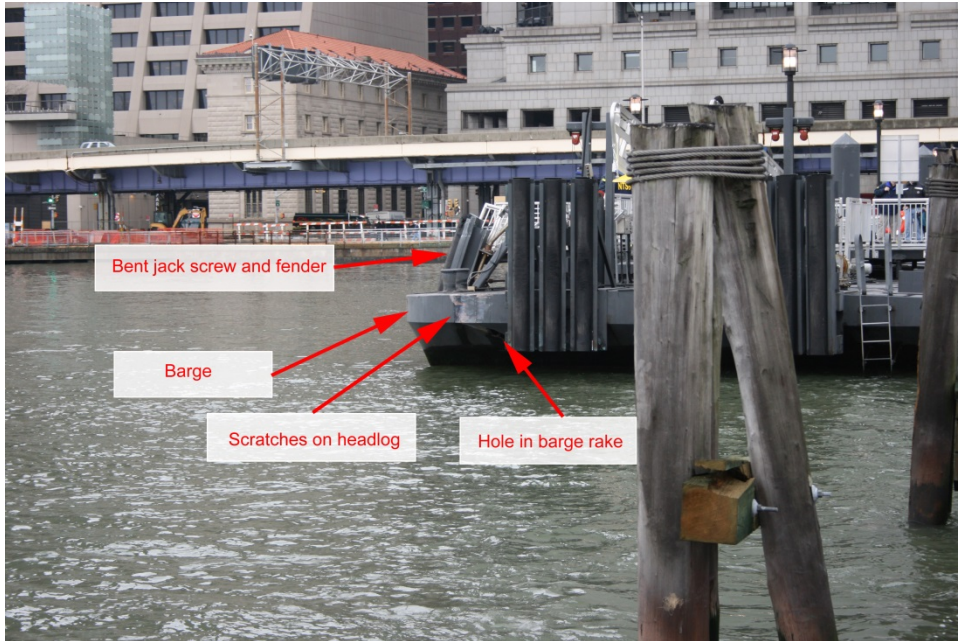
4.5.2. Slip D2, Pier 11 . According to witnesses, the vessel struck the D2 “sideloader”<sup>35</sup> at slip D, pier 11. The sideloader consisted of a deck barge<sup>36</sup> upon which a moveable platform was mounted, as well as associated fendering, hand railing, and a boarding ramp from the adjacent concrete pier. Damage to the raked deck barge consisted of scratching, indentation, and holing. The hole in the forward side (rake) of the barge was about 8 inches in diameter and about 2 feet above the barge’s waterline. Above the hole in the rake was an area of scratches about 2.5 feet wide at the barge headlog<sup>37</sup> (figure 13). Distinct white colored scratches about 4.5 feet in length by 2.5 feet wide were indicated on the main deck of the deck barge. The angle of the scratch relative to the top edge of the headlog was about 45° (figure 14). Damage to ramp and platform fitted to the deck barge consisted of bending damage to a jacking screw used to elevate the platform and fender along with

Figure 13. Damage to deck barge and sideloader.

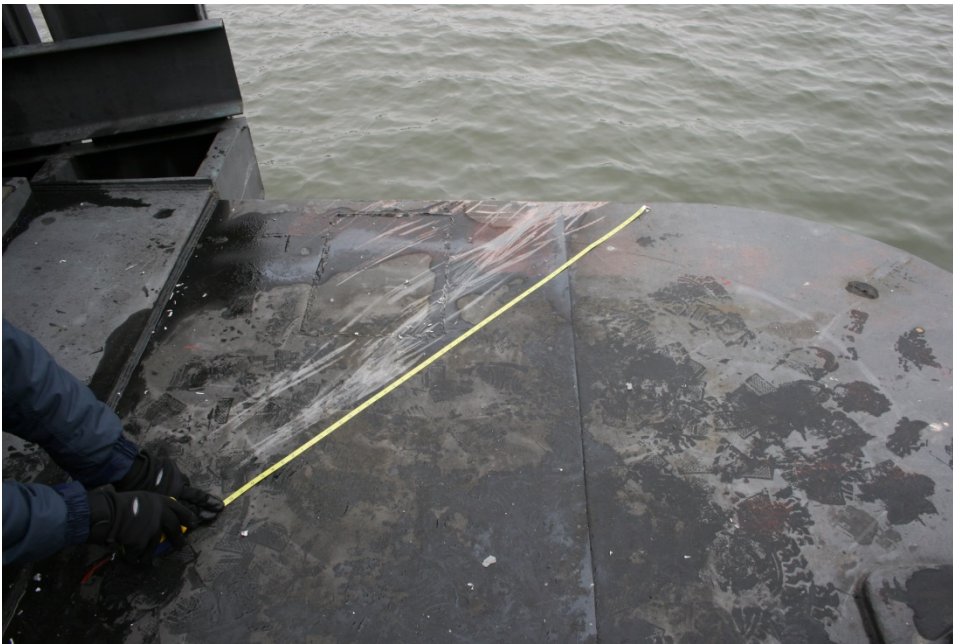
Figure 14. Scratches on deck of deck barge, at an approximate angle of 45° to top edge of the headlog.

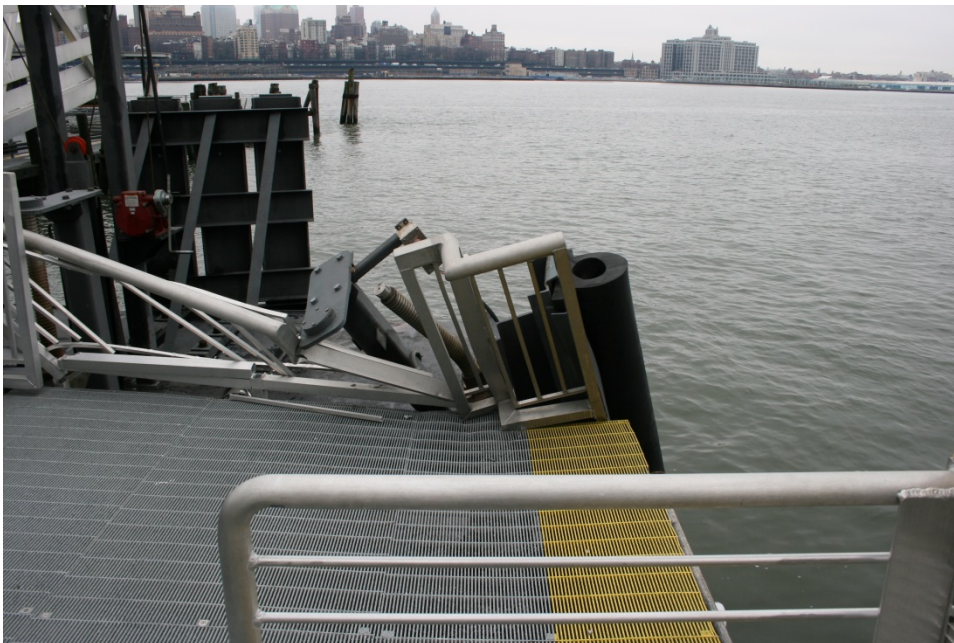
bending and distortion to several hand rails on the platform fitted to the deck barge (figure 15). According to a damage repair invoice, the cost of the repairs to the barge hull, platform, sideloader, and fender was \$333,349. This damage cost included \$36,000 round trip transportation of the barge to and from the repair facility.

Figure 15. Damage to fender, jackscrew, and platform
