FIELD REPORT: Entanglement Hazards at *El Faro* Wreckage Site

MISSION LIMITATIONS DUE TO STREAMING LINES (LINE HAZARDS TO OV & AUV)

NOTED LINE HAZARDS from ATLANTIS AT33-04 MISSION (At wreck site April 21-May 1 2016)

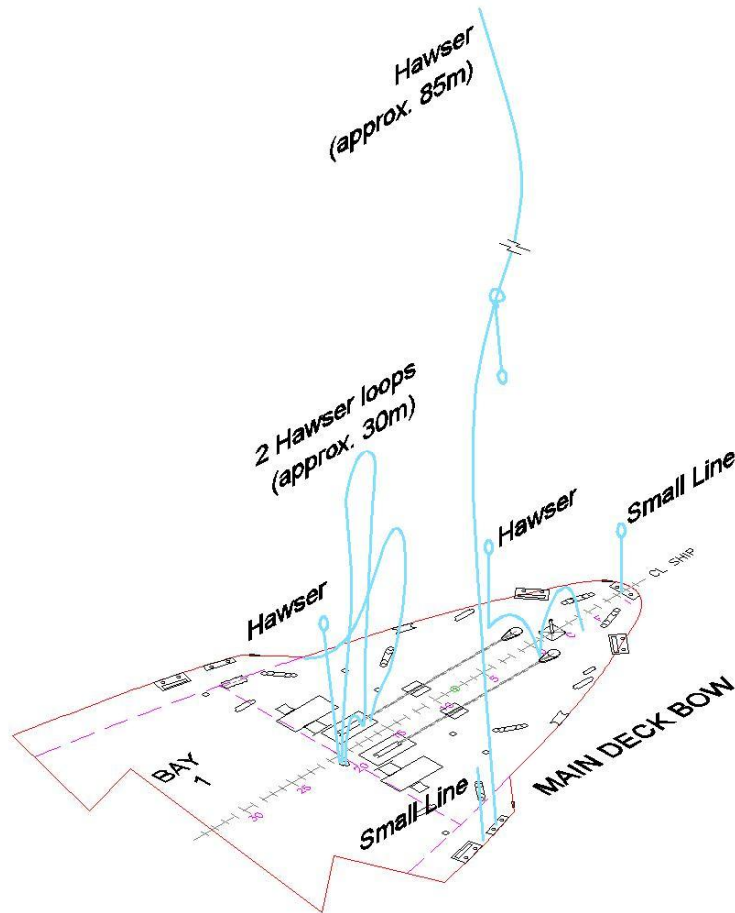
Figure 1: Diagram showing general location and orientation of lines on the focsle deck

Approximately midway between the bow and the windlass, two lines extend upward. The port side line is looped up into the water column and then back down to the deck. The line on the starboard side extends upward, and terminates in a spliced loop.

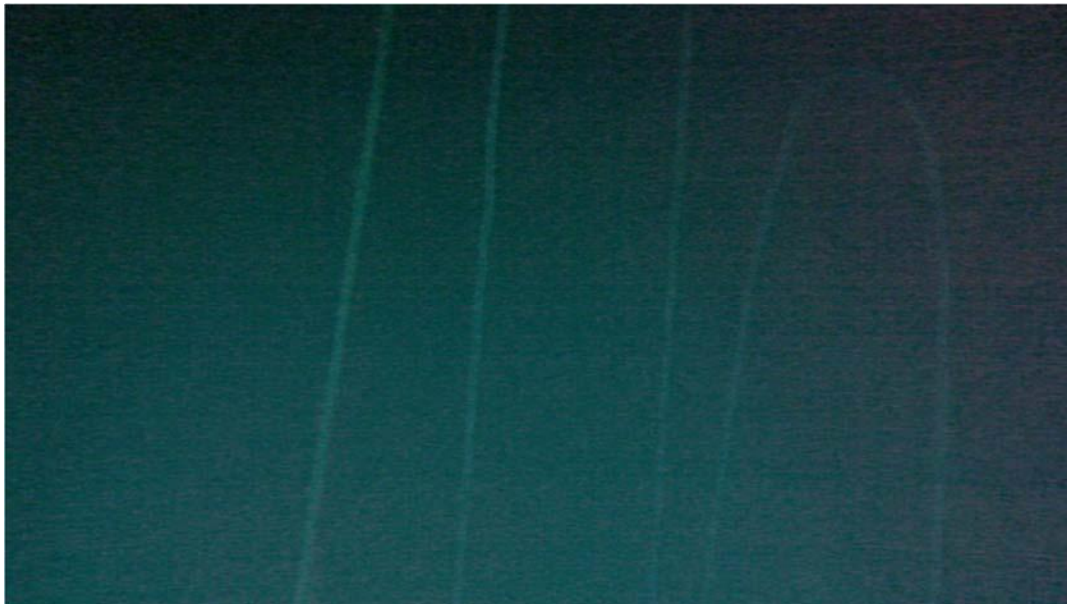
In the vicinity of the windlass, several blue polypropylene hawsers are tangled up, with two loops extending upward into the water column, and back down to the deck. The starboard-most hawser extends upward and terminates in a spliced loop.

Figure 3: Lines from vicinity of windlass extending up into the water column

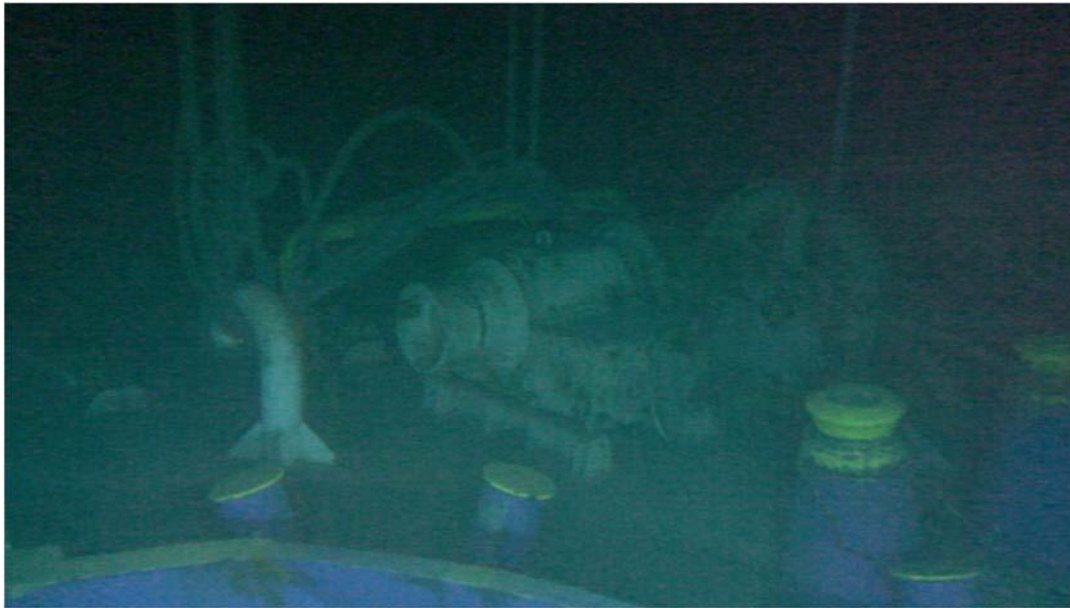
Figure 4: Lines entangled in the vicinity of the windlass

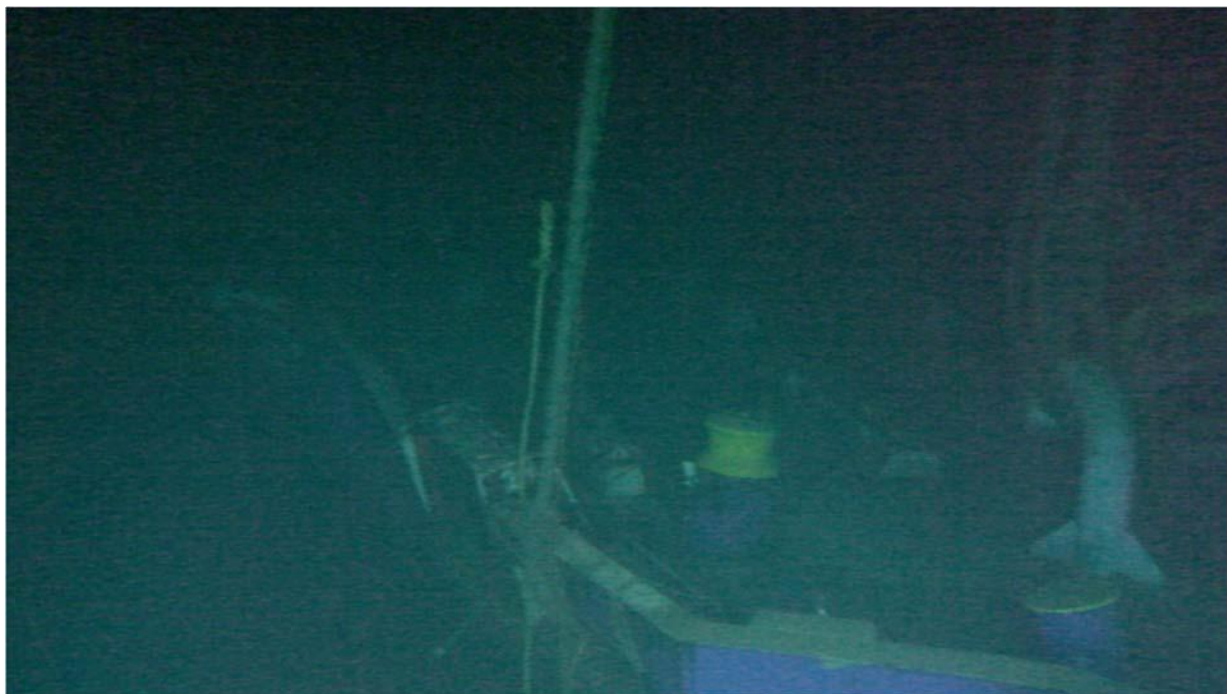
Outboard on the starboard side of the focsle deck, along the gunwale, another blue polypropylene hawser extends upward in the water column, and terminates 85 meters above the seafloor.

Figure 5: Hawser extending upward from starboard bow

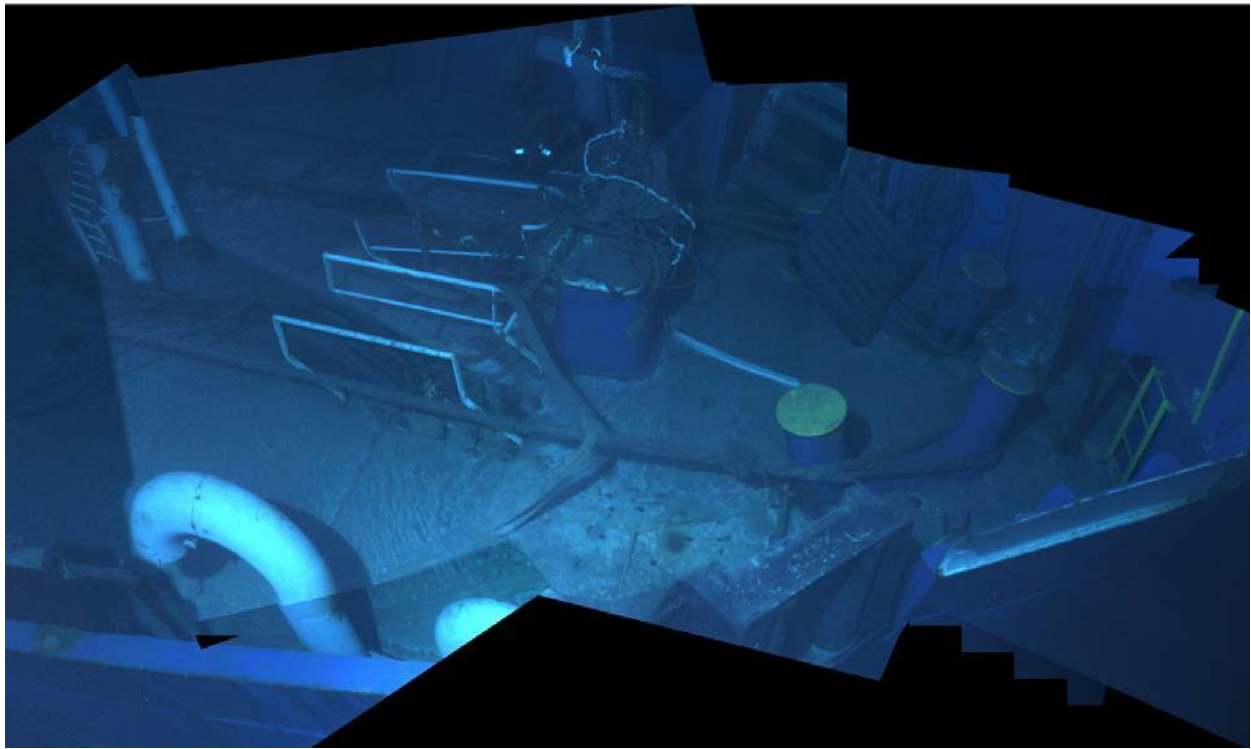
Figure 6: Preliminary Photo-Mosaic of Bow

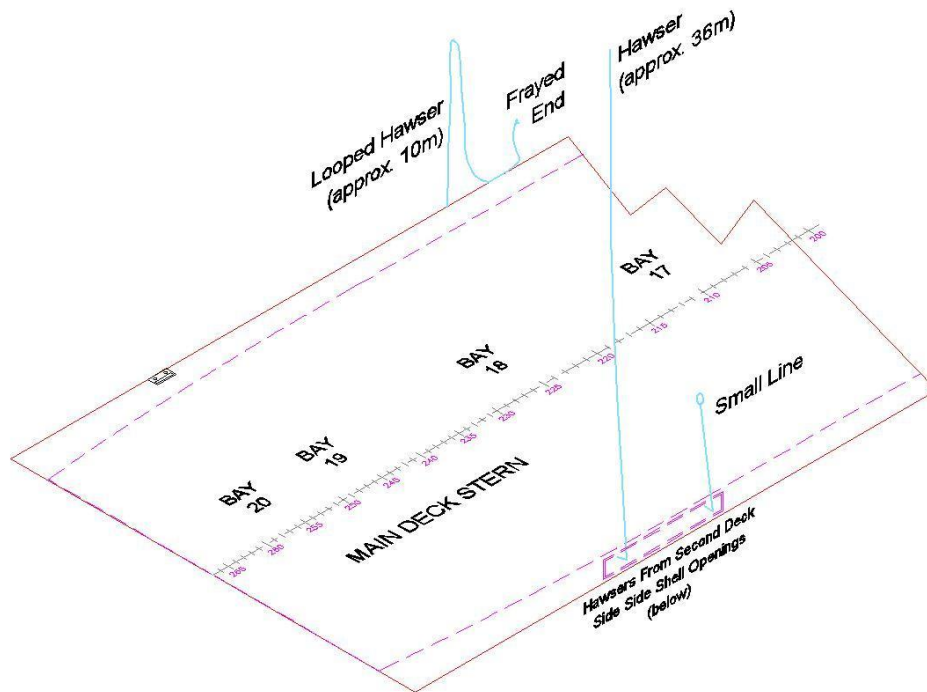
On the port and starboard quarters in the vicinity of cargo bays 18 and 19, hawsers protrude outward from openings on the second deck, and extend upward into the water column.

Figure 7: Diagram showing general location and orientation of lines on the port and starboard quarters

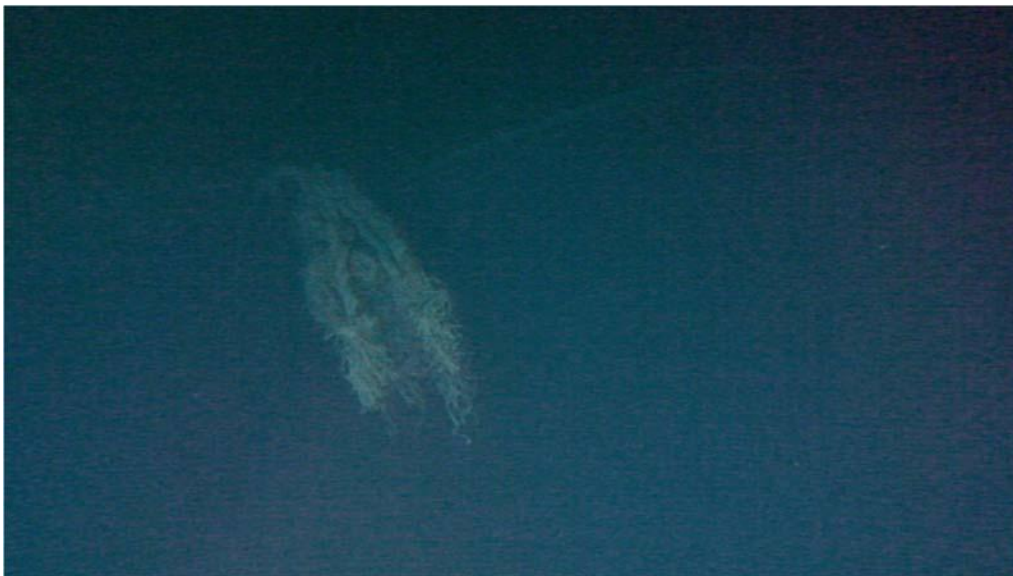
On the port side, a hawser with a frayed end protrudes just forward of a looped hawser.

Figure 8: End of frayed line extending from the port quarter

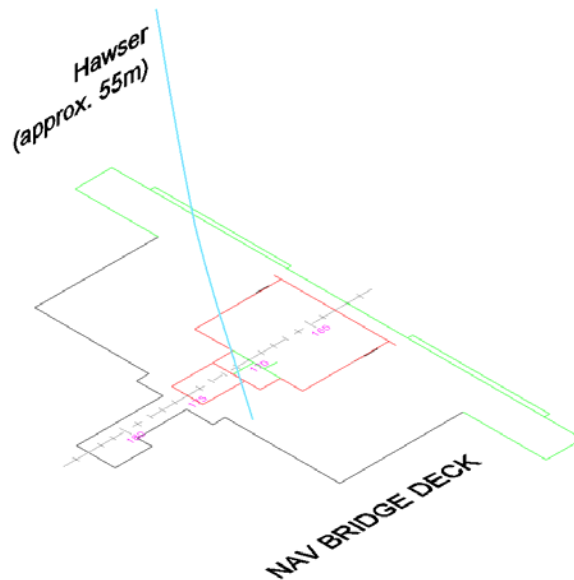
Another hawser was found entangled in debris on the aft side of the bridge deck, slightly to starboard of centerline. This one extends approximately 55 meters upward.

Figure 10: Diagram showing general location and orientation of the hawser on the bridge

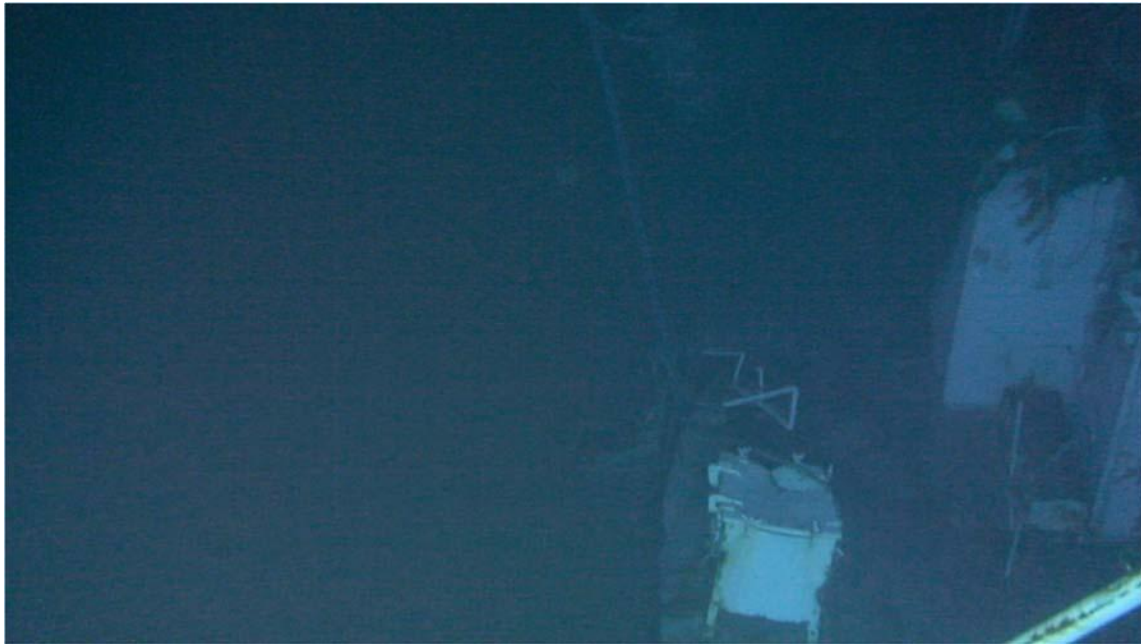
Figure 11: Hawser entangled in debris on the starboard aft side of the bridge, looking to port

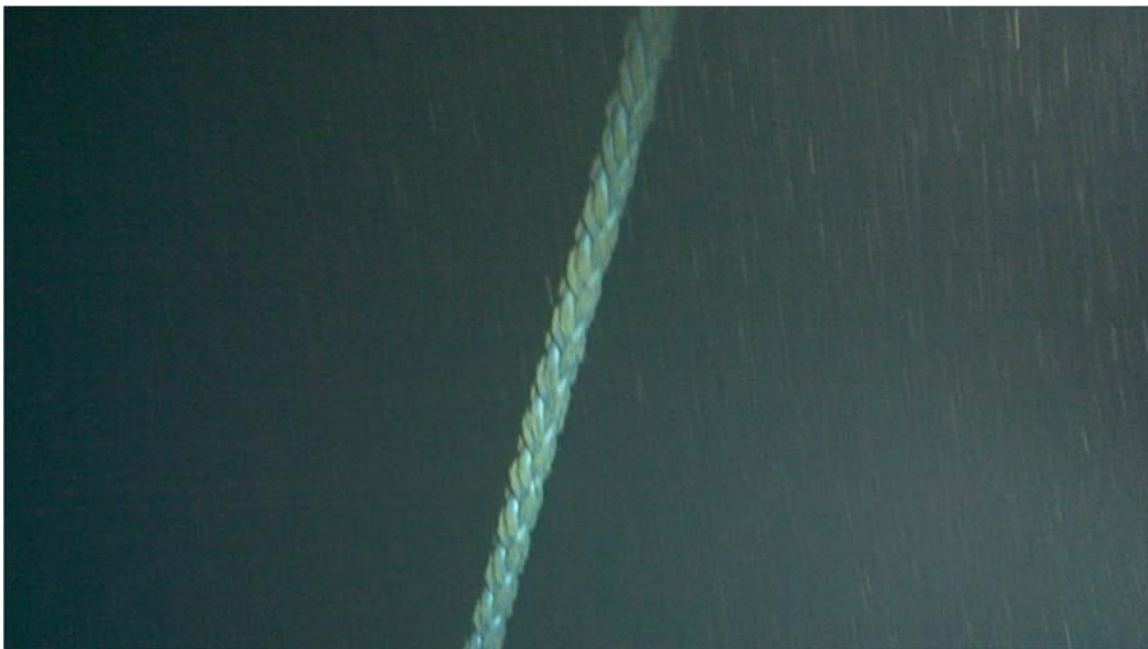
Figure 12: Close-up of bridge hawser

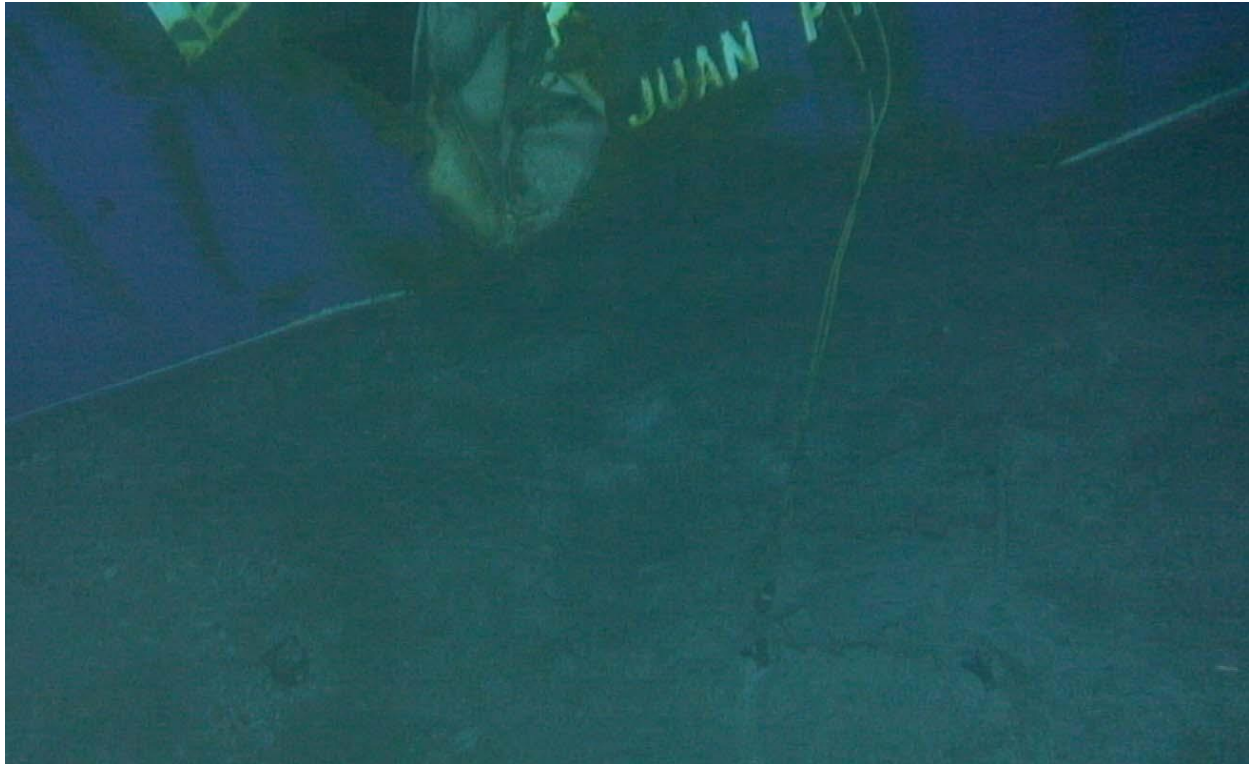
A line was found sinking aft of the transom to the seafloor.

Figure 13: Line from transom
