# National Transportation Safety Board

## Group Chairman's Factual Report

Naval Architecture Group

*SS El Faro*

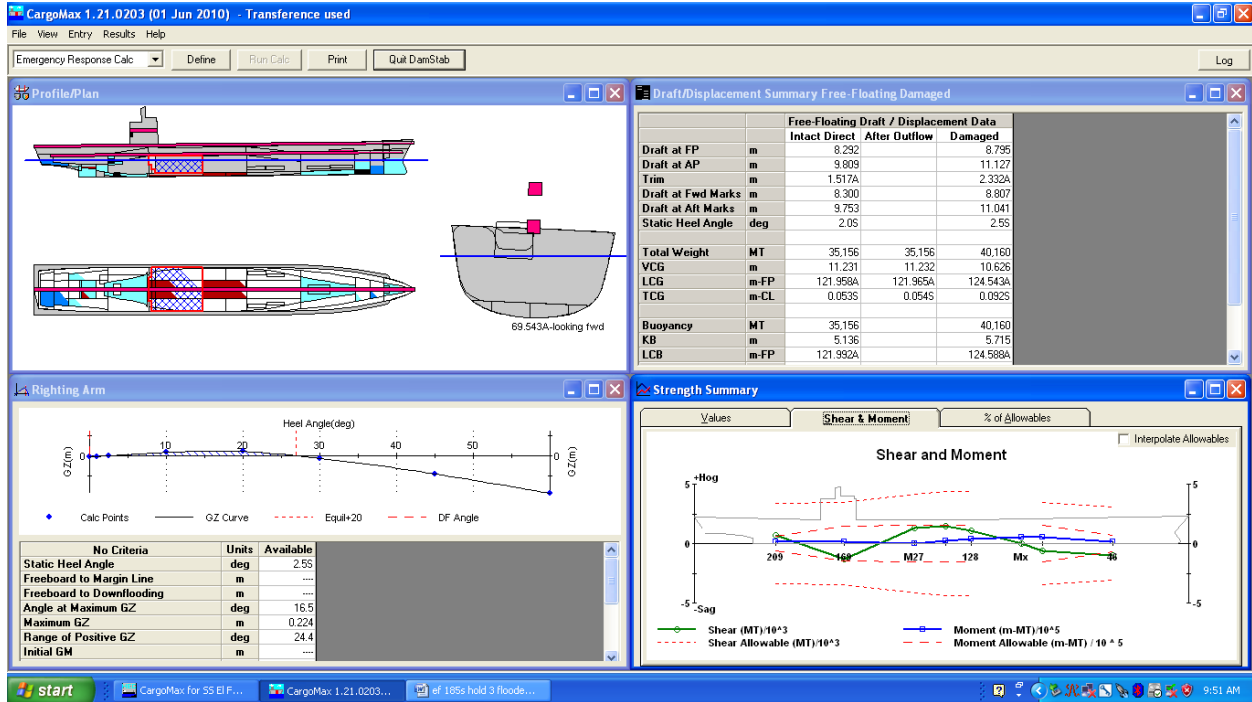
- 1 downflooding on the graph was generated. The damaged module in CargoMax did not provide
- 2 information regarding the vessel's downflooding angle to users.

3  
4 **Figure 7.** Screen capture of CargoMax damaged stability module, *El Faro* with damage to hold  
5 3.

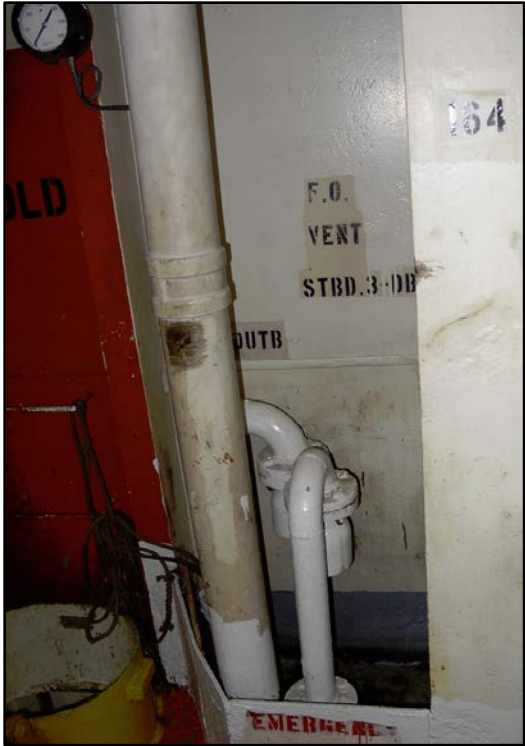
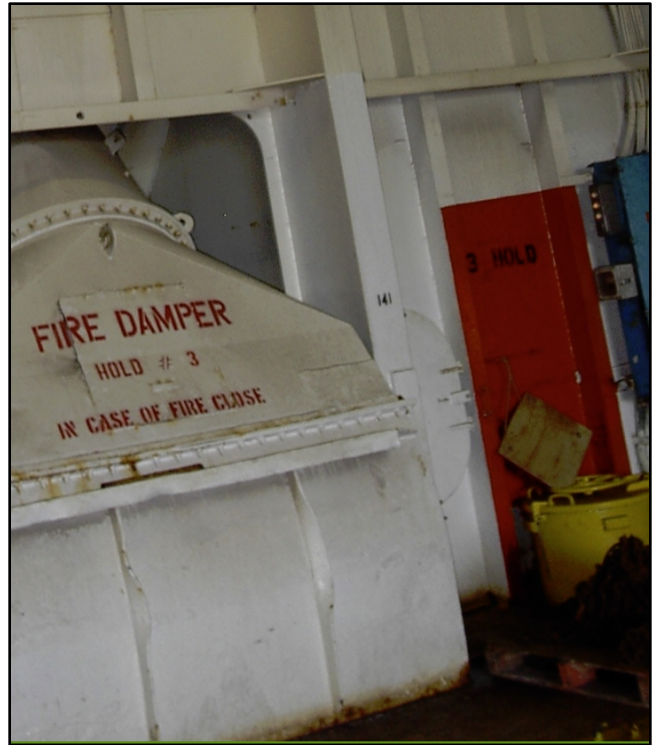
1  
 2 **Figure 11.** *El Faro* second deck scuttles to hold 3; starboard side at frame 163 (left image), port  
 3 side at frame 138.5 (right image). (HEC photo, June 2005)

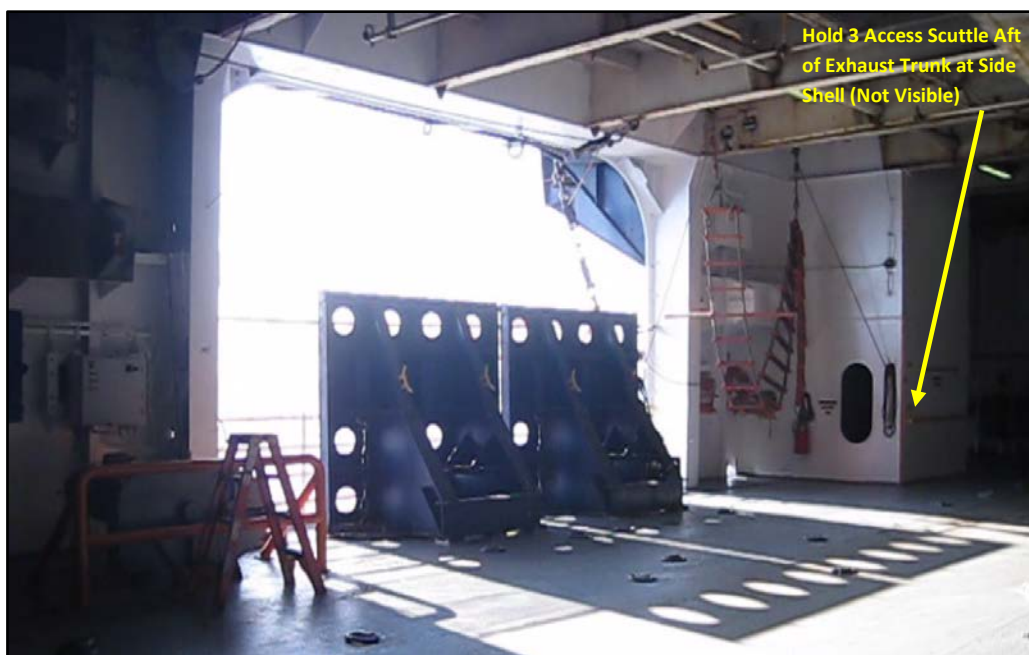
1  
2 **Figure 13.** *El Faro* starboard sideshell opening with installed bulwark. (Screen capture from video  
3 by former *El Faro* second mate, September 2008<sup>256</sup>)

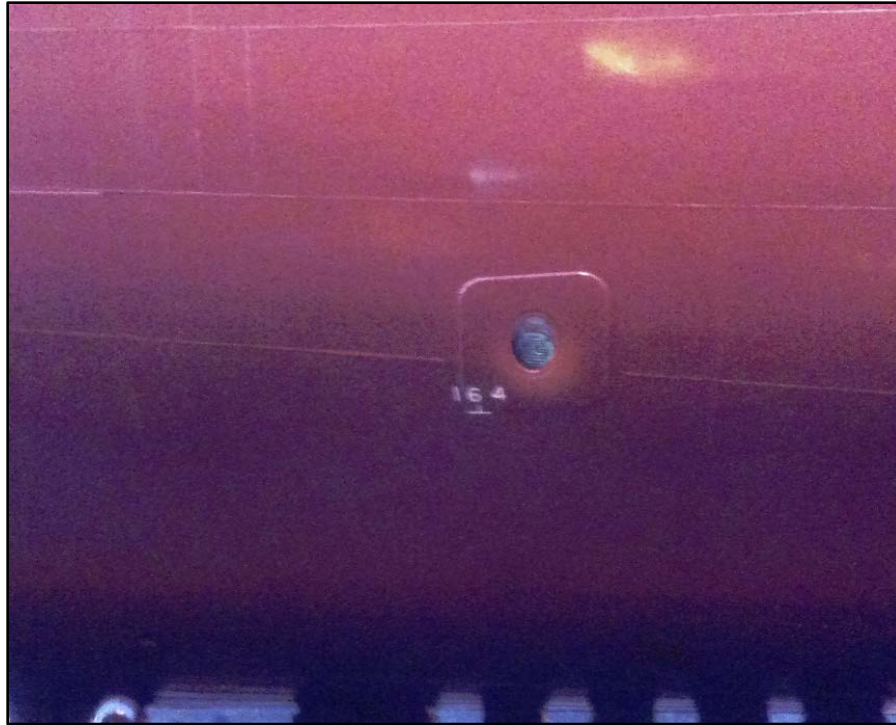
1  
2 **Figure 18.** Penetration of sea chest for *El Faro*'s emergency fire pump, viewed from exterior.  
3 (TOTE photo from December 2013 drydock)

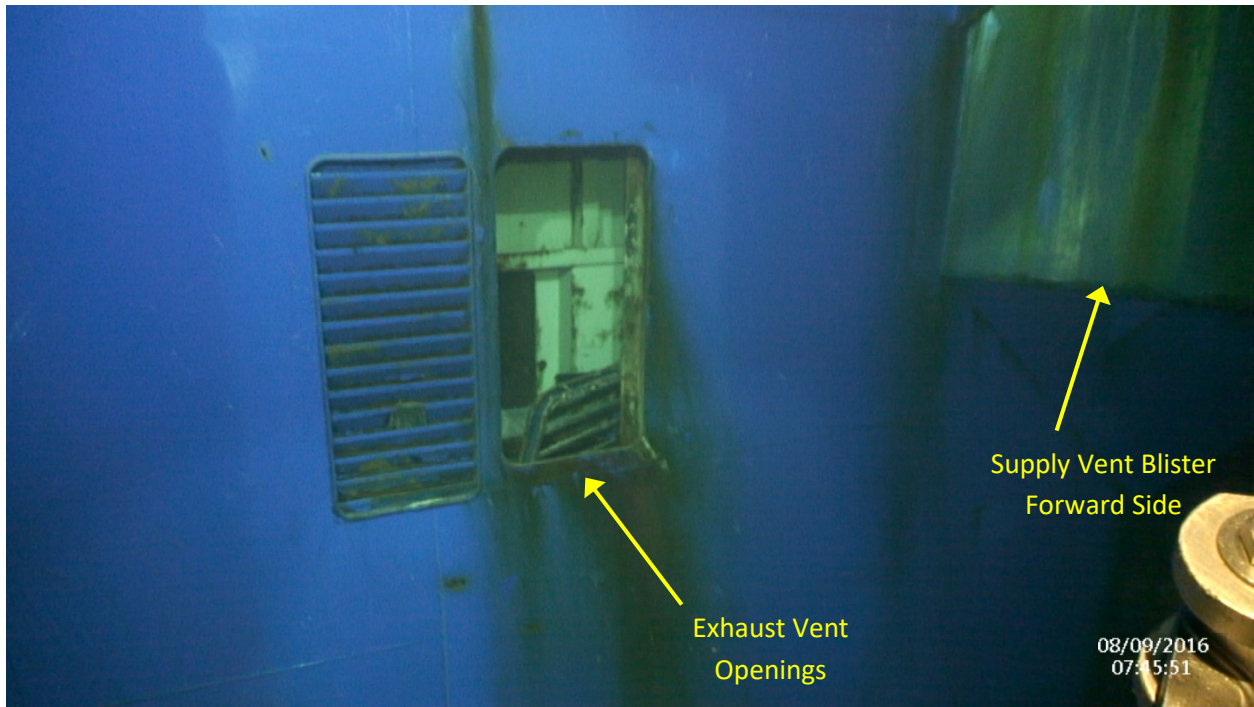
2 **Figure 24.** *El Faro* wreckage, port side, hold 3 forward exhaust ventilation openings at frame  
 3 134/33. Exhaust louver blades were installed with lower louver lip inboard and upper lip outboard.  
 4 (Photo from August 2016)

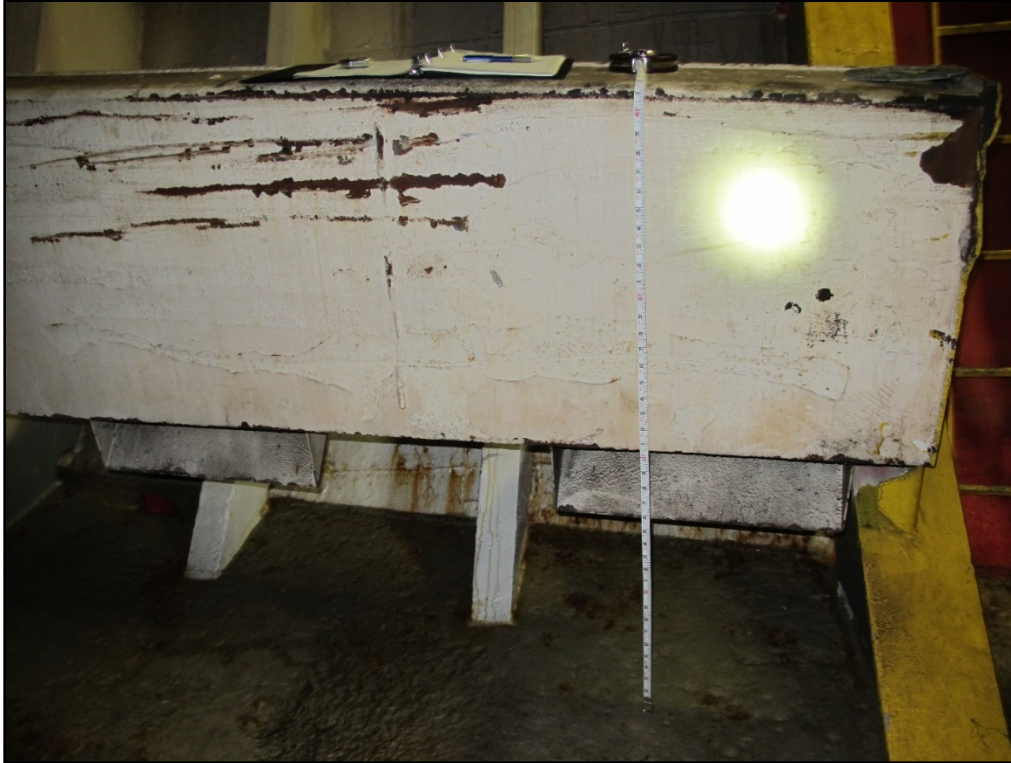
4           The lower horizontal supply ventilation trunks in the cargo holds were fitted with  
5 downward-facing registers. Investigators measured the distance from the tanktop to the bottom of  
6 the horizontal vent trunk at frame 162, near the emergency fire pump sea chest, as 24 inches. The  
7 inboard side of the vent trunk was 24 inches off the sideshell at the tanktop. The inboard lip of the  
8 45° downward-facing registers was about 16 inches off the tanktop (see **figure 29**).

1  
2 **Figure 29.** *El Yunque*, hold 3 starboard, aft, horizontal supply ventilation trunk end at fame. 162.  
3 Trunk bottom 24 inches off tanktop, registers 16 inches off tanktop. (Photo from September 2016)

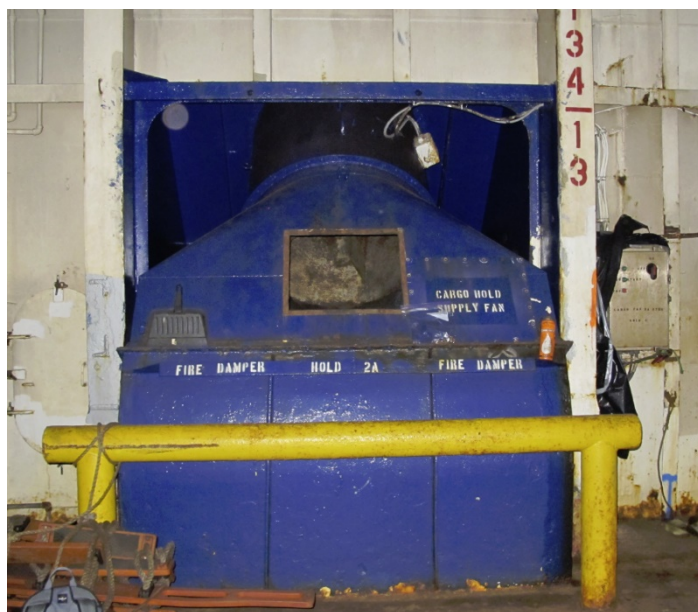
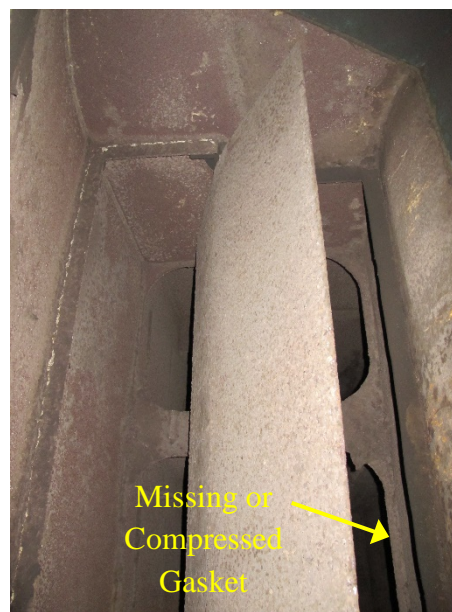
4 **Figure 31.** *El Yunque*, hold 2A starboard ventilation supply fan and fire damper housing on  
5 second deck (left), internal fire damper/closing appliance (right). Damper's rubber gasket was  
6 missing or compressed around most of seal perimeter. (Photo from September 2016)

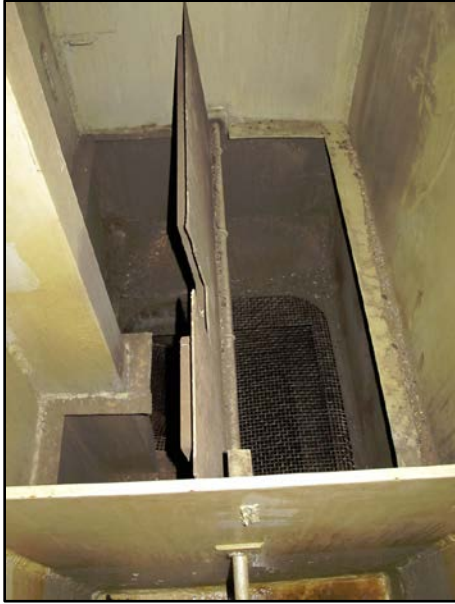
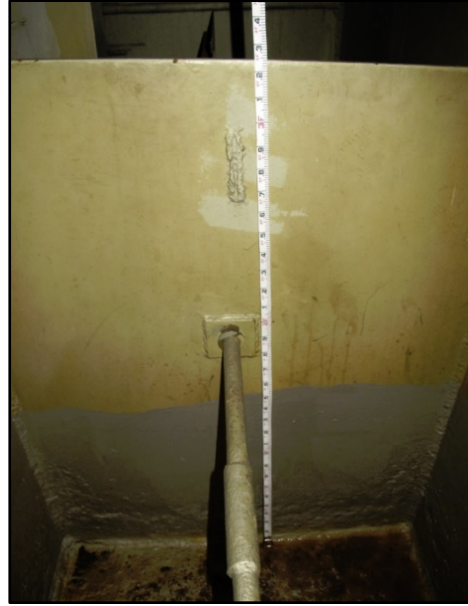
7           The coaming height for the fire damper was measured by investigators in October 2016 as  
8 38 inches above the second deck (**figure 33**). The drawings did not show gaskets for these  
9 “weathertight” closures, or fire dampers, and none were found to be installed.

1  
2 **Figure 33.** *El Yunque*, cargo hold 3, exhaust trunk fire damper at frame 161.5. Left image is top  
3 view of damper, right image is a side view looking outboard. (Photo from September 2016)

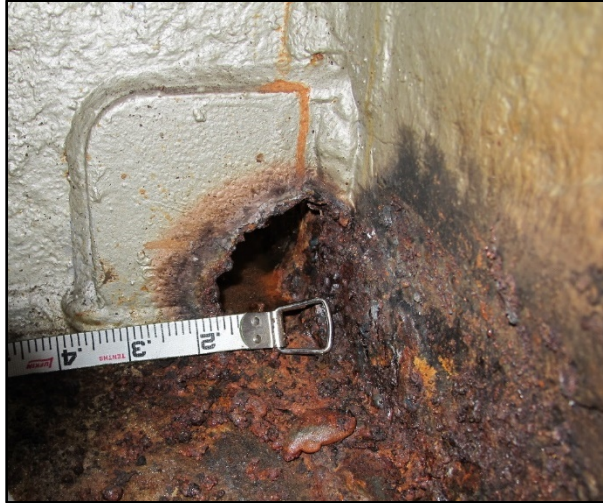
2 **Figure 34.** *El Yunque*, 1.5-inch-radius drainhole inside cargo hold 3 ventilation trunk, second deck  
3 at frame 138. (Photo from September 2016)

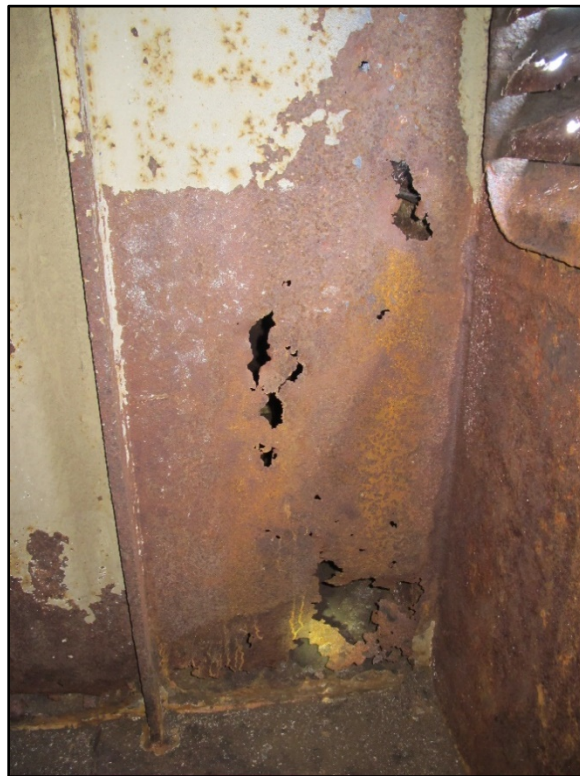
5 **Figure 35.** *El Yunque*, interior bulkhead of exhaust ventilation trunk holed from corrosion at frame  
6 123, viewed looking forward. Bulkhead separates two forward and aft exhaust ventilation trunks  
7 for hold 2. The holed plate depicted allows communication only between adjacent trunks to  
8 sideshell louver openings. It is not through a baffle plate and does not permit water ingress directly  
9 to exhaust ventilation trunks or into the cargo hold below. (Photo from September 2016)

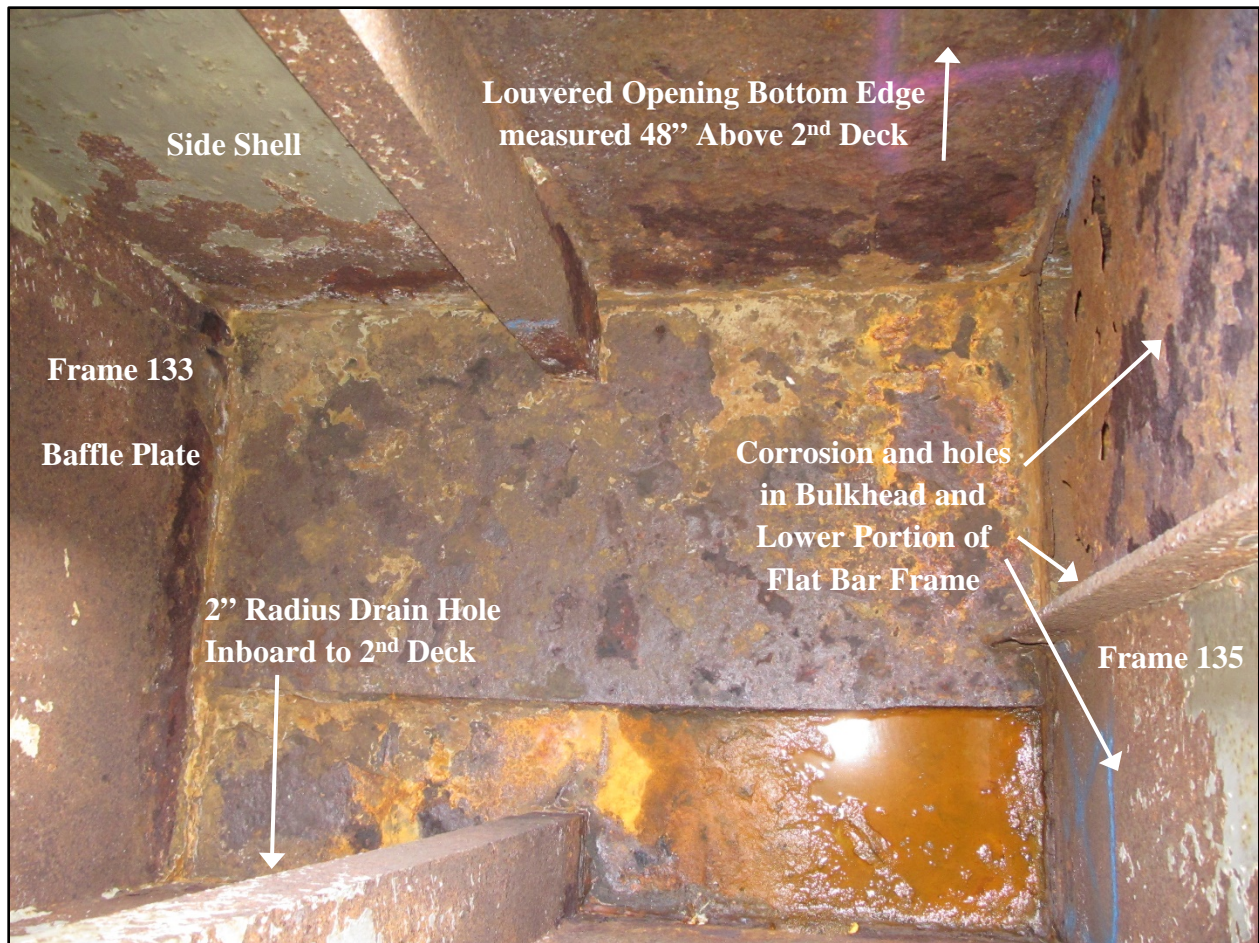
1  
 2 **Figure 36.** *El Yunque*, starboard side, forward exhaust ventilation trunk interior for hold 2A.  
 3 Bulkhead at frame 135 separates this forward trunk from aft trunk. Baffle plate height at frame  
 4 133 is referenced in load line and damaged stability calculations. View looking down to second  
 5 deck. Drainholes cut inboard to second deck cargo space. The holed plate at frame 135 allows  
 6 communication only between adjacent trunks to sideshell louver openings. It is not through the  
 7 baffle plate at frame 133 and does not permit water ingress directly to exhaust ventilation trunks  
 8 or into the cargo hold below. (Photo from September 2016)

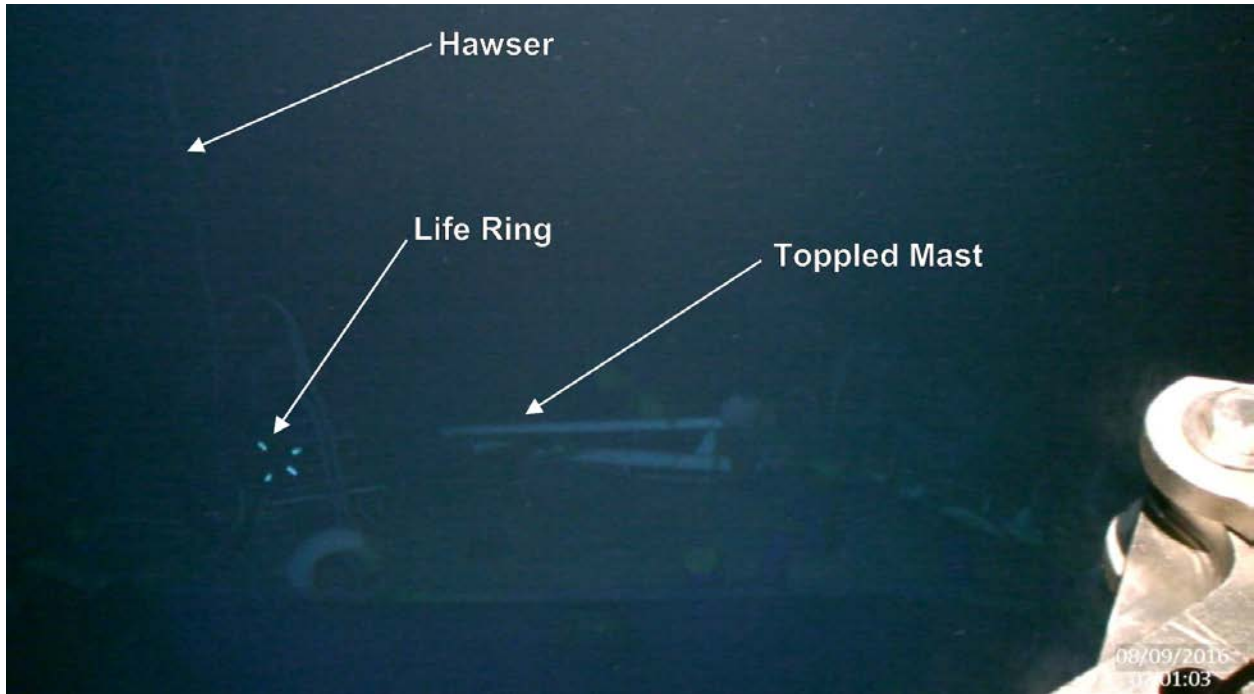
4  
5 **Figure 49.** Foremast toppled on port side of bow; reflection is from lifebuoy on railing next to  
6 hawser (mission 3 image).

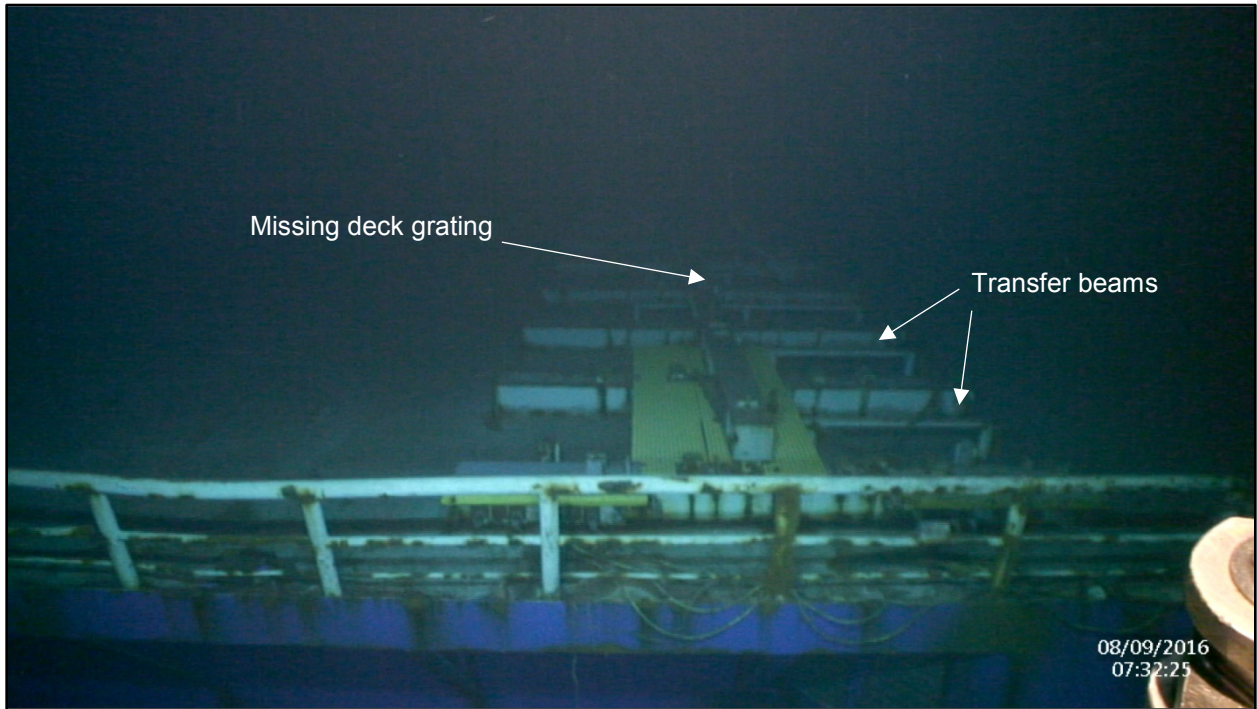
5  
6 **Figure 52.** Fiberglass deck grating missing from container support beams, port side at frame  
7 134/10 (mission 3 image).

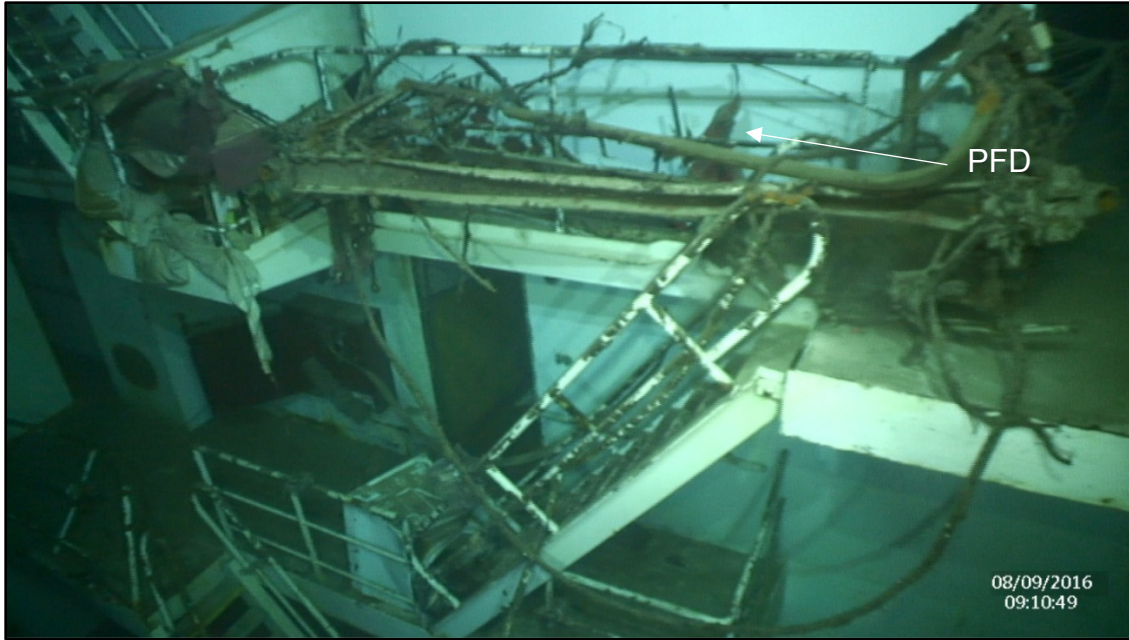
1  
2 **Figure 53.** PFD entangled on boat deck walkway, near ladder down to cabin deck (mission 3  
3 image).

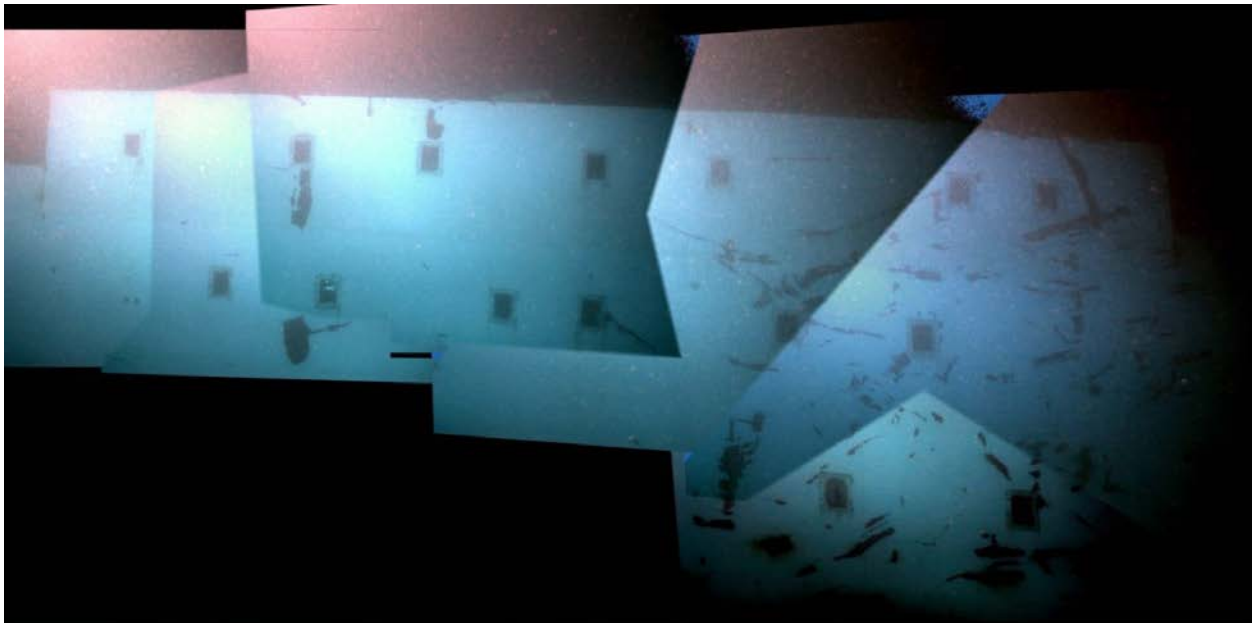
6  
7 **Figure 54.** Remaining upper part of forward side of deckhouse showing more scratches and dents  
8 on the port side than on the starboard side (mission 2 AOV mosaic image).

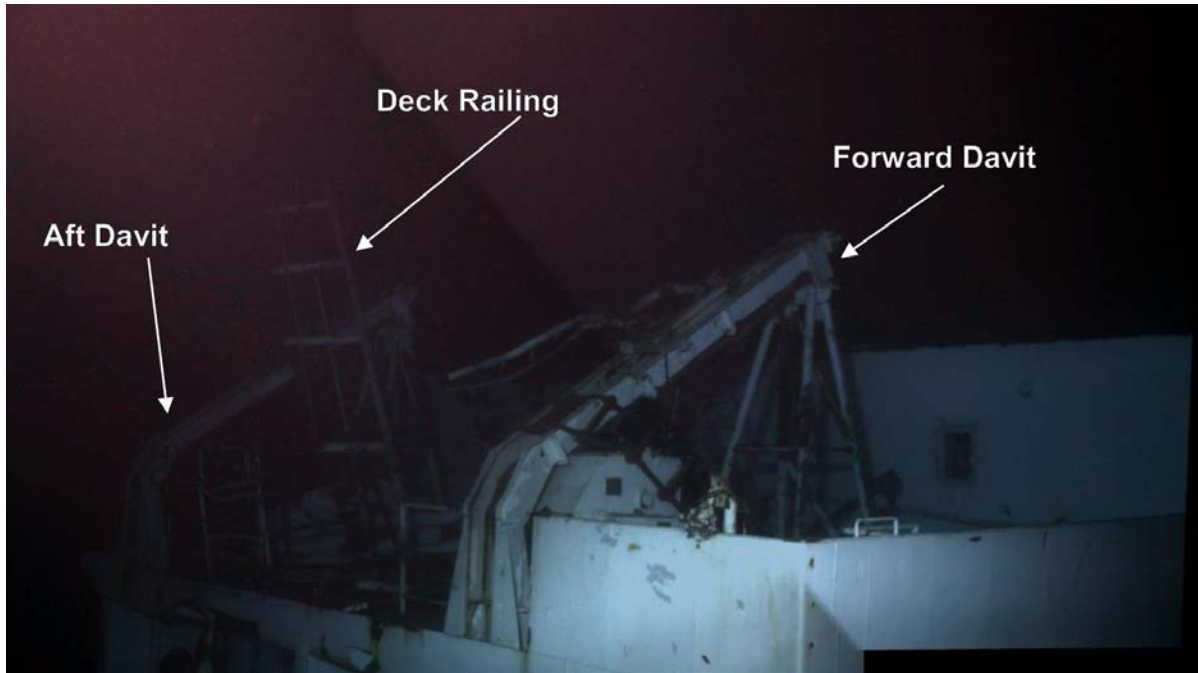
5  
6 **Figure 55.** Intact gravity davits for starboard lifeboat, with forward davit in foreground  
7 (photomosaic image from mission 2).

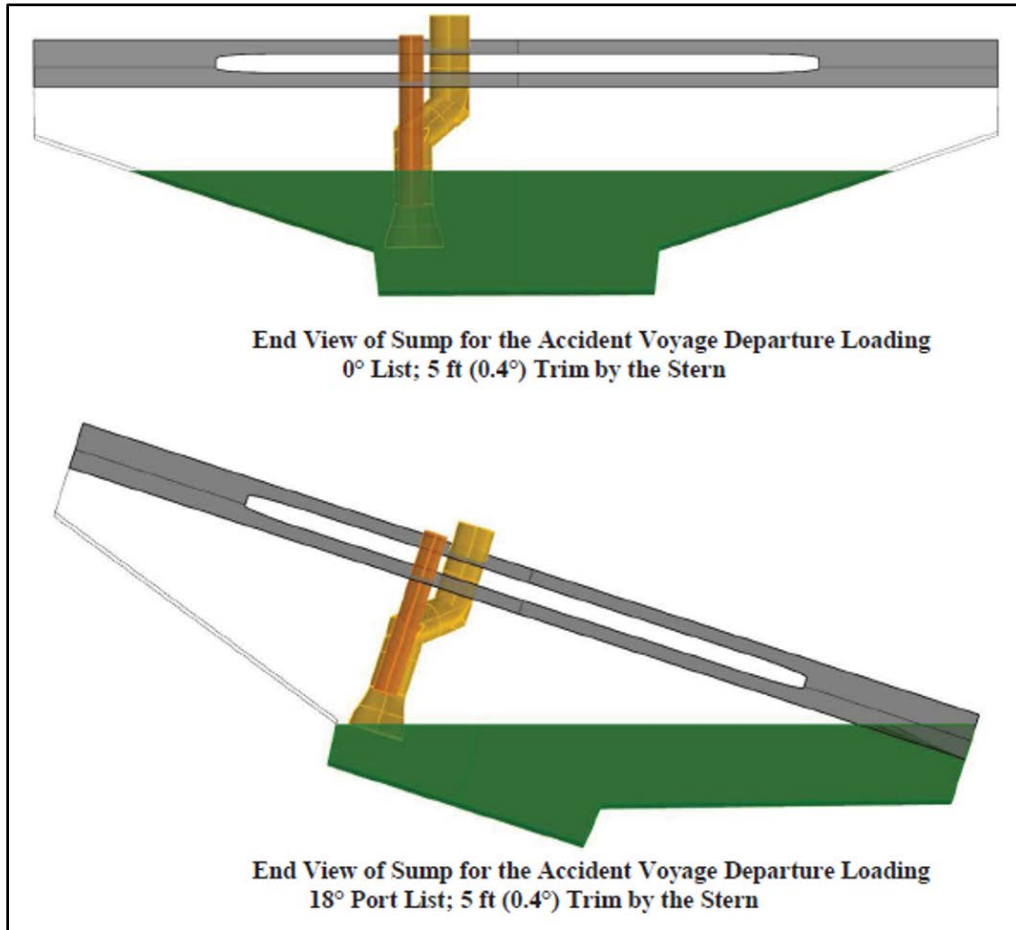
3  
4 **Figure 59.** Looking aft at model of main engine sump. Effect of port list on oil level at suction  
5 bellmouth, main lube oil sump. (Illustration from Coast Guard MSC lube oil modeling and static  
6 analysis)
