██████████ INFORMATION

11 August 2017

Investigation of an ELT involved in a helicopter crash incident.

Artex ELT model: C406NHM Rev C
Part Number: 453-5061
Serial Number: ██████████
C/S TAC: 135
Hex ID: 2DC843A1CCFFBFF (As on the manufacturer label on the beacon)
Hex ID: 2DC7540094FFBFF (As on the C/S Registration label and programmed into the beacon memory which means this is the ID that would have been transmitted during activation)
Date of manufacture: October 2007
Battery expiration date: June 2018

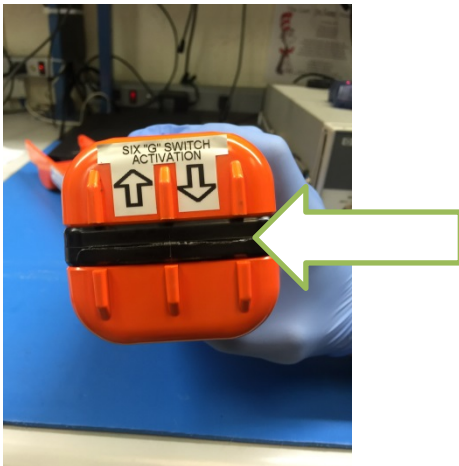
- The top part of the mounting case is missing.
- The only damage is a cracked H-shield on the bottom end of the beacon and a fair piece was broken off.

- All connectors were in place and in good condition.
- All screws fitted to beacon.
