**NATIONAL TRANSPORTATION SAFETY BOARD
Office of Aviation Safety
Washington, DC 20594**

Addendum to Factual Report

AIR TRAFFIC CONTROL GROUP

DCA-99-MA-060

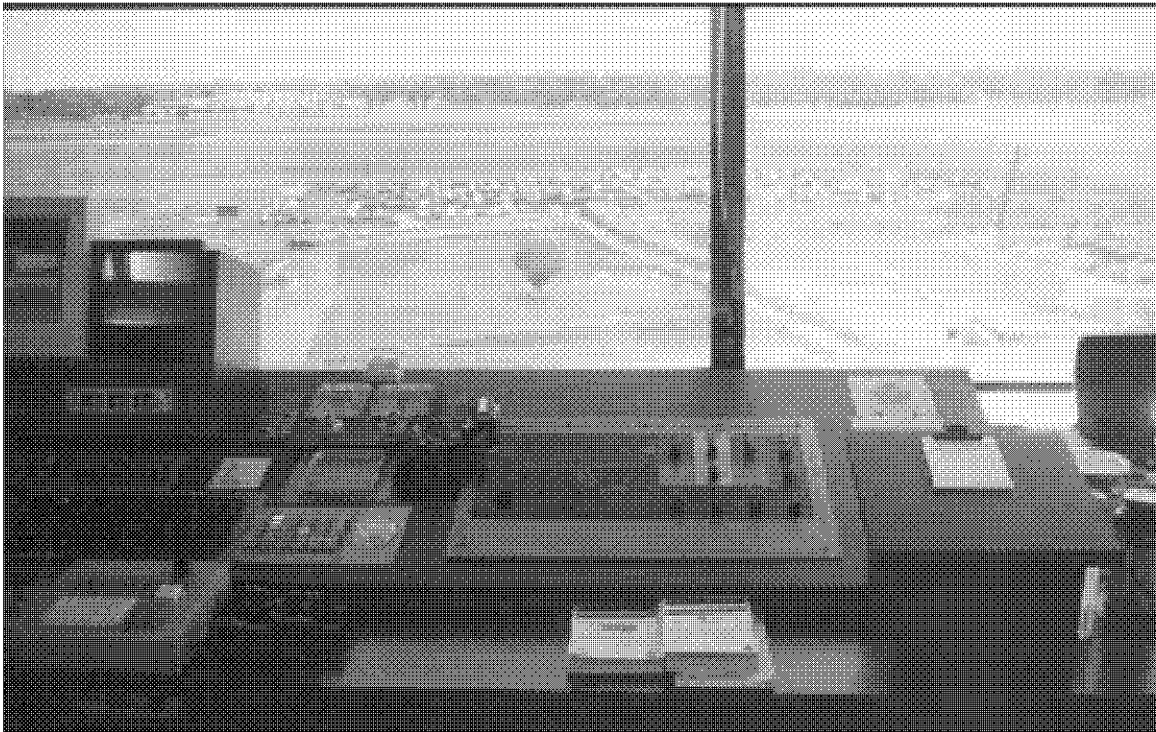
Photographs 1 and 2 show the HIRL light control panel for runway 4R located at the local control 2 position in the LIT tower cab. All photographs in this report were taken on August 1 and 2, 2000.

Photo 1: Little Rock runway 4R HIRL lighting control panel at LC2 position.

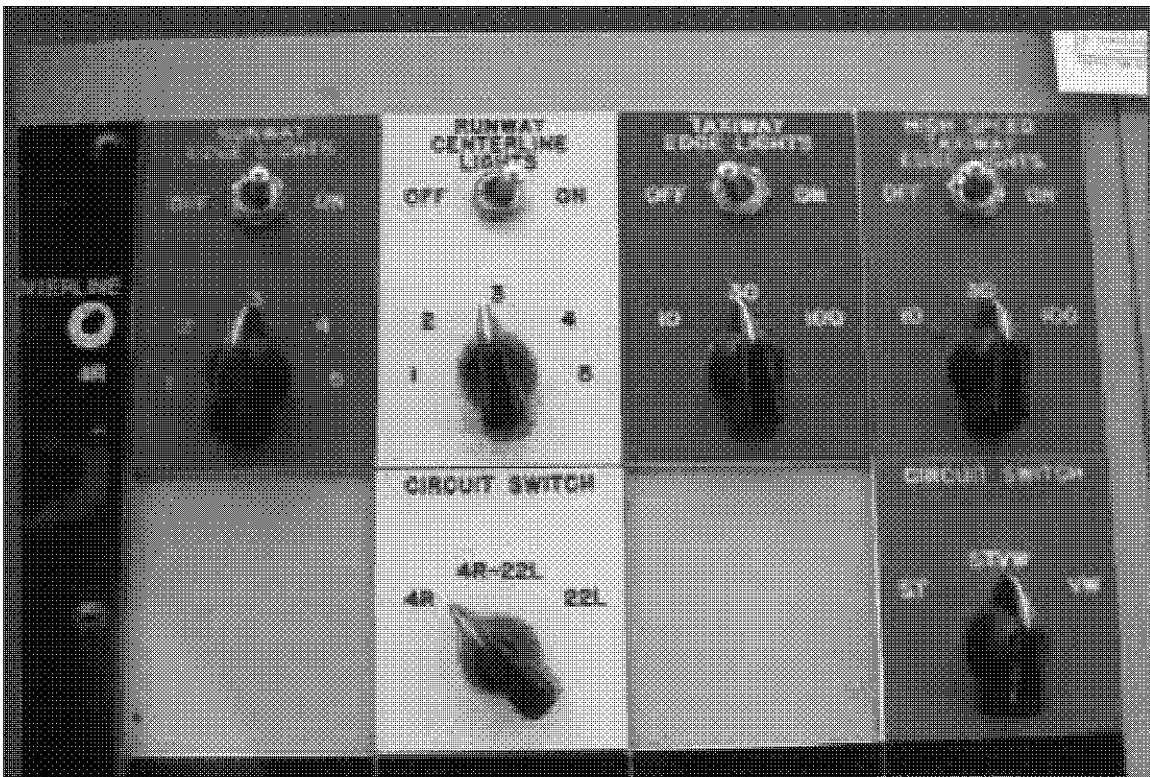
Photo 2: LIT runway 4R HIRL control panel detail

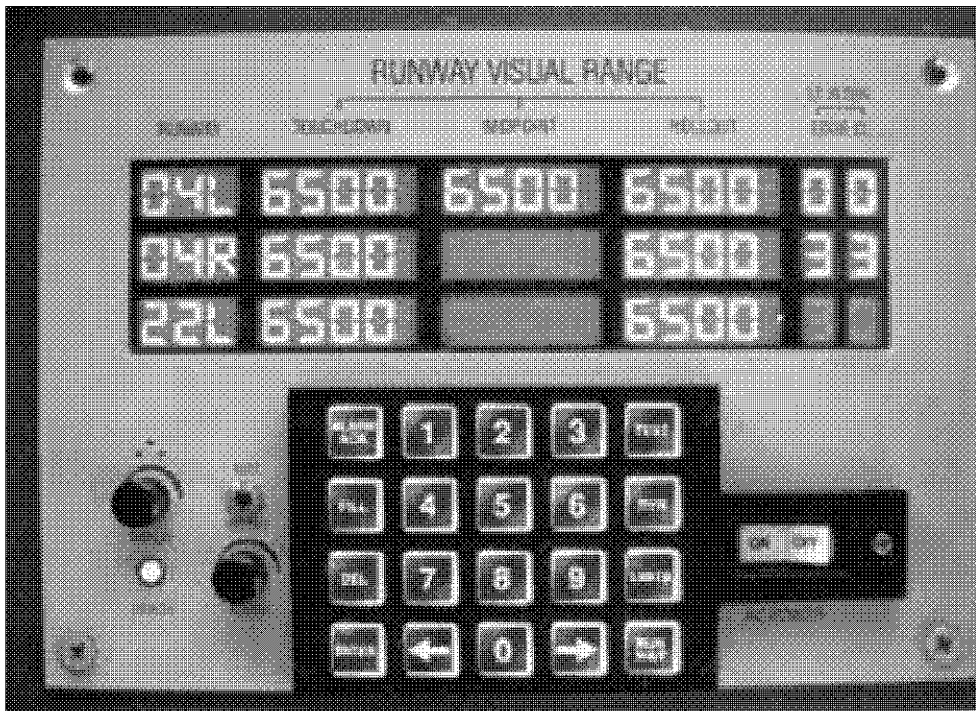
RVR displays are located at the LIT LC1 and GC1 positions. (Photo 3) According to FAA technicians, when activated these displays provide continuously updated (approximately two second refresh cycle) runway visibility information to tower controllers. Each horizontal line represents RVR readings for a single identified runway. Three columns are available to display touchdown, midpoint, and rollout RVR values. Runways 4R/22L have only touchdown and rollout sensors, so the midpoint column is blank. The far right numbers show the present light intensity settings for the runway edge and centerline lighting. Although photo 3 shows an RVR reading for runway 4L, on 6/1/99 the runway 4L RVR sensors were still being installed and were completely out of service. Runway 18/36 does not have RVR equipment installed. Therefore the only RVR available for display to controllers at the time of the AAL1420 accident would have been for runway 4R/22L. Each runway would have its own line as shown in the photograph, and under the equipment conditions existing on 6/1/99 the last line would have been blank.

Photo 3: LIT runway visual range display

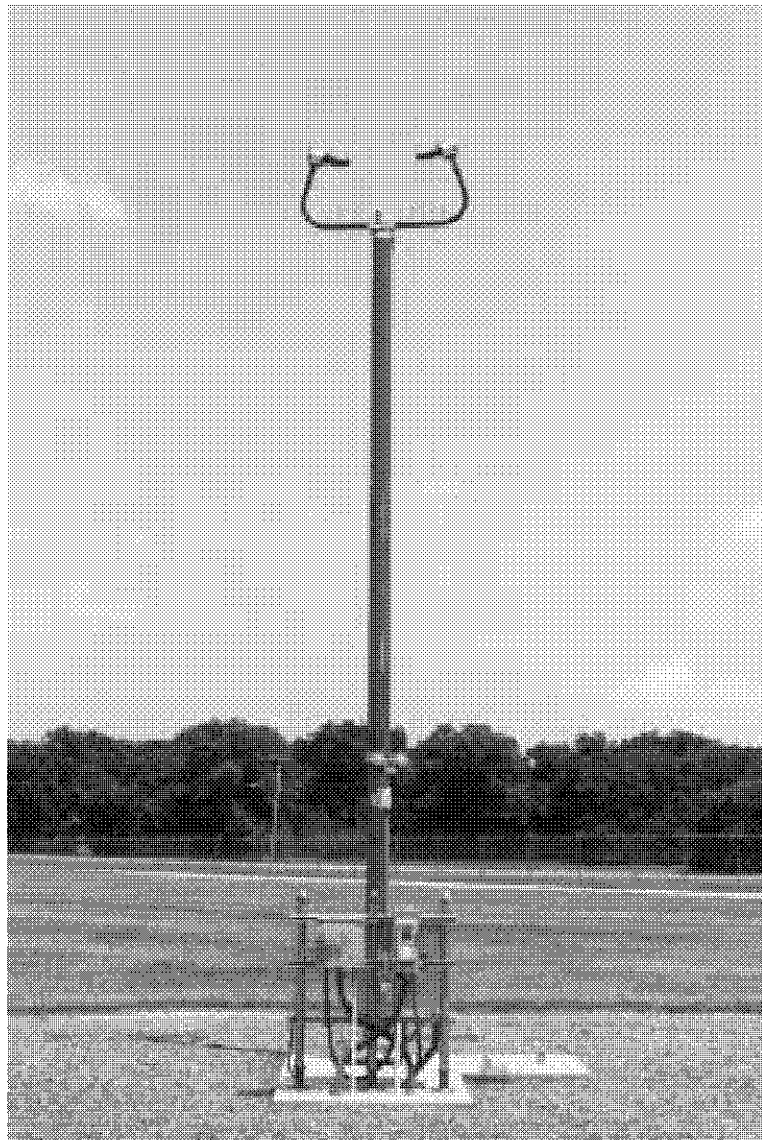
The runway visual range sensors for runway 4R/22L are located abeam the painted touchdown zone markers at each end of the runway. These sensors are of the “forward scatter meter” type. According to the Federal Meteorological Handbook, they operate by measuring the extinction coefficient of the atmosphere and deriving RVR from a series of computations. They sense particulate matter in the air of whatever type (dust, precipitation, etc.) and produce a display giving visual range along the runway in hundreds of feet. All the RVR sensors on the airport are identical, are about 18 feet tall, and are located next to the ILS glideslope antennas abeam the painted runway touchdown zone markers. (Photo 4) Their accuracy is unaffected by runway light settings, unlike the older RVR systems still in use at other airports. The RVR system has a rolling archive capability, recording and overwriting a finite number of records. In order to record and hold detailed RVR data, the system must be set to start an event log within two hours of occurrence, or the data will be lost. This was not done after the AAL1420 accident, hence no detailed RVR readings were retained. There is a separate log of data recorded at one hour intervals that shows displayed RVR values, runway edge light and centerline light settings, and the amount of ambient light in tenths of a foot-Lambert. There is no recorded RVR data available for the AAL1420 accident beyond that obtained as part of the initial on-scene investigation. RVR systems documentation is contained in FAA TI 6560.17, “Runway Visual Range On-Site Requirements.” FAA order 6563.31 contains data retention requirements and procedures for RVR systems.

Photo 4: LIT Runway 4R RVR Sensor

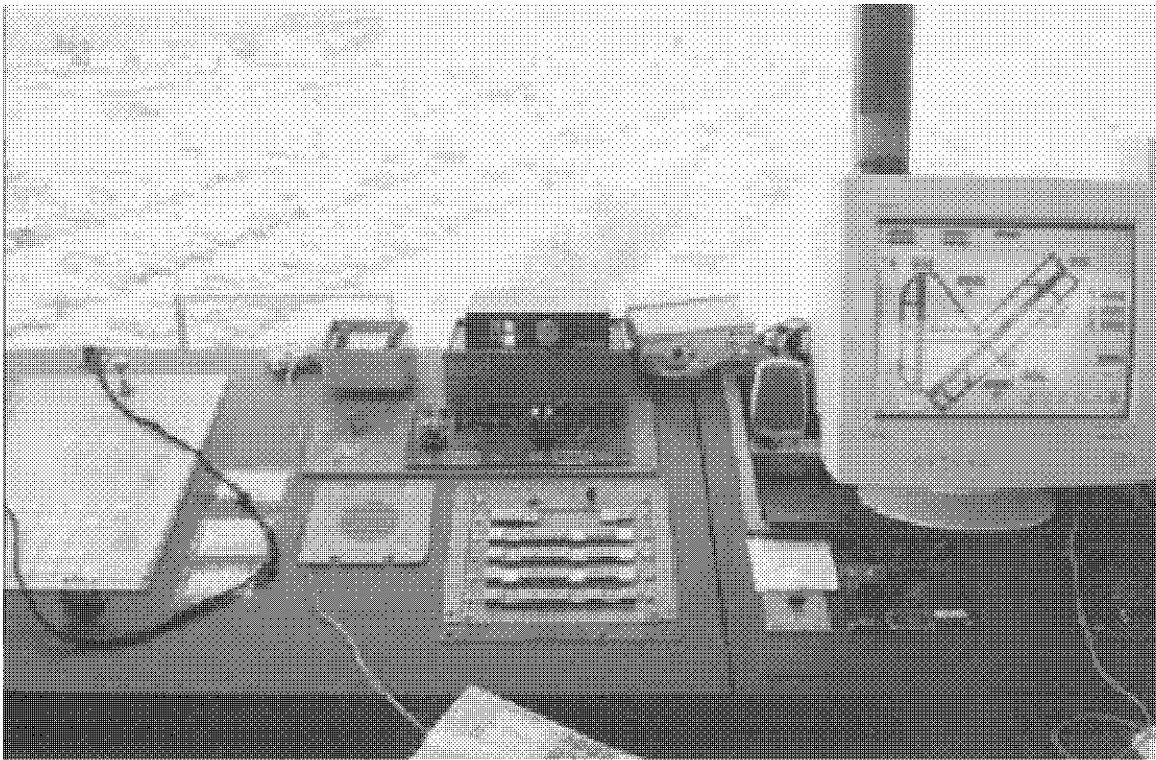
The approach lighting systems for all runways are controlled from a panel located to the left of the LIT LC1 position. (Photos 5, 6, and 7) The MALSR system for runway 4R is controlled by pushbuttons along the top row of the panel. The MALS portion of the system can be set to OFF or one of three progressively brighter steps. The RAIL segment has ON/OFF buttons. The RAIL cannot operate unless the MALS is activated. When the MALS is on, activating the RAIL system automatically sets it to the same step (1, 2, or 3) as the MALS. The MALSR controls are completely independent of the runway edge lighting systems: there is no interface between the MALSR and the runway lights. MALSR settings are not logged, so it is impossible to retrospectively determine approach light settings at a given time.

Photo 5: Approach lighting control panel at LC1 position

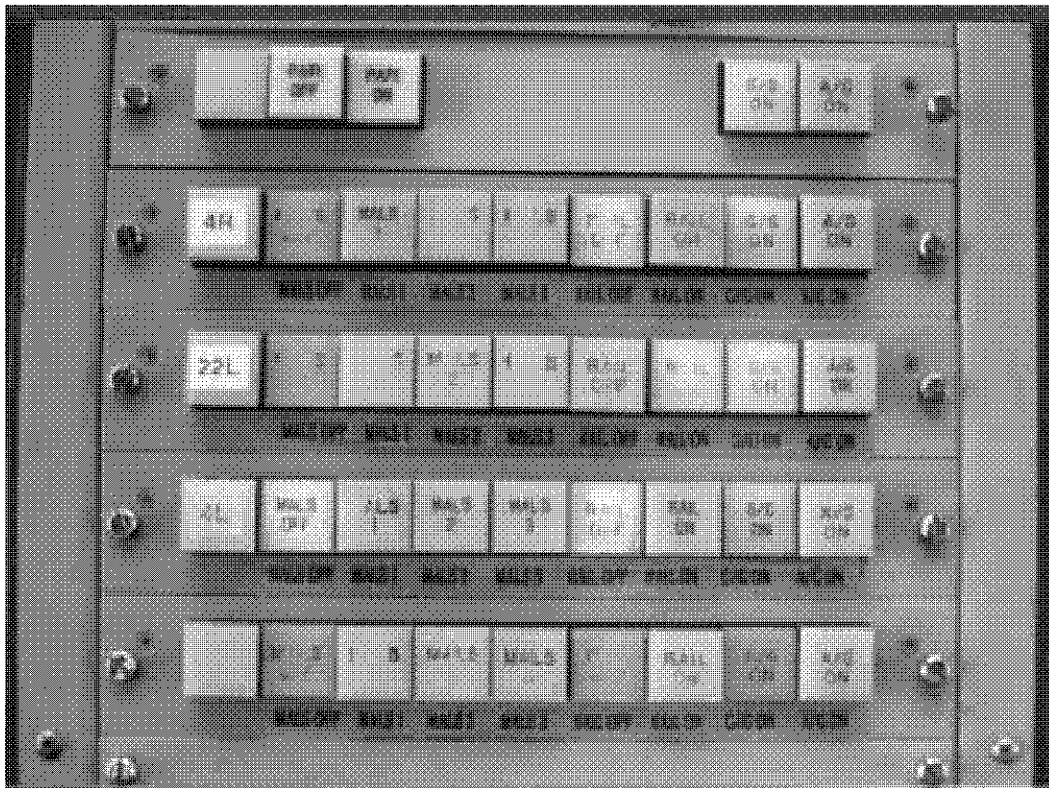
Photo 6: LIT approach lighting control panel

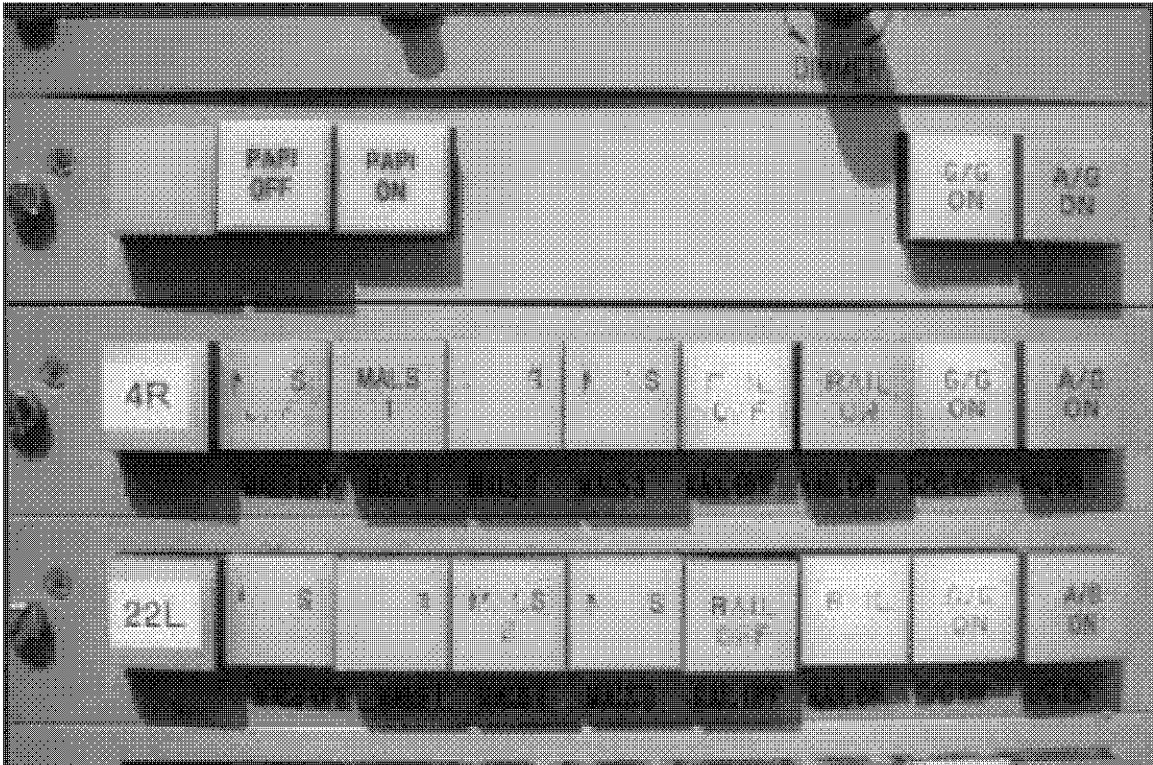
Photo 7: Closeup of runway 4R / 22L approach light controls

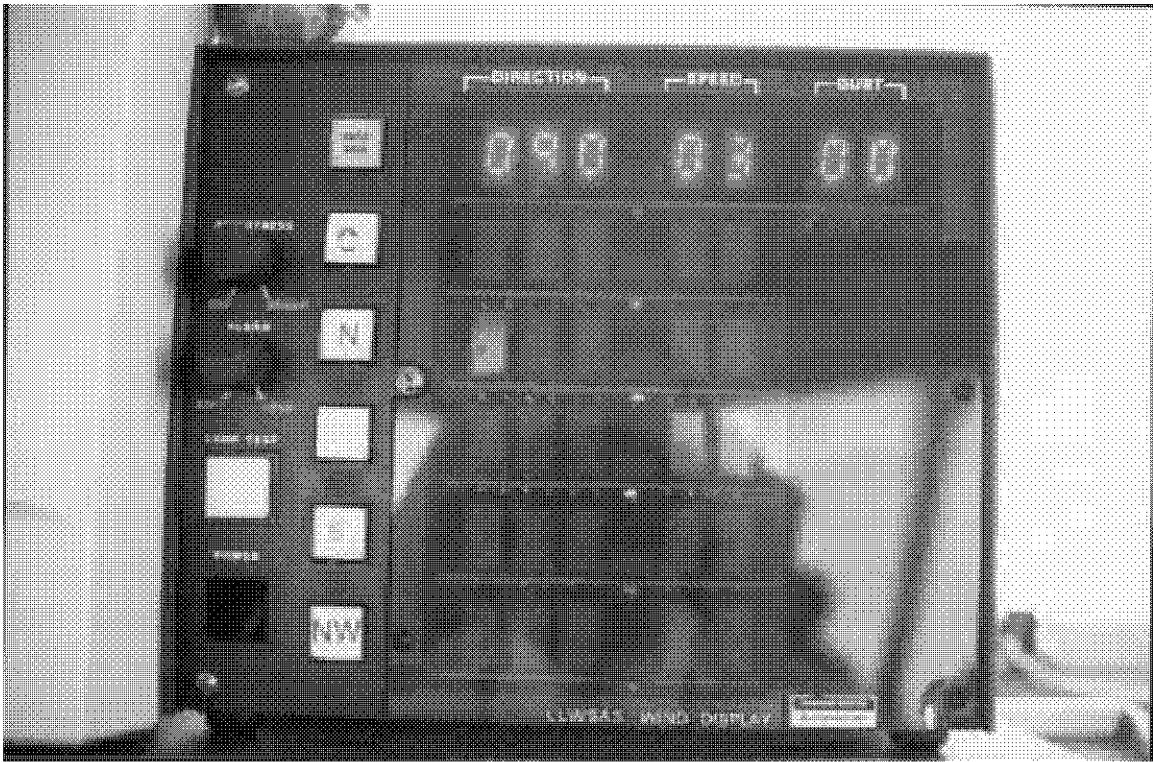
LIT ATCT is equipped with a low-level wind shear alert system that uses sensors around the airport to warn controllers of wind shear occurrences. There are two displays in the tower cab, located at the LC1 and ground control positions. (Photo 8) Each display has six rows. The top row shows the center field average wind direction and speed. This is normally the source of wind data reported to aircraft by the local controller. The second through sixth rows normally display a value only when a wind shear alert occurs, showing the controller the wind velocity and direction readings from each sensor contributing to the alert.

Photo 8: Low Level Wind Shear Alert System display.
