Letter from Captain Mohsen El Missiry, dated 7/31/00,
Egyptian Delegation comments on
Air Traffic Control Group Chairman's Factual Report

AIR TRAFFIC CONTROL ACCIDENT INVESTIGATION SUMMARY AND SUMMARY OF ADDITIONAL TASKS

Subject: EgyptAir Flight 990
Atlantic Ocean
October 31, 1999

Subject: EGYPT AIR MSR 990 ACCIDENT OCTOBER 31st, 1999

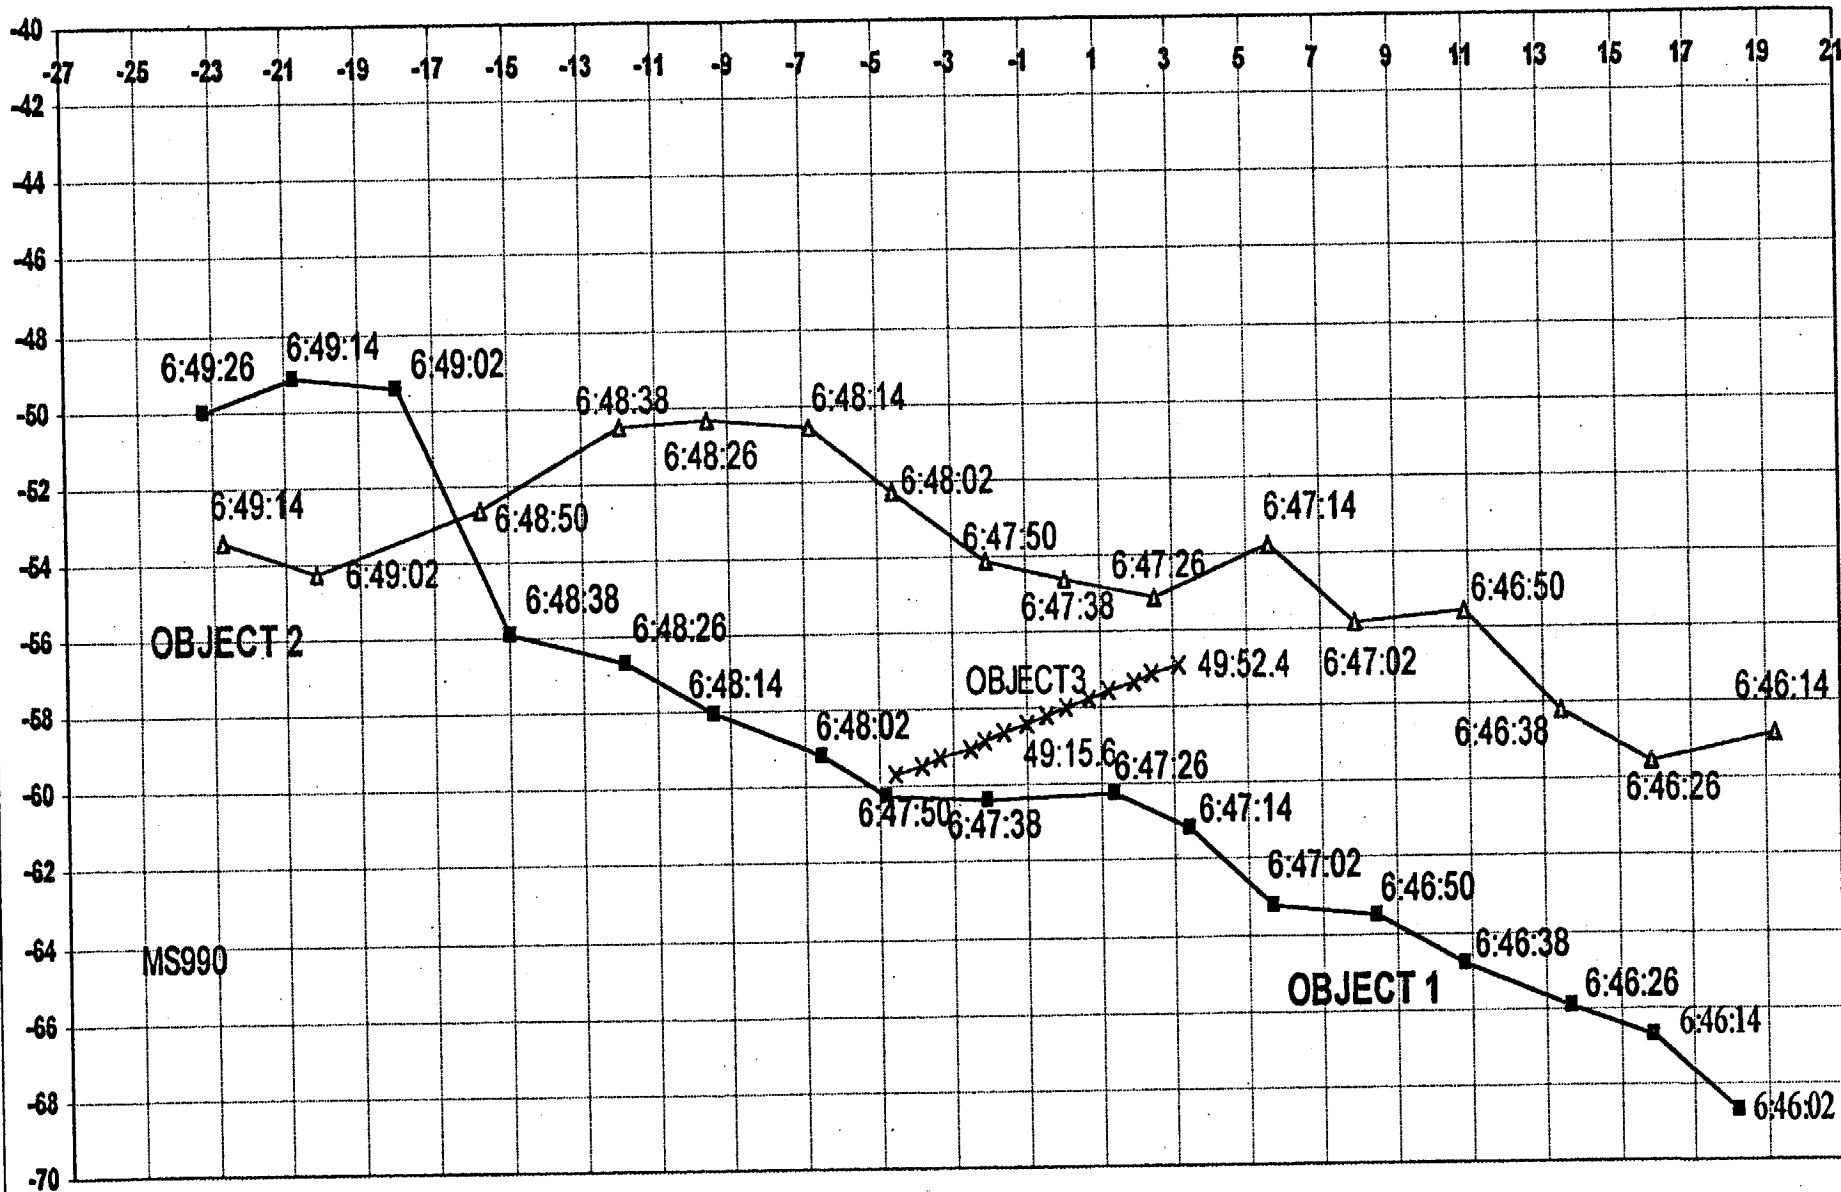
X-Y REL TO NANTUCKET

1 - The primary target which was detected for fourteen successive scans by Nantucket radar at 59.88 NM very close to and having the same path of the MSR 990. This target also detected by ISP radar site. MSR 990 was at that time at FL 330 and the transponder was still into full operation condition as detected by many other radar. It is impossible for Nantucket radar to detect MSR 990 at that level and that range as the software programmed for approximately 57 NM (Gohn Callhan report). The last detection of the primary target was just before MSR 990 started its dive!

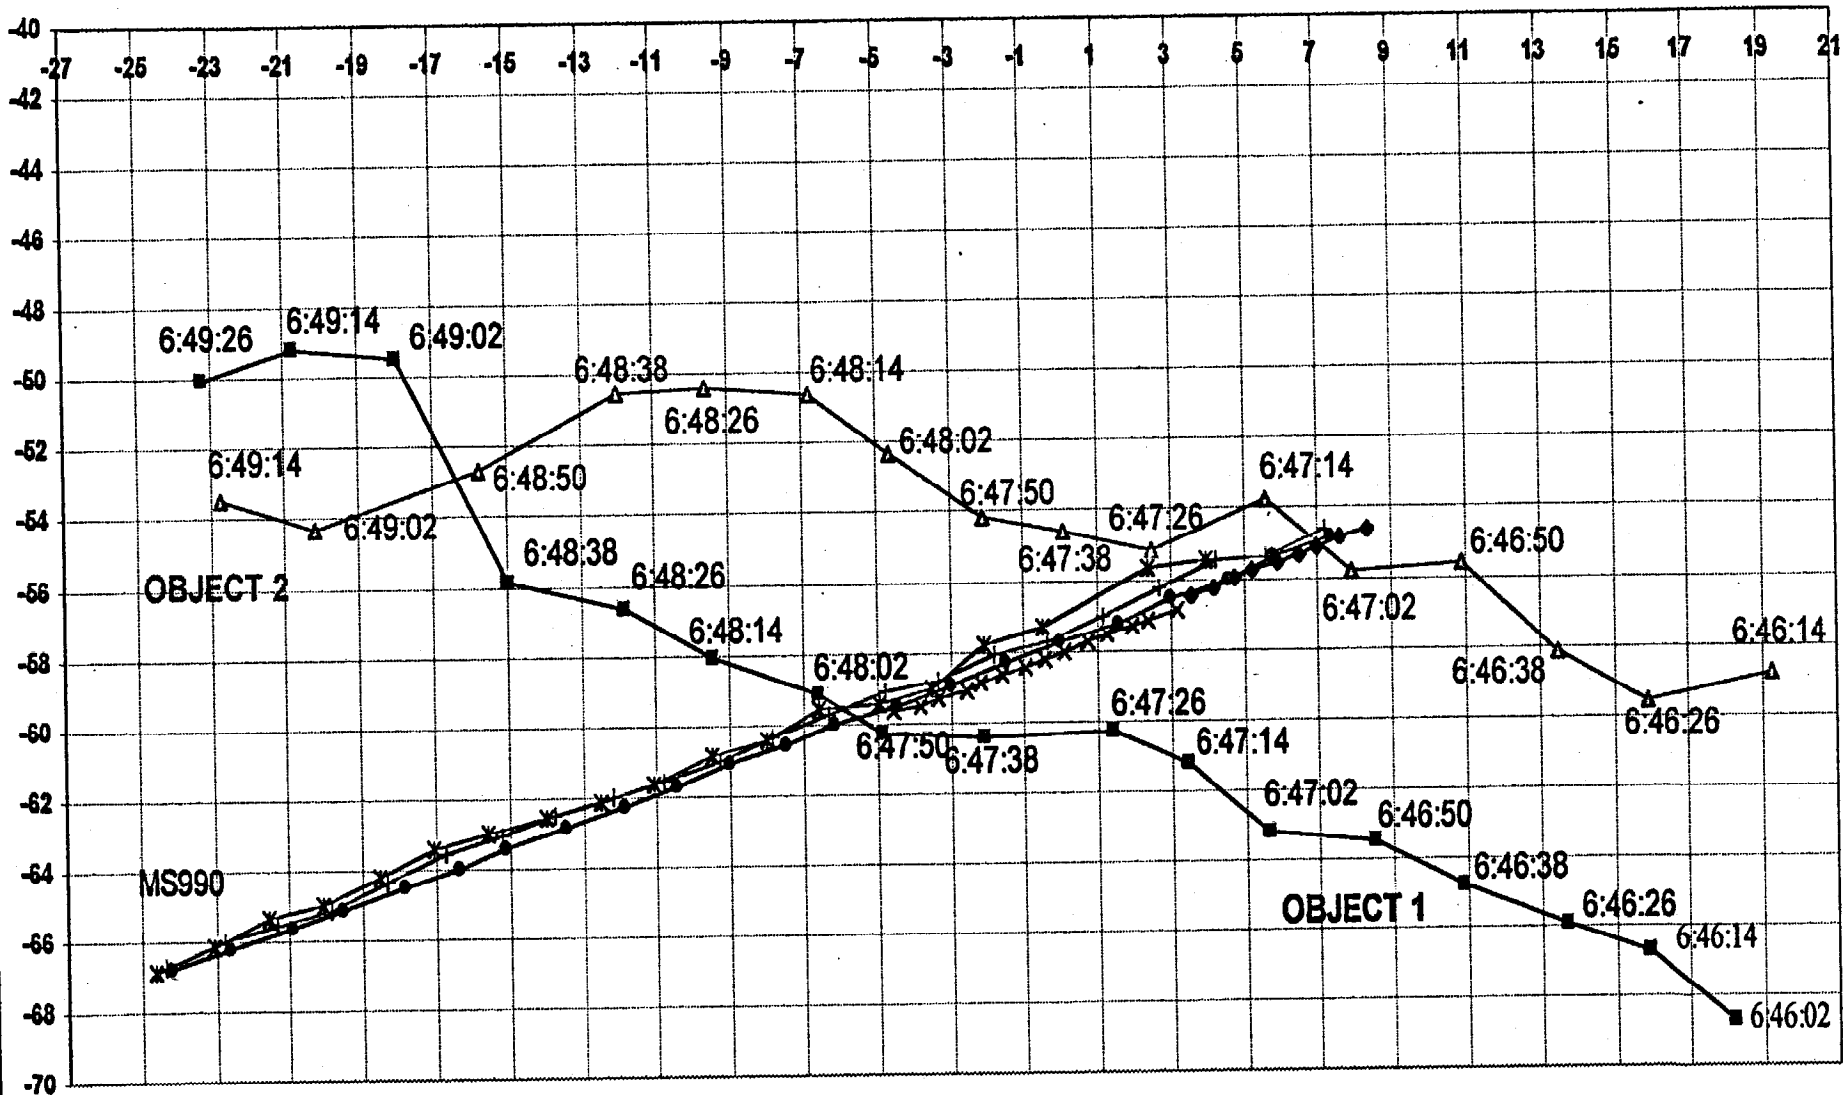
Radar Returns

It has been suggested that these returns actually strobing caused by interference between the RIV antenna and another antenna. No documentation of this interference has been provided except for some email communication between the RIV antenna and a Canadian facility. In a draft of the NTSB Factual Report, the strobing is attributed to interference between the RIV antenna and an antenna in Maine. It is also suggested that a solution to this strobing is being coordinated
