**NATIONAL TRANSPORTATION SAFETY BOARD  
Office of Aviation Safety  
Washington, DC 20594**

**ATC GROUP CHAIRMAN'S FACTUAL REPORT  
LAX02FA288A/B**

**A. AIRCRAFT ACCIDENT**

**Location:** 1 mile NW of McClellan-Palomar Airport (CRQ), Carlsbad, California  
**Date:** September 17, 2002  
**Time:** 1959 Coordinated Universal Time<sup>1</sup>  
**Aircraft:** N1828A, Beechcraft BE76 Duchess, and N7199U, Mooney MO20

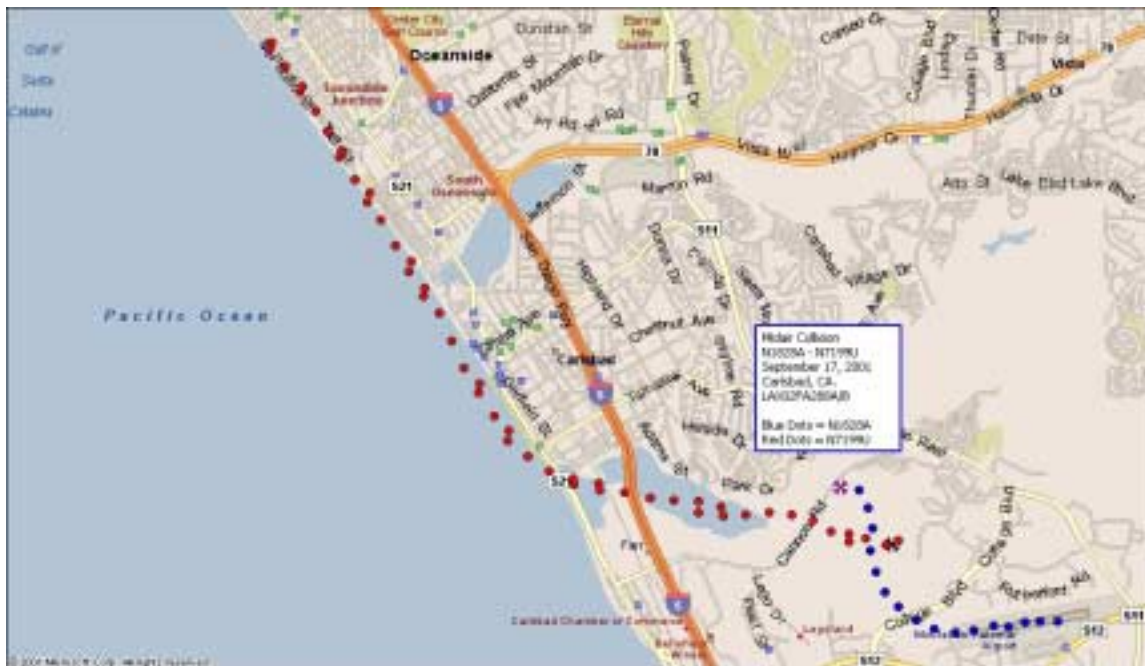
Figure 1. Overview of radar tracks

N1828A immediately turned right crosswind and crossed the arrival track of N7199U at about 1959:36, reporting 1400 feet. N1828A continued roughly northbound, then entered a rapid descent and struck the ground east of Cannon Road. The last radar target, received at 1959:48, showed the aircraft descending through 500 feet.

N7199U followed the coastline from Oceanside to a point about three miles northwest of CRQ. The aircraft then turned eastbound and tracked toward the right downwind leg for runway 24. At 1959:36, N7199U crossed the path of N1828A, reporting 1300 feet, and the two aircraft collided. N7199U entered a rapid descent, striking the ground approximately 300 yards from the estimated collision point at 1959:43.
