NATIONAL TRANSPORTATION SAFETY BOARD

Group Chairman's Factual Report

AIR TRAFFIC CONTROL

ERA12FA409

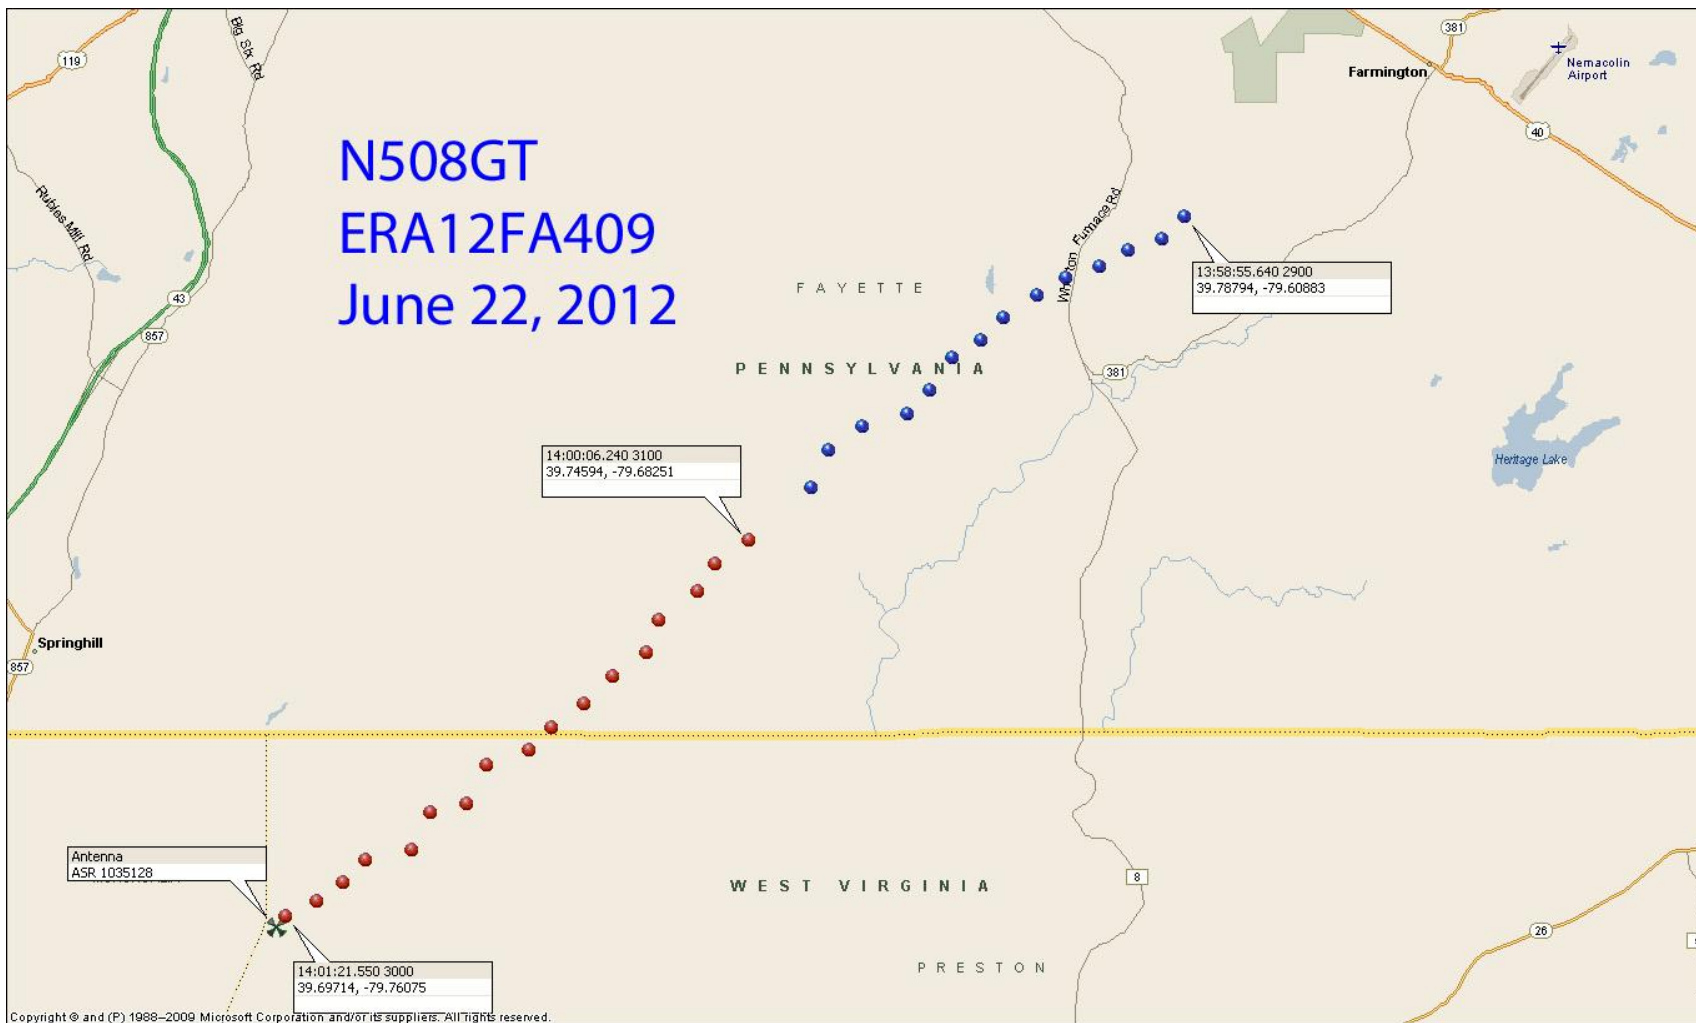
Figure 1. All 1200 (blue dots) and 0130 (red dots) transponder codes for N508GT between Nemaocolin and the antenna. Tags contain universal coordinated time (local time + 4 hours), altitude, and decimal latitude/longitude.

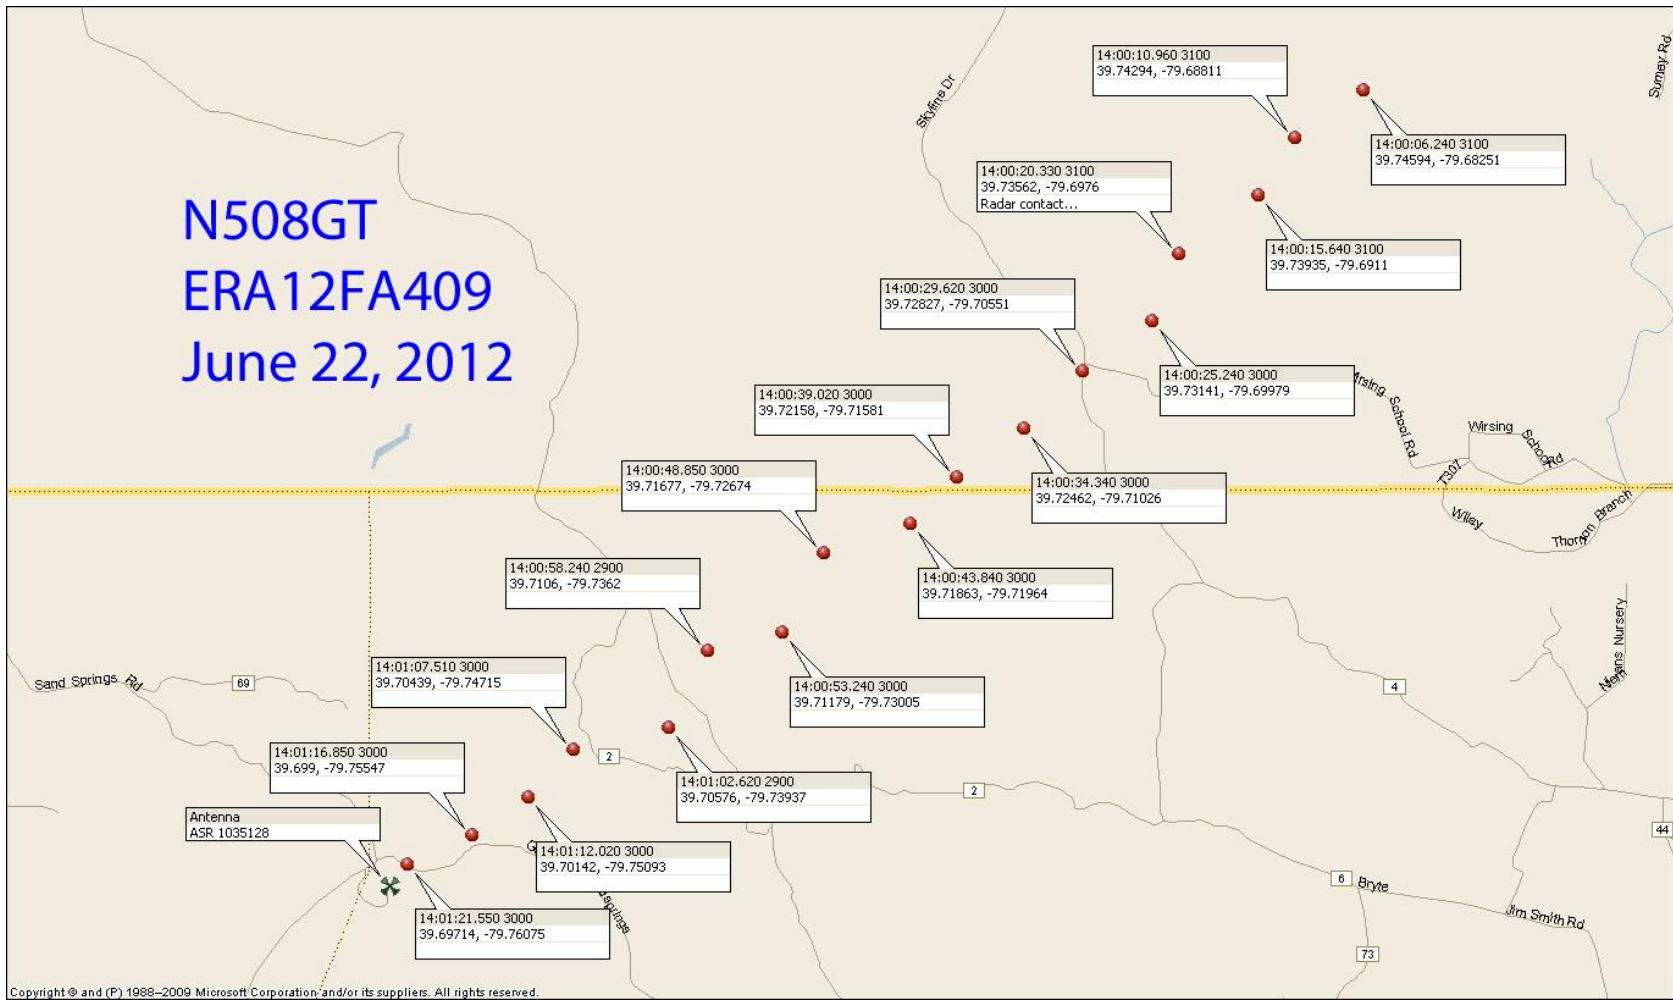
Figure 2. 0130 transponder codes for N508GT as it approached the antenna. Tags contain universal coordinated time (local time + 4 hours), altitude, and decimal latitude/longitude.

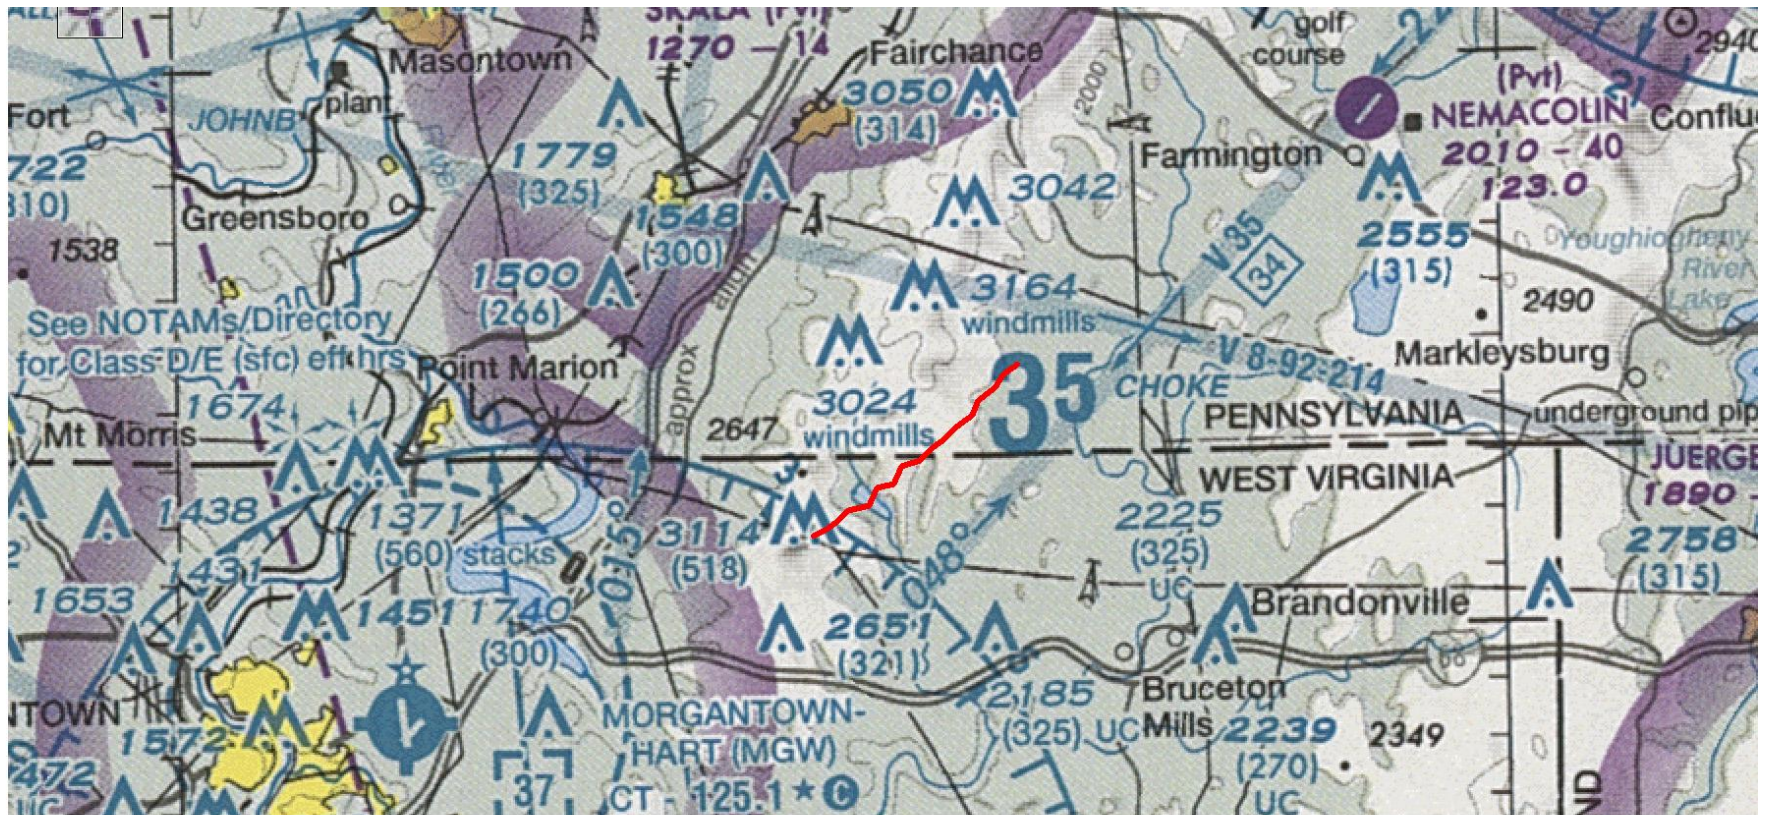
Figure 4 – Aircraft track shown on a Cincinnati sectional chart, with departure and destination airports. Red line indicates 0130 codes.
