NATIONAL TRANSPORTATION SAFETY BOARD

Group Chairman's Factual Report

AIR TRAFFIC CONTROL

DCA13MA133

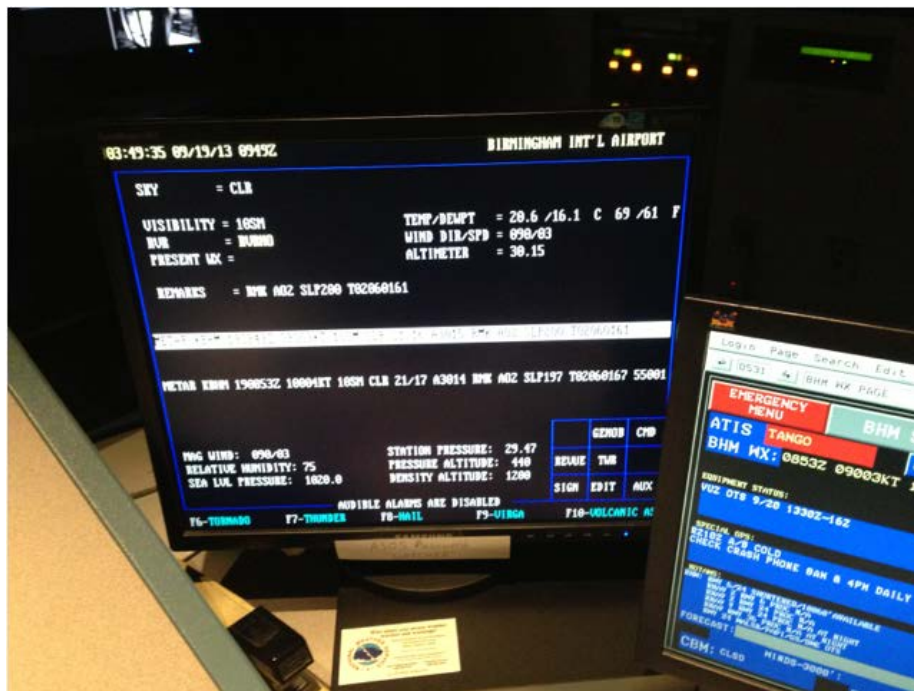
ATIS information “Papa” was prepared based on the 0353 ASOS observation, but did not include the METAR remarks about the observed ceiling being variable between 600 and 1300 feet.

Figure 5 – BHM ASOS Monitor located in the BHM ATCT

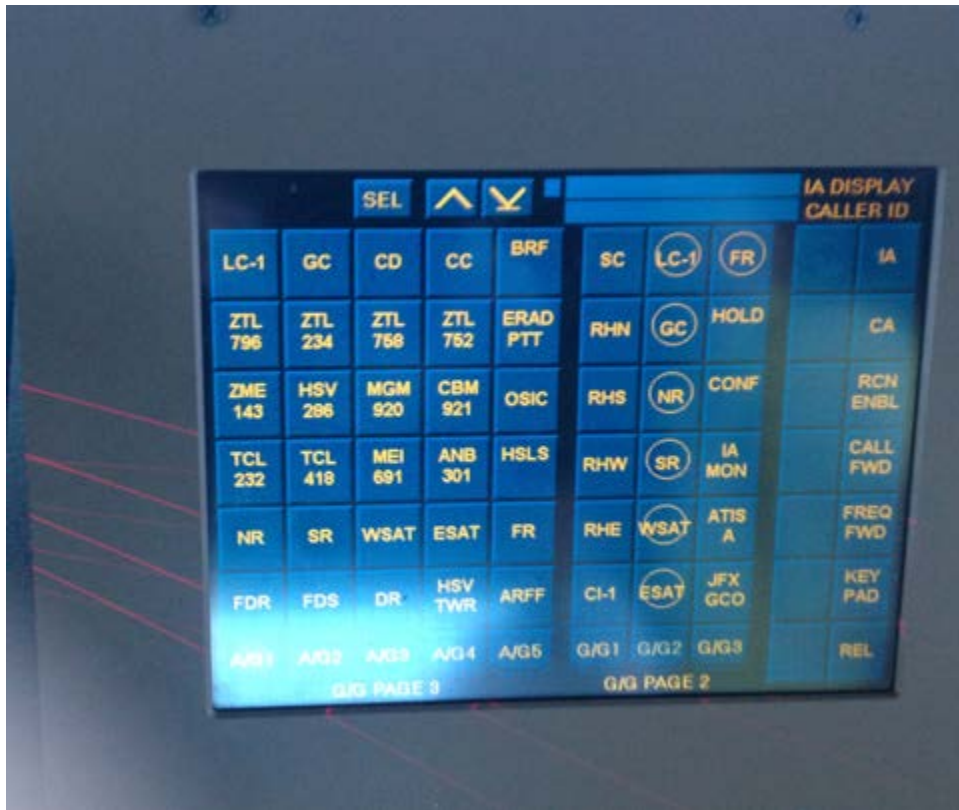
The BHM air traffic control tower was equipped with an ETVS communications system (See figure 7) that provided access to various communications circuits including the airport “crash phone.” The crash phone was the primary method for immediate notification to the airport’s first responders of an on or near airport accident or incident. The crash phone circuit connected the tower, the airport rescue and fire fighting (ARFF) station, Air National Guard operations, the Kaiser/Pemco maintenance facility, and the Birmingham airport authority operations office, and was the primary means for alerting BHM emergency services of an accident or serious incident on or near the airport.

When interviewed, the LCL1 controller said that the notification call was delayed for two reasons: first, because he was not immediately able to determine exactly where the aircraft had crashed, and second, because he had difficulty locating the correct button to activate the crash phone circuit on the ETVS display panel.

The ETVS communication system in the air traffic control tower had been reconfigured to accommodate consolidation of the tower and TRACON functions for the midnight shift. The reconfiguration resulted in various selection buttons on the ETVS display being displaced from their expected positions during day and evening operations. The LCL1 controller scrolled through several pages of frequency information before locating the correct button, which was on the first page but a different location than the daytime configuration, and notified the parties on the circuit of the accident. Following the accident, the tower and TRACON changed their procedures to ensure that the location of the crash phone button remained unchanged regardless of facility status.

Figure 7 – BHM ATC ETVS

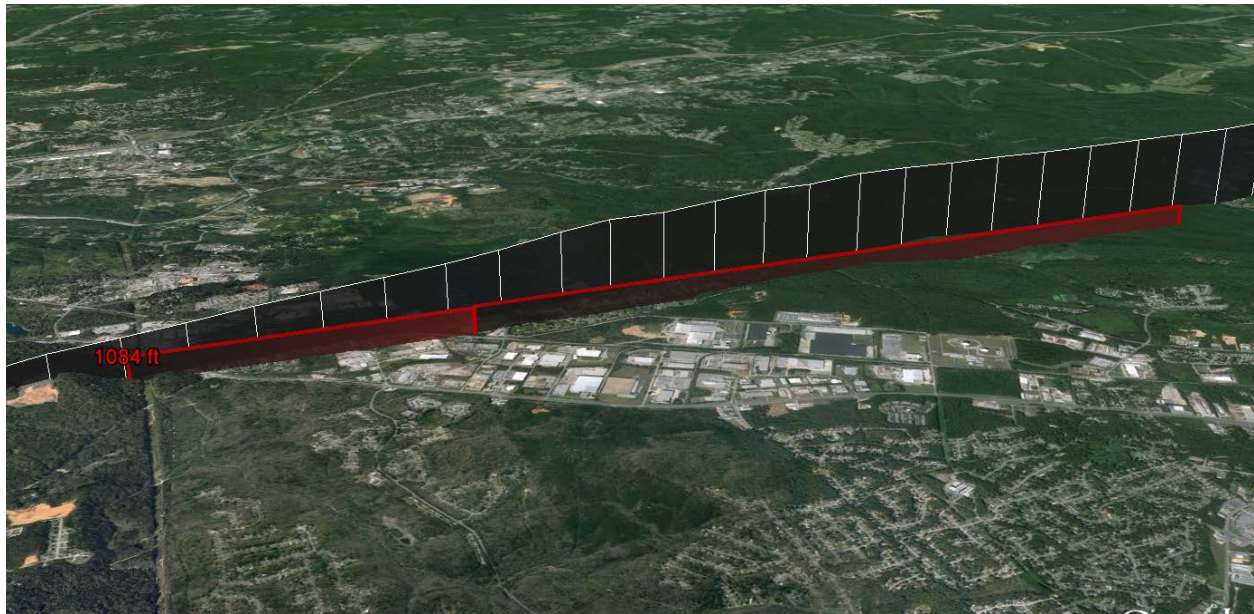
The current initiate monitor altitude was a two part adaptation configuration. with the first starting at 1084 feet MSL 1.99 NM from the approach end of runway 18 extending to 1170 feet MSL 3.0 NM from the approach end of runway 18 with the second portion beginning at 1200 feet MSL 2.99 NM from the approach end of runway 18 extending to 1202 feet MSL 5.9 NM from the approach end of runway 18. The predicted monitor altitude is 100 feet below the current initiate monitor altitude for both segments. (See figure 9)

Figure 9 – The UPS1354 radar flight path is indicated by the white line and the 2 segment MSAW type II area current initiate monitor altitude is indicated by a red line.

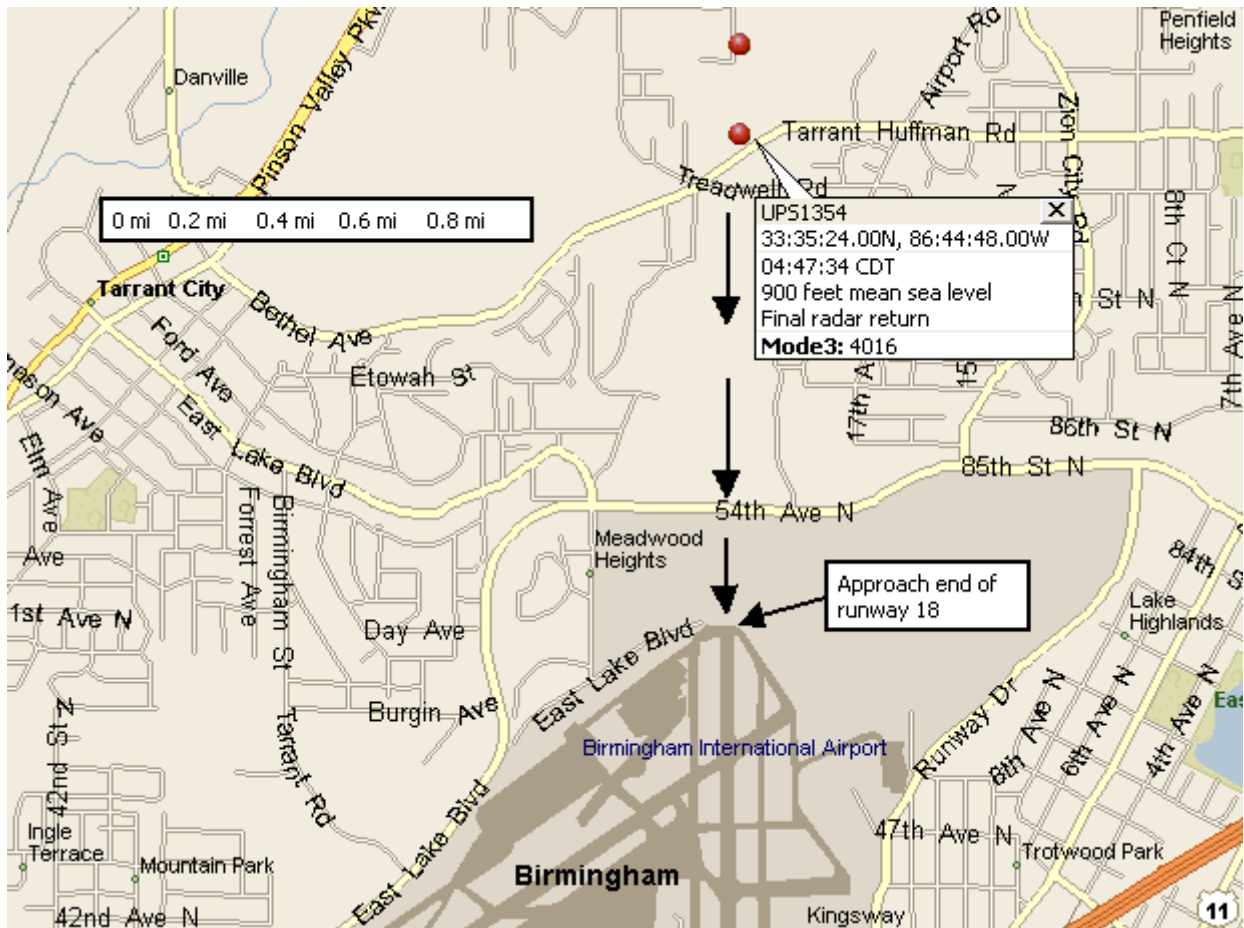
The final radar return for UPS1354 was at 04:47:34 at 900 feet MSL approximately 1.3 NM from the approach end of runway 18. (See figure 10) UPS1354's altitude profile on approach to runway 18 did not result in an MSAW alert. The flight path of the aircraft was above the current initiate monitor slope until intercepting the type I area.

Figure 10 – Radar flight track of UPS1354 showing final radar return
