NATIONAL TRANSPORTATION SAFETY BOARD

Group Chairman's Factual Report

AIR TRAFFIC CONTROL

ERA13FA088

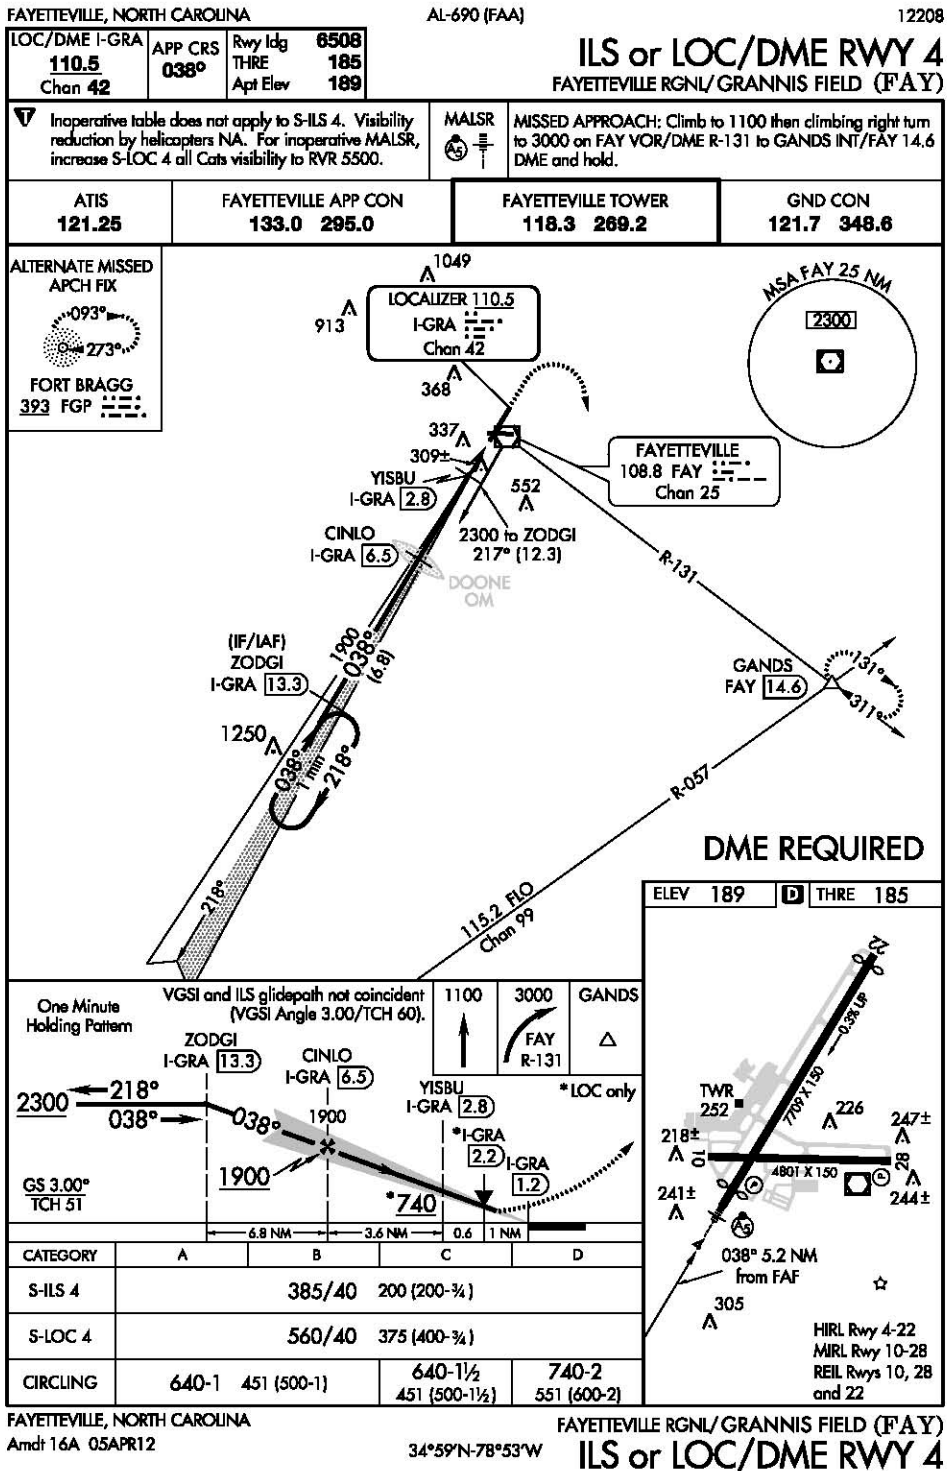
Figure 1 - FAY ILS Runway 4 Approach chart in effect on the date of the accident.

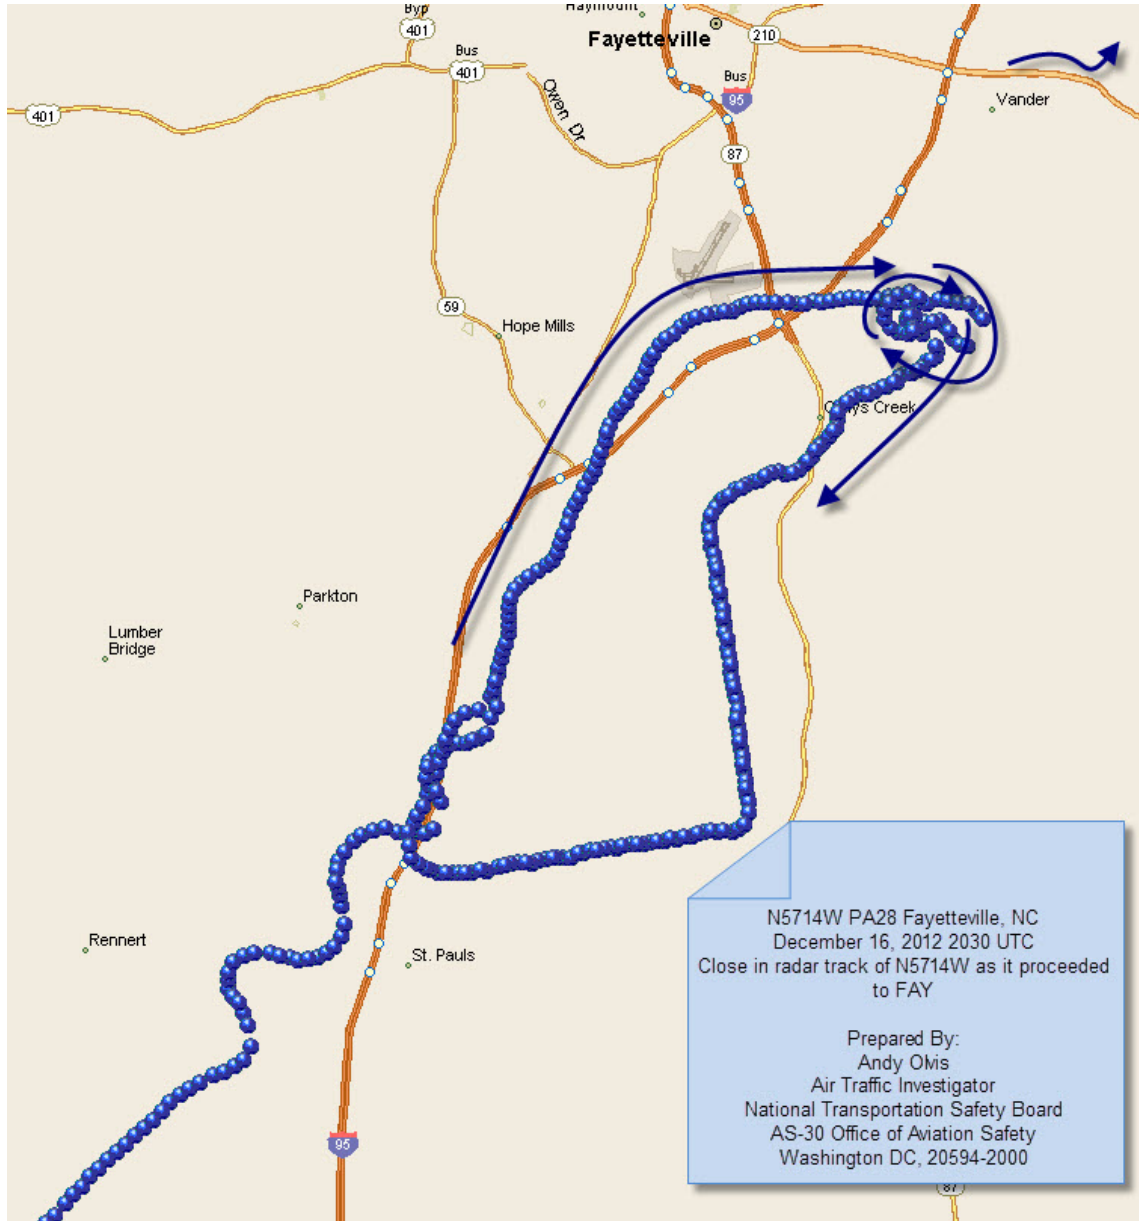
Figure 2 - Radar track as N5714W proceeded towards FAY

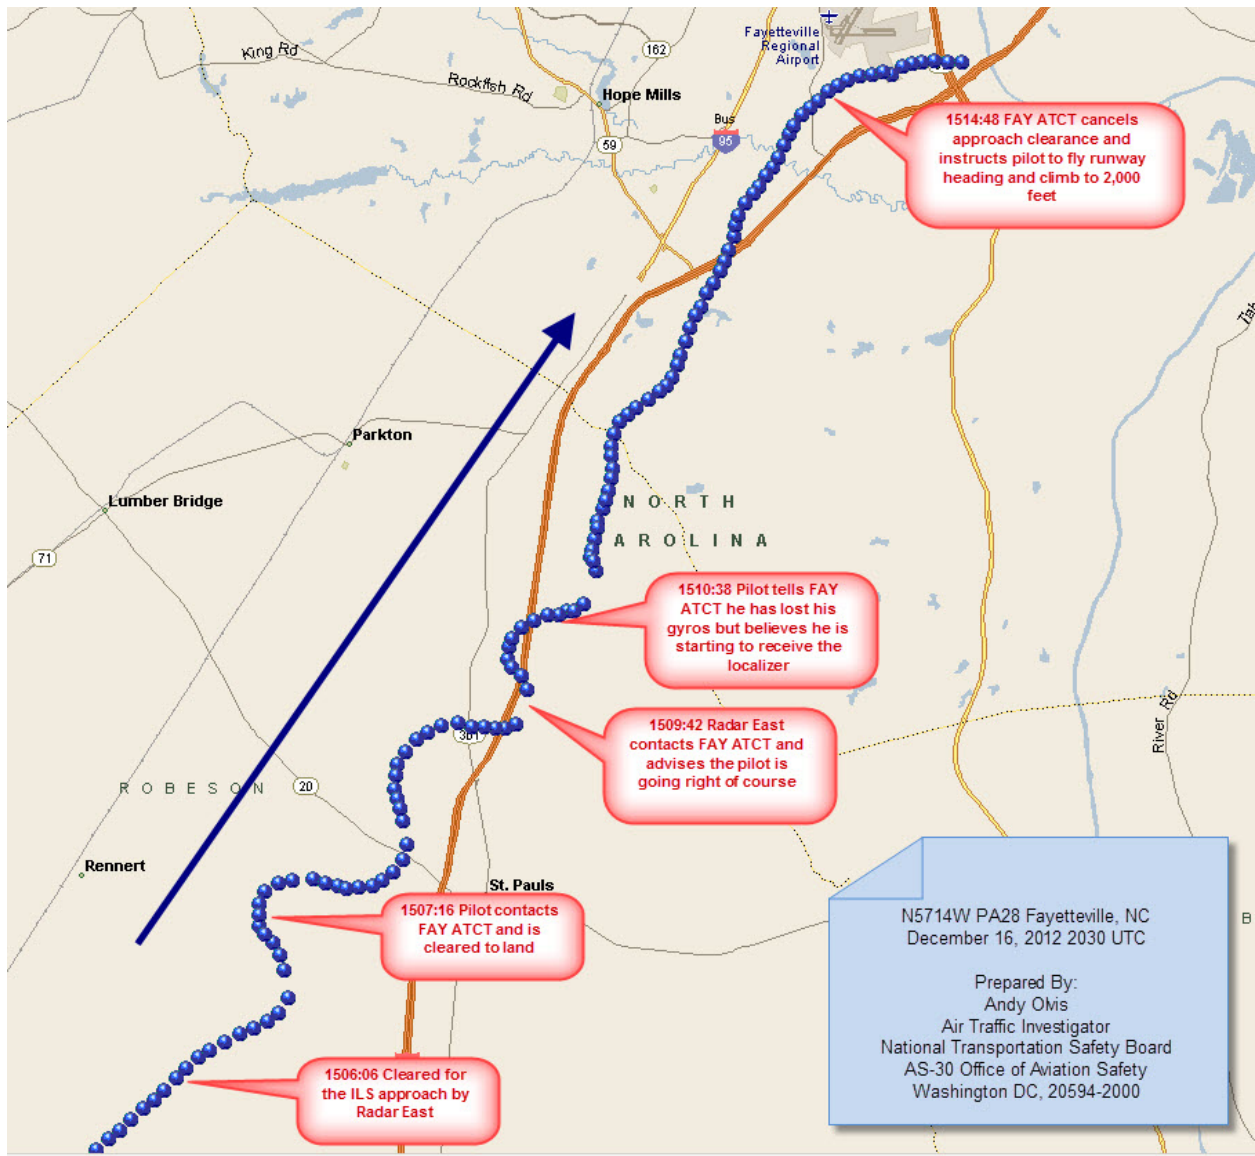
Figure 3 - Radar track of N5714W as it proceeded to FAY on the first ILS attempt.

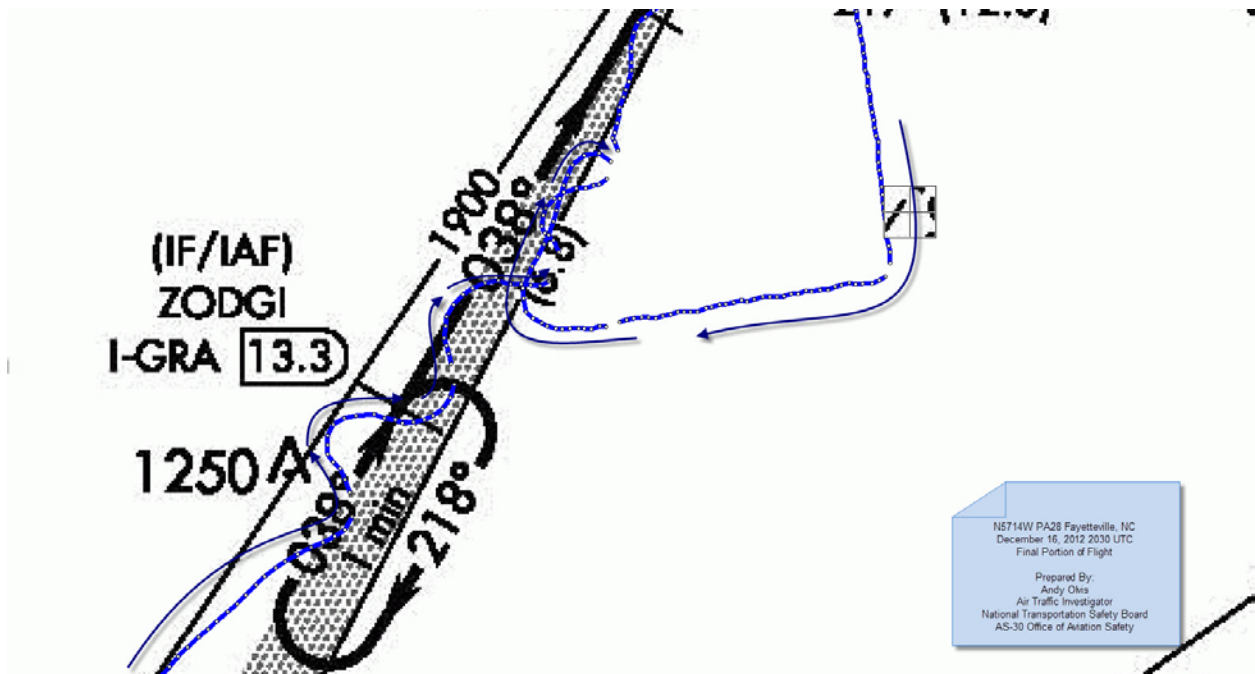
Figure 4 - Initial ILS approach attempt overlaid on an approach plate.

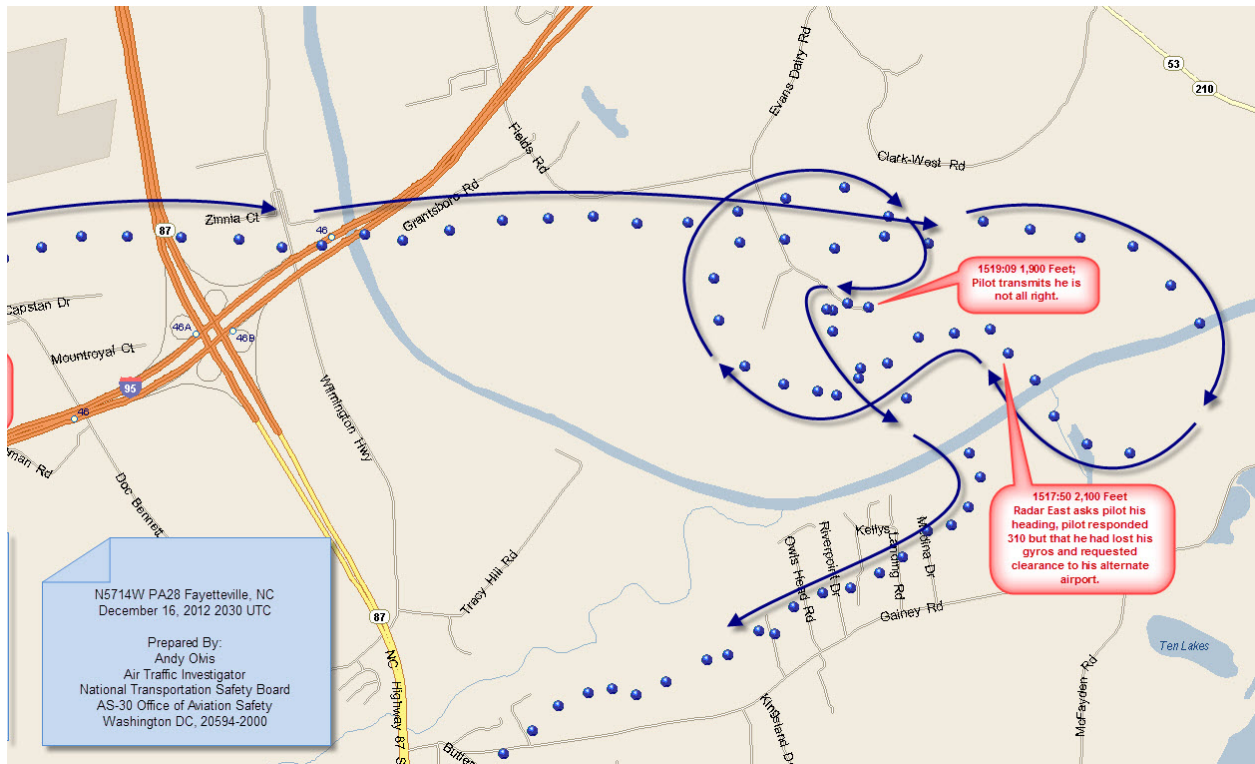
Figure 5 - Radar track of N5714W executing a missed approach after the first approach attempt to FAY.

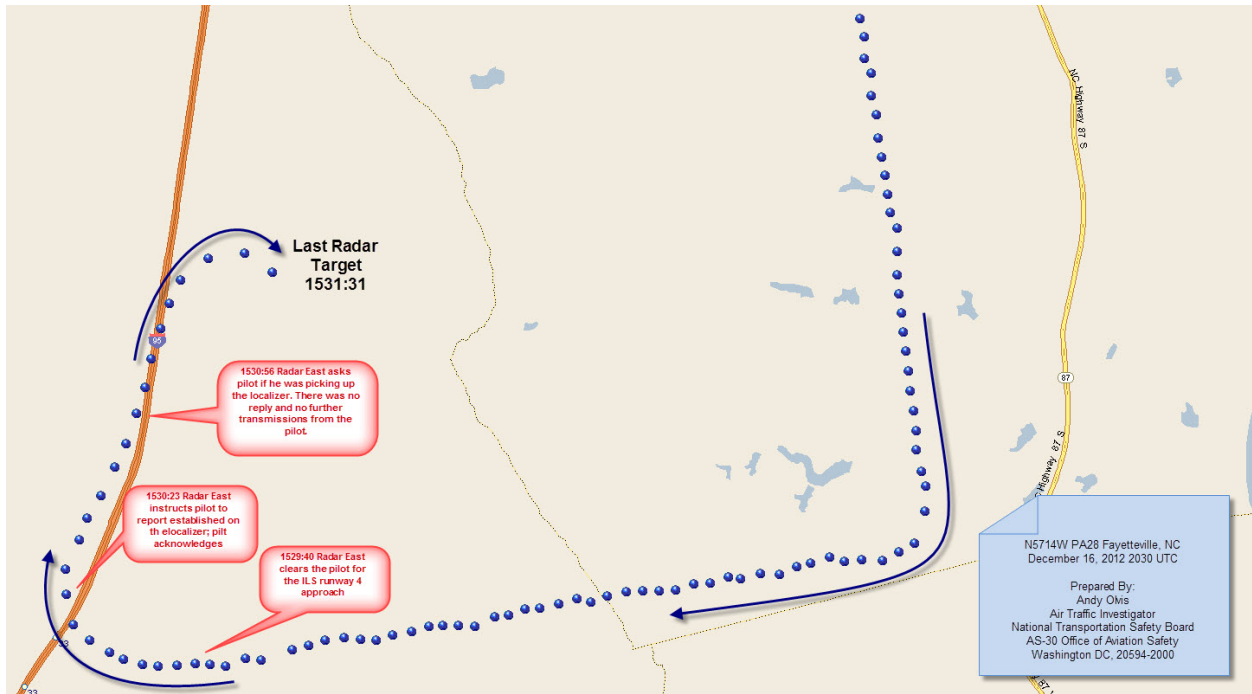
Figure 6 - Radar track of N5714W being vectored back to FAY.
