NATIONAL TRANSPORTATION SAFETY BOARD

Air Traffic Control Group Chairman's Factual Report

ATC GROUP CHAIRMAN'S FACTUAL REPORT

CEN09MA142

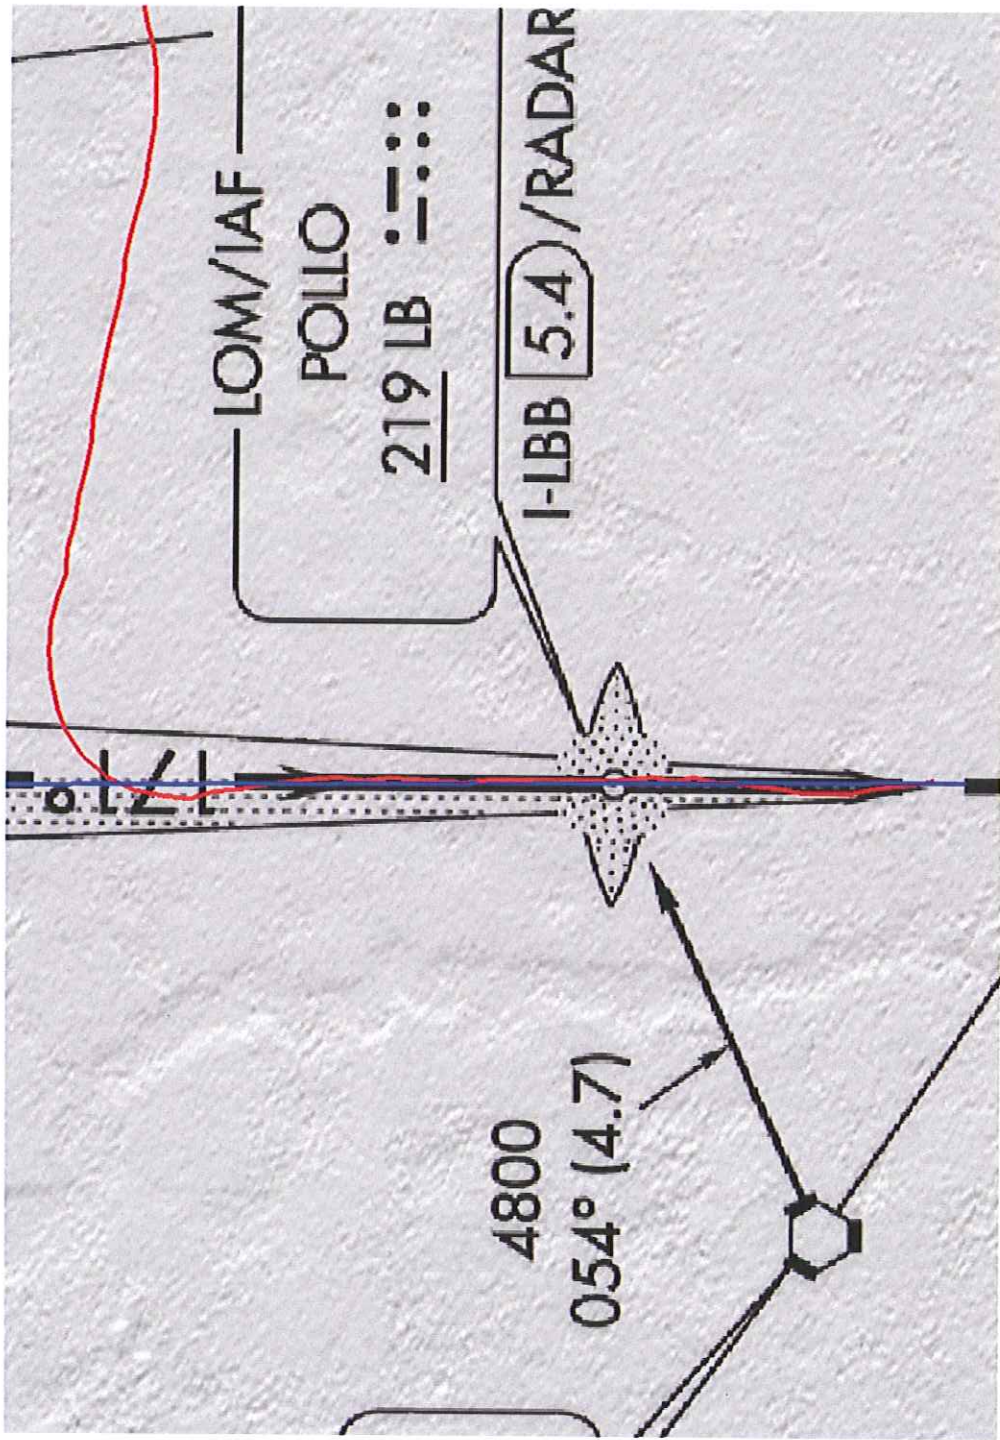
Figure 1 – CFS8284 ILS 17R overview.

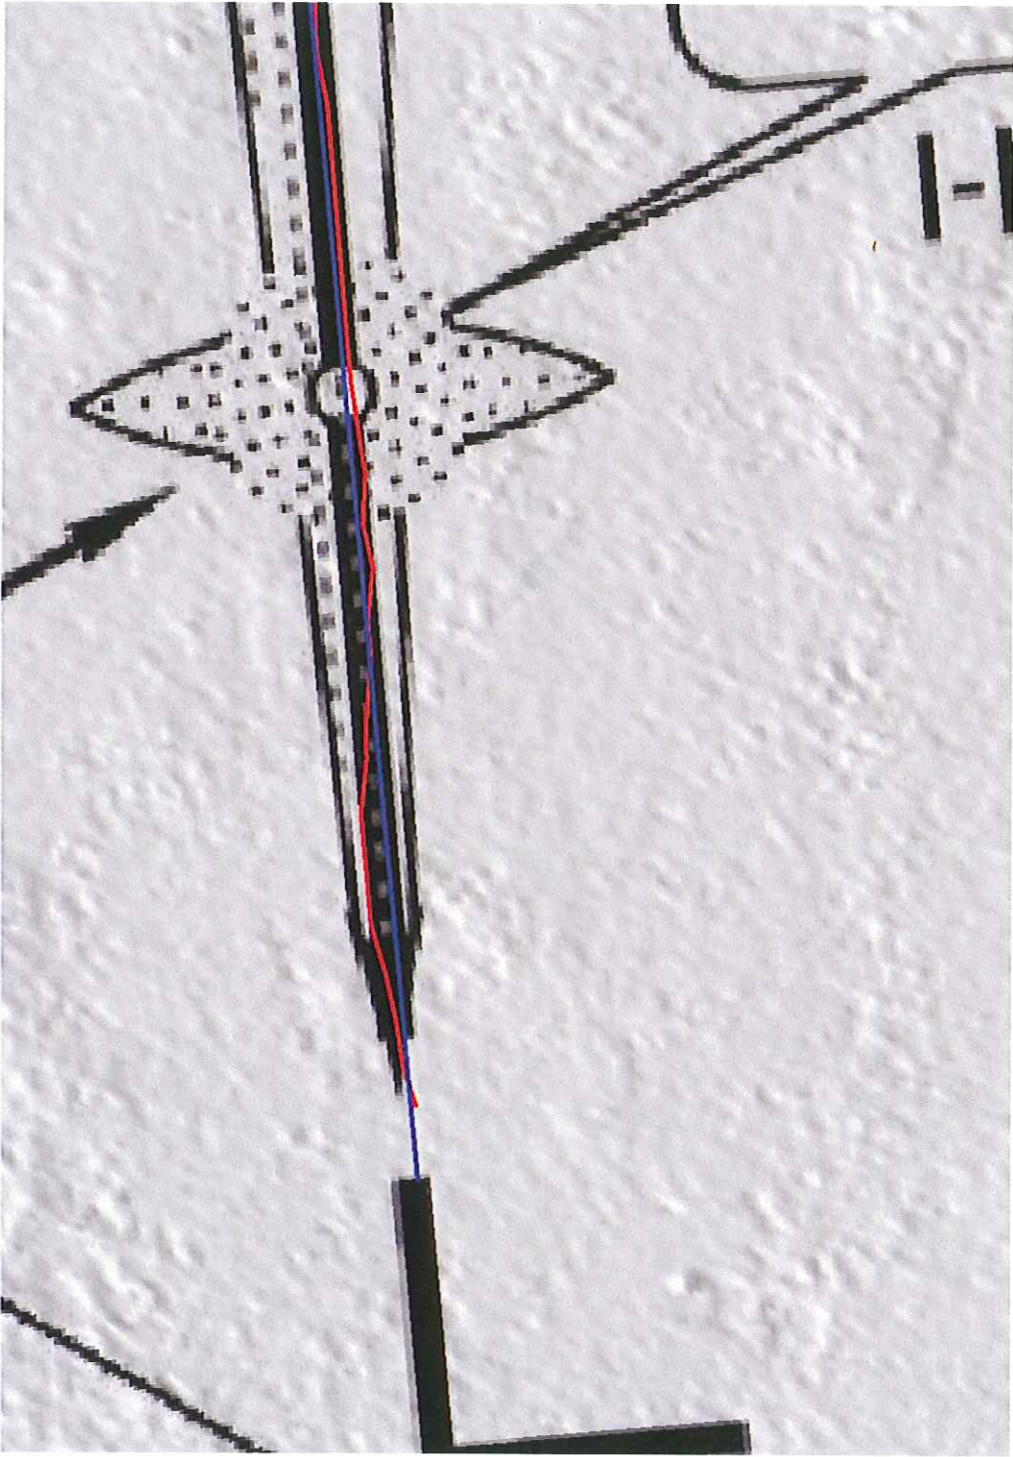
Figure 2 – CFS8284 ILS 17R final approach segment.

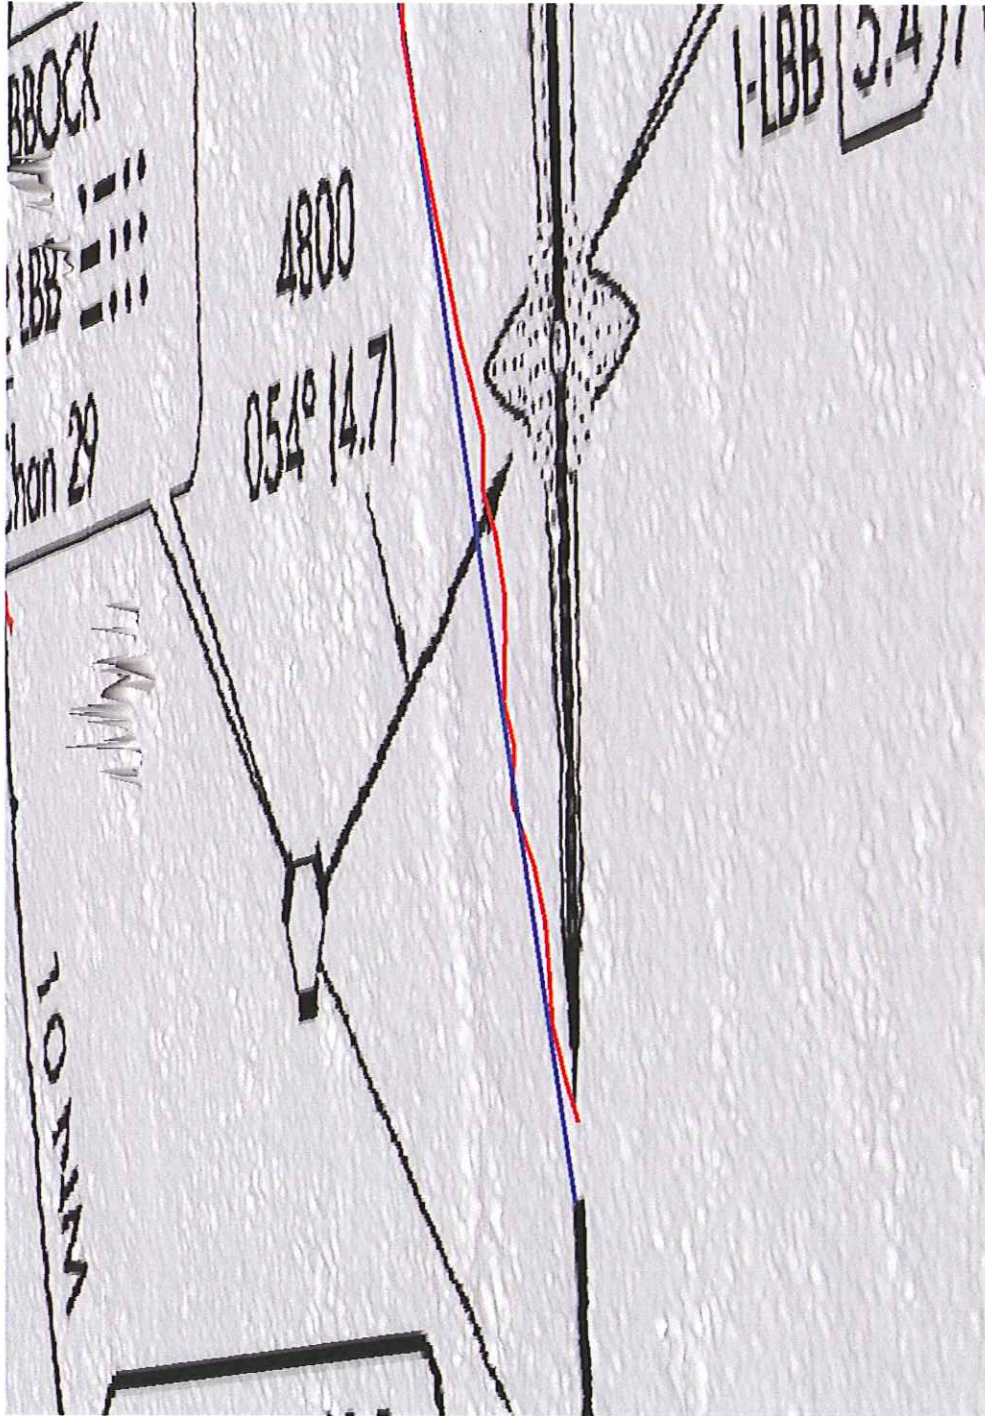
Figure 3 – Profile view of CFS8284 ILS 17R approach.
