## **NATIONAL TRANSPORTATION SAFETY BOARD**

### **Group Chairman's Factual Report**

#### **AIR TRAFFIC CONTROL**

**DCA14FA046**

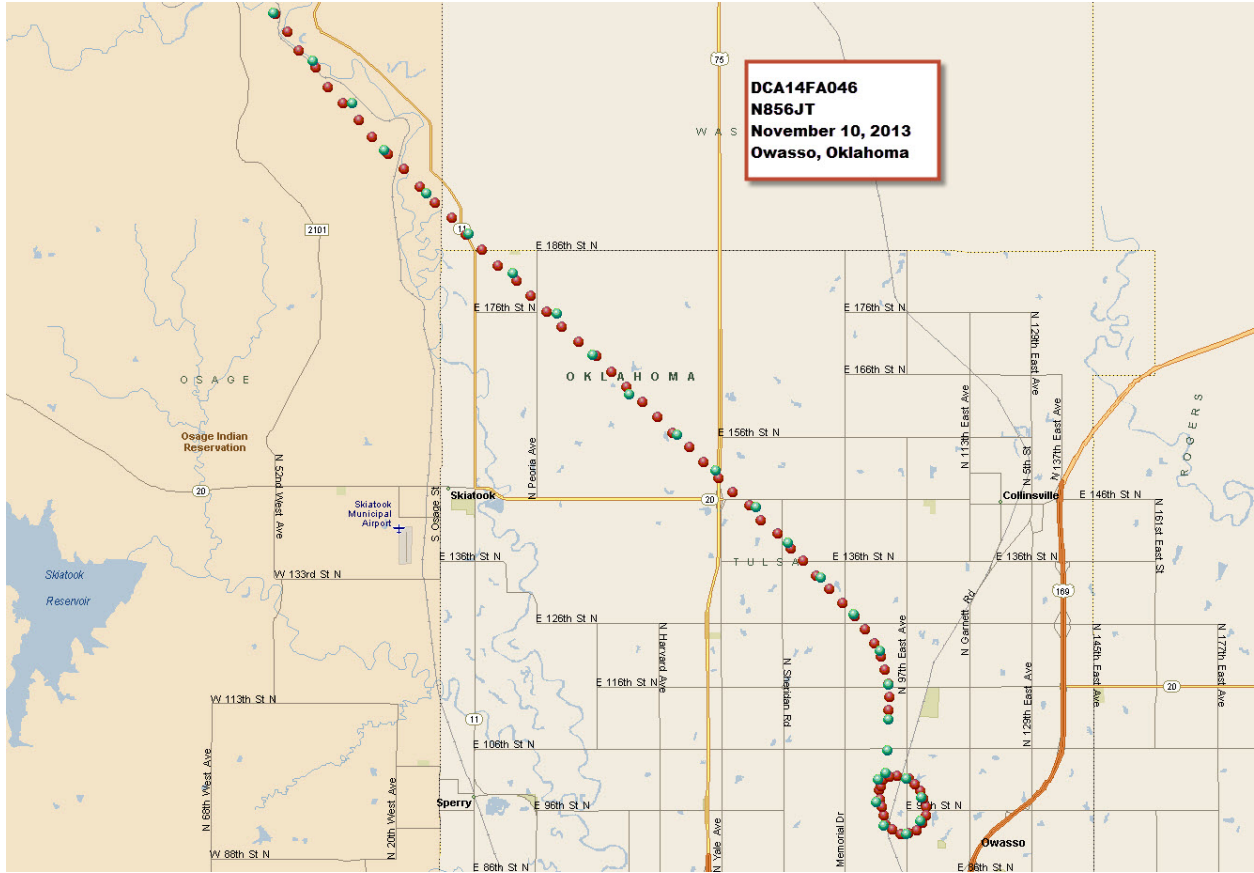
Figure 1 – Overview of flight – 1534 until loss of contact.

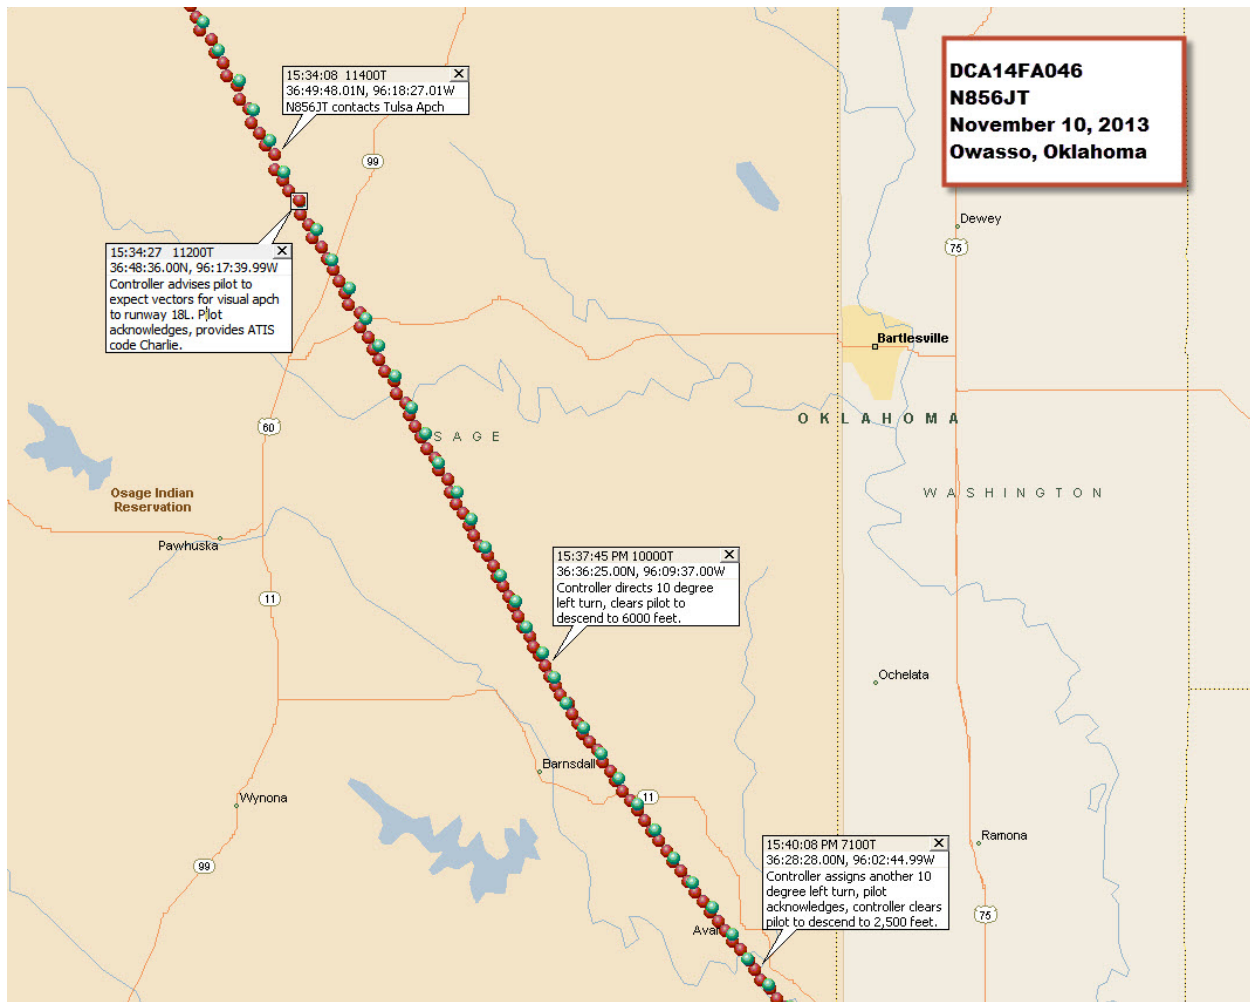
Figure 2 - Initial contact between N856JT and Tulsa Approach. Data tag line 1 shows time (CST) and true altitude +/- approximately 50 feet.

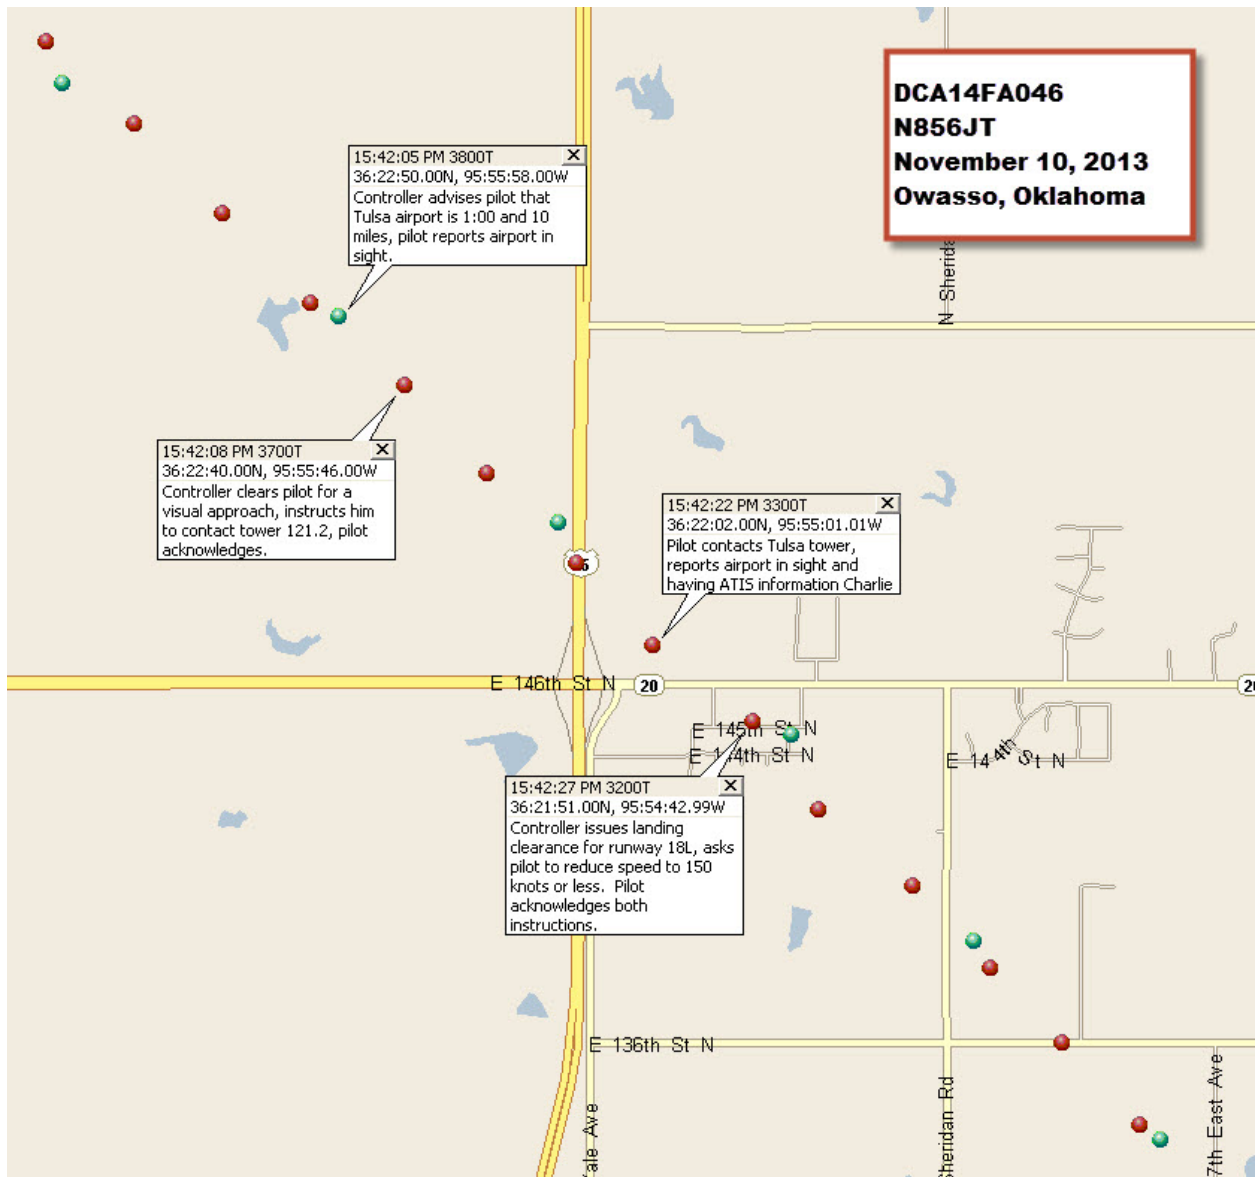
Figure 3 – Middle of flight with Tulsa Approach.

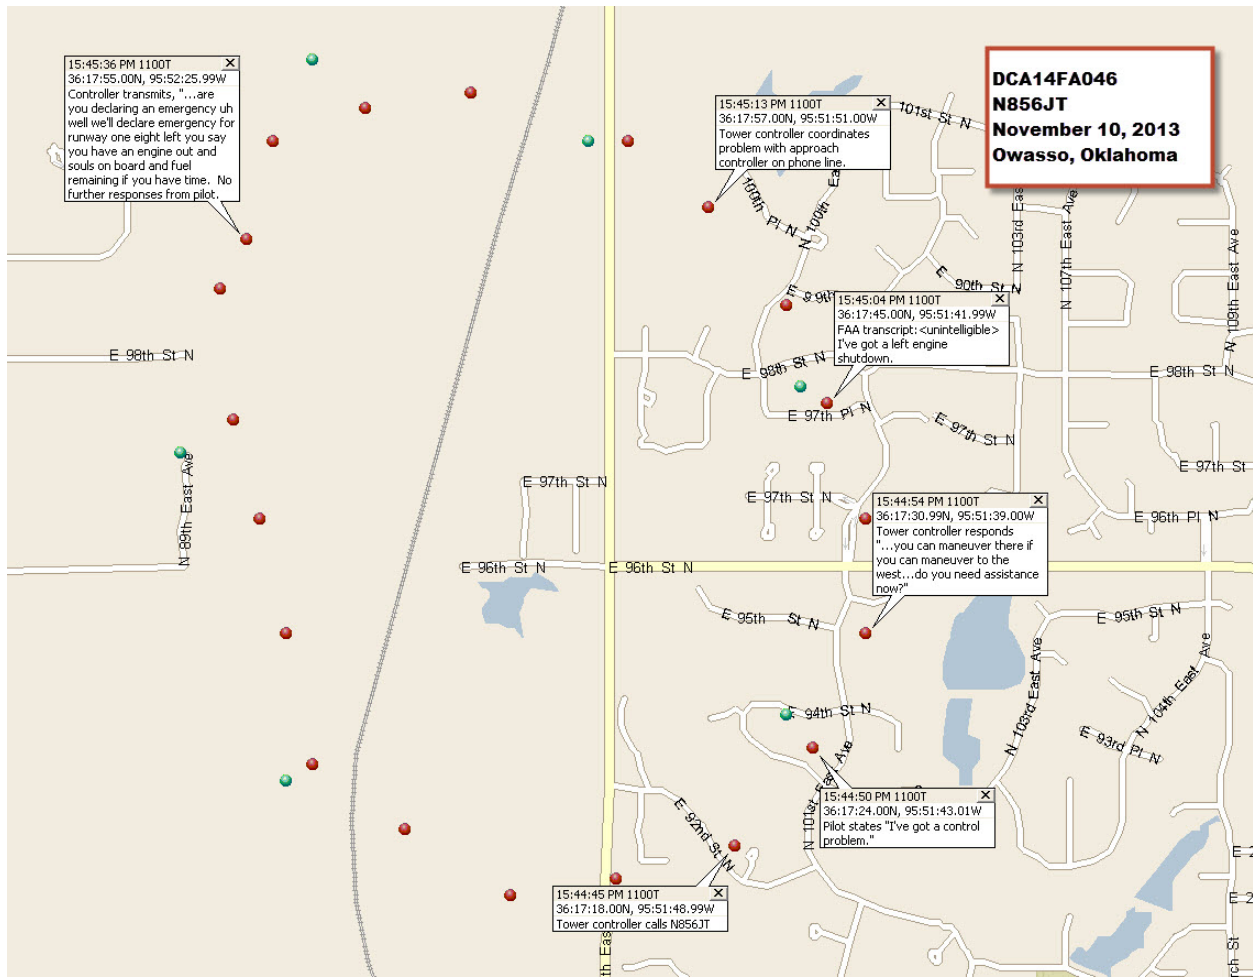
Figure 4 – End of flight.
