ATC GROUP CHAIRMAN'S FACTUAL REPORT

CEN10FA443

Location: Oshkosh, Wisconsin

Aircraft: N6JR, Raytheon 390 Premier

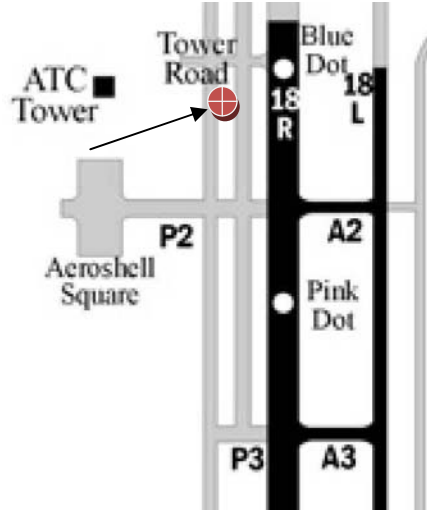
Figure 1 – Location of the Fly-by Mobile MOOCOW (arrow)

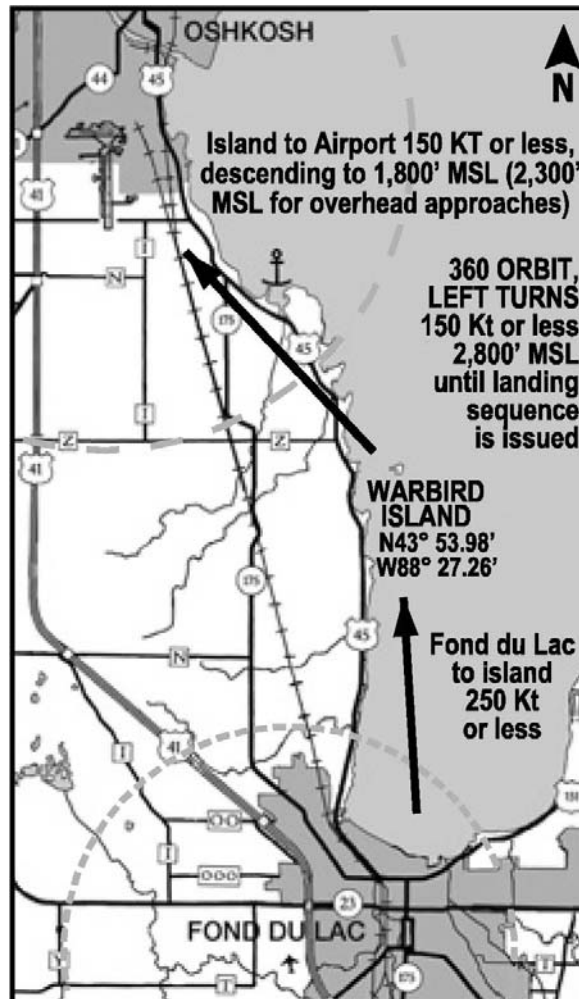
Figure 2 – Warbird arrival

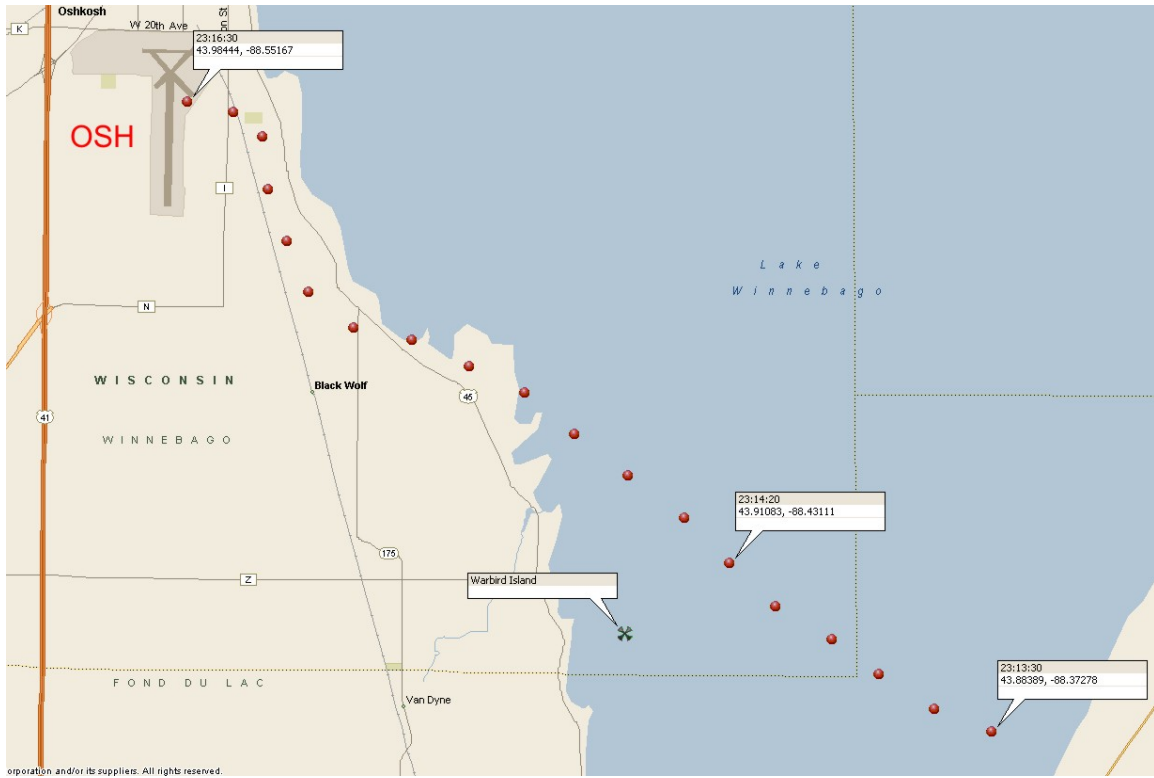
Radar coverage in the vicinity of OSH is limited, with antennas located at Horicon, Wisconsin, Milwaukee, Wisconsin, and Green Bay, Wisconsin. N6JR was visible on radar until turning left base for runway 18, but radar coverage was not sufficient to identify the position of the departing Cub or its relationship to N6JR during its takeoff roll and immediately after departure. Radar data for N6JR is shown in figure 3.

Figure 3 – N6JR approaching OSH. All targets are 1200 code, no altitude information. Times shown are Coordinated Universal Time, 5 hours later than local time.
