Pilot/Race 177, *The Galloping Ghost*
North American P-51D, N79111
Reno, Nevada
September 16, 2011

Accident Brief

NTSB/AAB-12/01
PB2012-916203

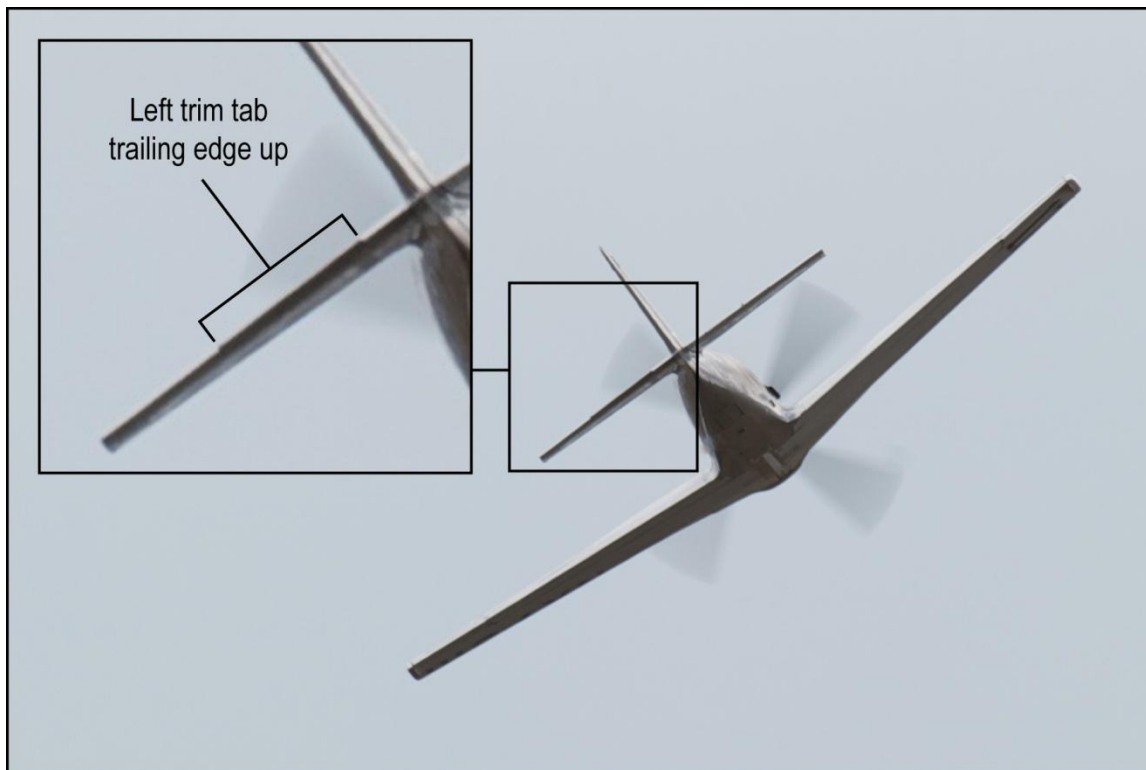
edge down when the right aileron was faired with the wing. Photographs of the airplane during flights on the race course 3 days before the accident showed that the airplane's left elevator trim tab was deflected trailing edge up; image study calculations determined that, in one photograph, the deflection was 5° trailing edge up, and in another photograph, it was 8° trailing edge up. Available telemetry data showed that, at the time that the photograph showing 8° trailing edge up was taken, the airplane was in a section of the race course between pylons 6 and 7 and had a ground speed of about 360 to 380 knots (see figure 4).

Figure 4. Left trim tab deflection of 8° trailing edge up during a previous flight.

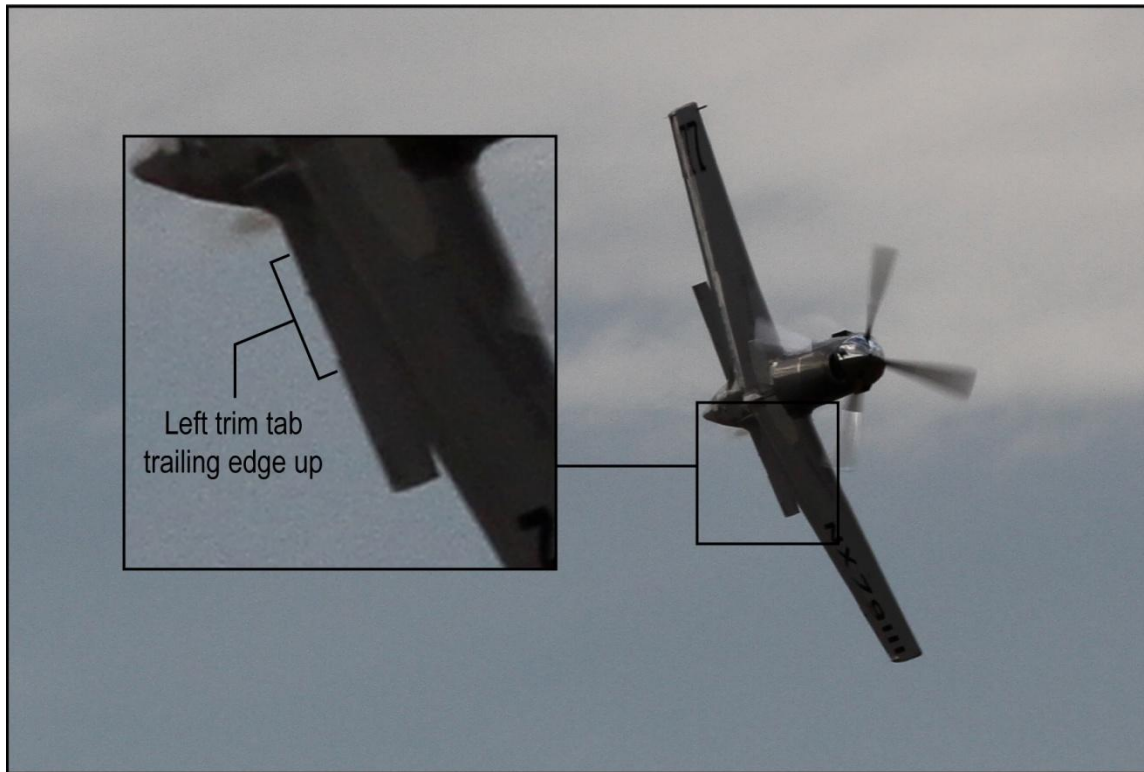
Trailing-edge-up left elevator trim tab deflection was also evident in photographs of the airplane during the accident race. One photograph showed that, as the airplane began to round pylon 8 at 1624:28.65²⁹ during the accident lap, the left elevator trim tab was trailing edge up, consistent with the position observed during previous laps (see figure 5).

Figure 5. Airplane rounding pylon 8 during accident lap before the left roll upset at 1624:28.65.

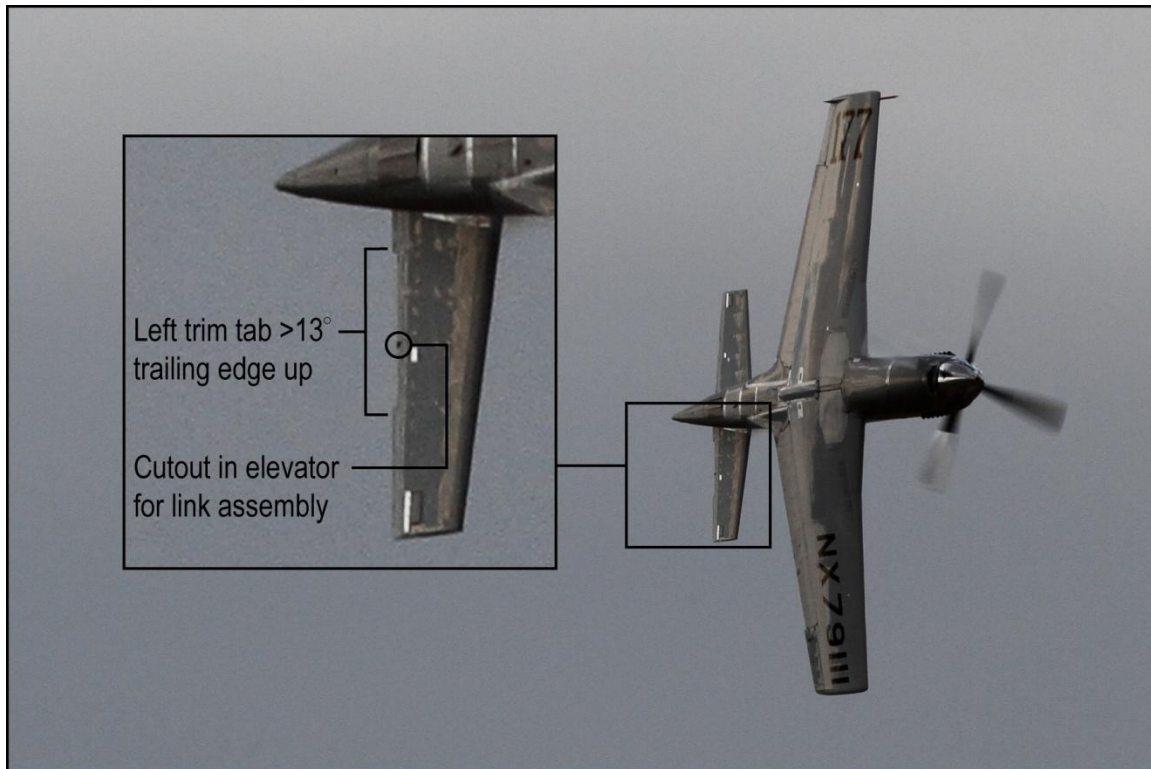
Figure 6. Airplane during left roll upset at 1624:29.46, before it reached maximum left bank angle. Inset shows detail of left elevator trim tab and the cutout in the elevator for the trim tab link assembly.

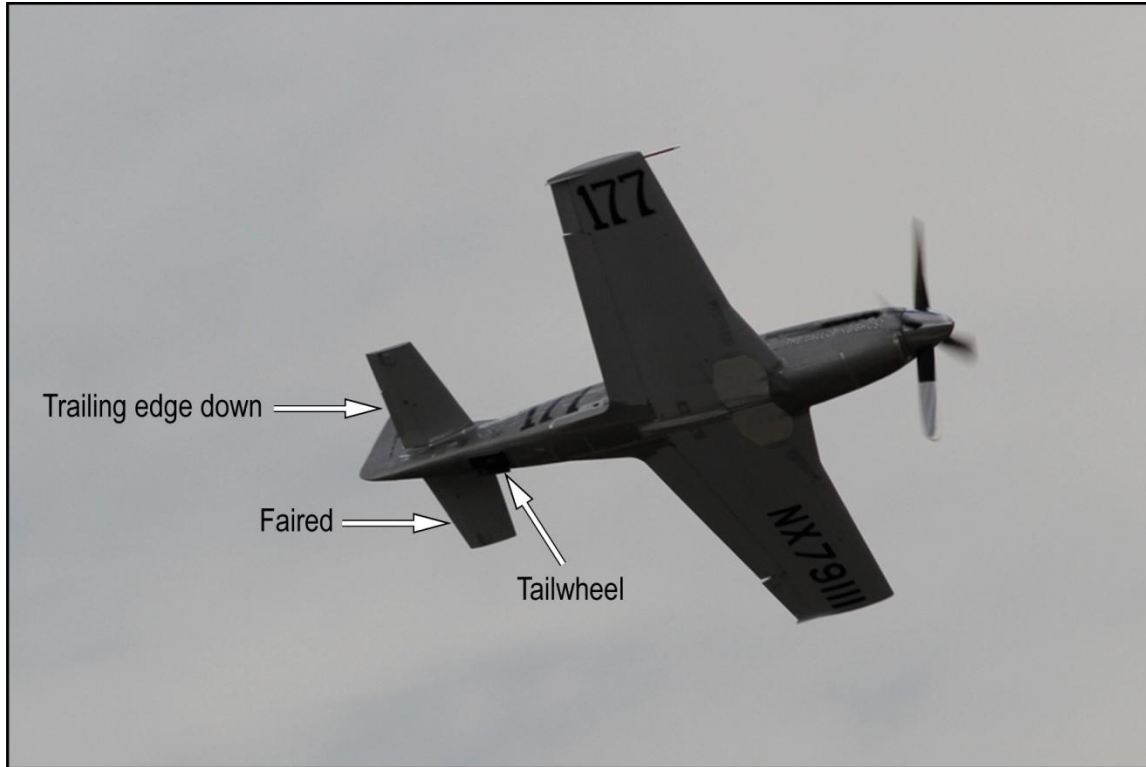
A subsequent photograph showed the airplane at 1624:30.20 as it rolled back to the right and pitched up. Examination of the photograph showed that the left elevator trim tab was faired with the elevator, and the right elevator trim tab was trailing edge down (see figure 7). The deflection of the right trim tab from its fixed, faired position indicates that the right elevator trim tab link assembly had also broken by this time in the flight. This image, which was captured about the time that the airplane sustained its maximum vertical load factor of 17.3 G, also showed that the tailwheel had begun to extend from its housing.

Figure 7. Airplane rolling right and pitching up at 1624:30.20, about the time it sustained its maximum vertical load factor.

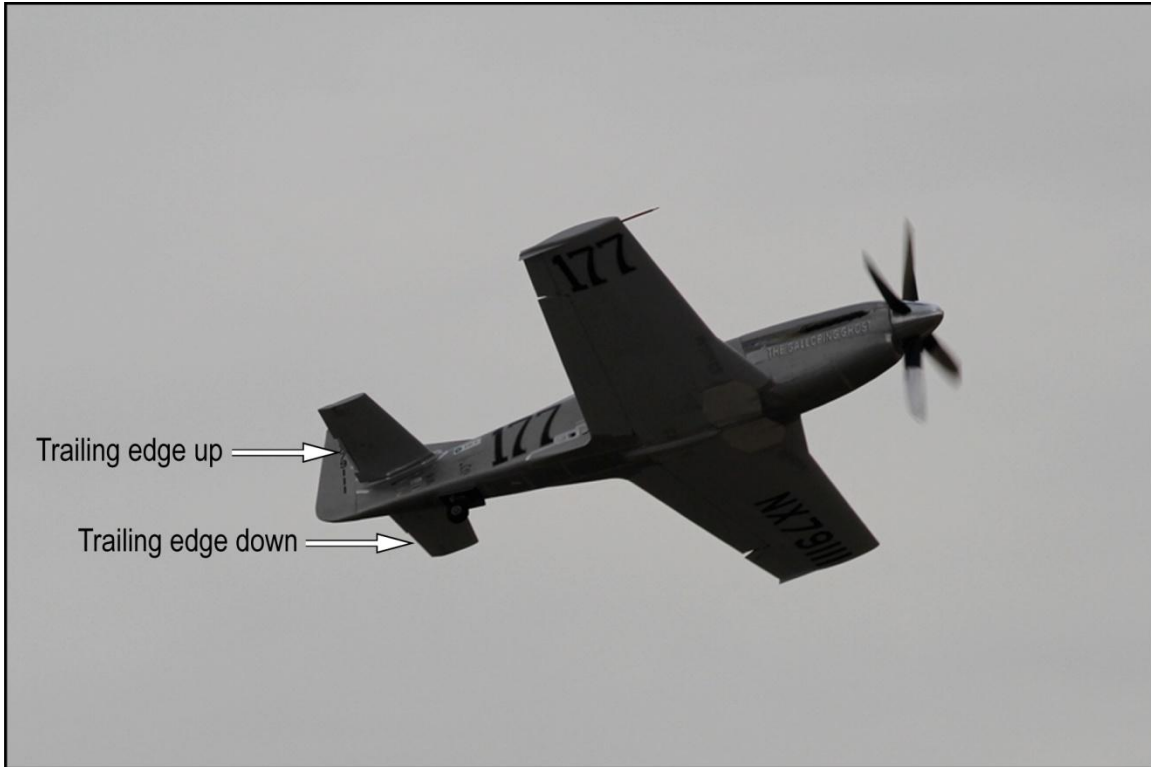
A photograph captured about 0.14 second later, at 1624:30.34, showed that the left elevator trim tab was trailing edge down, and the right elevator trim tab was trailing edge up. Nearly full right-wing-down aileron deflection (right aileron trailing edge up, left aileron trailing edge down) was also evident (see figure 8).

Figure 8. Airplane pitching up with left elevator trim tab trailing edge down at 1624:30.34, right elevator trim tab trailing edge up, and nearly full right-wing-down aileron deflection.

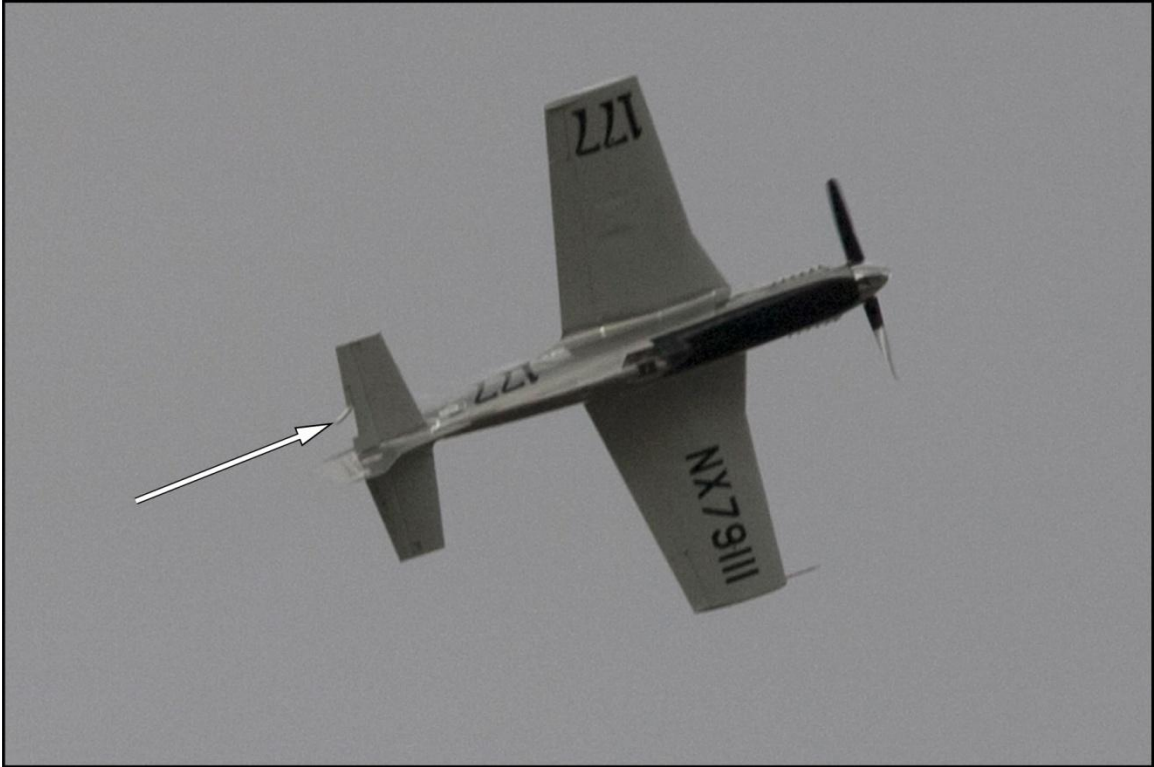
A photograph taken about 1624:32 showed that, as the airplane reached the apex of the climb, the left elevator trim tab was detached from its inboard hinge (see figure 9). Another photograph showed that, about 1624:33.5 (about 4.6 seconds after the left roll upset began), the inboard piece of the left elevator trim tab was separated from the airplane (see figure 10).

Figure 9. Inboard piece of left elevator trim tab detached from inboard hinge.

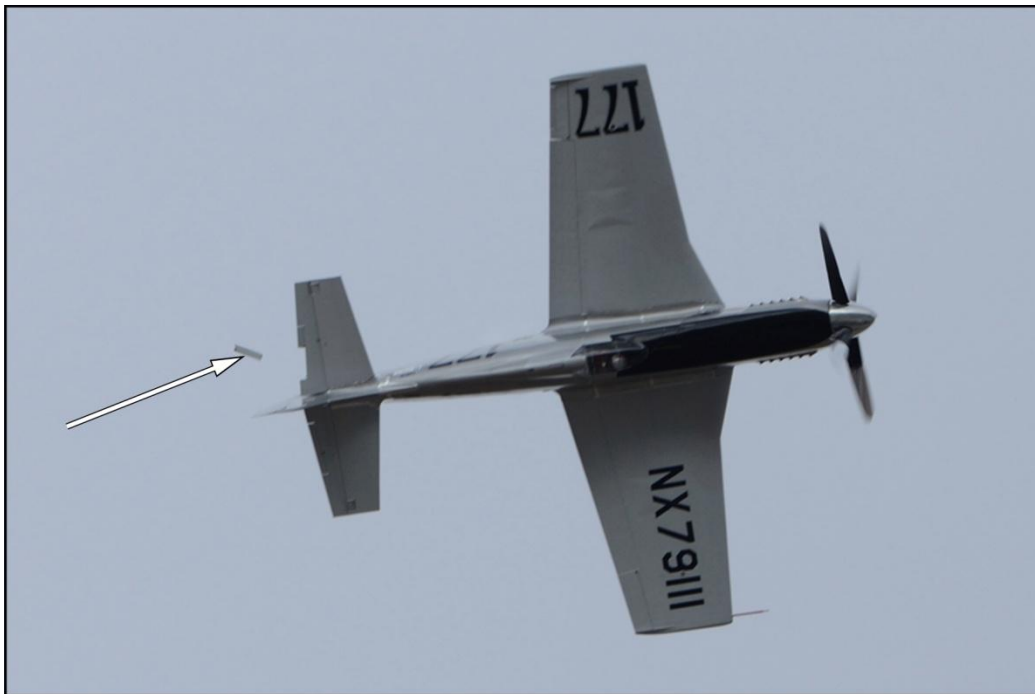
Figure 10. Inboard piece of left elevator trim tab separated.

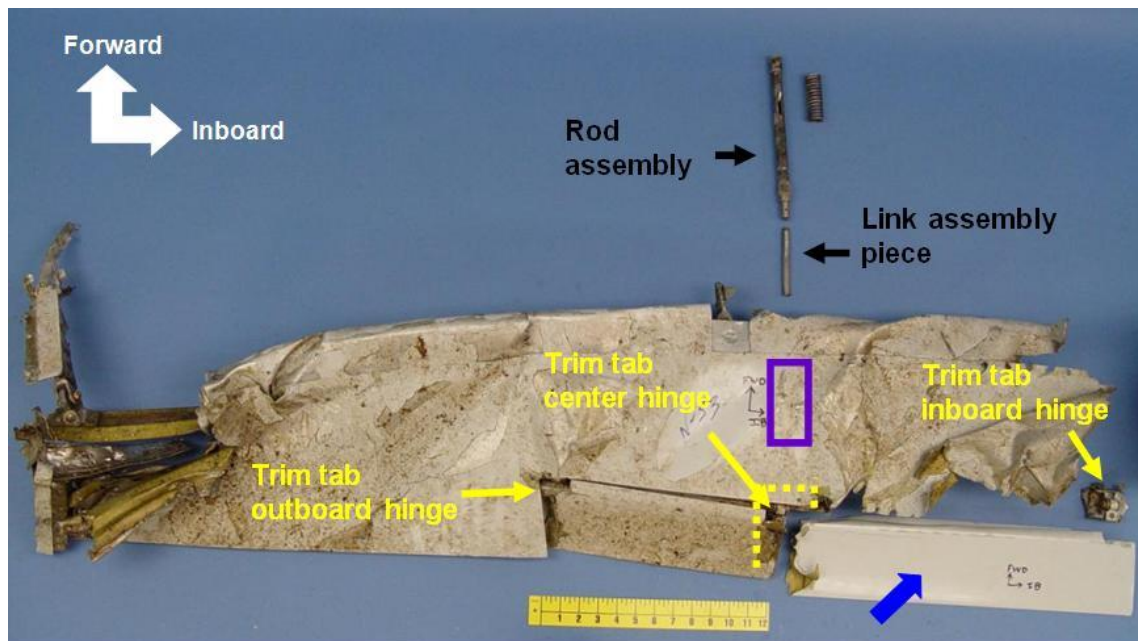
Figure 12. Left elevator showing the relative installed locations of the recovered trim tab pieces, trim tab hinges, trim tab rod assembly, and trim tab link assembly piece.

The blue arrow points to the piece of the tab that separated in flight, and the purple box shows a long, upward bulge in the upper elevator skin.

The left elevator trim tab link assembly was buckled and fractured in bending overload in the threaded portion of the clevis with the bending process producing an upward bulge in the upper skin of the elevator (indicated by the purple box in figure 12). Evidence of subsequent oscillations of the free trim tab was indicated by scoring on the elevator's lower skin material, and on the fracture of the link assembly's tubing section, which showed notched fracture faces from repeated contact.

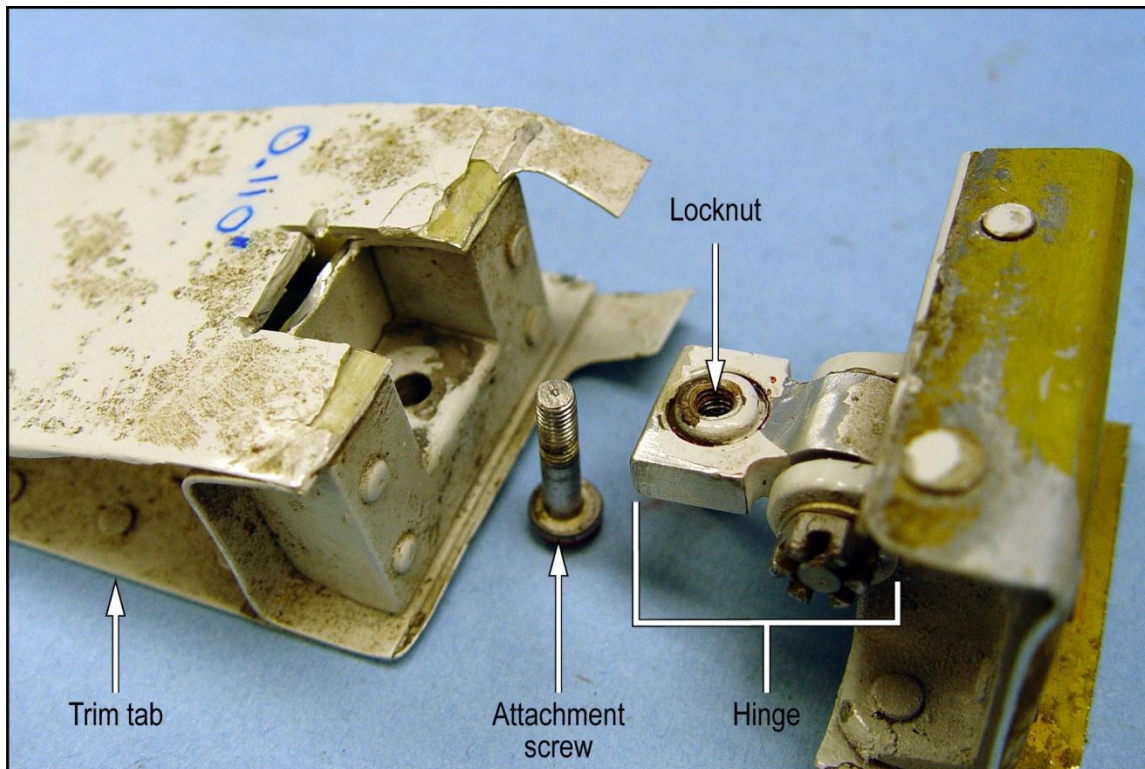
Figure 13. Section of right elevator trim tab (view of underside) showing the inboard hinge, attachment screw, and locknut.

All of the intact elevator trim tab attachment screws were loose with negligible resistance from their respective locknuts. The locknuts showed evidence of yellow paint beneath the uppermost coat of paint; records show that the airplane had been painted yellow before the 1985 NCAR. For each intact screw, the fiber locknut insert material applied little to no clamping pressure on the screw threads, and all of the inserts showed evidence of age and reuse³⁷ (see figure 14). The mating surfaces between each trim tab and its respective outboard, center, and inboard hinges displayed varying degrees of missing paint and exposure of bare metal, consistent with relative motion due to the loose screws. The left trim tab's outboard trim tab screw was slightly shorter than specified, and the center trim tab screw was significantly shorter than specified and its tail was flush with the end of the locknut.

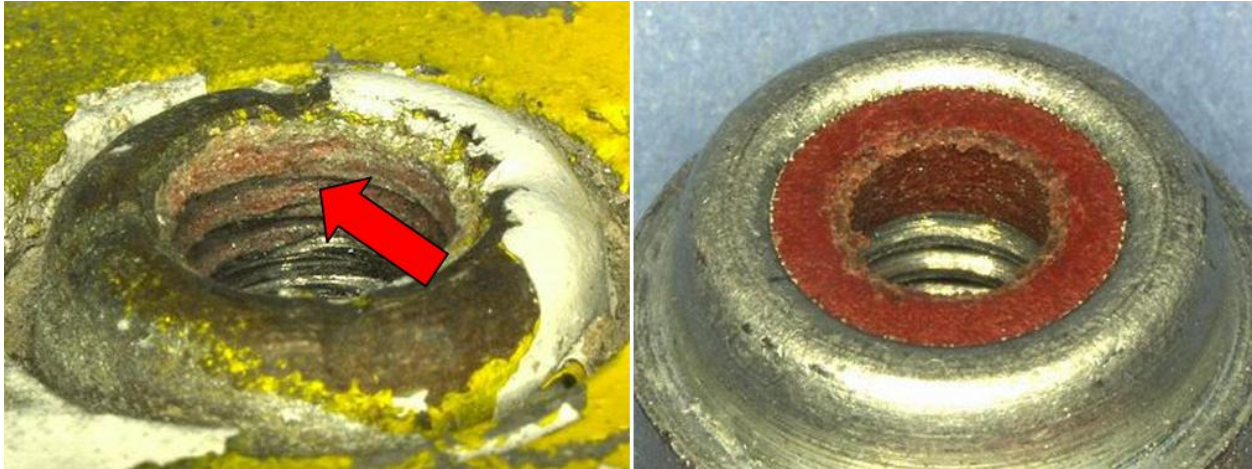
³⁷ Common maintenance guidance indicates that a locknut with a fiber or nylon insert should not be reused if it cannot meet the minimum prevailing torque values. See AC 43.13-1B, "Acceptable Methods, Techniques, and Practices – Aircraft Inspection and Repair," chapter 7, paragraph 64 (f).

Figure 14. Locknut in the left elevator trim tab outboard hinge.

Red arrow indicates red insert material (left) and an exemplar new locknut shows intact fiber insert material (right).

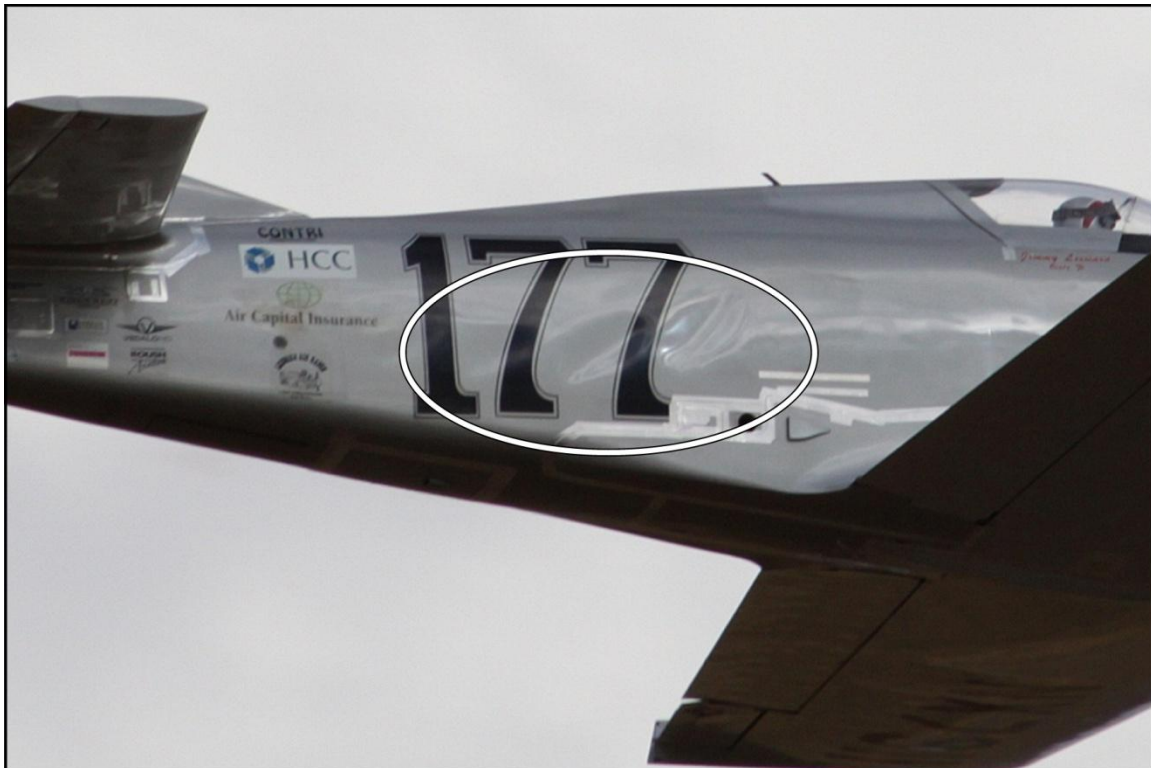
Photographs of the airplane taken during the accident race showed that structural deformation was visible in flight. Figure 15, which was cropped from a photograph taken during the race's second lap, shows that diagonal wrinkles were evident on the right side of the aft

Figure 15. Diagonal wrinkles on right side during accident race.

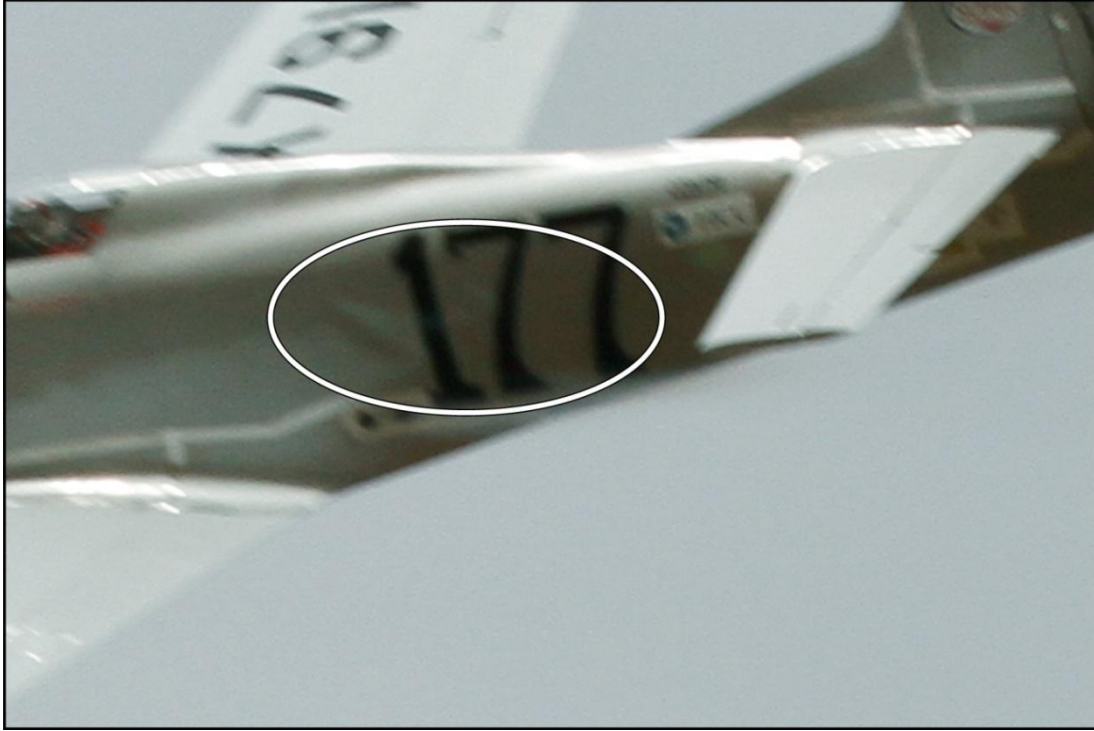
fuselage. Figure 16, which is a photograph that was taken as the airplane passed pylon 2 during the accident lap, shows that similar (although less pronounced) diagonal wrinkles were evident on the airplane's left side; photographs showed that this deformation was evident during all three laps of the accident race and during qualifying flights performed on September 13, 2011. Figure 17, which was taken during the first lap of the accident race, shows that deformation was evident along the canopy and windscreen, such that a gap was visible; this deformation was also evident in photographs taken during the third lap of the accident race but was not evident in prerace photographs of the airplane on the ground.

Figure 16. Diagonal wrinkles on left side during accident race.

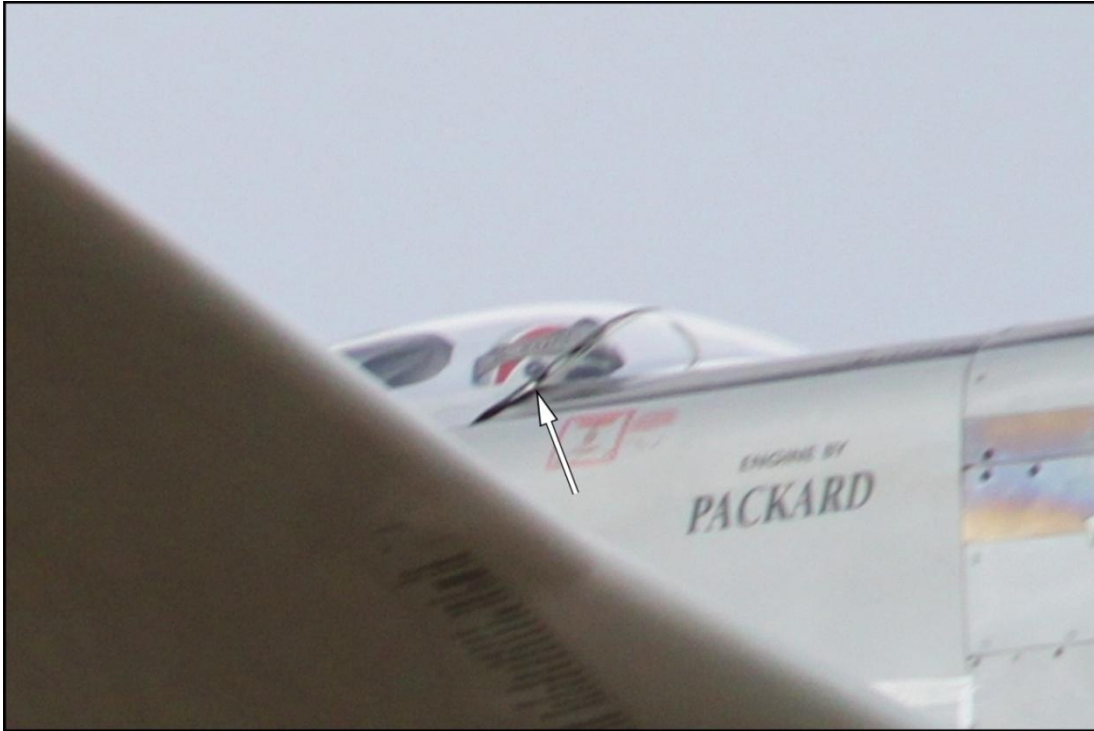
Figure 17. Gap between canopy and windscreen in flight.
