National Transportation Safety Board

Railroad Accident Brief

Accident No.: DCA-12-FR-003
Location: Amarillo, Texas
Date: January 9, 2012
Time: 11:09 a.m. central standard time
Railroad: BNSF Railway
Property Damage: \$150
Injuries: 0
Fatalities: 1
Type of Accident: Employee struck by moving equipment

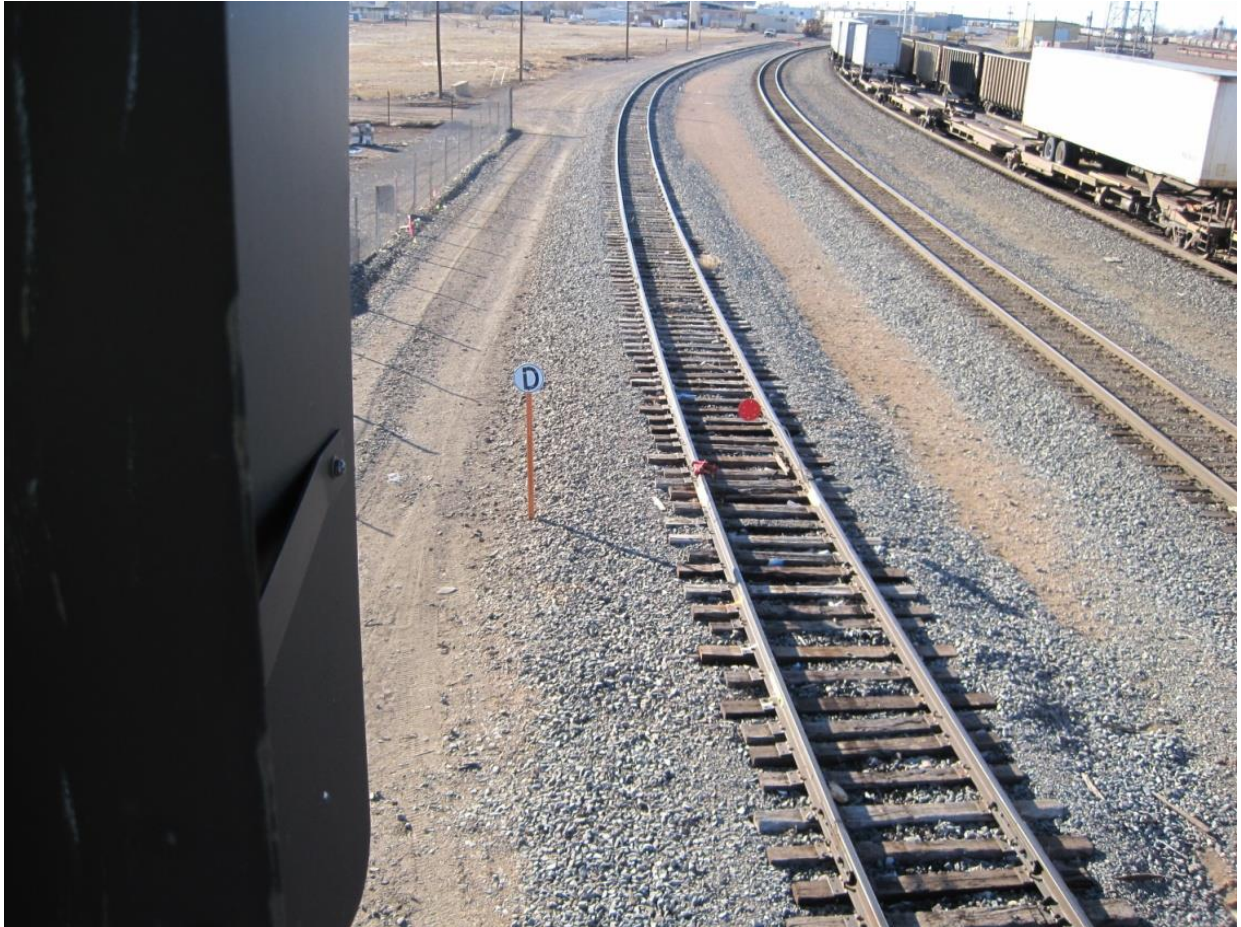
BNSF radio recordings indicated that the welding foreman had spoken with the yardmaster before leaving his yard location and moving the equipment eastward on track No. 1805 toward main track No. 2 of the Red River Valley Subdivision. (See figure 3 for an overhead view of the accident area at the derail.)

Figure 3. Overhead view facing west of track No. 1805 with derail opposite signpost D.

After the equipment stopped,⁸ the welding foreman restored the derail to the derailing “on” position and secured the derail with its lock. He then walked to the control cab to tell the machine operator he had noticed a hydraulic leak as the grinding machine passed him. The welding foreman, the machine operator, and the Loram laborer evaluated the leak and determined they needed to move the equipment back into the yard to make the necessary repairs, because the leak was too severe to continue to the work location. The operator told investigators that he and the welding foreman decided that the derail would have to be removed to allow for the reverse movement. The operator also said that he and the welding foreman had walked together to the cab of the grinding machine, and then he had climbed into the cab. The operator said that shortly after he entered the cab, the welding foreman gave him a hand signal to make a westbound (that is, a reverse) movement.
