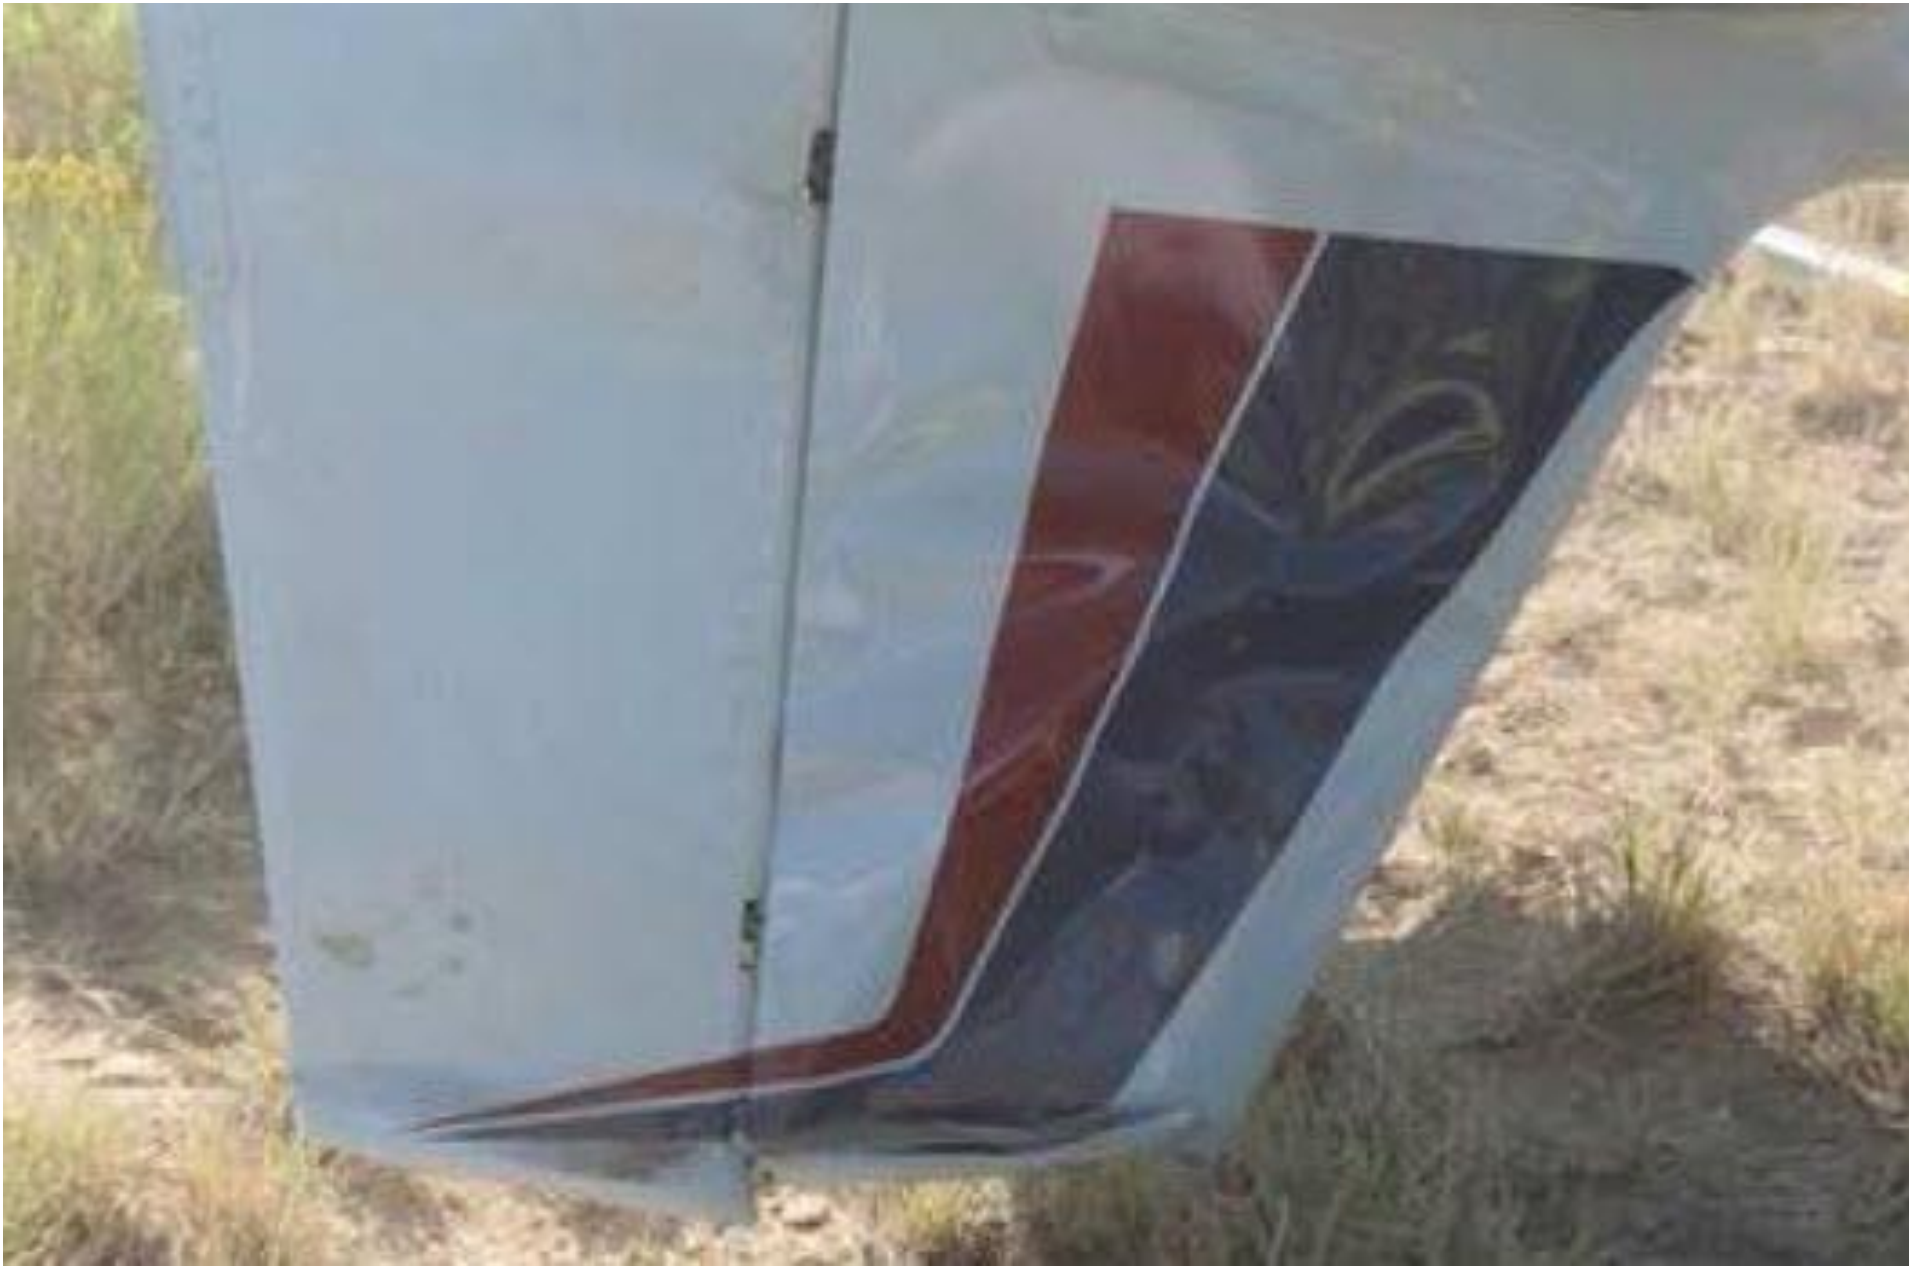
Photo 1 – View of empennage damage (photo courtesy of the FAA)
