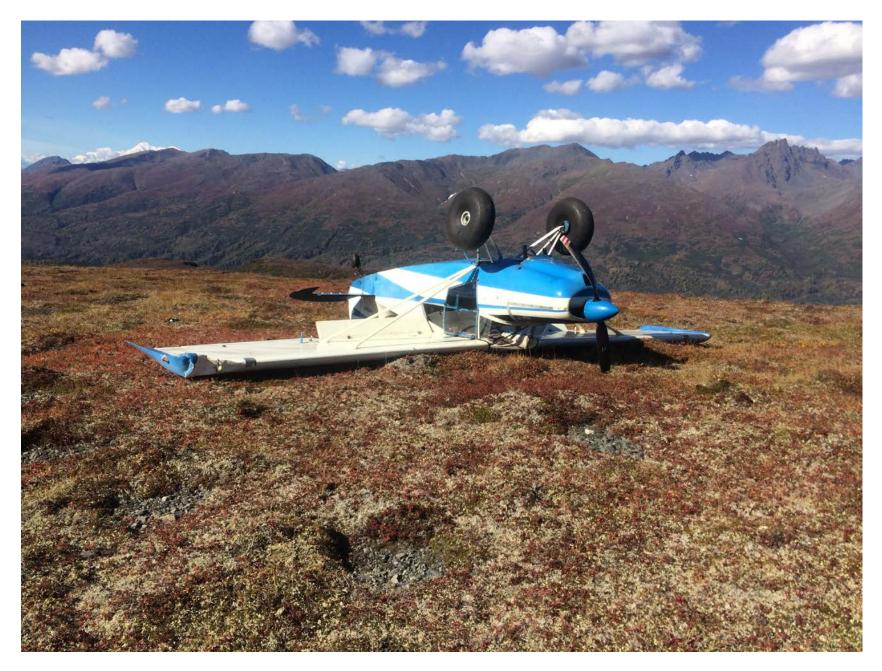
Photo 1 – View of airplane from front (photo courtesy of the FAA)

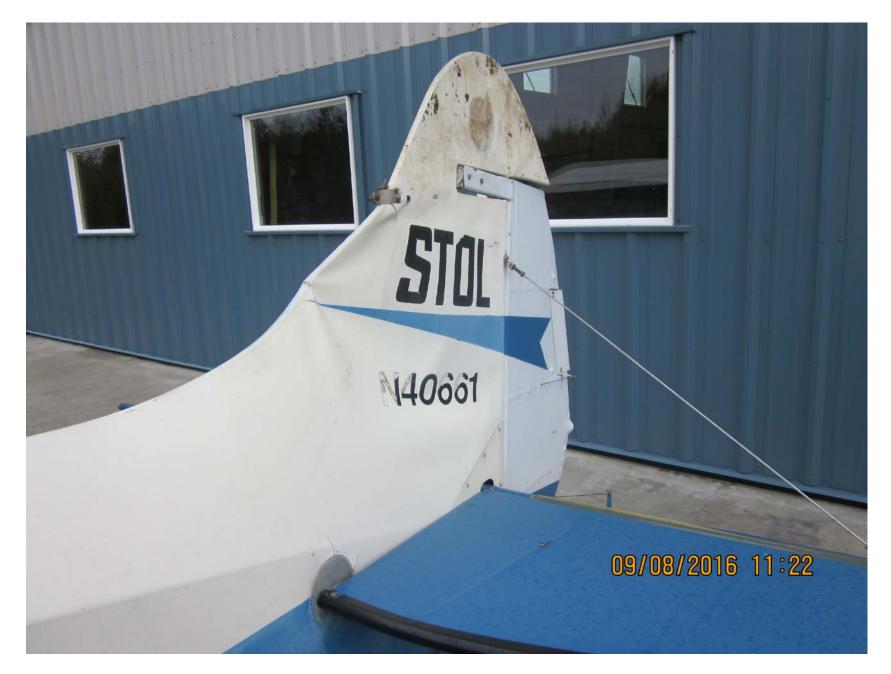
Photo 2 - View of empennage damage (photo courtesy of the FAA)
