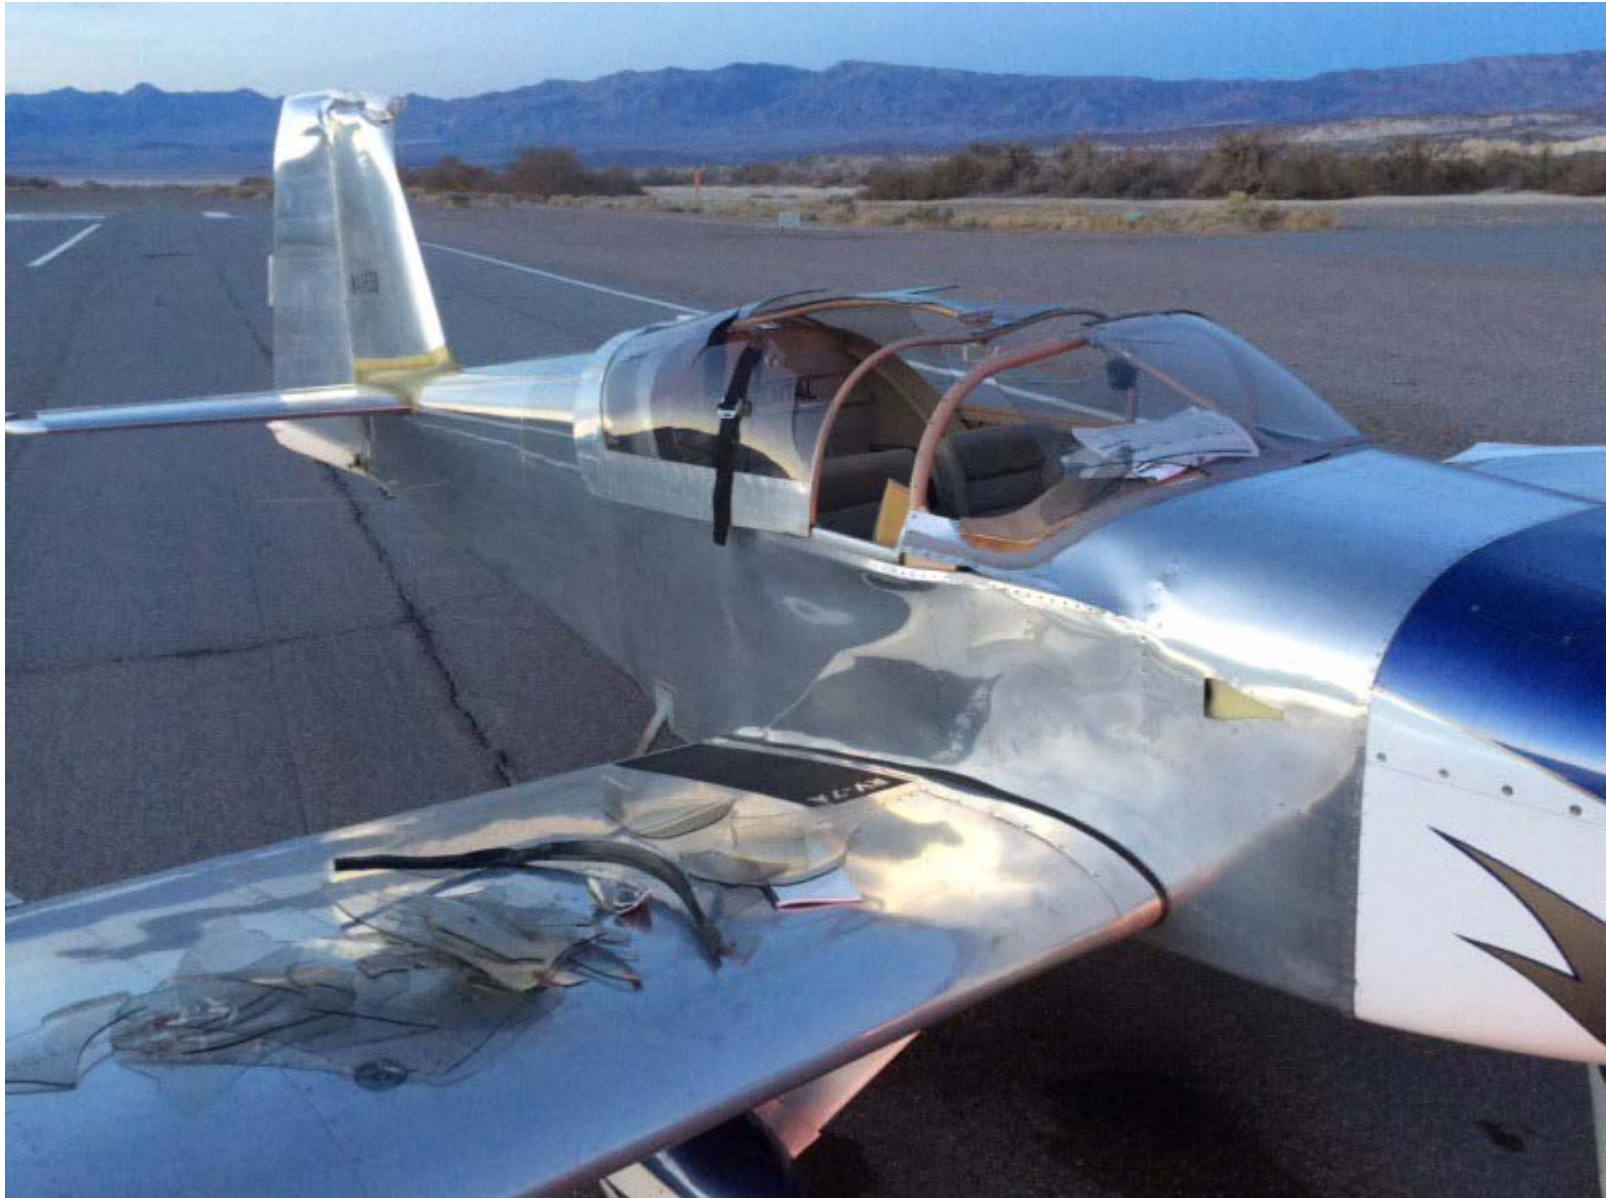
Photo 1 – View of damaged canopy and empennage (Photo courtesy unknown)
